**New York State Department of Environmental Conservation  
Waste Tire Stockpile Assessment Summary Sheet - Site 5-23**

## **East Side Auto Village of Hudson Falls**

**Region 5, Washington County**

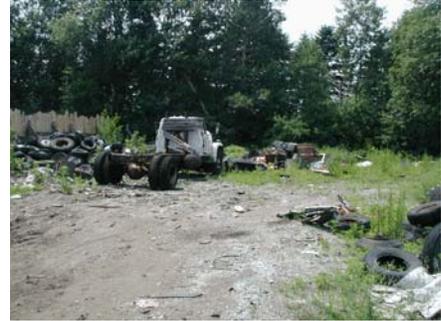
**Site of an operating automobile junkyard. Tire piles located adjacent to the road on the south side. The junkyard is located on the north side of the road. Site is located adjacent to residential areas and less than 1/4 mile from 2 schools.**

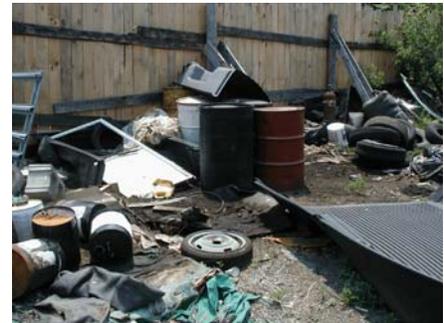
**Number of tire piles: 2 piles 15 feet apart**

**34'W X 120'L X 7'H and  
29'W X 120'L X 10'H**

**Mostly passenger car tires. Two piles are segregated from other waste/debris.**

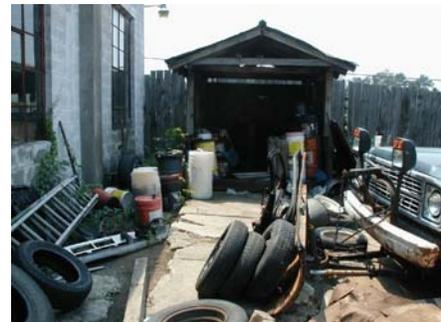
**Somewhat dilapidated fence with open gate. Tire piles are visible from road (approx 40 feet off road). Grassy field.**

**Concerns: Vectors, Fire, Aesthetics, Schools**
