**New York State Department of Environmental Conservation
Waste Tire Stockpile Assessment Summary Sheet - Site 6-09**

**Clark Property
(Formerly Davis Property)
Town of Morristown**

Region 6, St. Lawrence County

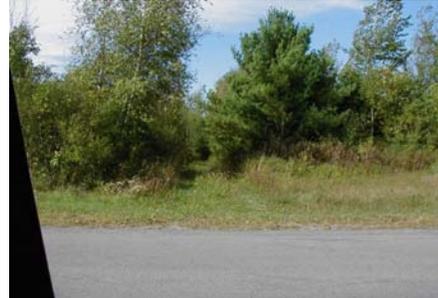
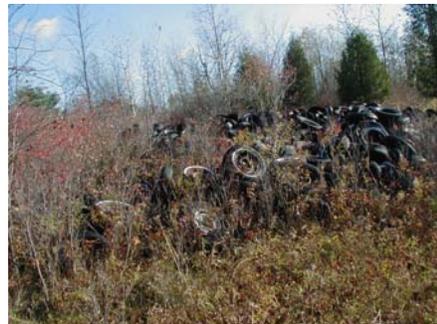
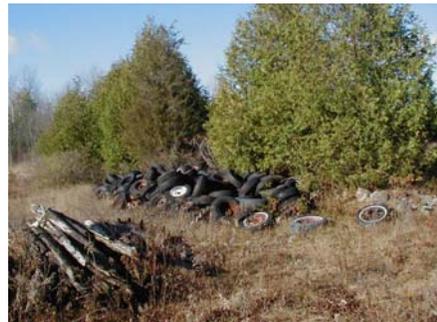
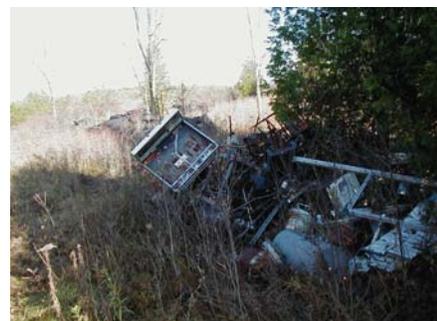
One large pile of 2,000 tires plus 3 small piles with volume ranging from 200 to 500 tires.

All relatively clean whole tires. 15% to 20 % of tires are on rims.

Concerns: Fire and vectors

There is only a grassy farm road to the tires. It would need to be improved prior to attempting to remove the tires. Vehicle access would not be difficult but could damage the property during the wetter seasons.
