**New York State Department of Environmental Conservation
Waste Tire Stockpile Assessment Summary Sheet - Site 9-12**

**Route 20 Auto Parts
Town of Angola**

Region 9, Erie County

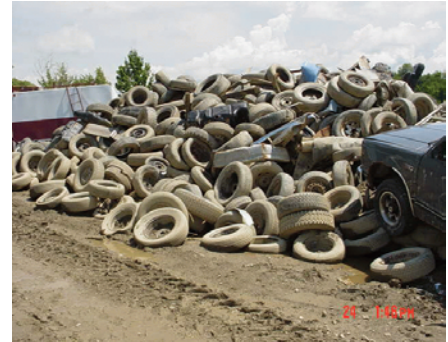
The tires are in 10 separate piles scattered around the yard ranging from 300 to 11,000 tires. Some of the tires are mixed with other scrap. Many have rims and are dirty. One or two of the piles also contains burned tires from a fire in 2001.

Concerns: Vectors and fire
