SANITARY SEWER INVESTIGATION AND REMEDICATION

COLVIN BOULEVARD AND 96TH STREET

**GLENN SPRINGS HOLDINGS, INC.
NIAGARA FALLS, NEW YORK**

**MARCH 2011
REF. NO. 009954 (21)**

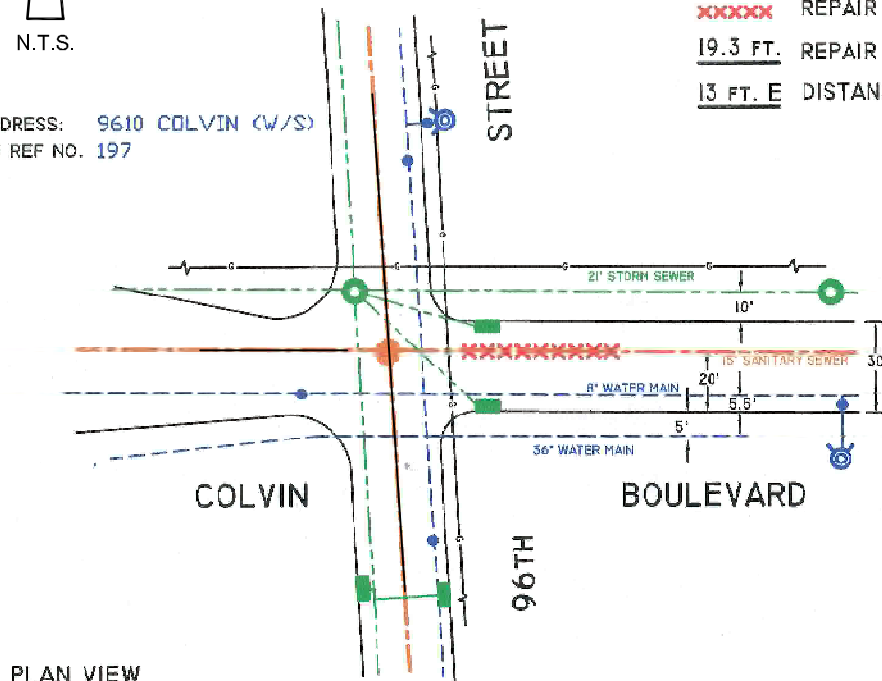
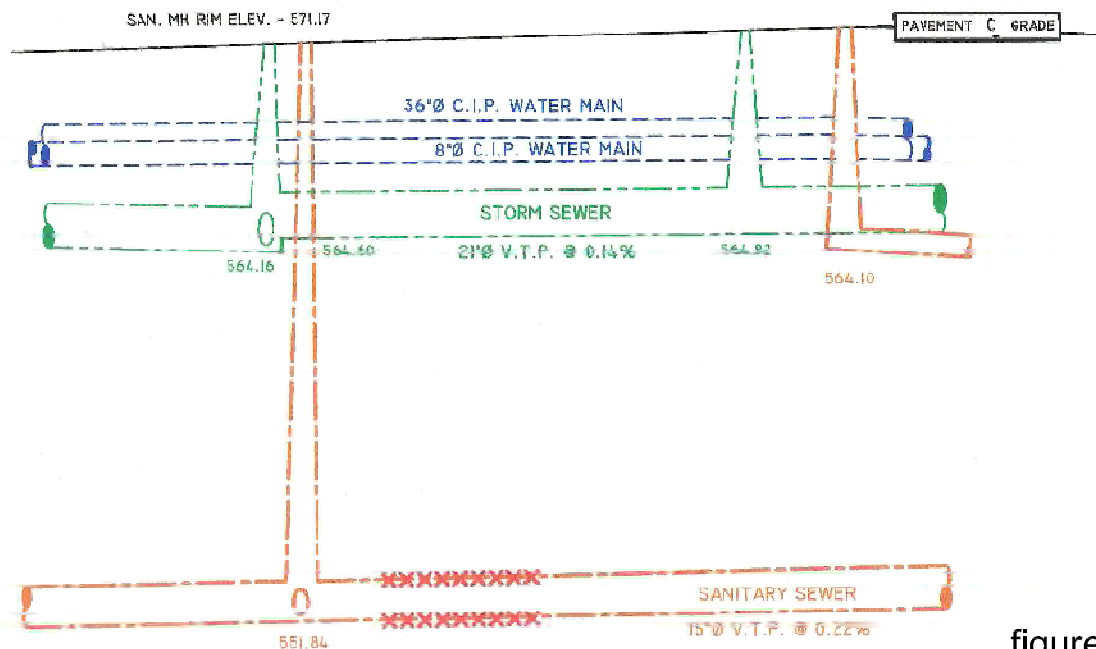
The video inspection identified a deflection (i.e., low spot) in a 50-foot section of the sanitary sewer beneath the median area of Colvin Boulevard immediately east of the 96th Street. As part of the NFWB LaSalle Area Spot Sewer Repair project, this section of sewer was to be excavated and replaced to eliminate the low spot. The location of the 50-foot section of sanitary sewer is shown on Figure 2.1 and a plan and profile of the area to be repaired is shown on Figure 2.2.

19.3 FT. REPAIR DEPTH (APPROX.)

13 FT. E DISTANCE FROM MANHOLE (APPROX.)

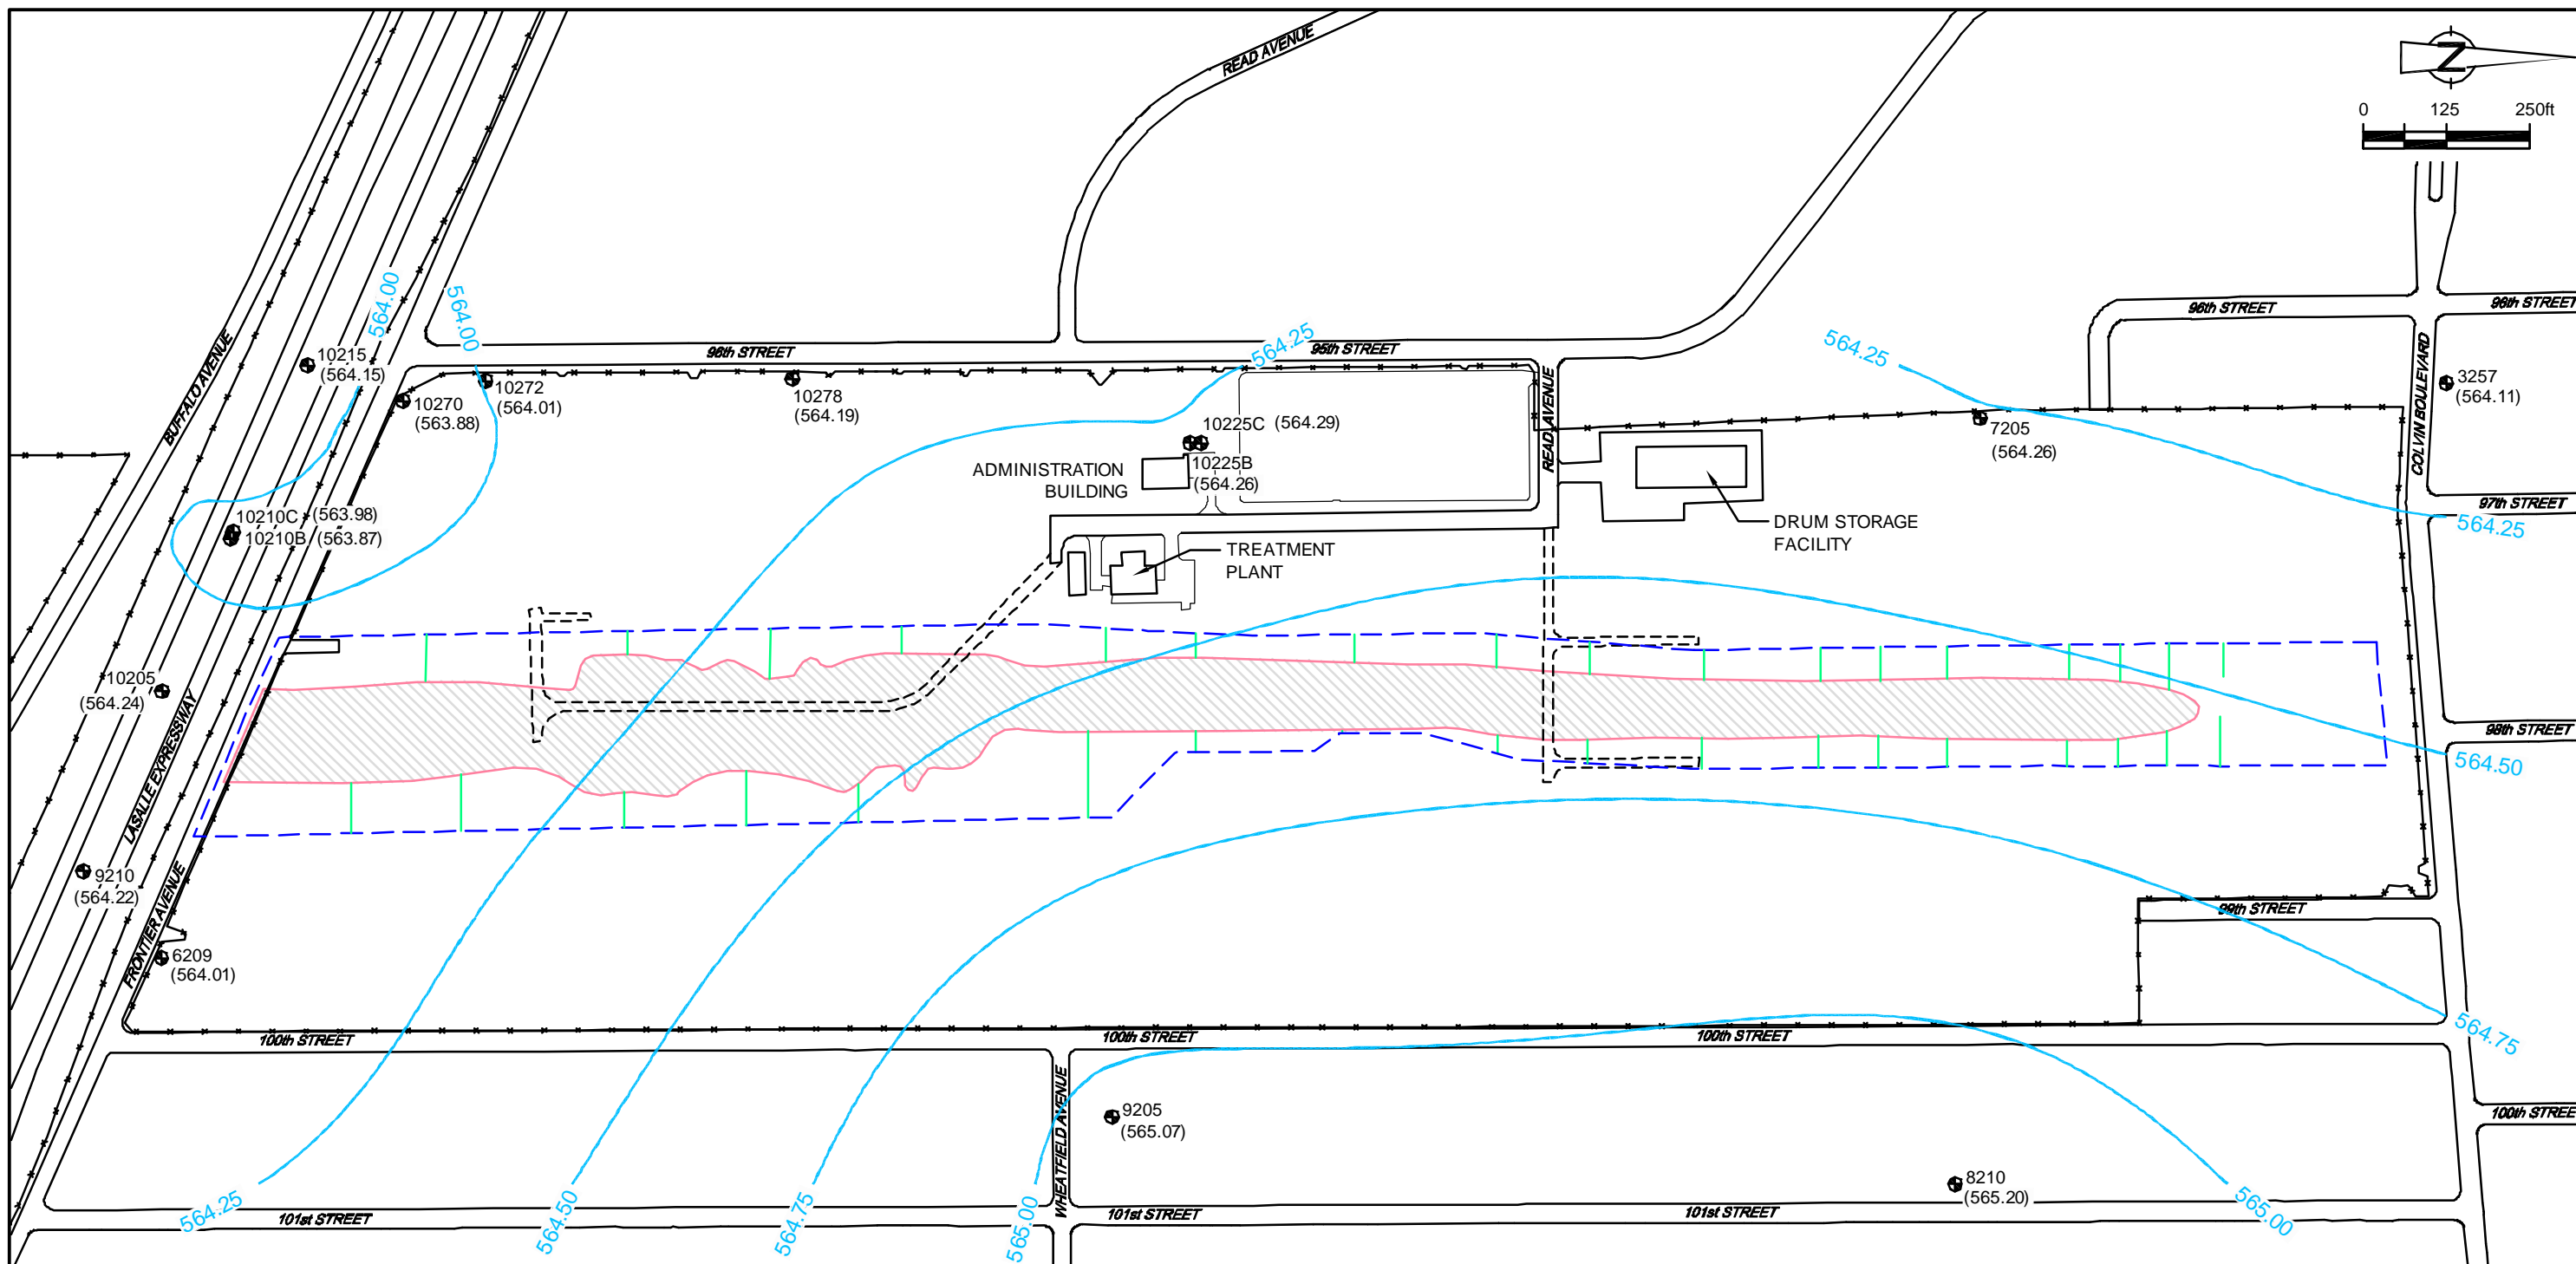
figure 3.4

The analytical monitoring data (essentially non detects) and hydraulic monitoring data (inward gradients) evaluated above show that the remedial system at Love Canal is effective, operating as designed, and is not the source of the chemistry observed in the section of sanitary sewer pipe on Colvin Boulevard just east of 96th Street.

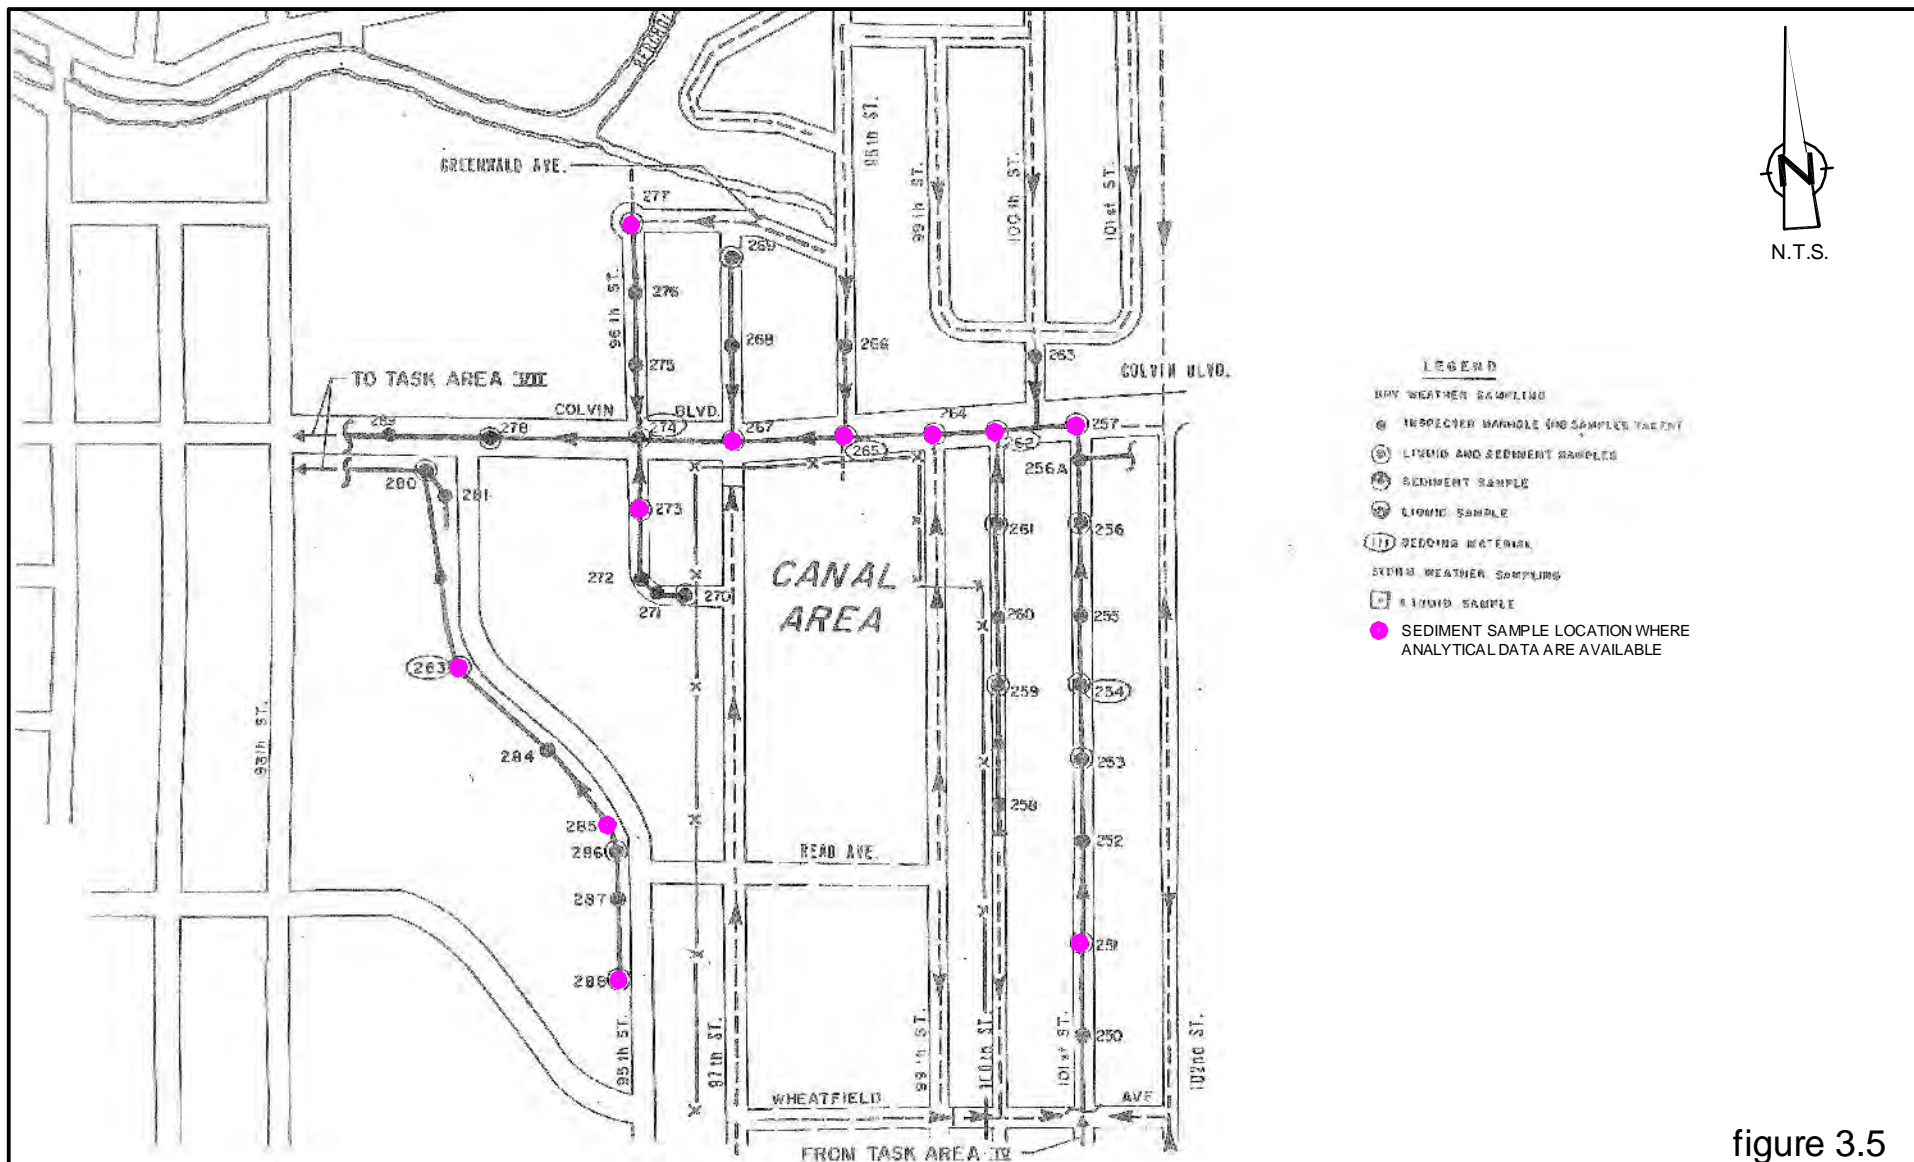
figure 3.5

summary of the analytical data is presented in Table 3.2. Sediment was present at manholes MH257 (101st Street – furthest east from the sewer excavation site on figure), MH262 (100th Street), MH264 (99th Street), MH265 (98th Street), and MH267 (97th Street). However, sediments were not found in MH274, which is located at the corner of 96th Street. The absence of sediment in MH274 indicates that the low spot in the sewer pipe identified by the video inspection conducted by the NFWB in 2000 (which is located approximately 10 feet east of MH274) acts as a "sediment trap." Therefore, it is reasonable to conclude that contaminated sediments present upstream from MH274 could have possibly been flushed down to the low spot, prior to 1983 and the original Love Canal remedial actions, and settled there, being unable to move further west to MH274.

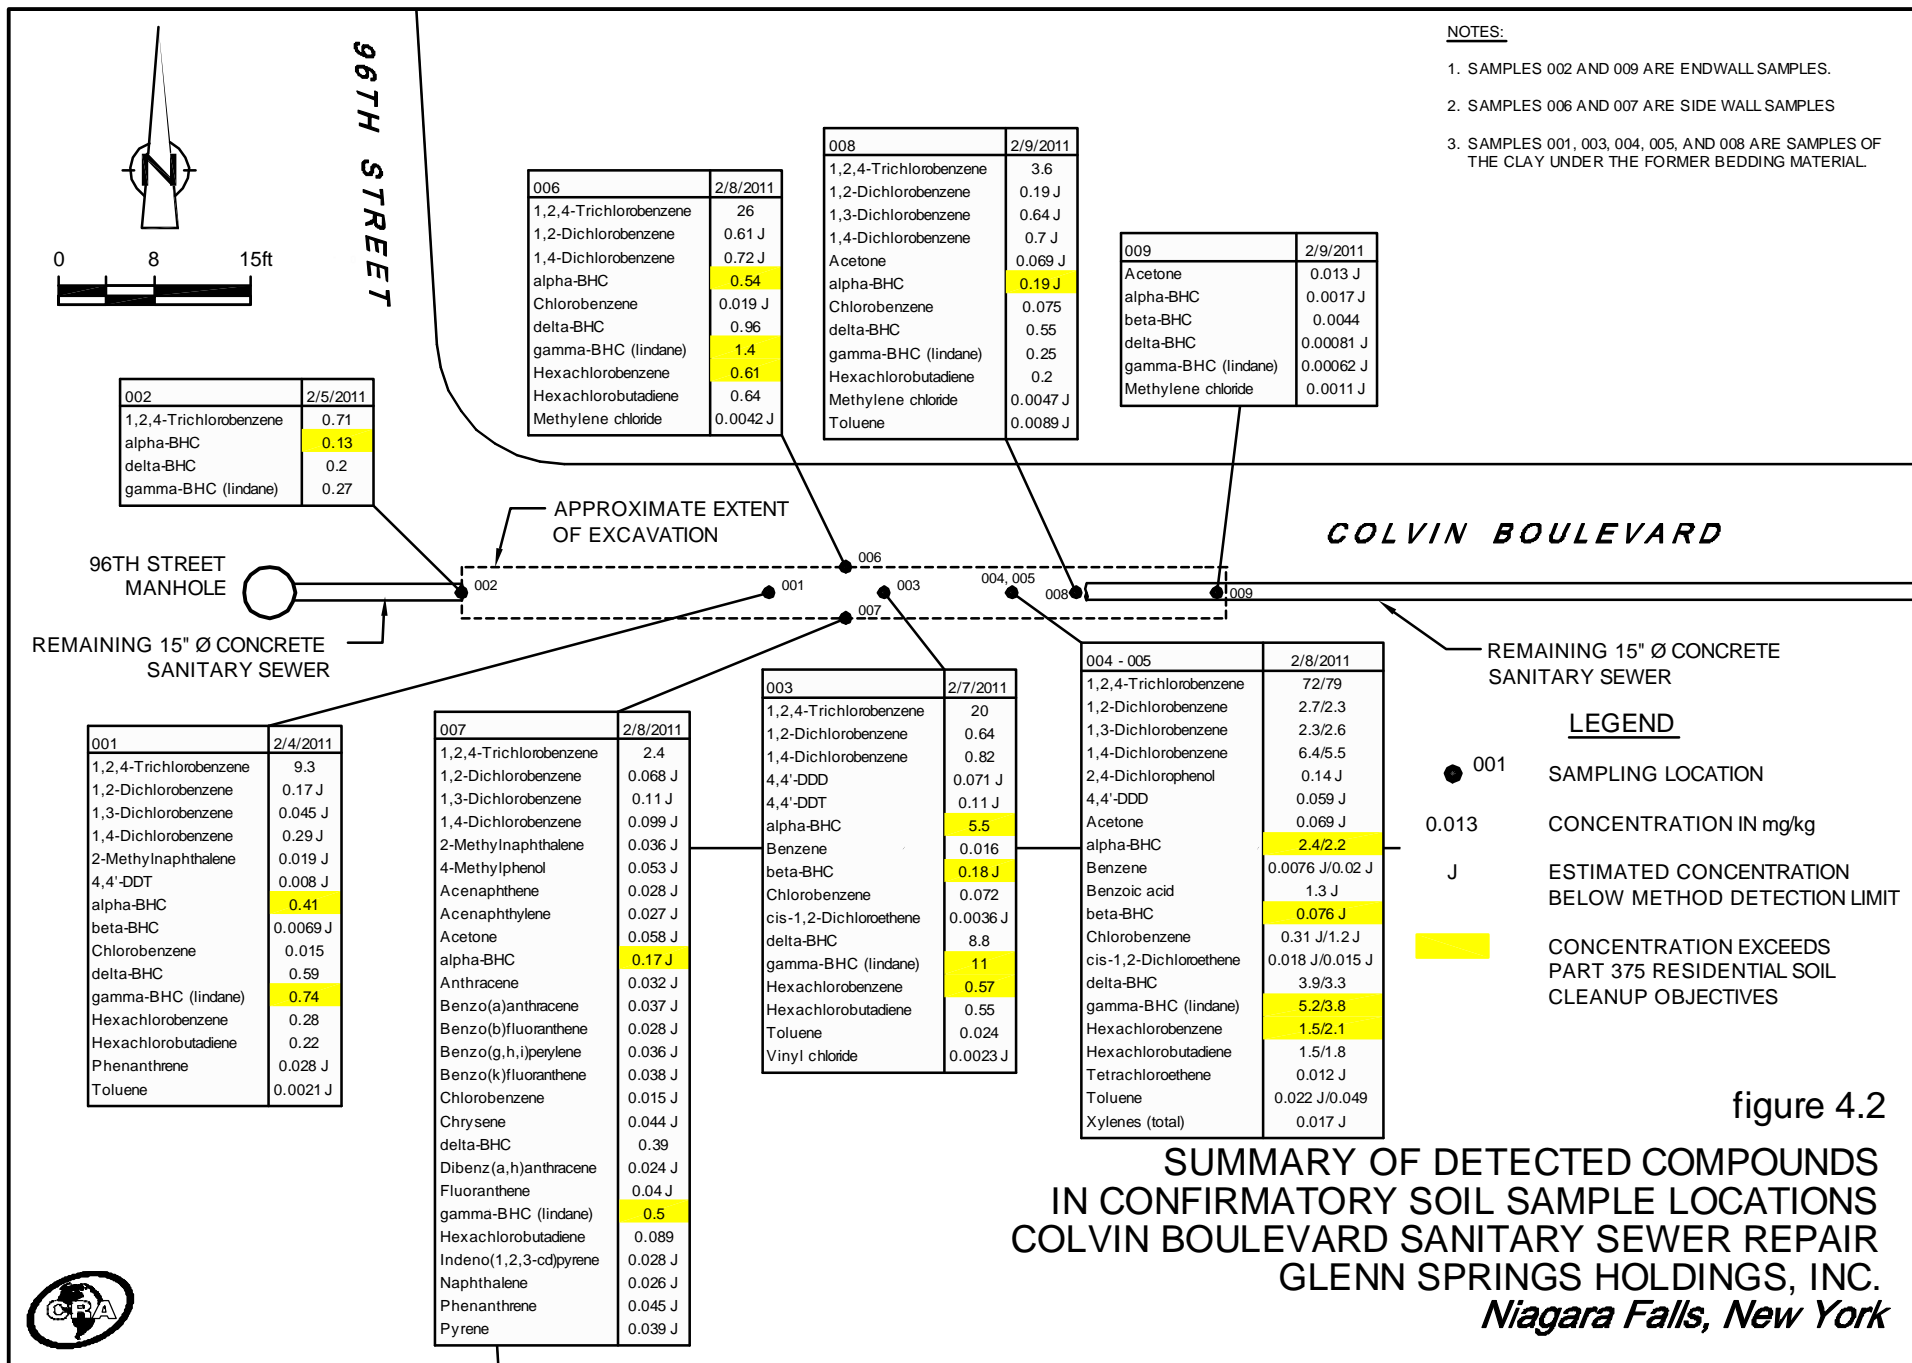
figure 4.2

Based on the confirmatory soil sampling data, residual impacts remain at the bottom of the trench; however, the end wall sample results show that the residual impacts do not extend east or west beyond the sewer repair area.

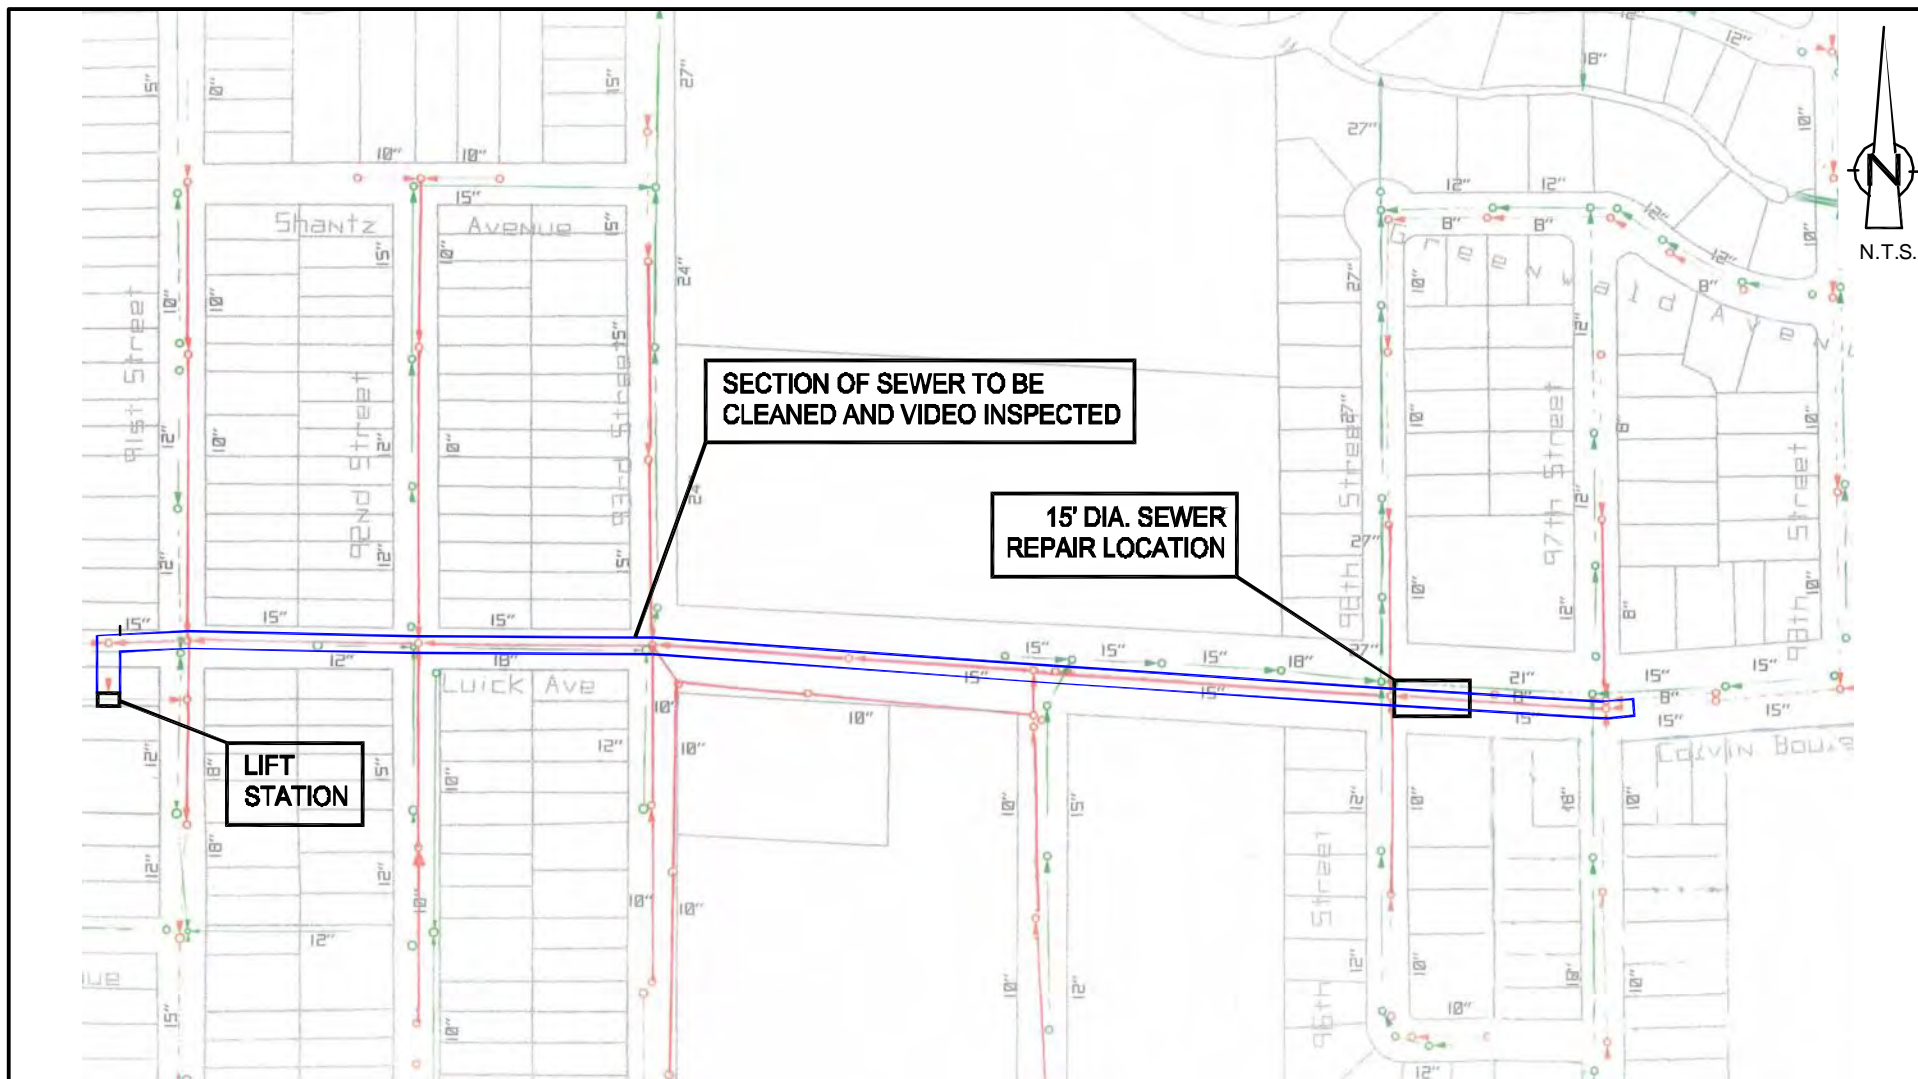
figure 4.3

- Video inspection of the repaired and cleaned Colvin Boulevard sanitary sewer confirmed that no sediments were present in the section of sanitary sewer between 97th Street and the lift station at 91st Street. Therefore, since residual sediments were removed from within the sanitary sewer line, there is no future potential for sediments to impact water quality in the sewer or air quality in the vicinity of the sewer.
