Appendix B
Photograph Log

APPENDIX B – PHOTOGRAPHIC LOG

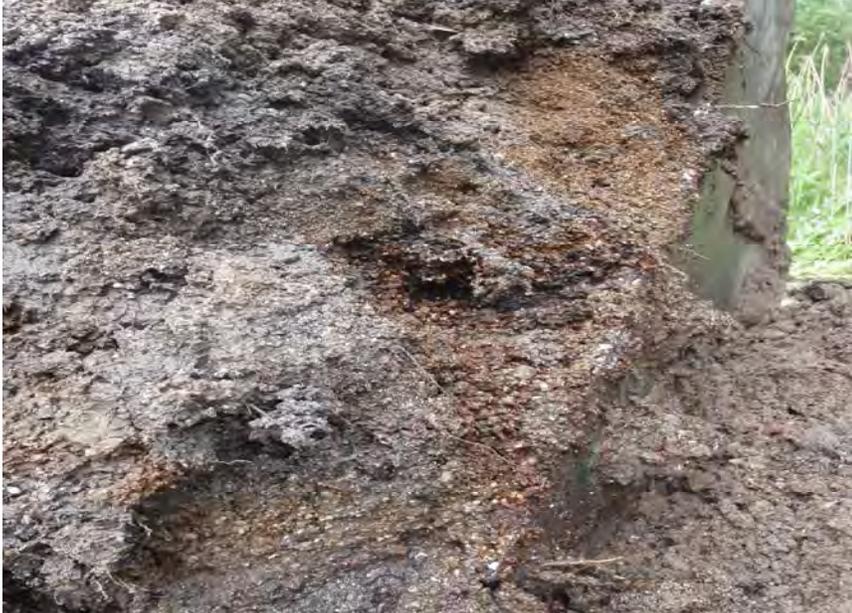
CLIENT NAME: Honeywell		SITE LOCATION: HB-TP-54A	PROJECT NO. 49362
PHOTO NO. 1	DATE: 6/4/12

DESCRIPTION Excavator bucket spoils from roughly 6 feet below grade (ft bgs) at the Northeast end of HB-TP-54A showing shells, oncolites, and coal slag.

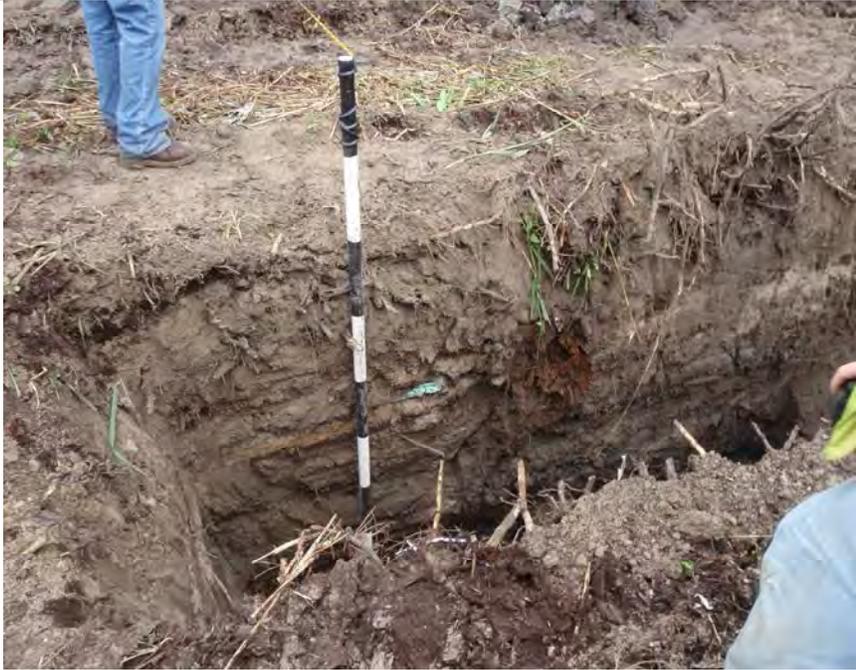
CLIENT NAME: Honeywell		SITE LOCATION: HB-TP-54A	PROJECT NO. 49362
PHOTO NO. 2	DATE: 6/4/12

DESCRIPTION Northeast end of HB-TP-54A showing fill with blue plastic bucket

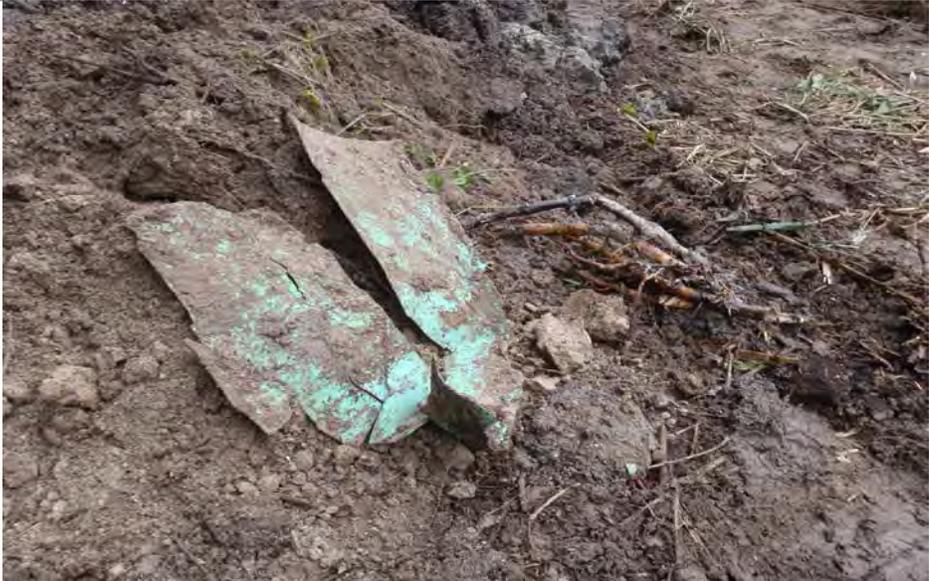
CLIENT NAME: Honeywell		SITE LOCATION: HB-TP-54A	PROJECT NO. 49362
PHOTO NO. 3	DATE: 6/4/12

DESCRIPTION Blue plastic bucket noted in picture 2

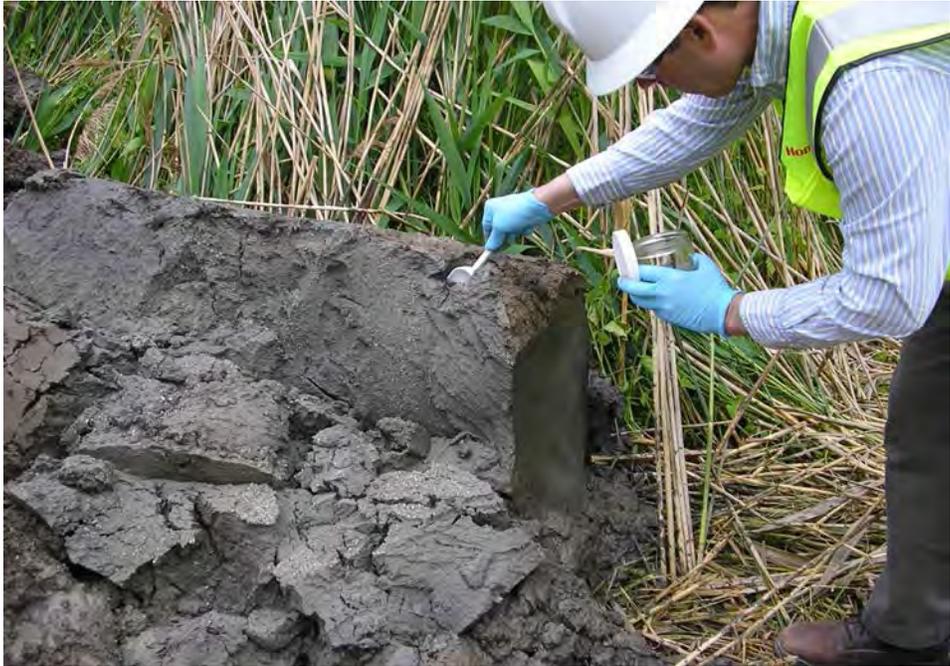
CLIENT NAME: Honeywell		SITE LOCATION: HB-TP-54A	PROJECT NO. 49362
PHOTO NO. 4	DATE: 6/4/12

DESCRIPTION Marl Sample collected at 20 ft from Northeast end of HB-TP-54A.

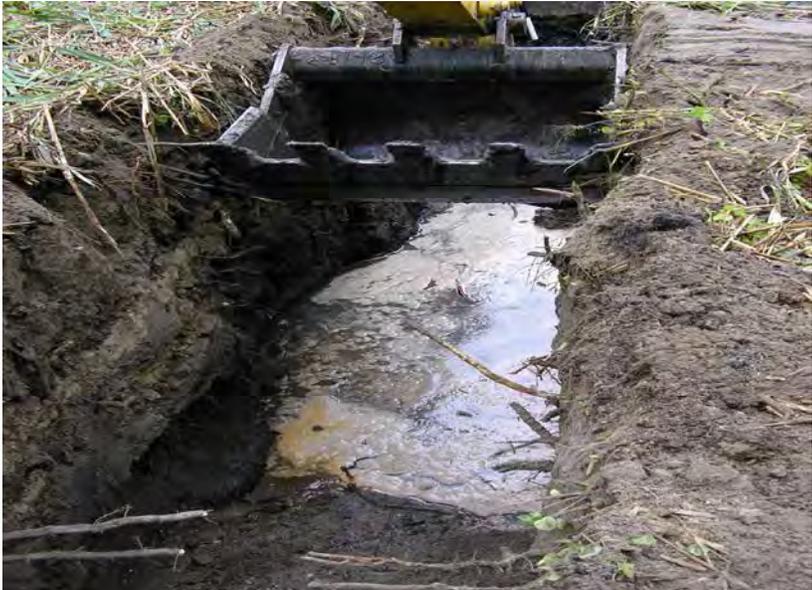
CLIENT NAME: Honeywell		SITE LOCATION: HB-TP-54A	PROJECT NO. 49362
PHOTO NO. 5	DATE: 6/4/12

DESCRIPTION Groundwater Entering HB-TP-54A.

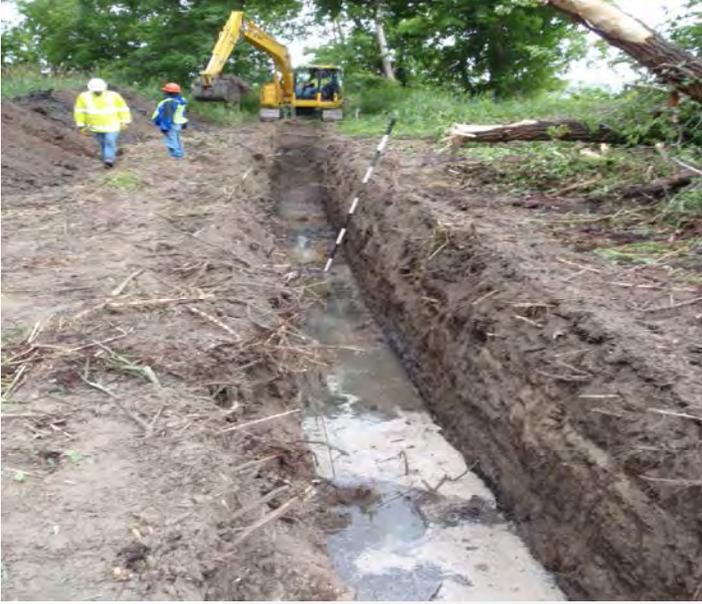
CLIENT NAME: Honeywell		SITE LOCATION: HB-TP-54A	PROJECT NO. 49362
PHOTO NO. 6	DATE: 6/4/12

DESCRIPTION HB-TP-54A looking west.

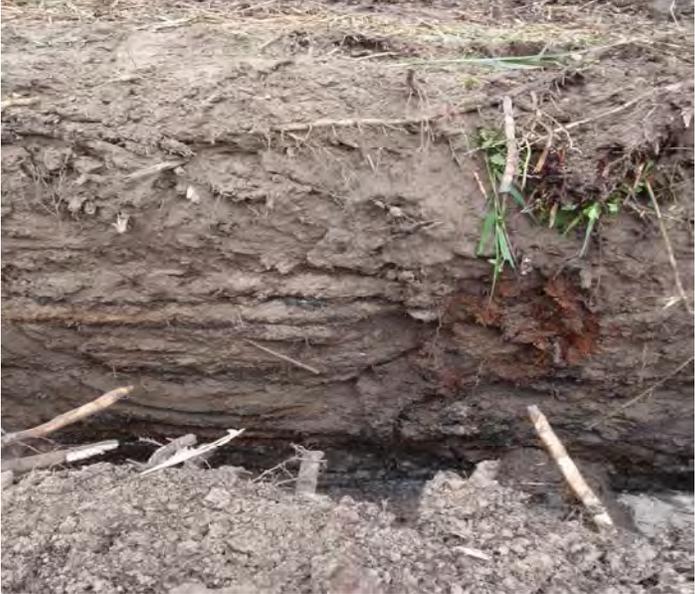
CLIENT NAME: Honeywell		SITE LOCATION: HB-TP-54A		PROJECT NO. 49362
PHOTO NO. 7	DATE: 6/4/12

DESCRIPTION Northeast end of HB-TP-54A showing fill to roughly 6 ft and shell, oncolite, and coal slag layer at roughly 6 to 6.5 ft bgs.

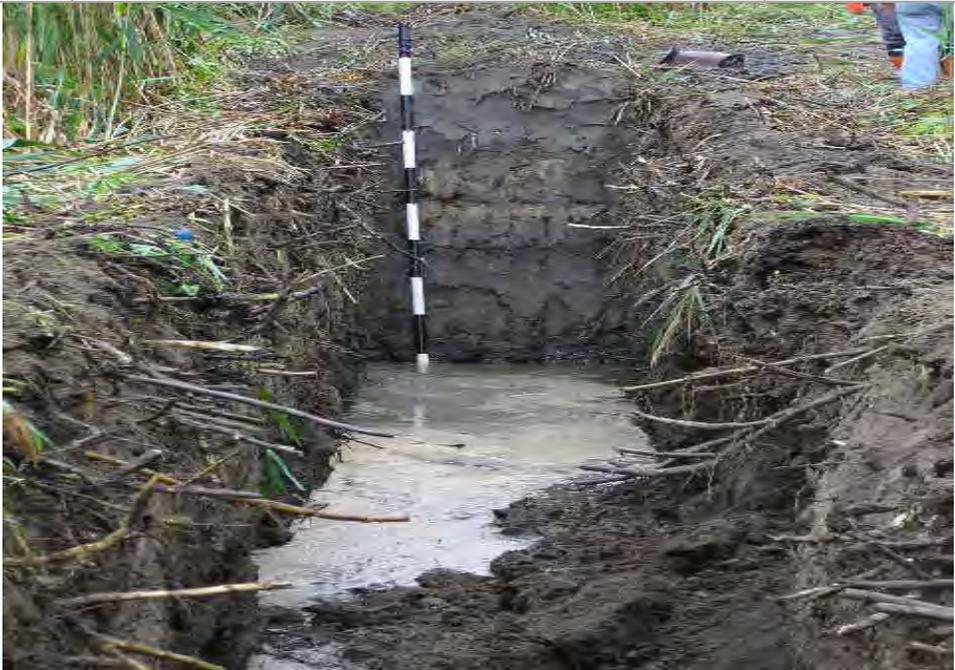
CLIENT NAME: Honeywell		SITE LOCATION: HB-TP-54A		PROJECT NO. 49362
PHOTO NO. 8	DATE: 6/4/12

DESCRIPTION Groundwater and test pit depth approximately 80 ft. from Northeast end of HB-TP-54A.

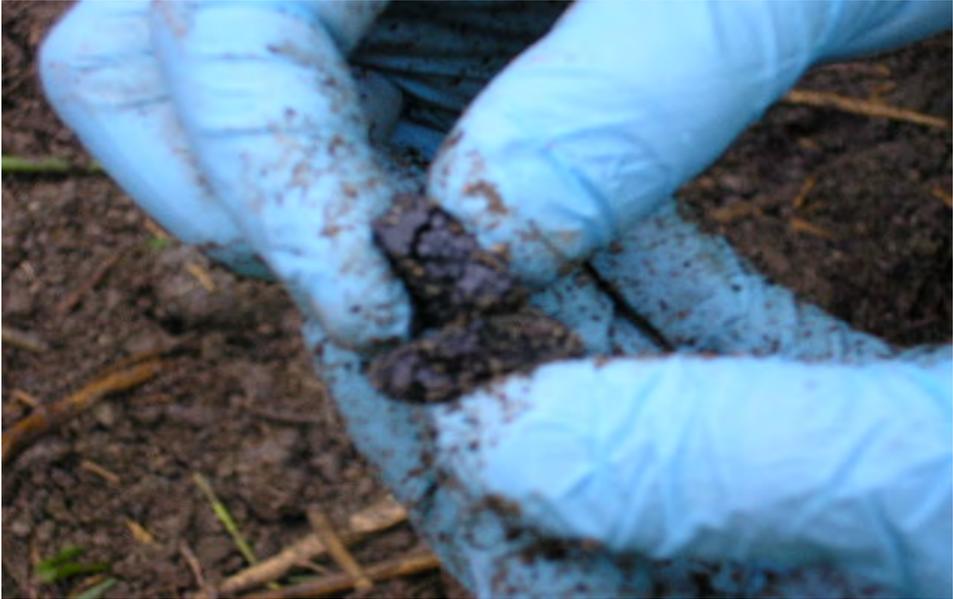
CLIENT NAME: Honeywell		SITE LOCATION: HB-TP-54A	PROJECT NO. 49362
PHOTO NO. 9	DATE: 6/4/12

DESCRIPTION Coal Fragments from 78 ft. from Northeast end of HB-TP-54A.

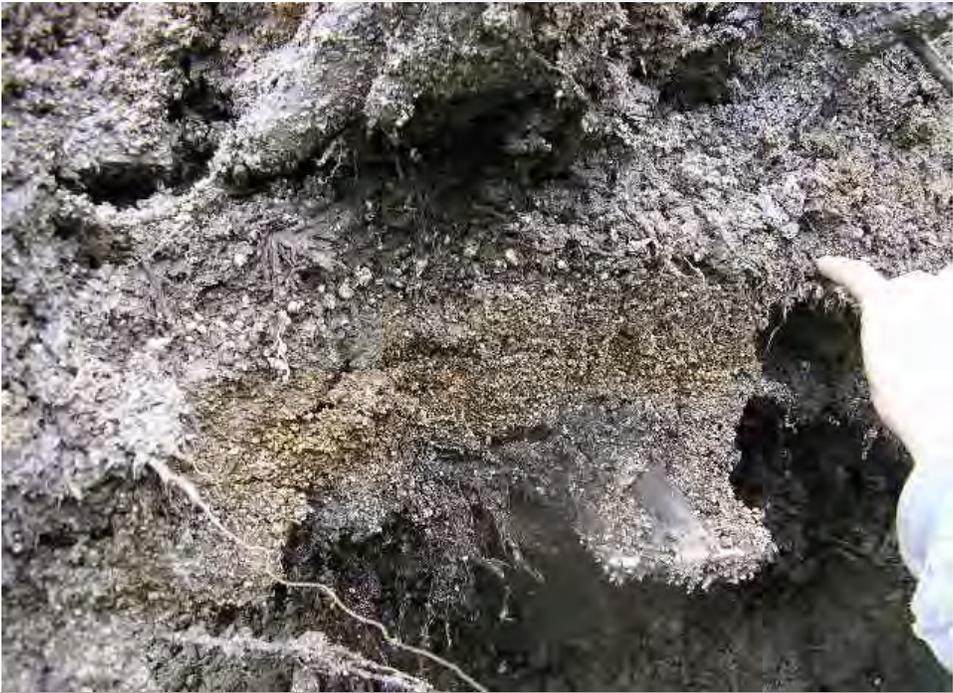
CLIENT NAME: Honeywell		SITE LOCATION: HB-TP-54A	PROJECT NO. 49362
PHOTO NO. 10	DATE: 6/4/12

DESCRIPTION Red stained coal, cinder and shell layer at approximately 6 ft. bgs and 96 ft. from Northeast end of HB-TP-54A.

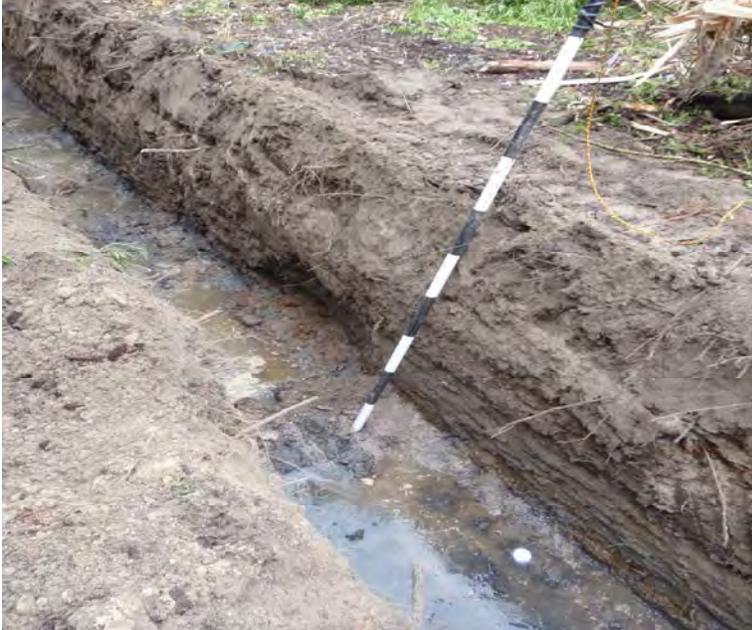
CLIENT NAME: Honeywell		SITE LOCATION: HB-TP-54A	PROJECT NO. 49362
PHOTO NO. 11	DATE: 6/4/12

DESCRIPTION Midpoint HB-TP-54A.

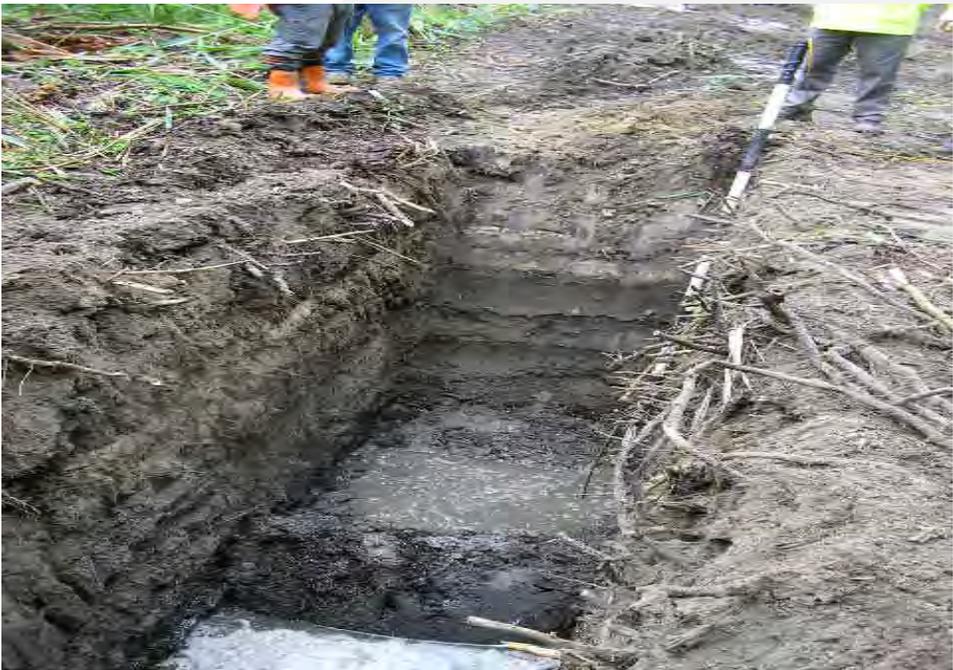
CLIENT NAME: Honeywell		SITE LOCATION: HB-TP-54A	PROJECT NO. 49362
PHOTO NO. 12	DATE: 6/4/12

DESCRIPTION Stratification and groundwater depth at approximately 161 ft from Northeast end of HB-TP-54A

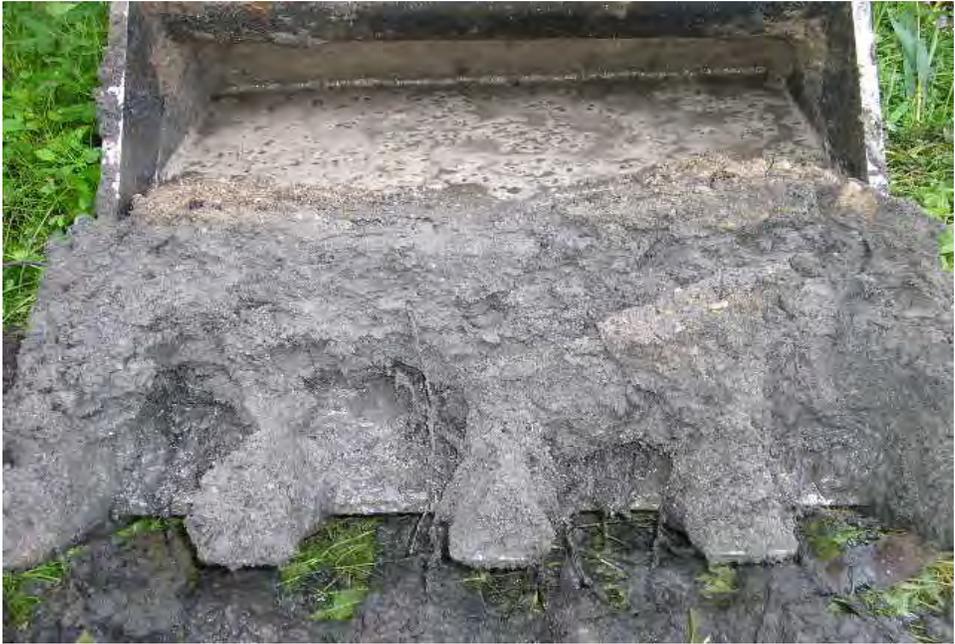
CLIENT NAME: Honeywell		SITE LOCATION: HB-TP-54A	PROJECT NO. 49362
PHOTO NO. 13	DATE: 6/5/12

DESCRIPTION Marl and groundwater in excavator bucket approximately 200 ft from Northeast end of HB-TP-54A.

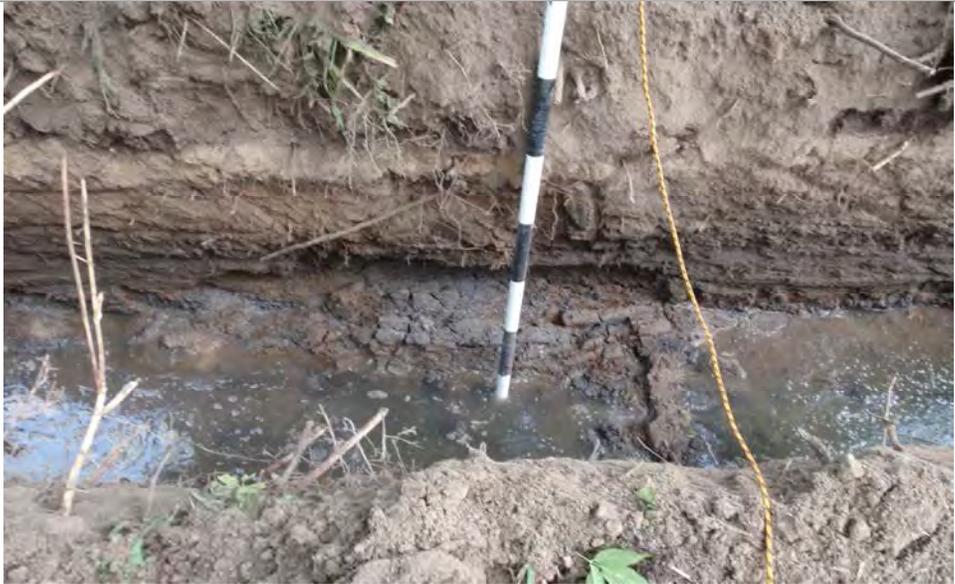
CLIENT NAME: Honeywell		SITE LOCATION: HB-TP-54A.	PROJECT NO. 49362
PHOTO NO. 14	DATE: 6/5/12

DESCRIPTION Midpoint of trench section 165-200 in HB-TP-54A.

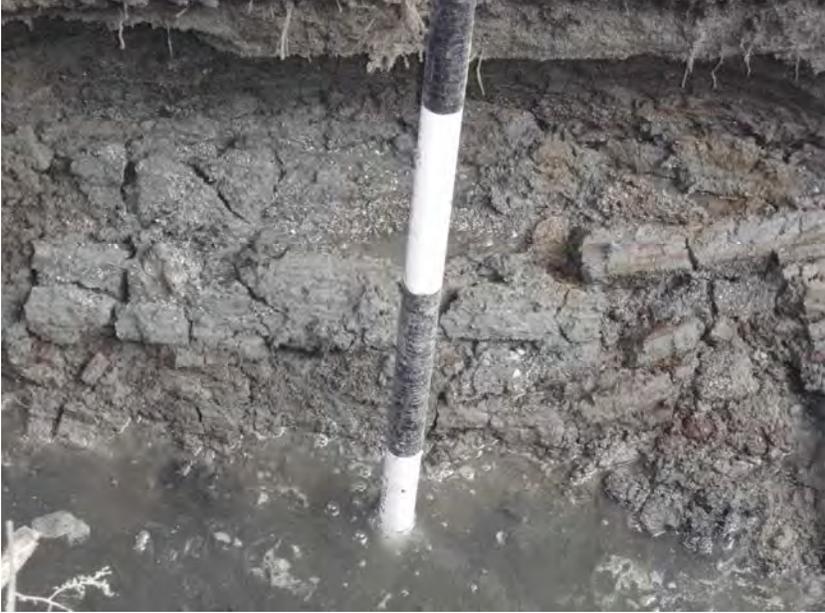
CLIENT NAME: Honeywell		SITE LOCATION: HB-TP-54A.		PROJECT NO. 49362
PHOTO NO. 15	DATE: 6/5/12

DESCRIPTION Close-up of fill/marl contact at 6.5 ft bgs @ Midpoint of trench section 165-200 in HB-TP-54A.

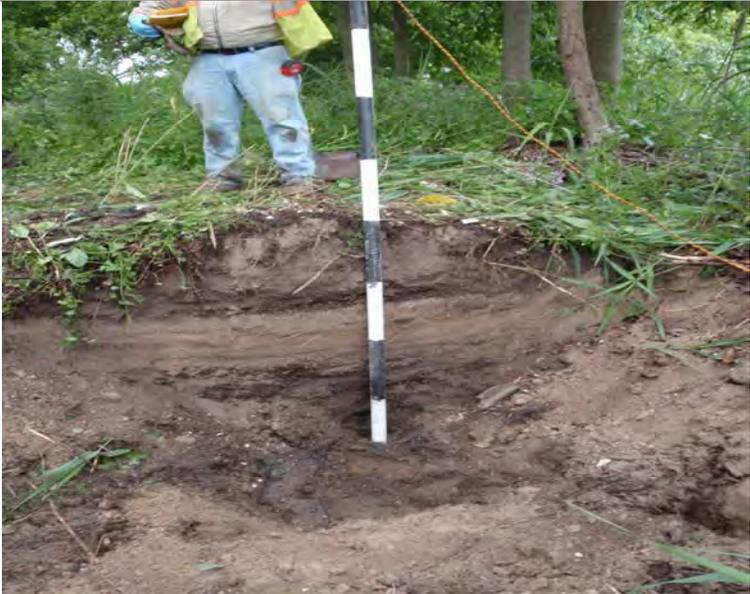
CLIENT NAME: Honeywell		SITE LOCATION: HB-TP-54A		PROJECT NO. 49362
PHOTO NO. 16	DATE: 6/5/12

DESCRIPTION Strata in fill at Southwestern end of HB-TP-54A.

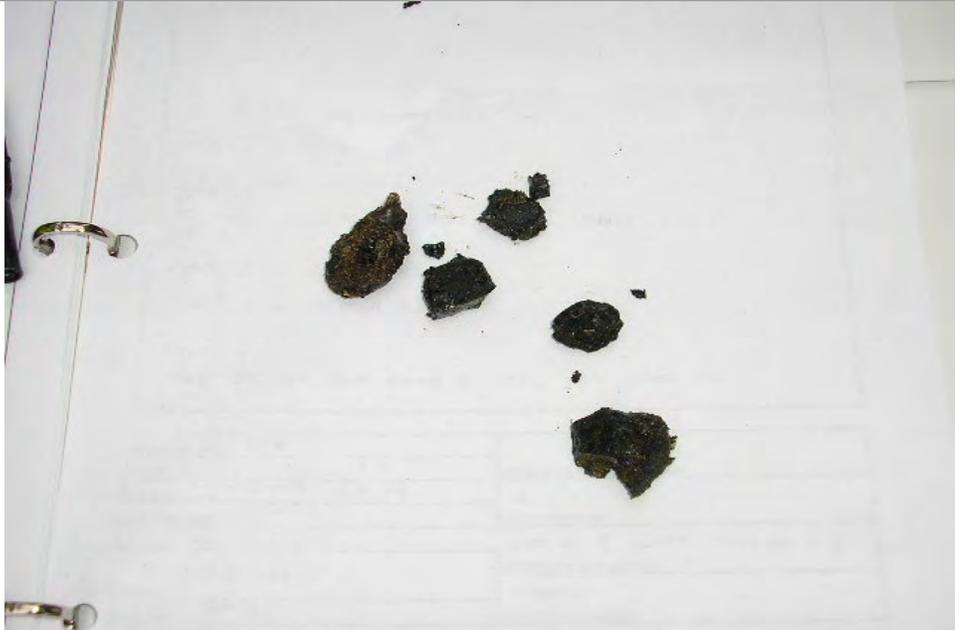
CLIENT NAME: Honeywell		SITE LOCATION: HB-TP-54A	PROJECT NO. 49362
PHOTO NO. 17	DATE: 6/5/12

DESCRIPTION Coal, cinder, and shell spoils approximately 260 ft from Northeast end of HB-TP-54A.

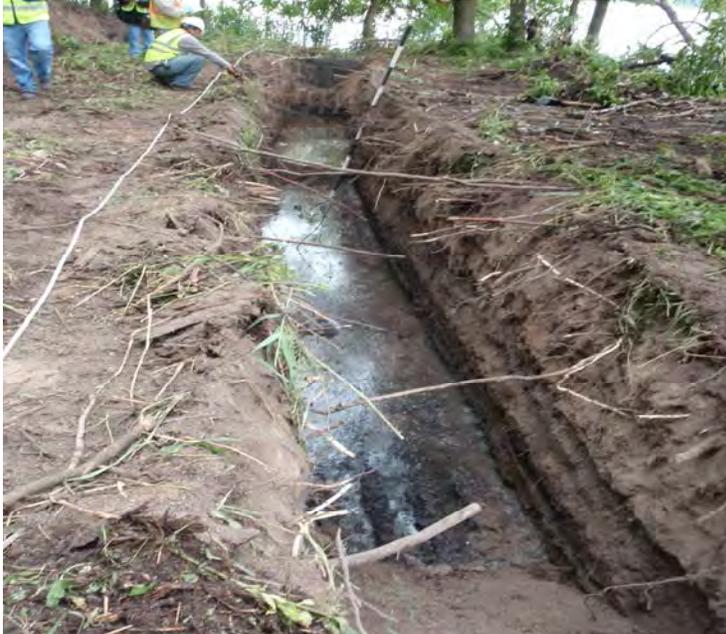
CLIENT NAME: Honeywell		SITE LOCATION: HB-TP-54A	PROJECT NO. 49362
PHOTO NO. 18	DATE: 6/5/12

DESCRIPTION HB-TP-54A looking west at section 200-270 west of northeastern end. Note roughly 6 ft of fill overlying marl contact at bottom.

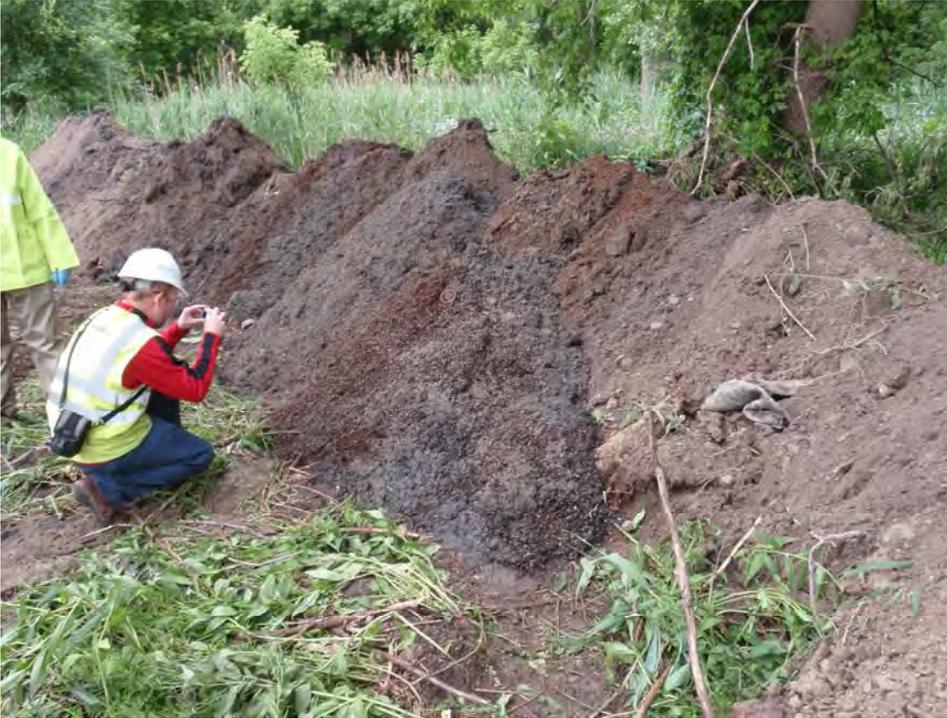
CLIENT NAME: Honeywell		SITE LOCATION: HB-TP-54A	PROJECT NO. 49362
PHOTO NO. 19	DATE: 6/5/12

DESCRIPTION Coal, cinder, and shell spoils approximately 260 ft from Northeast end of HB-TP-54A.

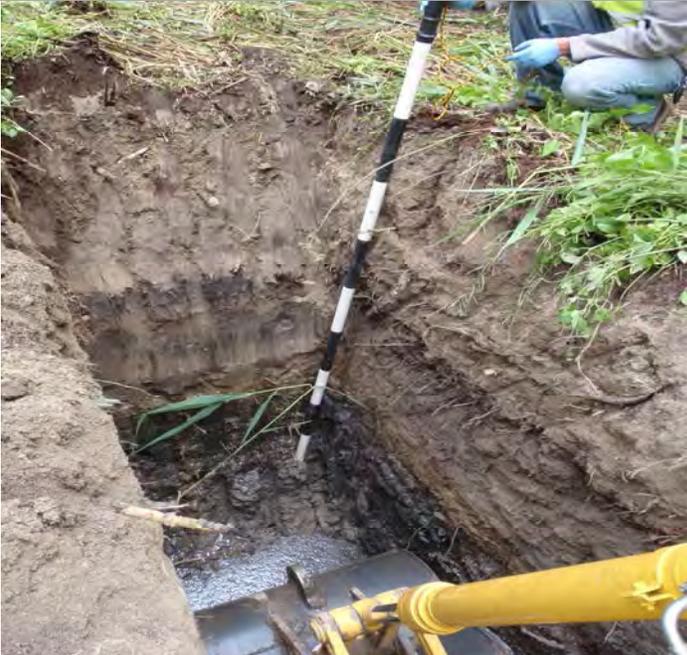
CLIENT NAME: Honeywell		SITE LOCATION: HB-TP-55	PROJECT NO. 49362
PHOTO NO. 20	DATE: 6/5/12

DESCRIPTION Start of HB-TP-55 at northeastern end. Note black stained material at roughly 6.5 ft bgs.

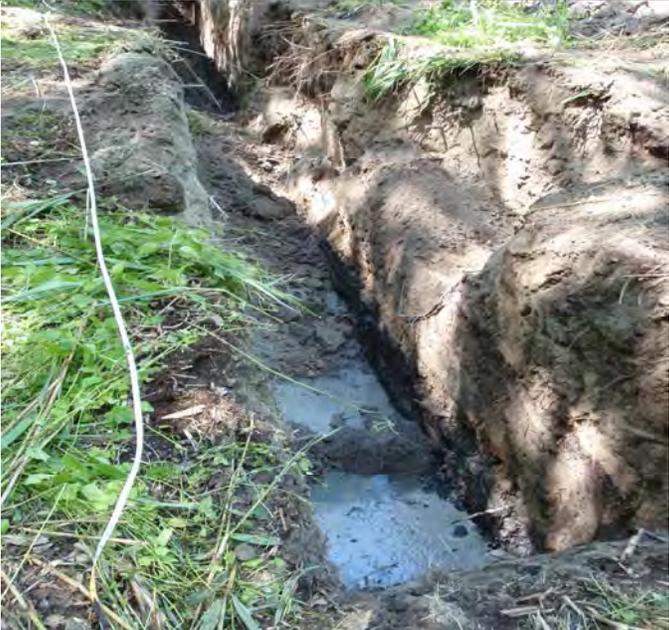
CLIENT NAME: Honeywell		SITE LOCATION: HB-TP-55		PROJECT NO. 49362
PHOTO NO. 21	DATE: 6/5/12

DESCRIPTION Start of HB-TP-55 at northeastern end looking to the west. The collapsed section is coarse material from the eastern berm area.

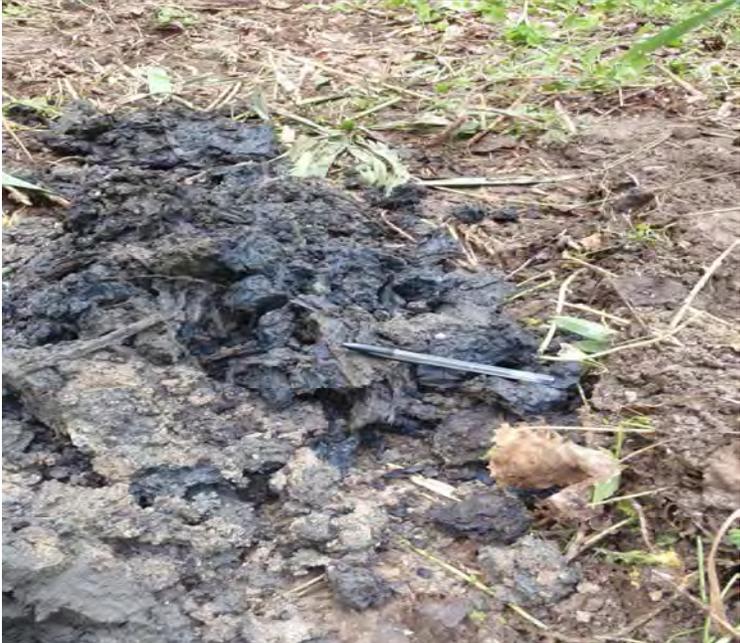
CLIENT NAME: Honeywell		SITE LOCATION: HB-TP-55		PROJECT NO. 49362
PHOTO NO. 22	DATE: 6/5/12

DESCRIPTION stained organic debris mat with coal tar odor from northeastern end of HB-TP-55

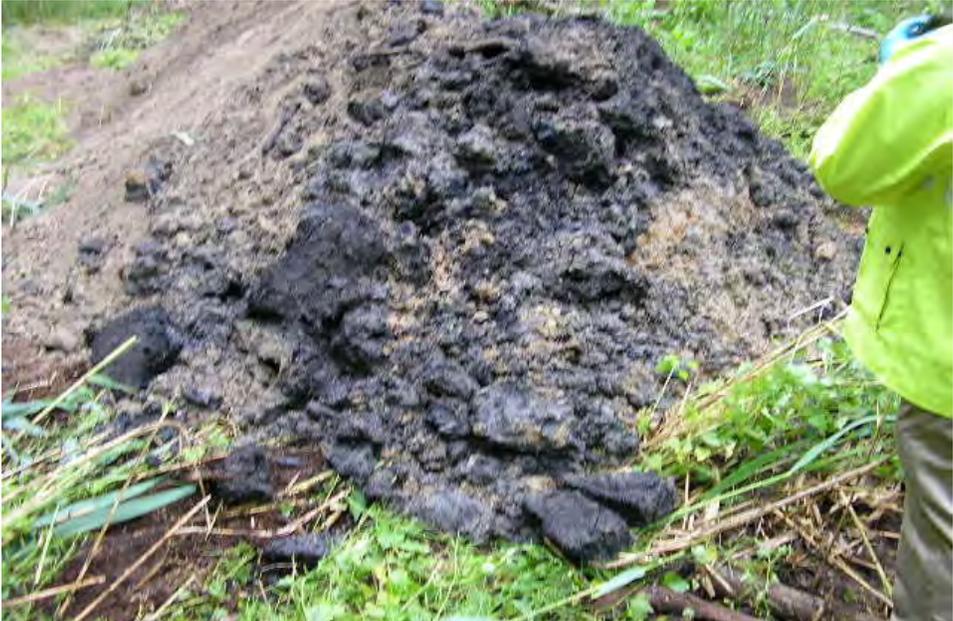
CLIENT NAME: Honeywell		SITE LOCATION: HB-TP-55	PROJECT NO. 49362
PHOTO NO. 23	DATE: 6/5/12

DESCRIPTION Spoils containing coal Tar like material approximately 6.5 ft bgs and 1 ft from Northeast end of HB-TP-55

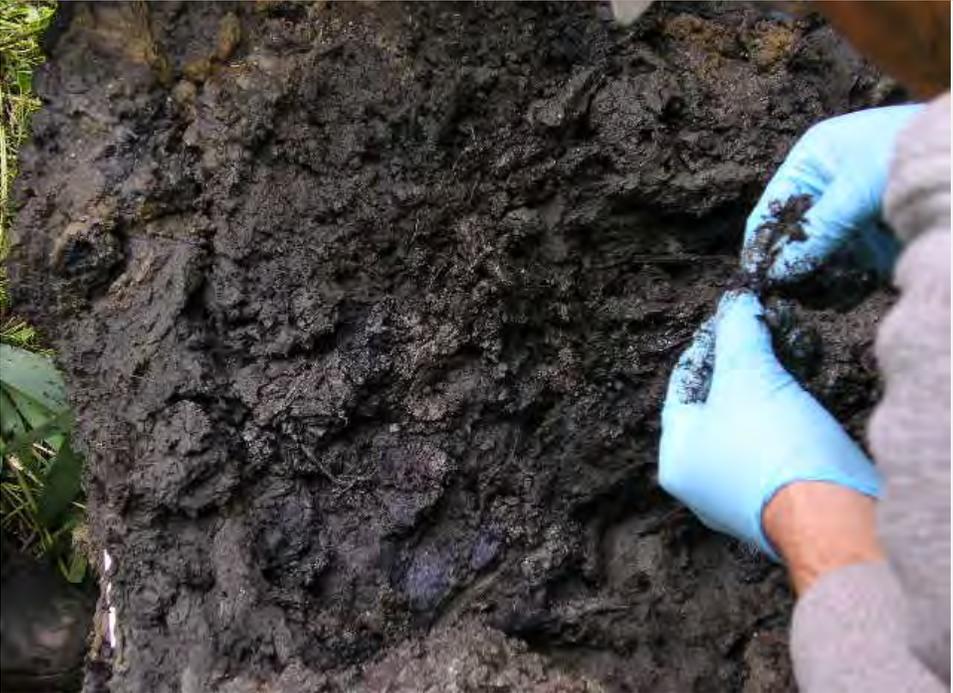
CLIENT NAME: Honeywell		SITE LOCATION: HB-TP-55	PROJECT NO. 49362
PHOTO NO. 24	DATE: 6/5/12

DESCRIPTION Spoils containing coal Tar like material approximately 6.5 ft bgs and 1 ft from Northeast end of HB-TP-55

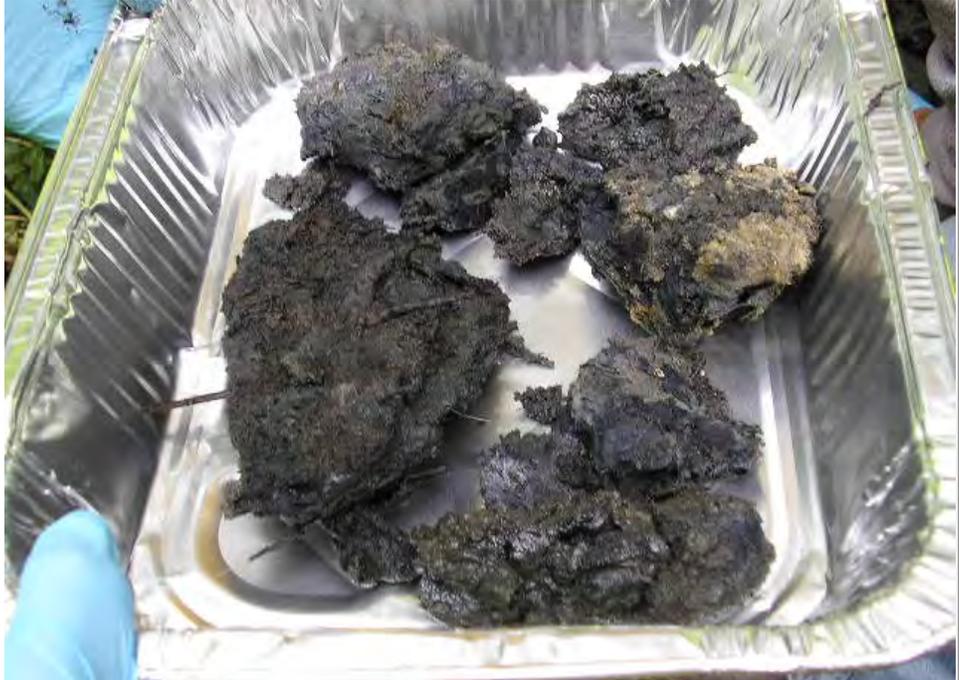
CLIENT NAME: Honeywell		SITE LOCATION: HB-TP-55	PROJECT NO. 49362
PHOTO NO. 25	DATE: 6/5/12

DESCRIPTION Soil with coal tar like approximately 6.5 ft bgs and 1 ft from Northeast end of HB-TP-55

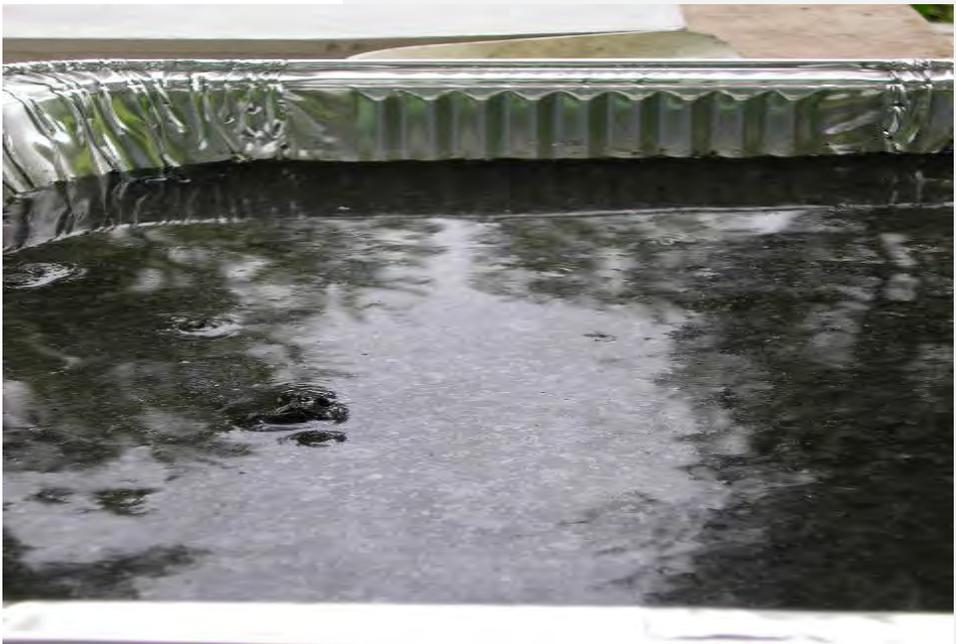
CLIENT NAME: Honeywell		SITE LOCATION: HB-TP-55	PROJECT NO. 49362
PHOTO NO. 26	DATE: 6/5/12

DESCRIPTION Sheen generated in pan from coal tar like material approximately 6.5 ft bgs and 1 ft from Northeast end of HB-TP-55.

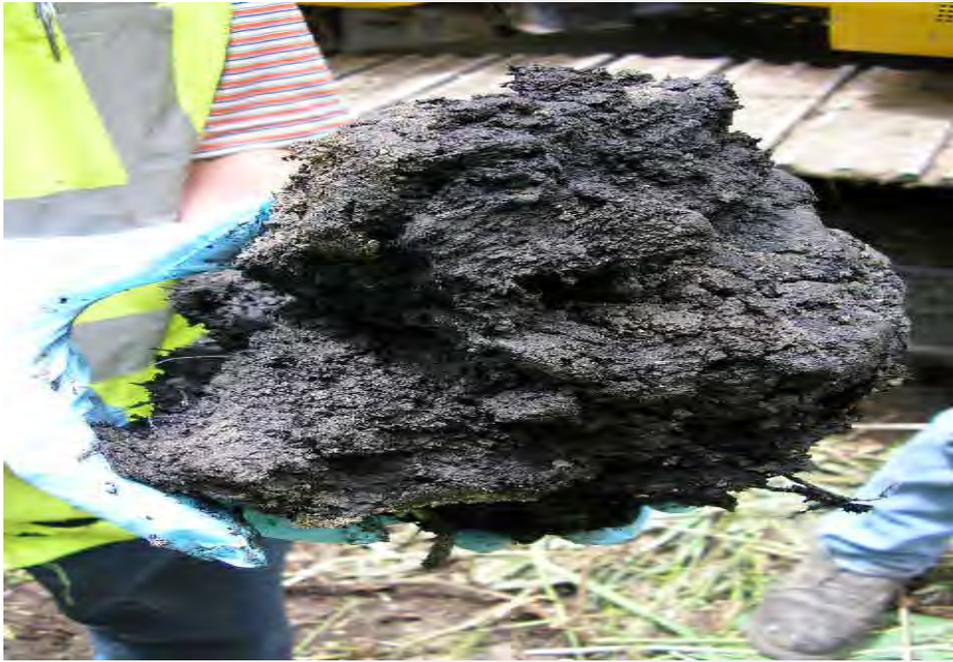
CLIENT NAME: Honeywell		SITE LOCATION: HB-TP-55	PROJECT NO. 49362
PHOTO NO. 27	DATE: 6/5/12

DESCRIPTION Coal tar like material approximately 10 ft from Northeast end of HB-TP-55.

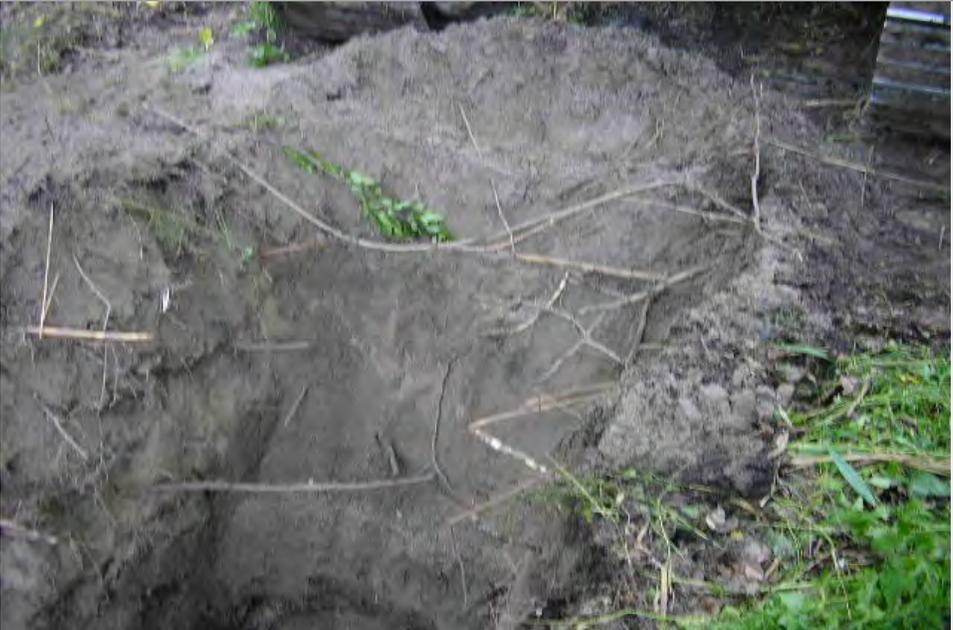
CLIENT NAME: Honeywell		SITE LOCATION: HB-TP-55	PROJECT NO. 49362
PHOTO NO. 28	DATE: 6/5/12

DESCRIPTION Unimpacted sand layer approximately 0-5 ft bgs and 70 ft from Northeast end of HB-TP-55.

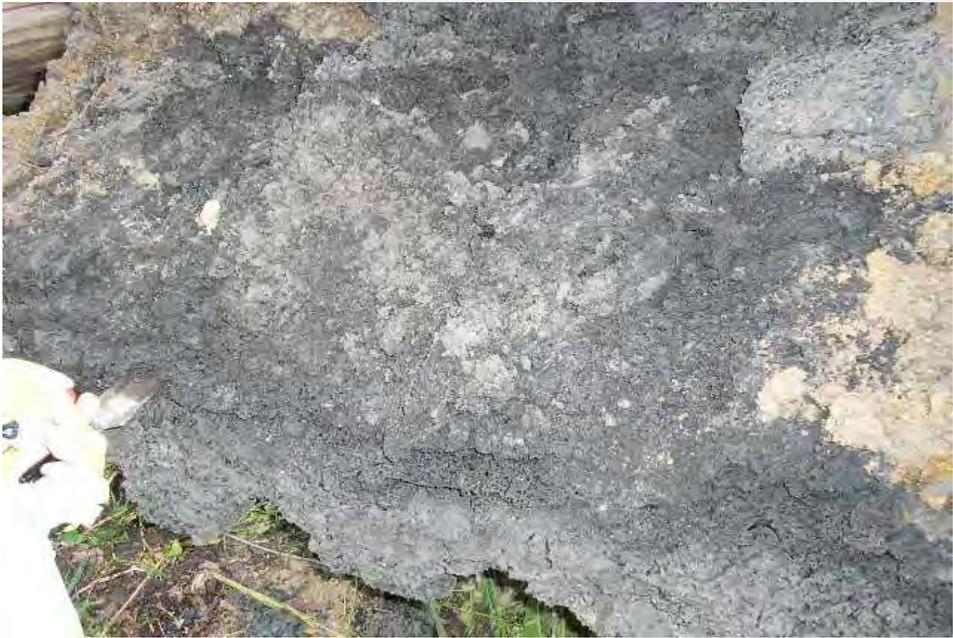
CLIENT NAME: Honeywell		SITE LOCATION: HB-TP-55	PROJECT NO. 49362
PHOTO NO. 29	DATE: 6/5/12

DESCRIPTION Excavator Bucket containing stained soils with coal tar like odor approximately 70 ft from Northeast end of HB-TP-55.

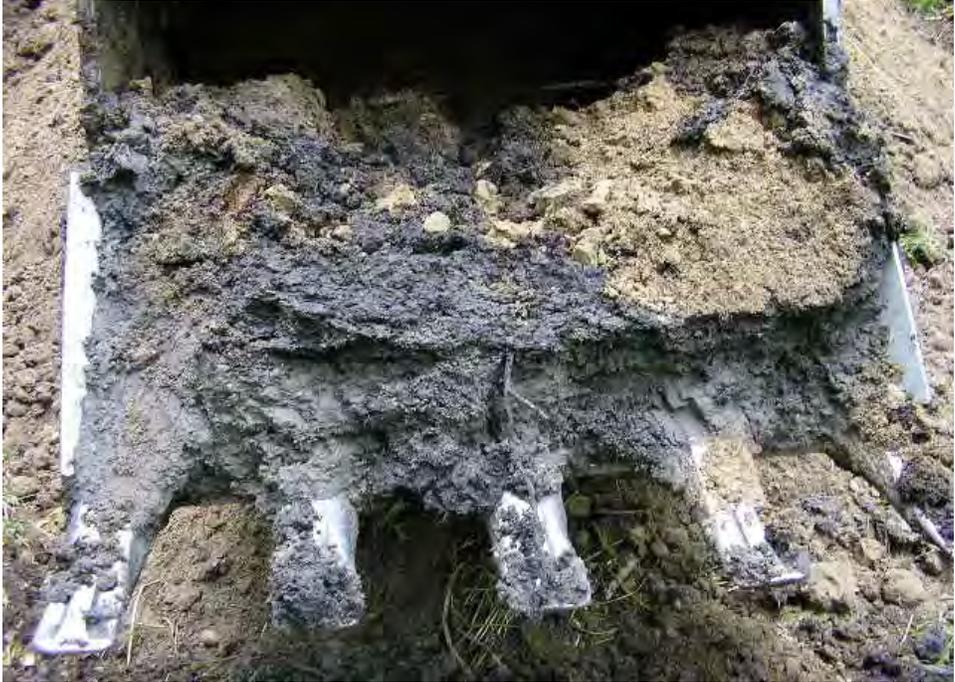
CLIENT NAME: Honeywell		SITE LOCATION: HB-TP-55	PROJECT NO. 49362
PHOTO NO. 30	DATE: 6/5/12

DESCRIPTION Excavator Bucket containing stained soils with coal tar like odor approximately 135 ft from Northeast end of HB-TP-55.

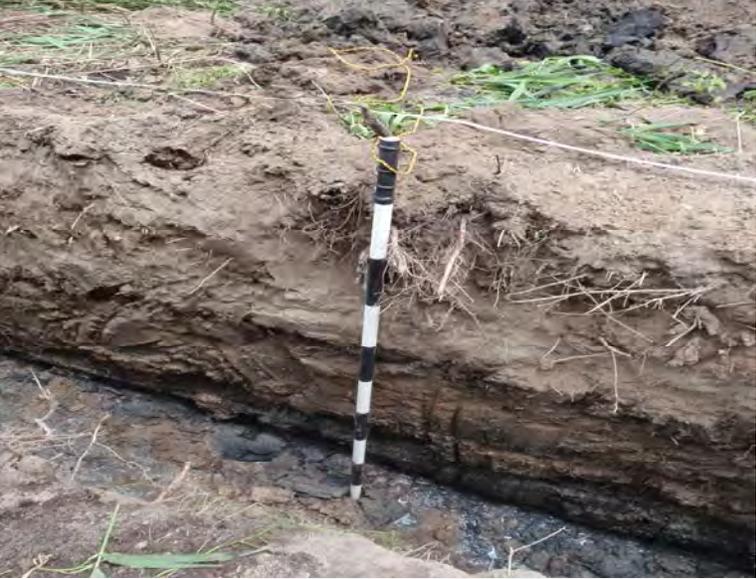
CLIENT NAME: Honeywell		SITE LOCATION: HB-TP-55	PROJECT NO. 49362V
PHOTO NO. 31	DATE: 6/5/12

DESCRIPTION Strata in HB-TP-55. Staff location 110 ft west of the northeastern end.

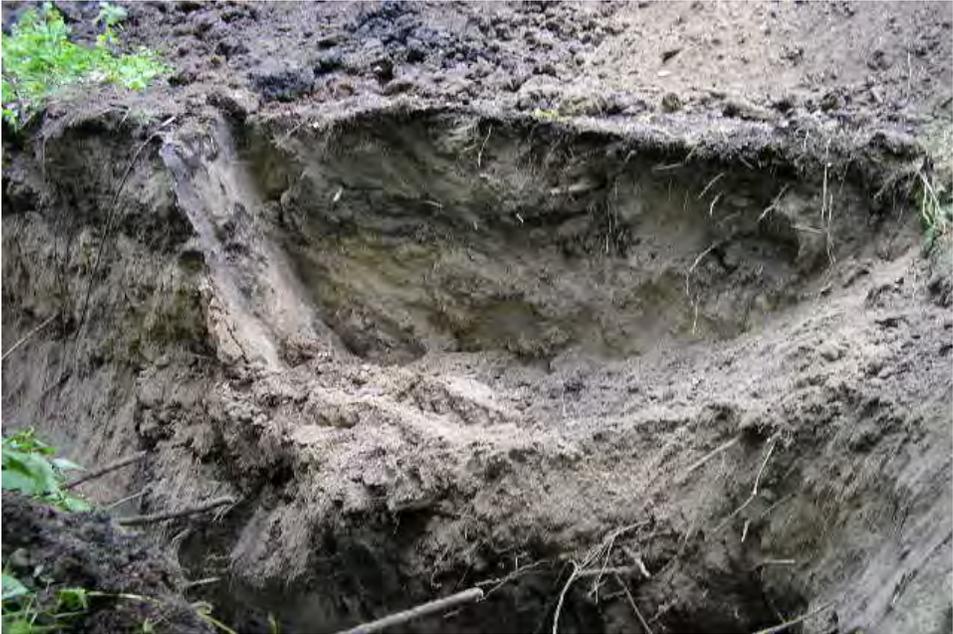
CLIENT NAME: Honeywell		SITE LOCATION: HB-TP-55	PROJECT NO. 49362
PHOTO NO. 32	DATE: 6/5/12

DESCRIPTION Unimpacted sand layer approximately 0-4 ft bgs and 135 ft from Northeast end of HB-TP-55.

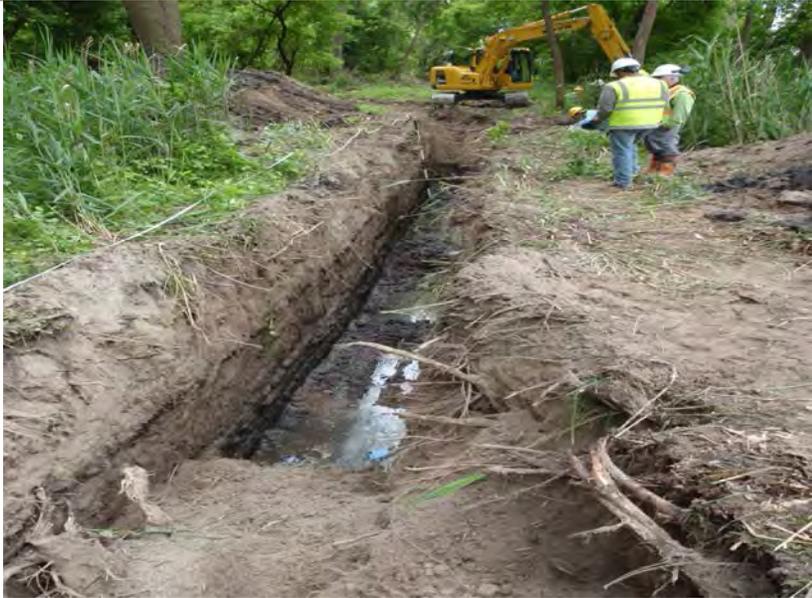
CLIENT NAME: Honeywell		SITE LOCATION: HB-TP-55		PROJECT NO. 49362
PHOTO NO. 33	DATE: 6/5/12

DESCRIPTION HB-TP-55 section 72 to 135 looking west

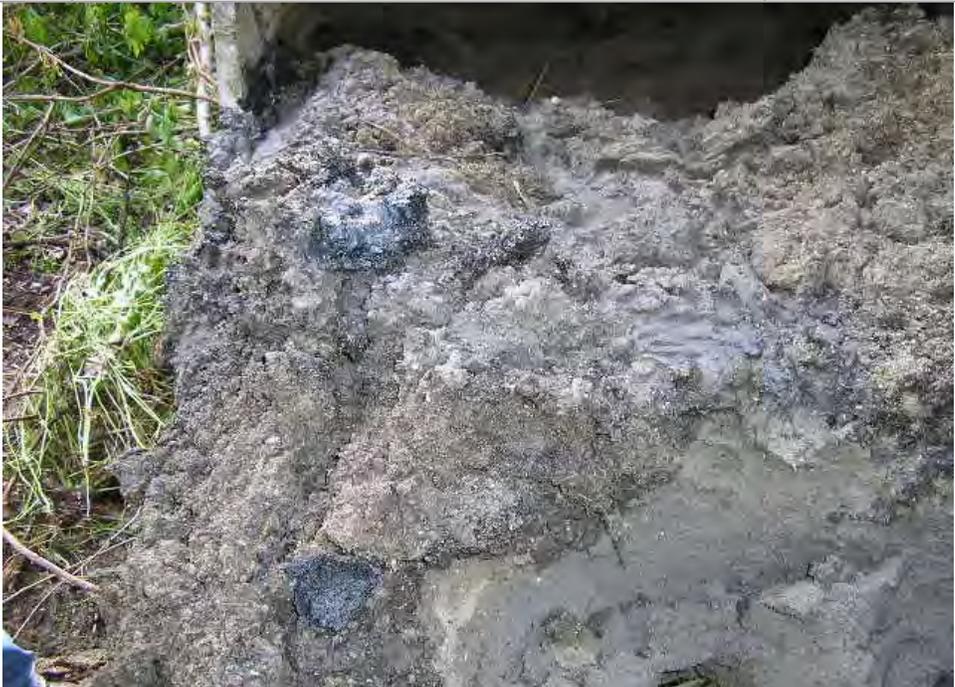
CLIENT NAME: Honeywell		SITE LOCATION: HB-TP-55		PROJECT NO. 49362
PHOTO NO. 34	DATE: 6/6/12

DESCRIPTION Spoils with some staining and coal tar like odor at approximately 200 ft from the Northeast end of HB-TP-55.

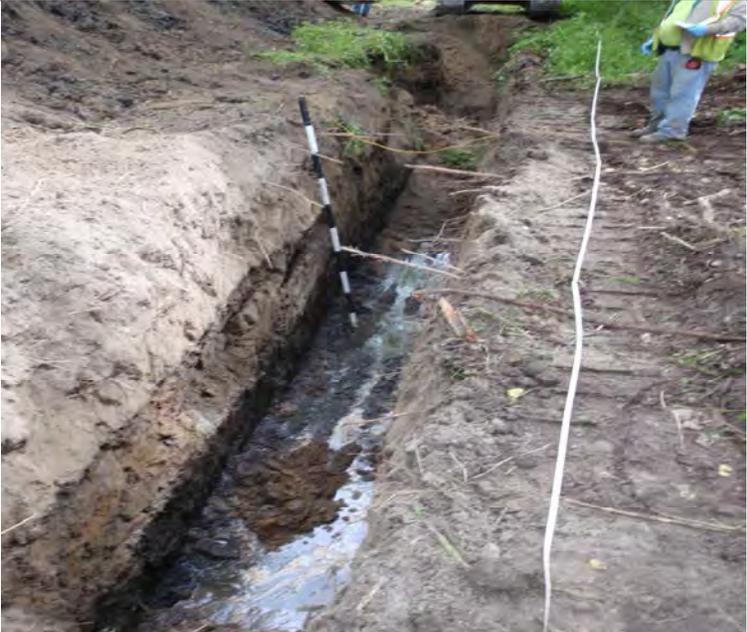
CLIENT NAME: Honeywell		SITE LOCATION: HB-TP-55		PROJECT NO. 49362
PHOTO NO. 35	DATE: 6/5/2012

DESCRIPTION HB-TP-55 section 135 to 195 looking west

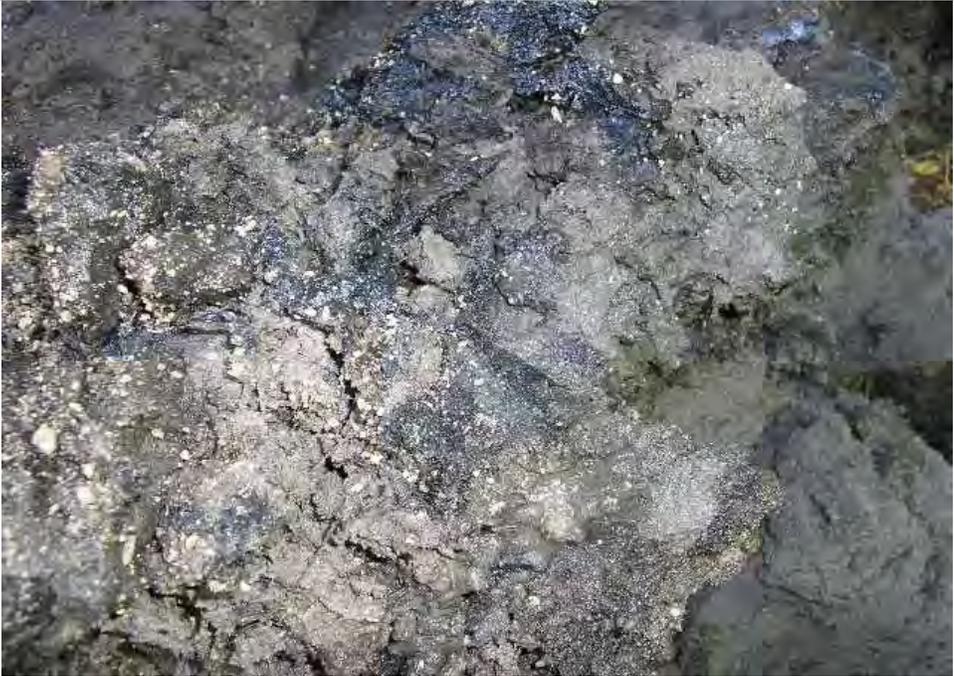
CLIENT NAME: Honeywell		SITE LOCATION: HB-TP-55		PROJECT NO. 49362
PHOTO NO. 36	DATE: 6/6/12

DESCRIPTION Spoils with some staining and coal tar like odor at approximately 255 ft. from the Northeast end of HB-TP-55.

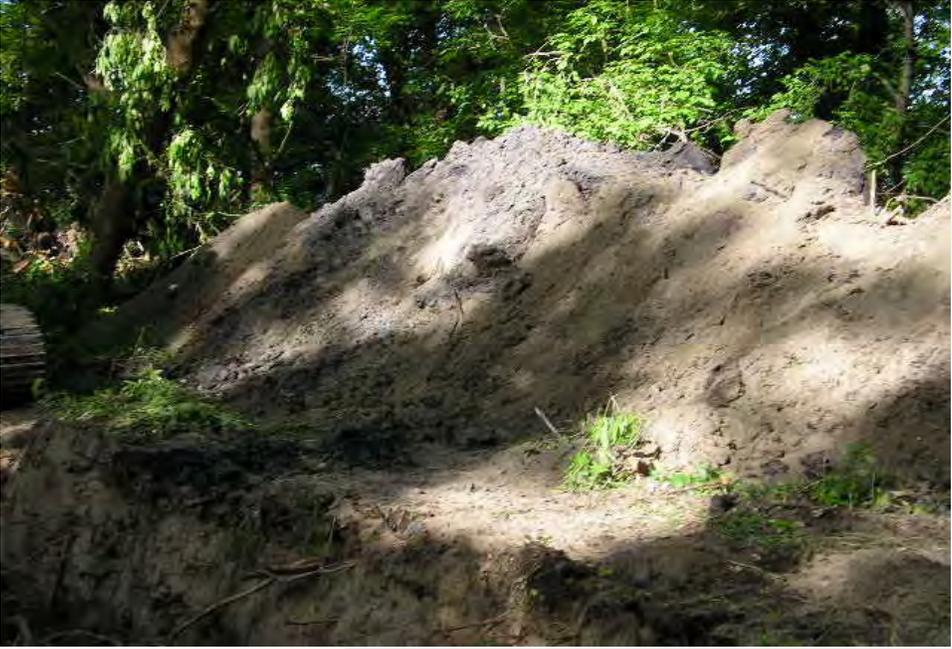
CLIENT NAME: Honeywell		SITE LOCATION: HB-TP-55	PROJECT NO. 49362
PHOTO NO. 37	DATE: 6/6/12

DESCRIPTION Unimpacted surface spoils at approximately 255 ft. from Northeast end of HB-TP-55.

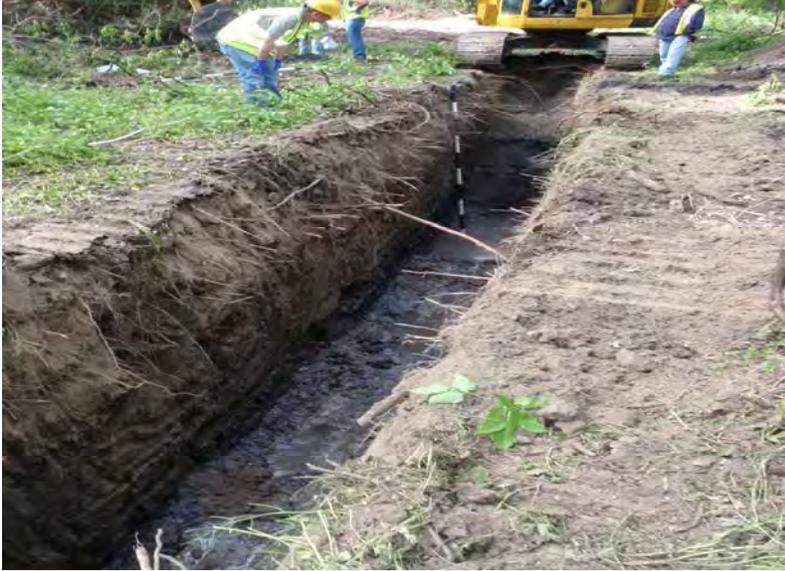
CLIENT NAME: Honeywell		SITE LOCATION: HB-TP-55	PROJECT NO. 49362
PHOTO NO. 38	DATE: 6/6/12

DESCRIPTION HB-TP-55 - section 195-270 looking east. Photo taken at roughly 235 ft along test pit where black stained layer appears thicker.
