Appendix B
Photograph Log

APPENDIX B – PHOTOGRAPHIC LOG

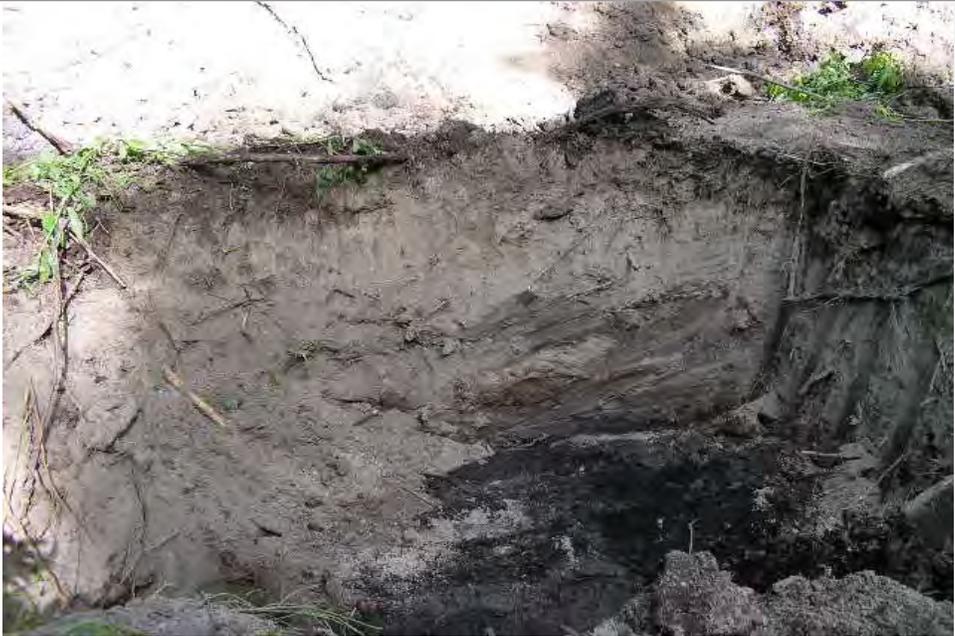
CLIENT NAME: Honeywell		SITE LOCATION: HB-TP-55	PROJECT NO. 49362
PHOTO NO. 39	DATE: 6/6/12

DESCRIPTION Unimpacted surface material over impacted coal tar like material at approximately 280 ft. from Northeast end of HB-TP-55.

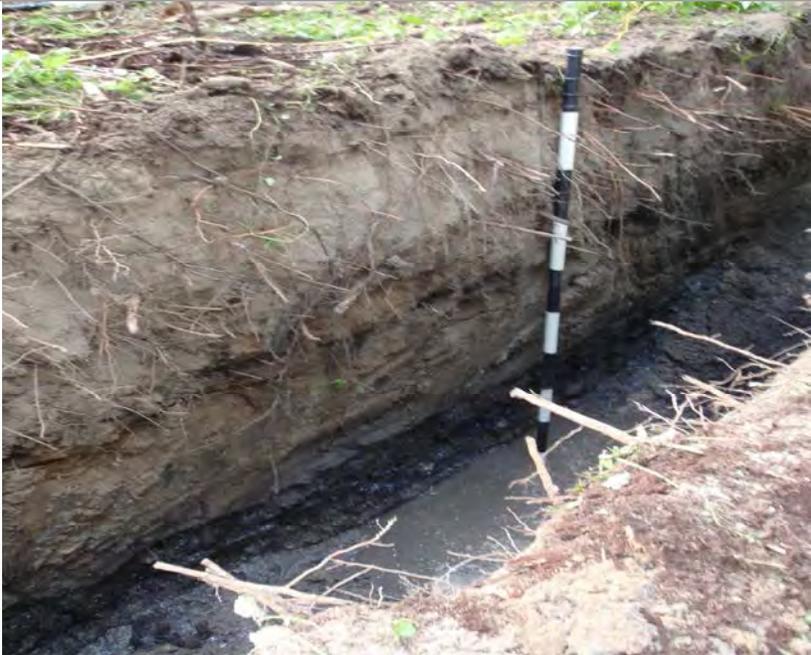
CLIENT NAME: Honeywell		SITE LOCATION: HB-TP-55	PROJECT NO. 49362
PHOTO NO. 40	DATE: 6/6/12

DESCRIPTION HB-TP-55 - section 195-270 looking at southern wall of excavation. Photo taken at roughly 235 ft along test pit where black stained layer appears thicker

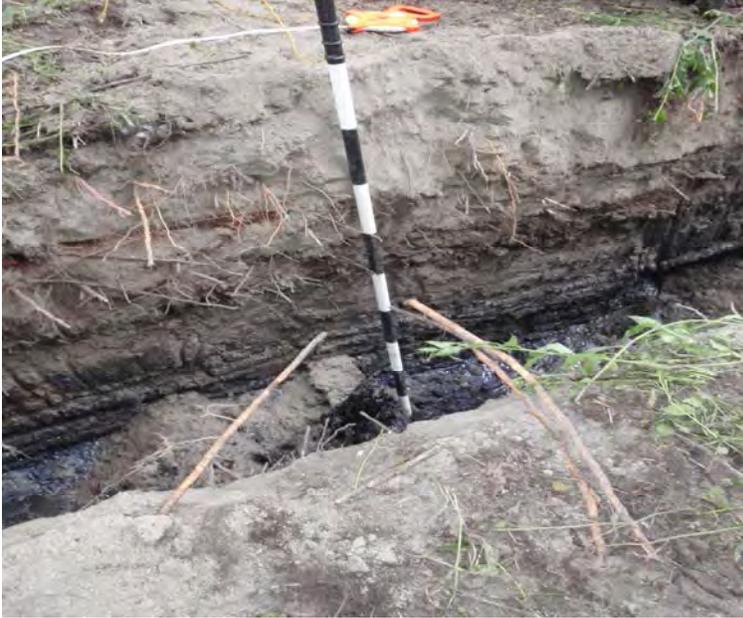
CLIENT NAME: Honeywell		SITE LOCATION: HB-TP-55	PROJECT NO. 49362
PHOTO NO. 41	DATE: 6/6/12

DESCRIPTION HB-TP-55 piling at 286 - sheen noted in water and black stained material prevalent at roughly 6.5-7 ft bgs. NAPL noted.

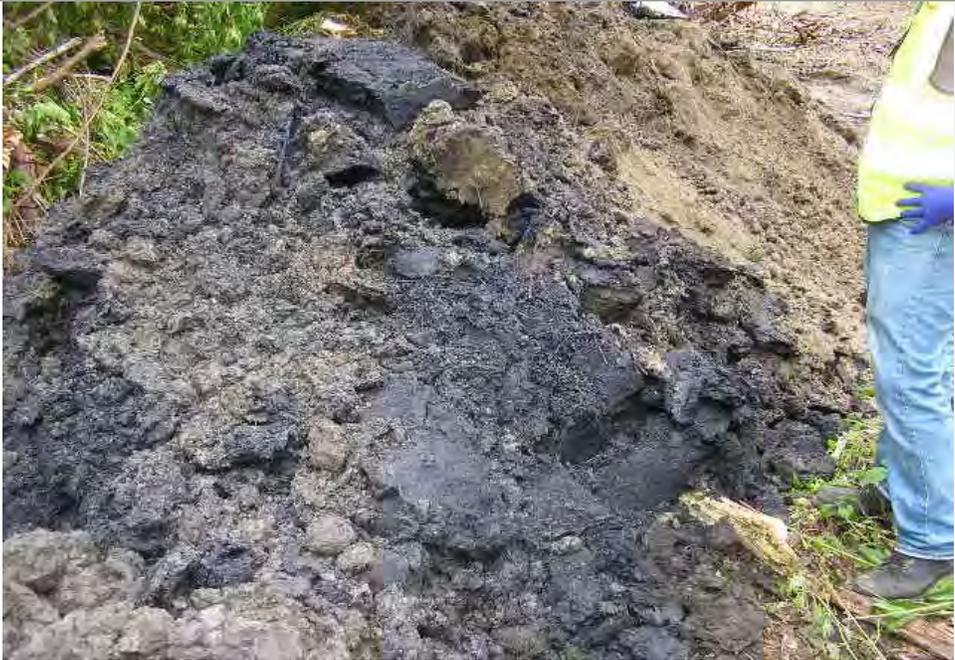
CLIENT NAME: Honeywell		SITE LOCATION: HB-TP-55	PROJECT NO. 49362
PHOTO NO. 42	DATE: 6/6/12

DESCRIPTION Spoils with coal tar like material at approximately 286 ft. from the Northeast end of HB-TP-55.

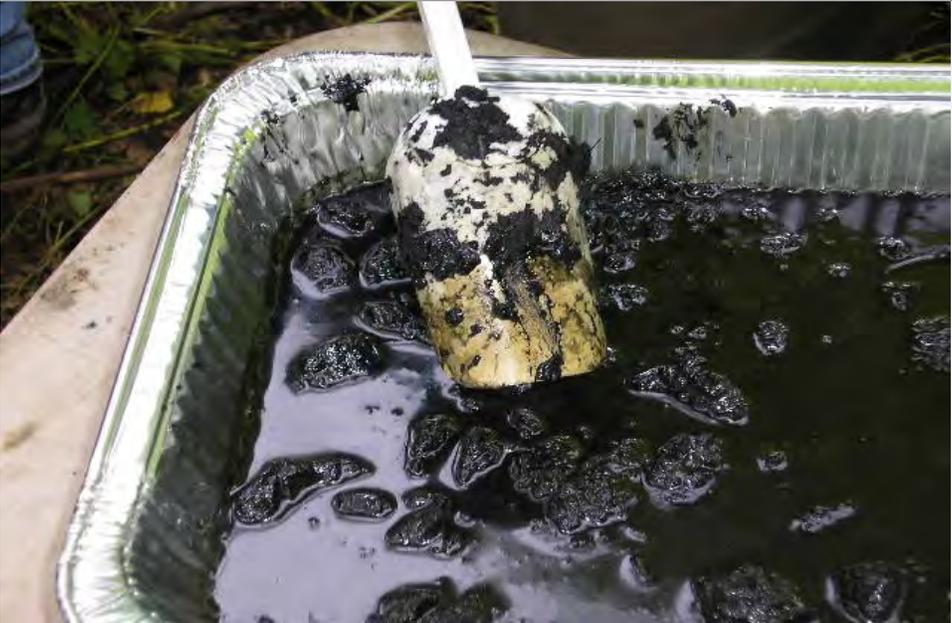
CLIENT NAME: Honeywell		SITE LOCATION: HB-TP-55	PROJECT NO. 49362
PHOTO NO. 43	DATE: 6/6/12

DESCRIPTION Staining on plastic scoop from sheen generated in pan from soil collected 286 ft from the Northeast end of HB-TP-55.

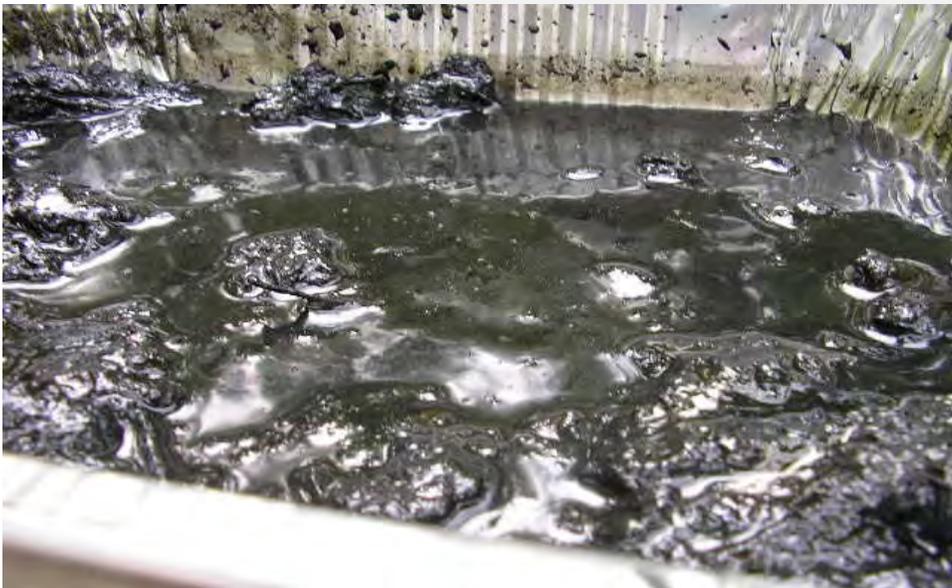
CLIENT NAME: Honeywell		SITE LOCATION: HB-TP-55	PROJECT NO. 49362
PHOTO NO. 44	DATE: 6/6/12

DESCRIPTION Sheen generated in pan from soil collected 286 ft from the Northeast end of HB-TP-55.

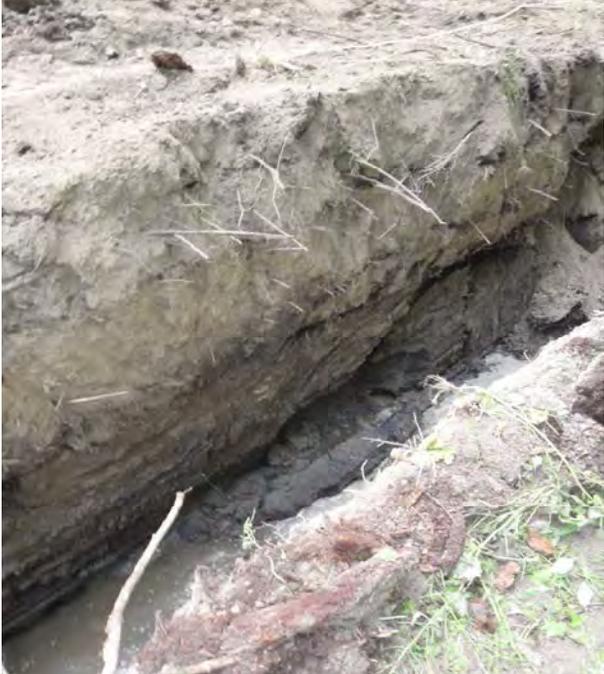
CLIENT NAME: Honeywell		SITE LOCATION: HB-TP-55		PROJECT NO. 49362
PHOTO NO. 45	DATE: 6/6/12

DESCRIPTION Cross sectional view of fill

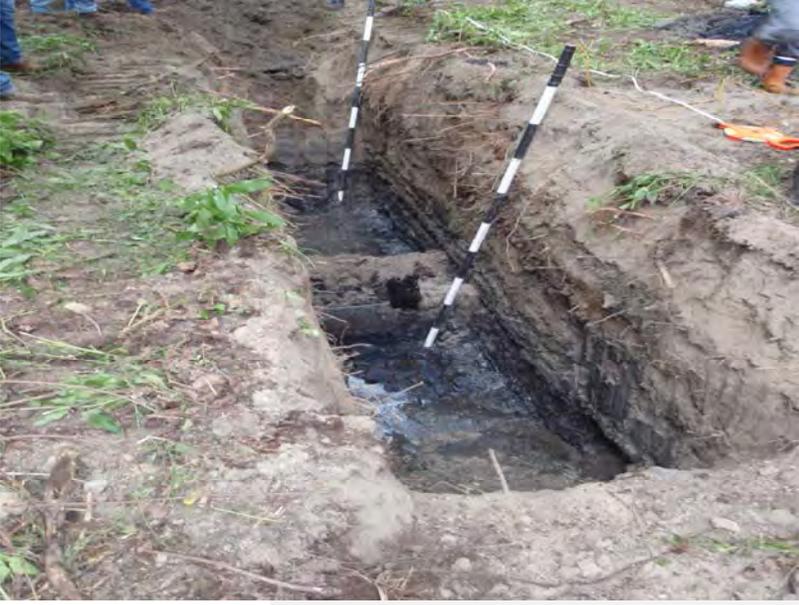
CLIENT NAME: Honeywell		SITE LOCATION: HB-TP-55		PROJECT NO. 49362
PHOTO NO. 46	DATE: 6/6/12

DESCRIPTION HB-TP-55 piling at 286 - sheen noted in water and black stained material prevalent at roughly 6.5-7 ft bgs. NAPL noted.

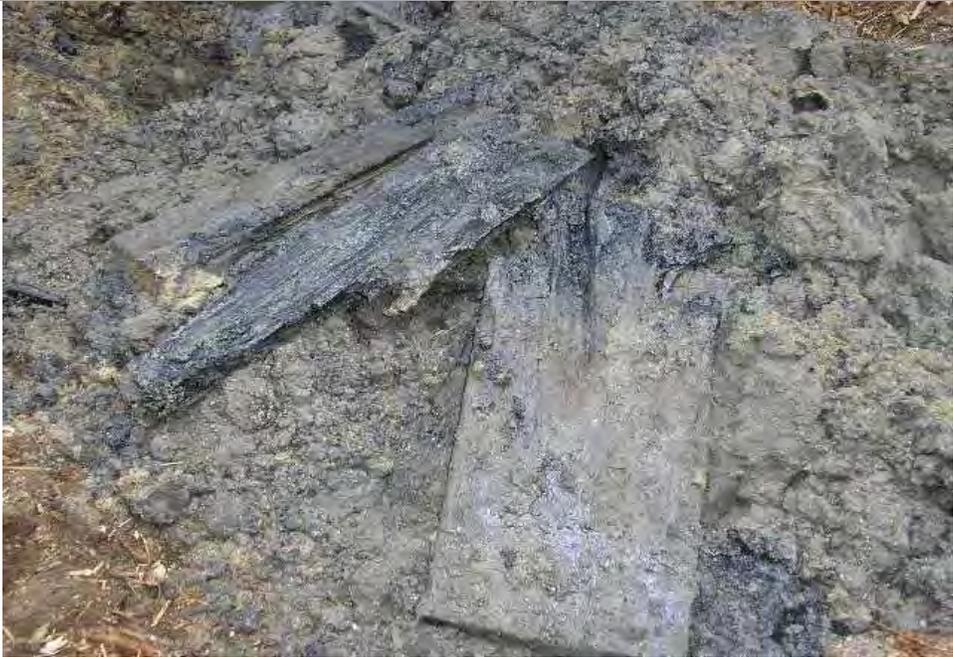
CLIENT NAME: Honeywell		SITE LOCATION: HB-TP-55	PROJECT NO. 49362
PHOTO NO. 47	DATE: 6/6/12

DESCRIPTION Milled wood from bank of former Onondaga Creek Channel, at approximately 286 ft from the Northeast end of HB-TP-55.

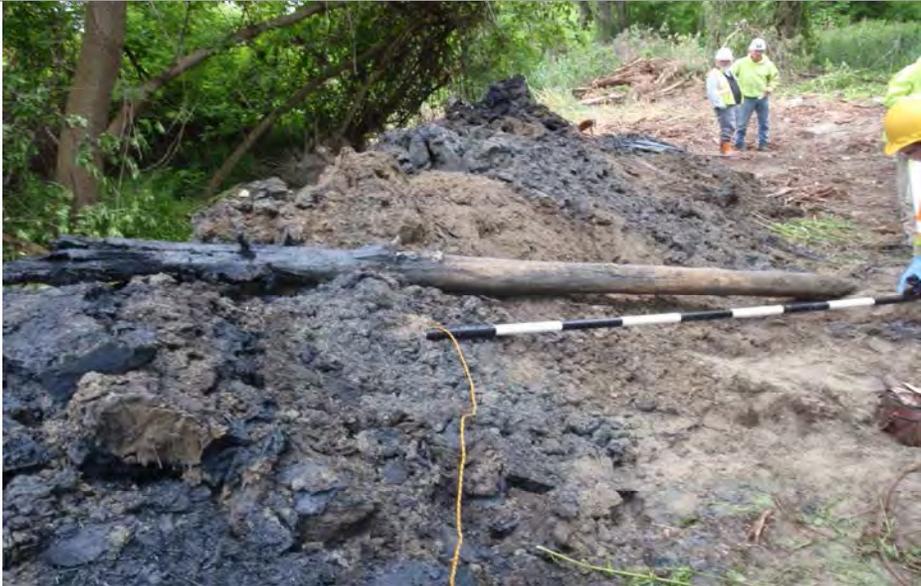
CLIENT NAME: Honeywell		SITE LOCATION: HB-TP-55	PROJECT NO. 49362
PHOTO NO. 48	DATE: 6/6/12

DESCRIPTION Piling removed from subsurface at 286 ft Northeast of start of HB-TP-55.

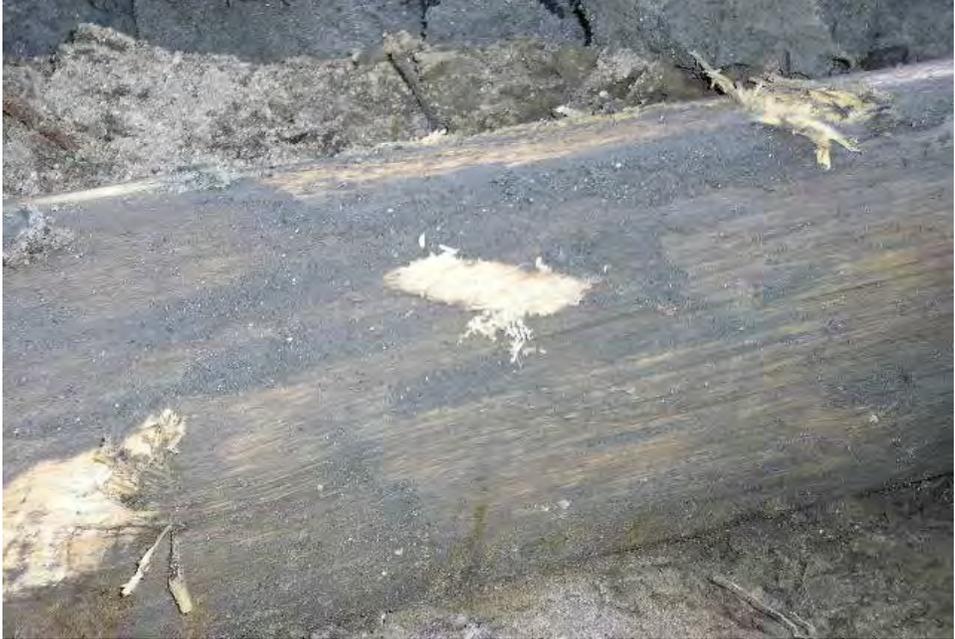
CLIENT NAME: Honeywell		SITE LOCATION: HB-TP-55	PROJECT NO. 49362
PHOTO NO. 49	DATE: 6/6/12

DESCRIPTION Wood piling removed at 286 ft from the Northeast end of HB-TP-55. Scrapped areas of piling show wood was not chemically preserved.

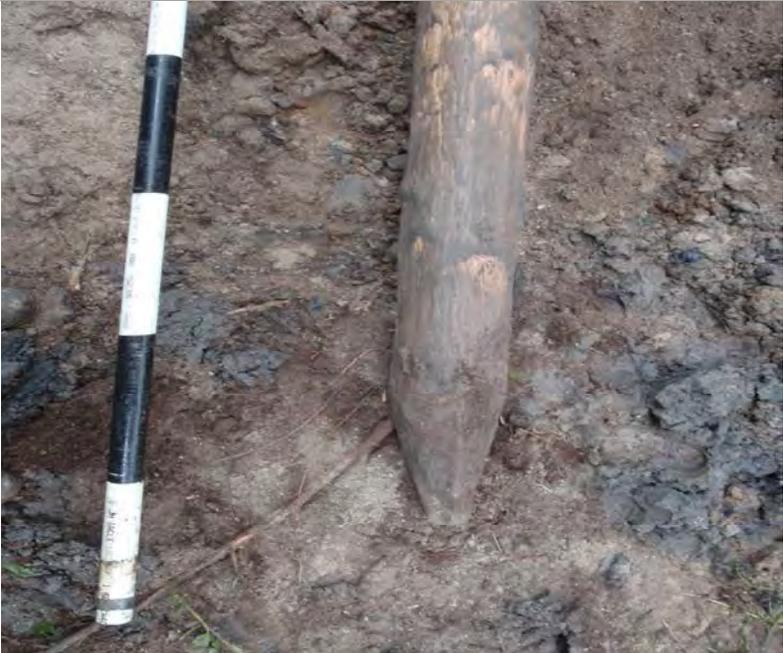
CLIENT NAME: Honeywell		SITE LOCATION: HB-TP-55	PROJECT NO. 49362
PHOTO NO. 50	DATE: 6/6/12

DESCRIPTION Piling removed from subsurface at 286 ft from the Northeast start of HB-TP-55.

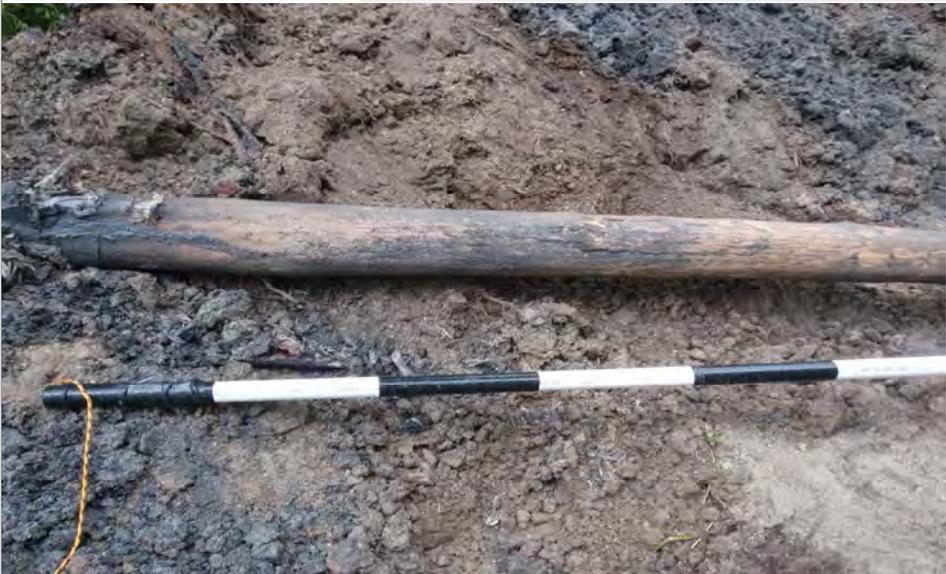
CLIENT NAME: Honeywell		SITE LOCATION: HB-TP-55	PROJECT NO. 49362
PHOTO NO. 51	DATE: 6/6/12

DESCRIPTION Piling removed from subsurface at 286 ft Northeast of start of HB-TP-55

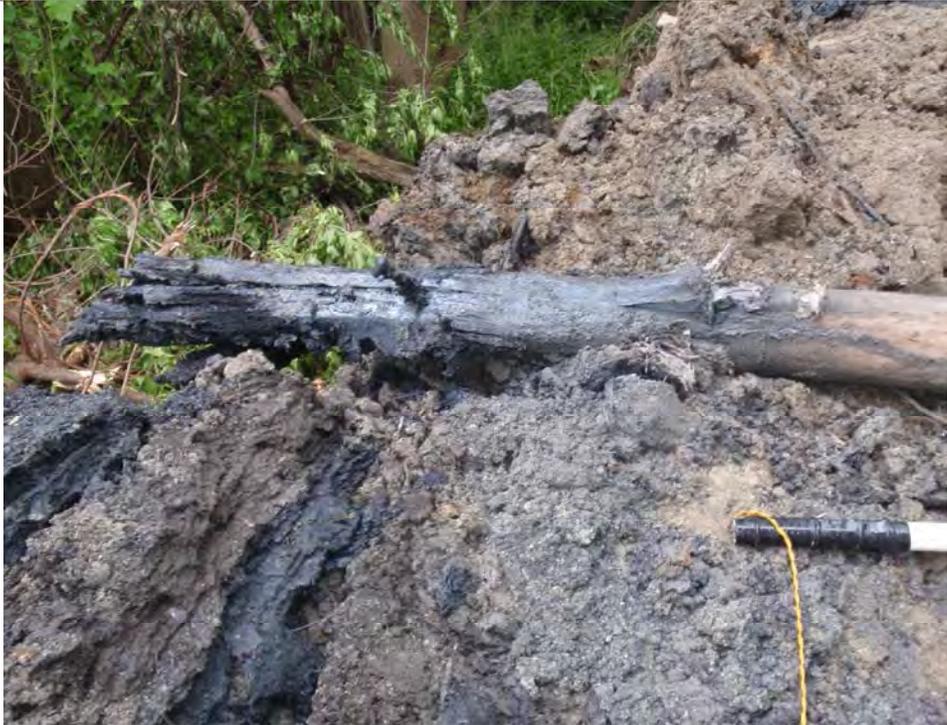
CLIENT NAME: Honeywell		SITE LOCATION: HB-TP-55	PROJECT NO. 49362
PHOTO NO. 52	DATE: 6/6/12

DESCRIPTION Piling removed from subsurface at 286 ft Northeast of start of HB-TP-55

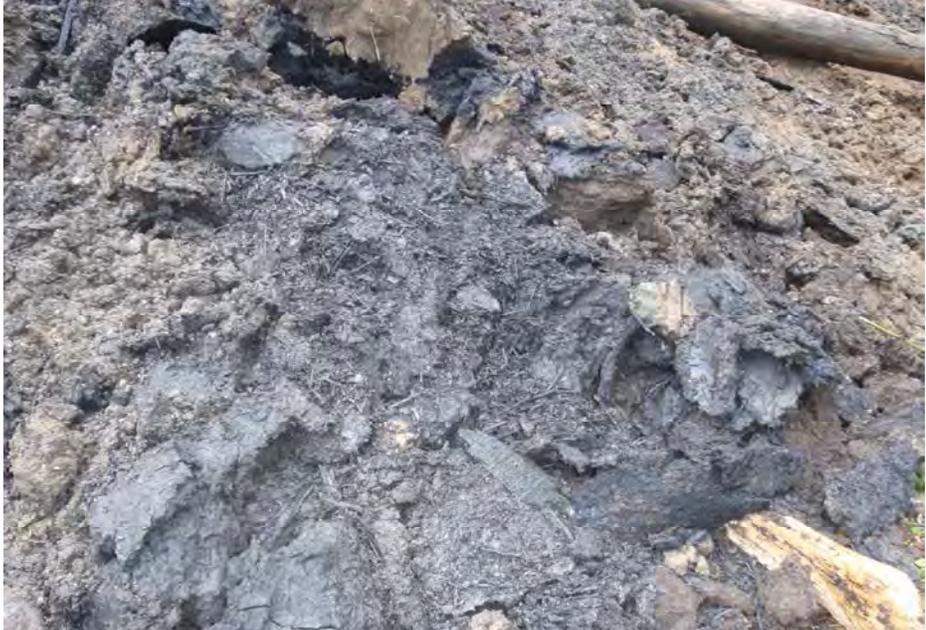
CLIENT NAME: Honeywell		SITE LOCATION: HB-TP-55	PROJECT NO. 49362
PHOTO NO. 53	DATE: 6/6/12

DESCRIPTION Black stained material at approximately 290 ft - noting twig like material and pine needles.

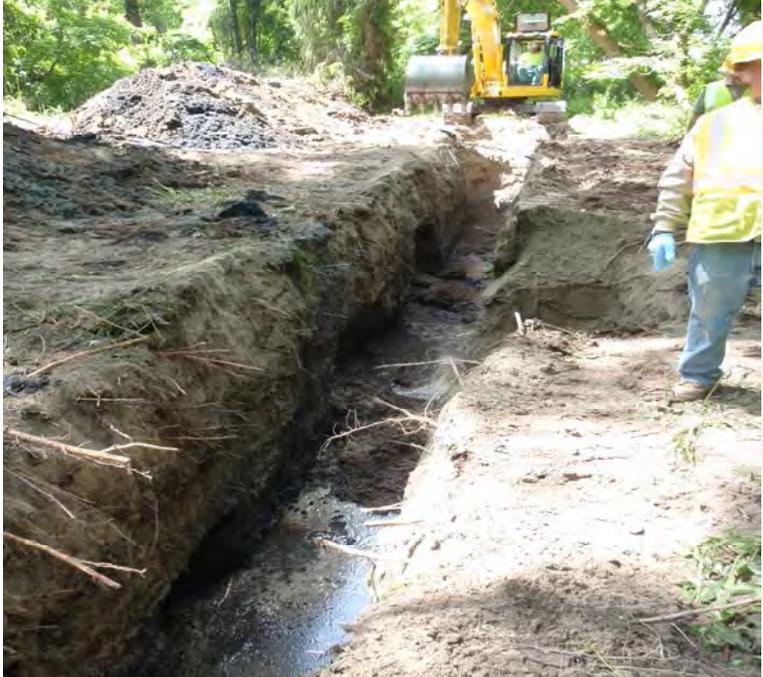
CLIENT NAME: Honeywell		SITE LOCATION: HB-TP-55	PROJECT NO. 49362
PHOTO NO. 54	DATE: 6/6/12

DESCRIPTION Groundwater with sheen at approximately 356 ft. from the Northeast end of HB-TP-55.

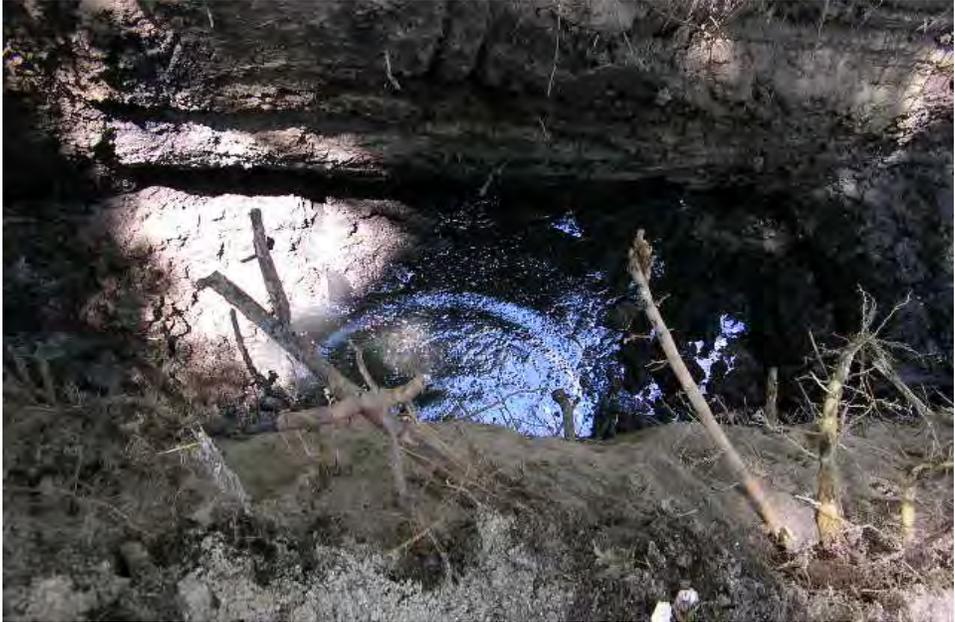
CLIENT NAME: Honeywell		SITE LOCATION: HB-TP-55	PROJECT NO. 49362
PHOTO NO. 55	DATE: 6/6/12

DESCRIPTION Groundwater with sheen at approximately 356 ft. from the Northeast end of HB-TP-55.

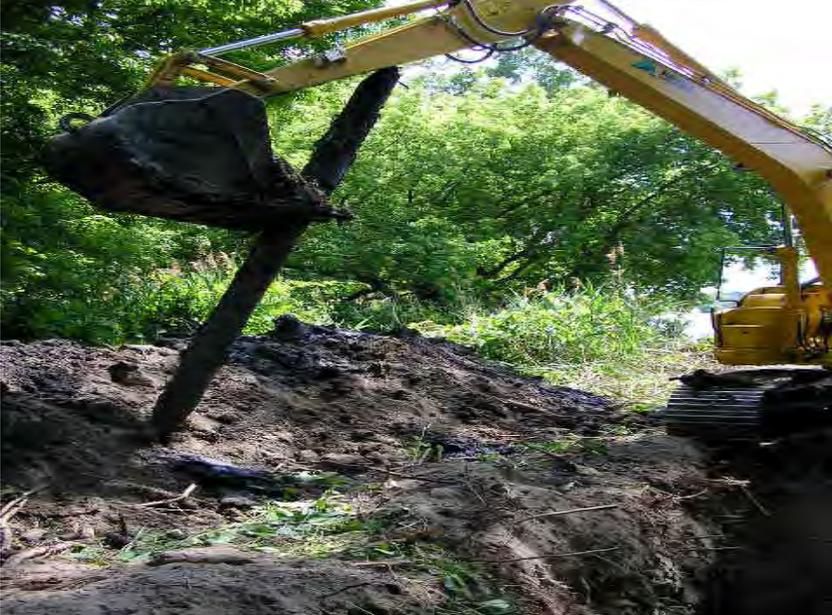
CLIENT NAME: Honeywell		SITE LOCATION: HB-TP-55	PROJECT NO. 49362
PHOTO NO. 56	DATE: 6/6/12

DESCRIPTION Wood piling from bank of former Onondaga Creek Channel, at 413 ft. from the Northeast start of HB-TP-55.

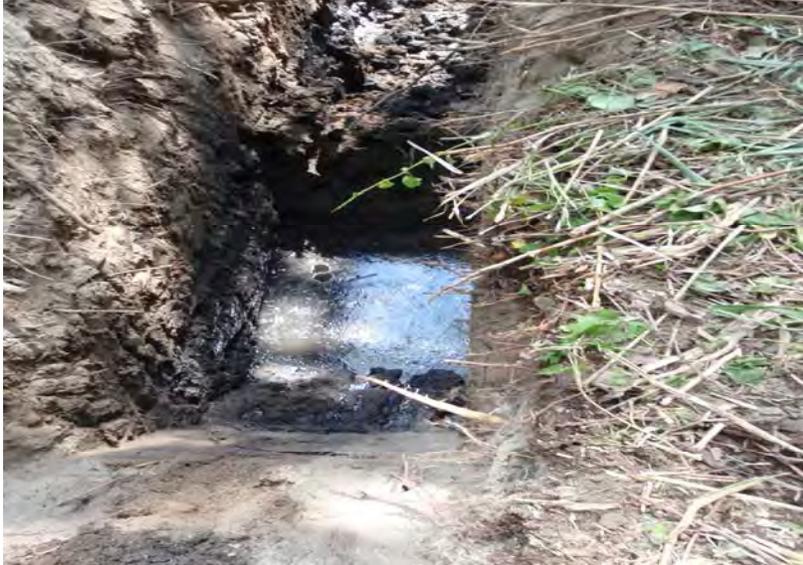
CLIENT NAME: Honeywell		SITE LOCATION: HB-TP-55	PROJECT NO. 49362
PHOTO NO. 57	DATE: 6/6/12

DESCRIPTION Section 400-425 with sheen noted in section 400- 413 ft Southwest of Northeastern start of HB-TP-55.

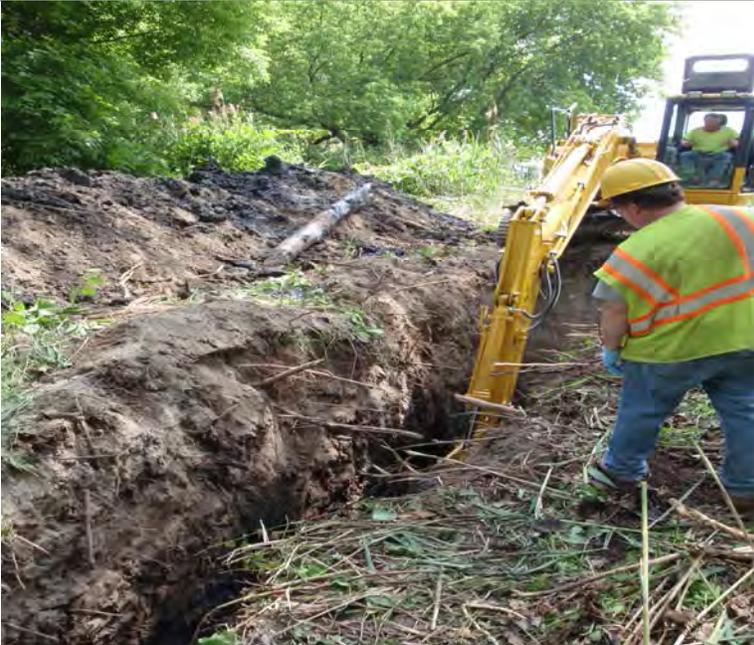
CLIENT NAME: Honeywell		SITE LOCATION: HB-TP-55	PROJECT NO. 49362
PHOTO NO. 58	DATE: 6/6/12

DESCRIPTION Section 400-425 with piling encountered at 413 ft Southwest of Northeastern start of HB-TP-55.
