CLIENT NAME: Honeywell		SITE LOCATION: HB-TP-55		PROJECT NO. 49362
PHOTO NO. 59	DATE: 6/6/12

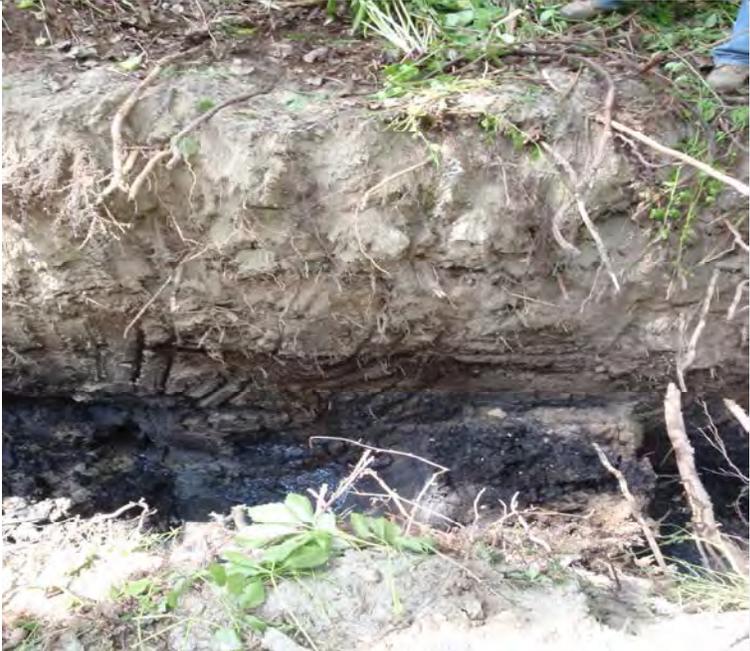
DESCRIPTION Section 400-425 with piling encountered at 413 ft Southwest of Northeastern start of HB-TP-55.

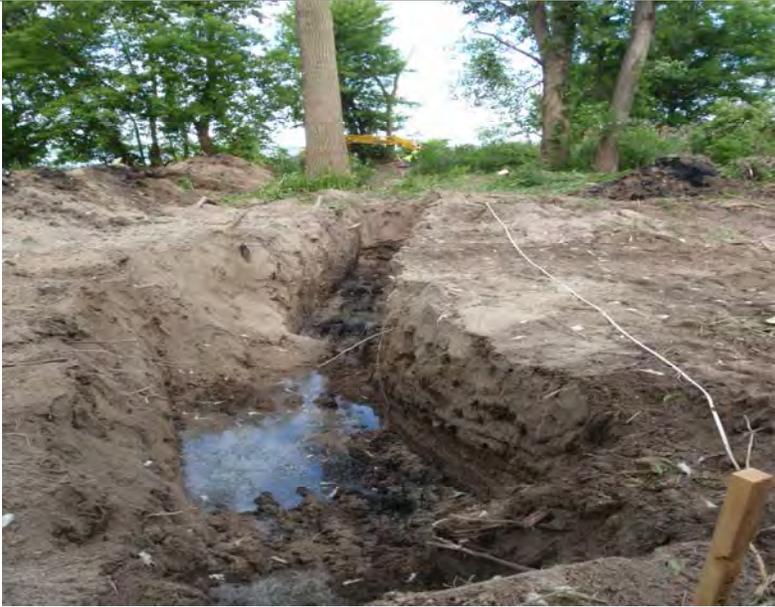
CLIENT NAME: Honeywell		SITE LOCATION: HB-TP-55AN		PROJECT NO. 49362
PHOTO NO. 70	DATE: 6/7/12

DESCRIPTION HB-TP-55AN Start at 286 ft southwest in HB-TP-55. View to the North from intersection of HB-TP55 and HB-TP-55AN

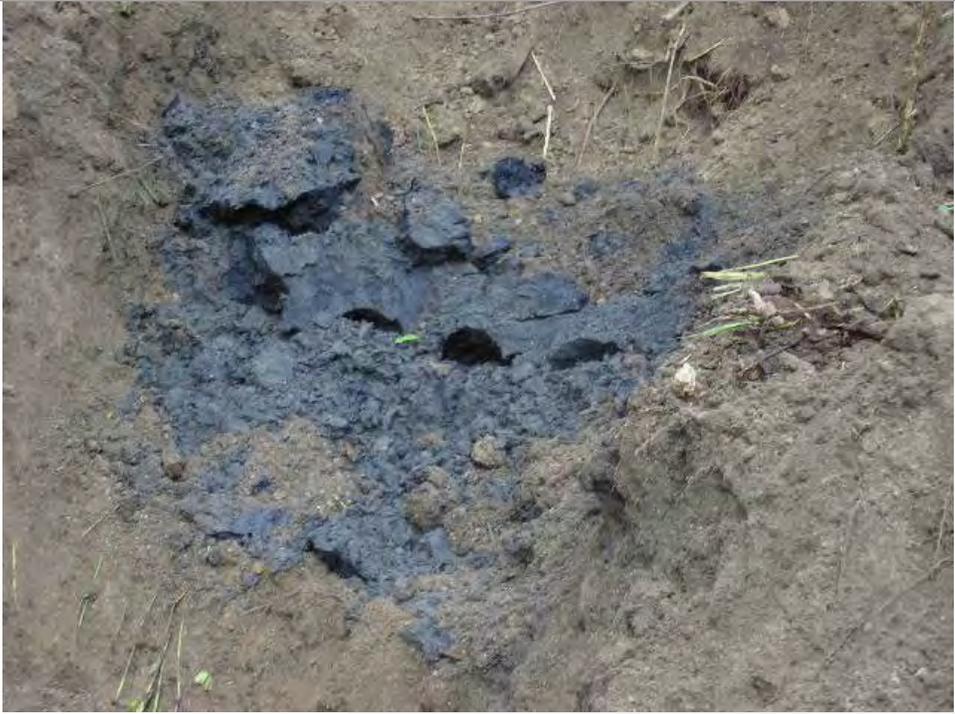
CLIENT NAME: Honeywell		SITE LOCATION: HB-TP-55AN	PROJECT NO. 49362
PHOTO NO. 71	DATE: 6/7/12

DESCRIPTION Stained soils from approximately 50 ft. from the Southern end of HB-TP-55AN.

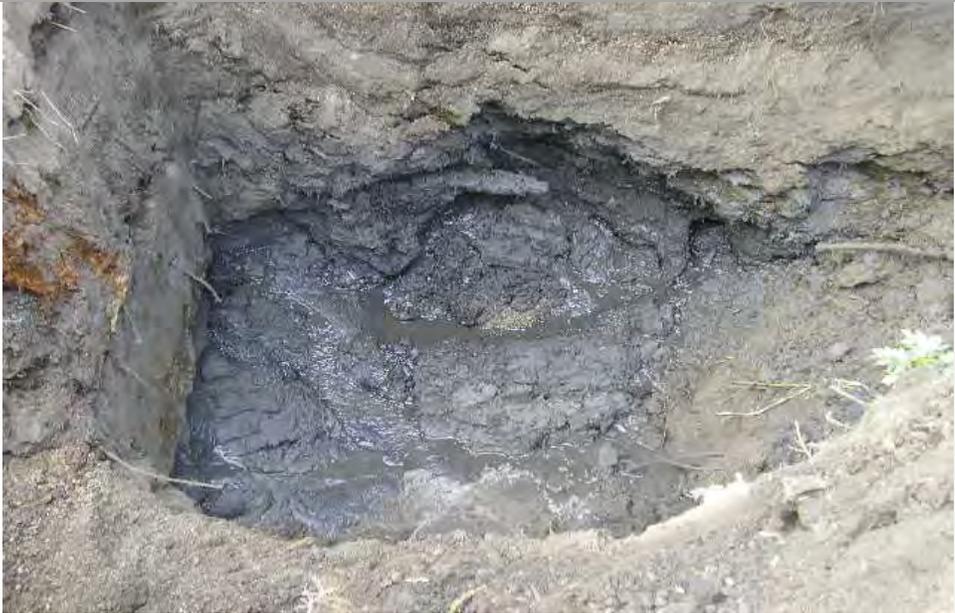
CLIENT NAME: Honeywell		SITE LOCATION: HB-TP-55AN	PROJECT NO. 49362
PHOTO NO. 72	DATE: 6/7/12

DESCRIPTION Stained soils 64 ft. from the Southern end of HB-TP-55AN.

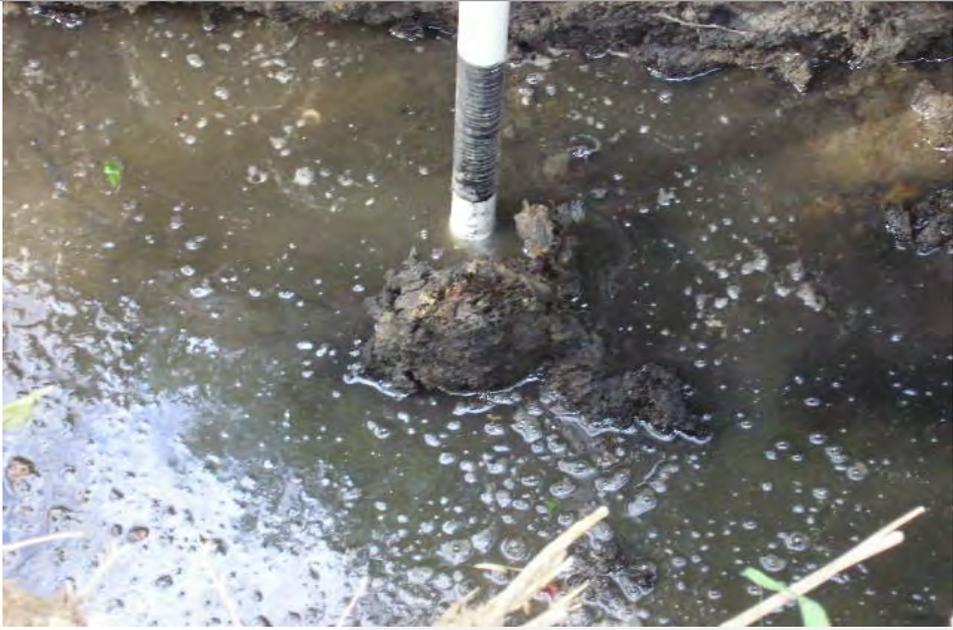
CLIENT NAME: Honeywell		SITE LOCATION: HB-TP-55AN	PROJECT NO. 49362
PHOTO NO. 73	DATE: 6/7/12

DESCRIPTION Piling and groundwater with sheen at 68 ft. from the Southern end of HB-TP-55AN

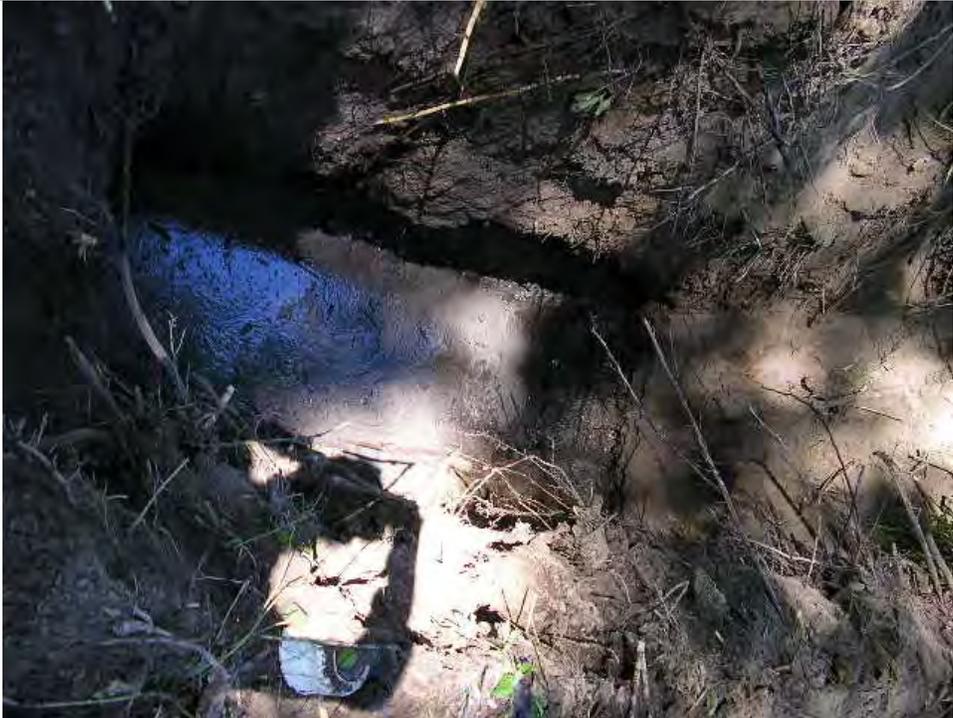
CLIENT NAME: Honeywell		SITE LOCATION: HB-TP-55AN	PROJECT NO. 49362
PHOTO NO. 74	DATE: 6/7/12

DESCRIPTION Groundwater with sheen entering excavation at approximately 152 ft.

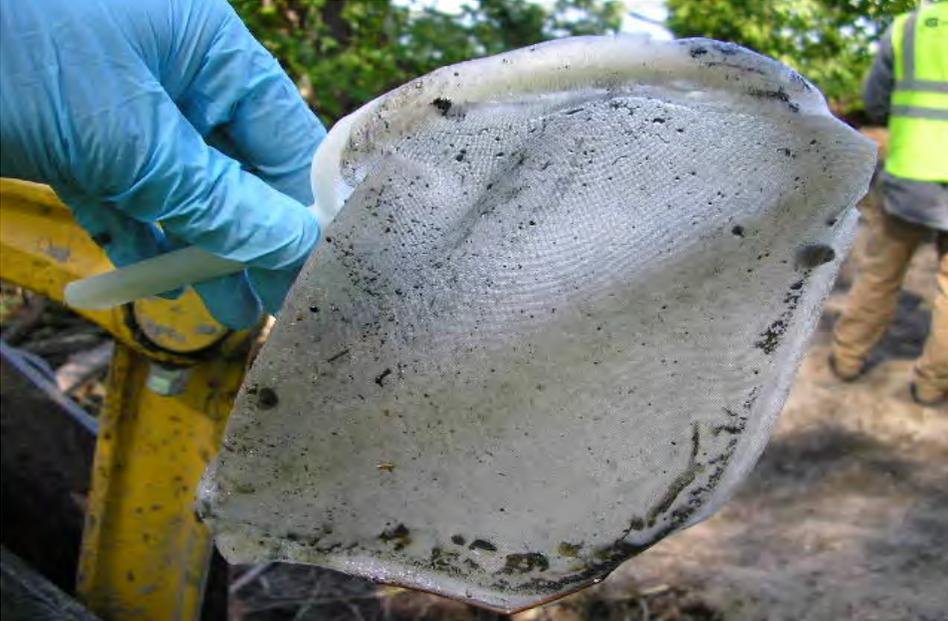
CLIENT NAME: Honeywell		SITE LOCATION: HB-TP-55AN	PROJECT NO. 49362
PHOTO NO. 75	DATE: 6/7/12

DESCRIPTION Sheen net with visible sheen collected from 152 ft from southern end of HB-TP-55AN

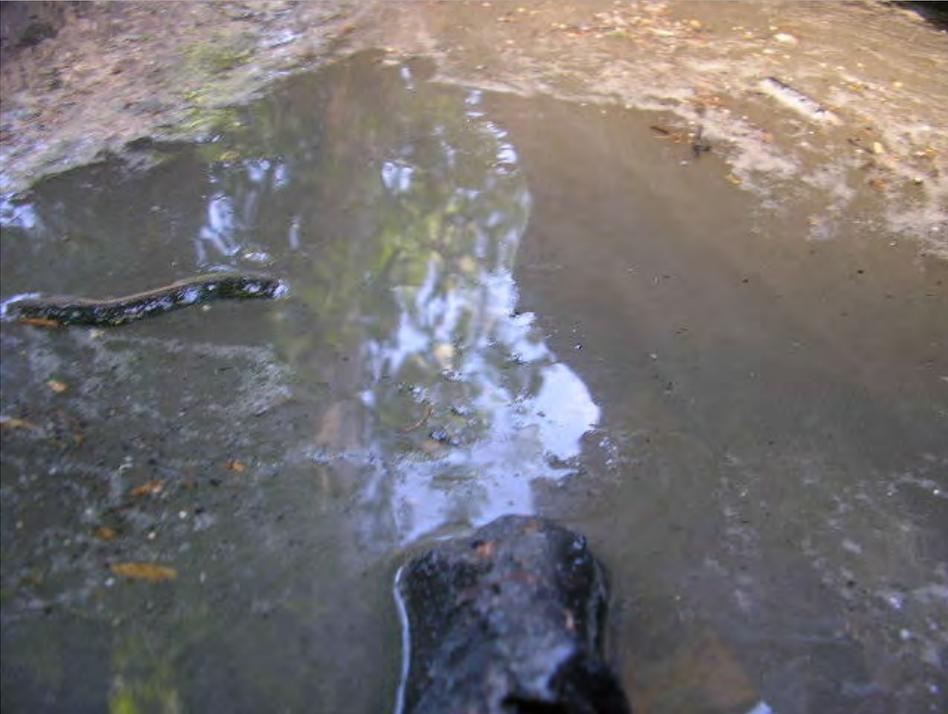
CLIENT NAME: Honeywell		SITE LOCATION: HB-TP-55AN	PROJECT NO. 49362
PHOTO NO. 76	DATE: 6/7/12

DESCRIPTION Groundwater in excavator bucket with sheen, entering 152 ft from the southern end of HB-TP-55AN.

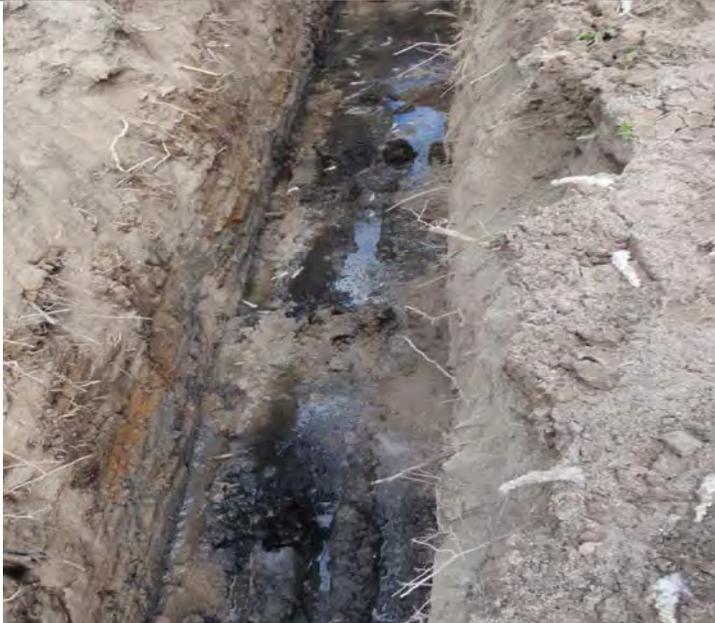
CLIENT NAME: Honeywell		SITE LOCATION: HB-TP-55AN		PROJECT NO. 49362
PHOTO NO. 77	DATE: 6/7/12

DESCRIPTION Tops of pilings noted in HB-TP-55AN. Pilings noted approximately every 5 to 10 linear ft along test pit to HB-TP-55AN.

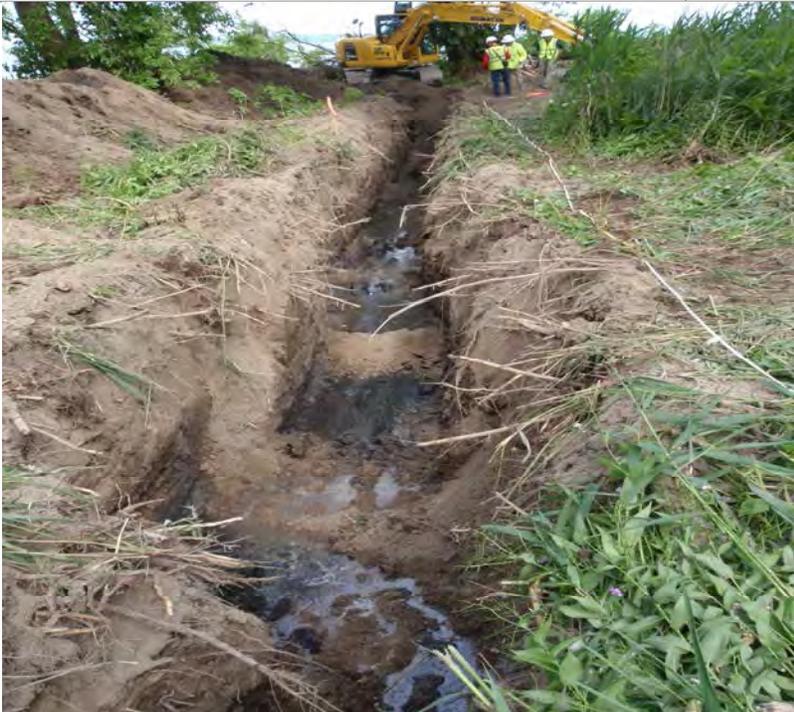
CLIENT NAME: Honeywell		SITE LOCATION: HB-TP-55AN		PROJECT NO. 49362
PHOTO NO. 78	DATE: 6/7/12

DESCRIPTION Tops of pilings noted in HB-TP-55AN. Pilings noted approximately every 5 to 10 linear feet along test pit to HB-TP-55AN.

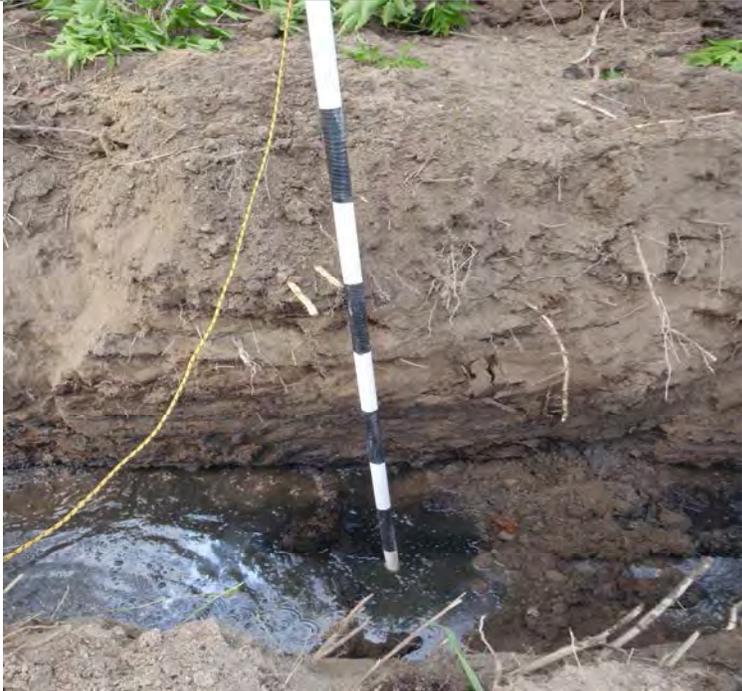
CLIENT NAME: Honeywell		SITE LOCATION: HB-TP-55AN	PROJECT NO. 49362
PHOTO NO. 79	DATE: 6/7/12

DESCRIPTION Tops of pilings noted in HB-TP-55AN. Pilings noted approximately every 5 to 10 linear feet along test pit to HB-TP-55AN.

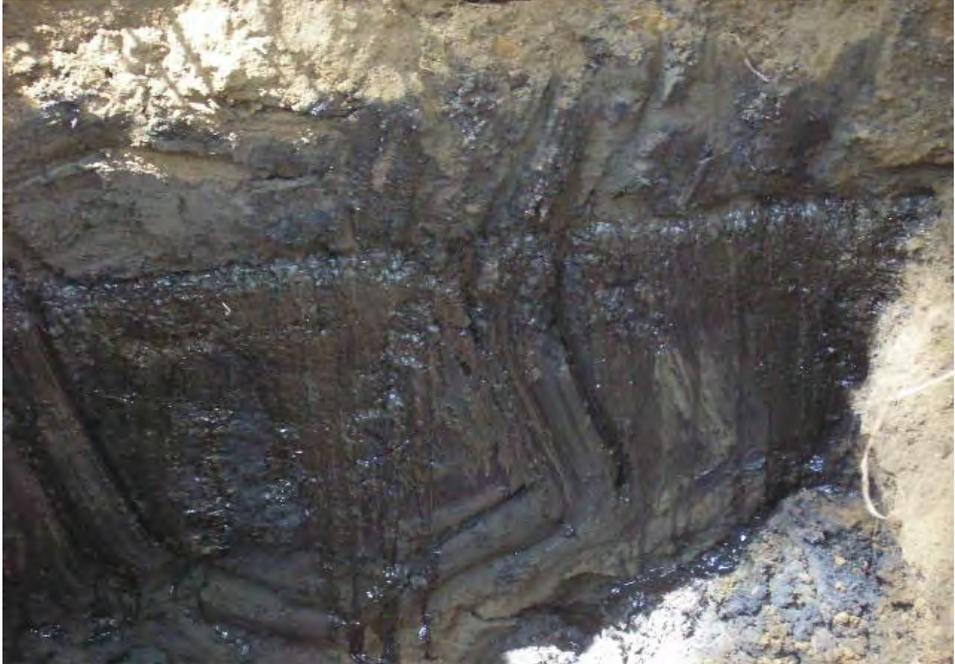
CLIENT NAME: Honeywell		SITE LOCATION: HB-TP-55AN	PROJECT NO. 49362
PHOTO NO. 80	DATE: 6/7/12

DESCRIPTION Sediment laden groundwater with sheen entering excavation at 30 ft. from the southern end of HB-TP-55AN.

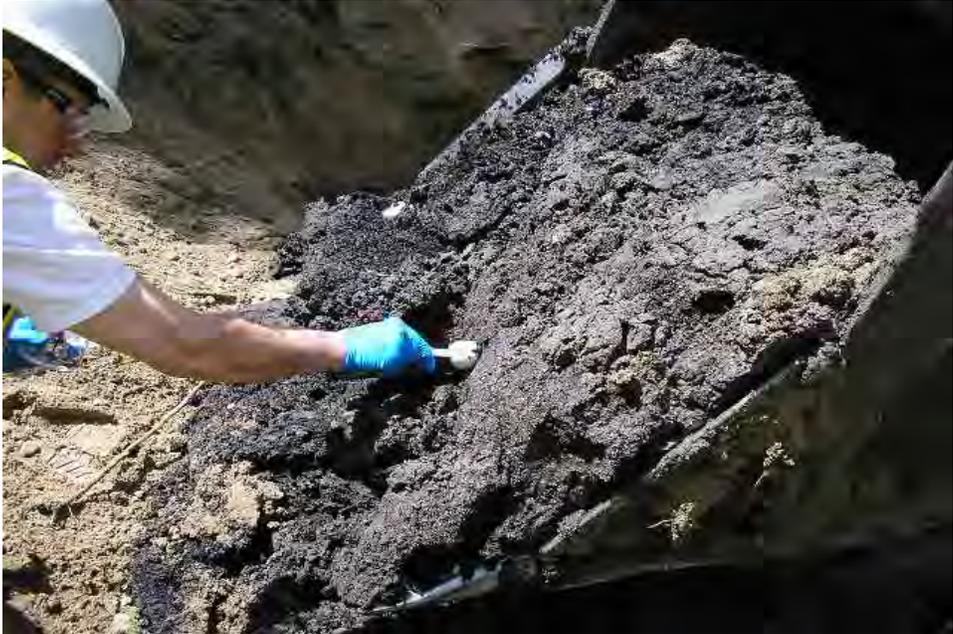
CLIENT NAME: Honeywell		SITE LOCATION: HB-TP-55AN	PROJECT NO. 49362
PHOTO NO. 81	DATE: 6/7/12

DESCRIPTION Stained soil at approximately 42 ft. from the North end of HB-TP-55BS.

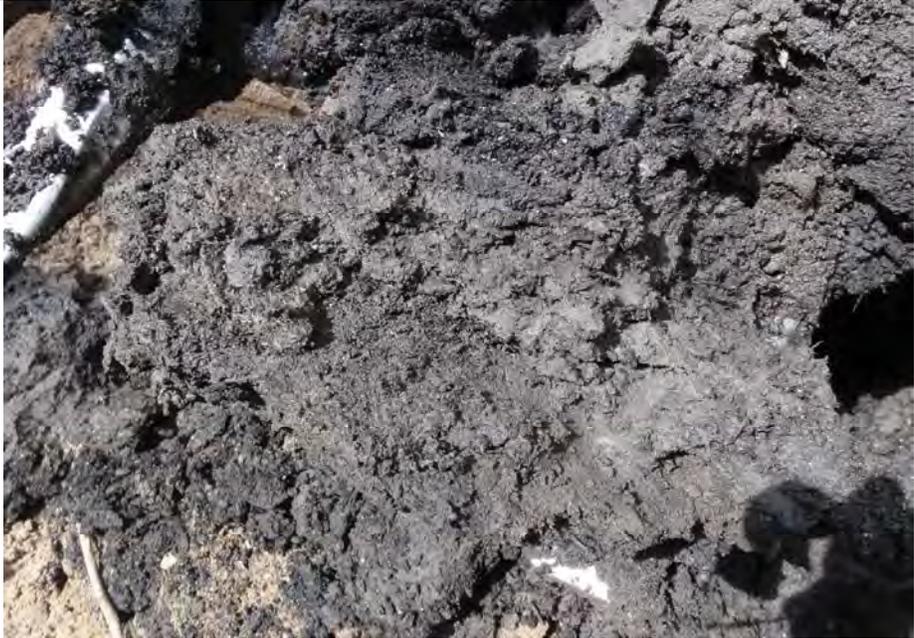
CLIENT NAME: Honeywell		SITE LOCATION: HB-TP-55AN	PROJECT NO. 49362
PHOTO NO. 82	DATE: 6/11/12

DESCRIPTION Spoils pile from North end of HB-TP-55AN.

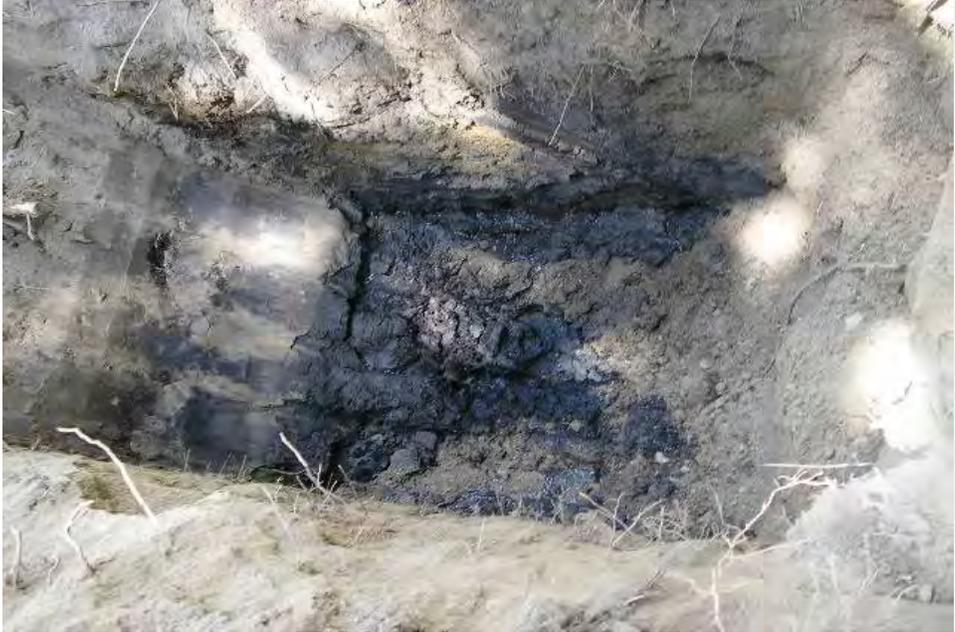
CLIENT NAME: Honeywell		SITE LOCATION: HB-TP-55AN	PROJECT NO. 49362
PHOTO NO. 83	DATE: 6/7/12

DESCRIPTION Stained soils in test pit HB-TP-55BS.

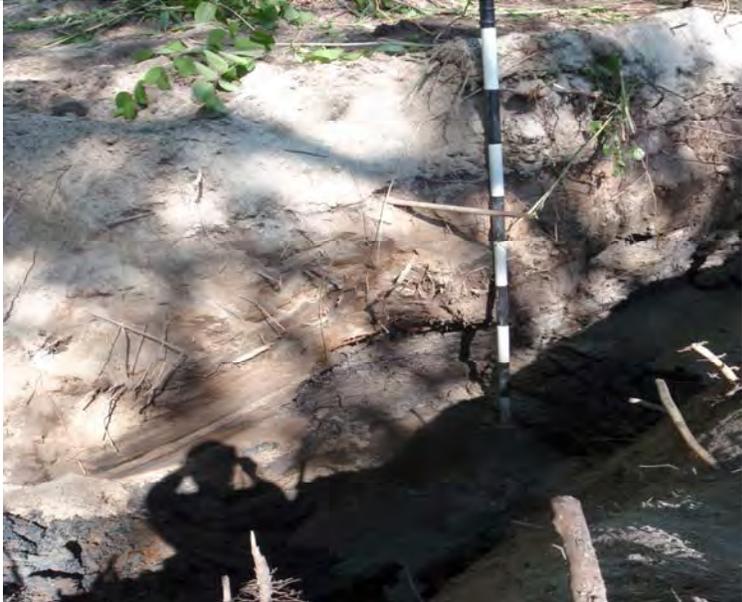
CLIENT NAME: Honeywell		SITE LOCATION: HB-TP-55BS	PROJECT NO. 49362
PHOTO NO. 86	DATE: 6/7/12

DESCRIPTION East wall of excavation at 35 ft south of intersecion of HB-TP-55 and HB-TP-55BS

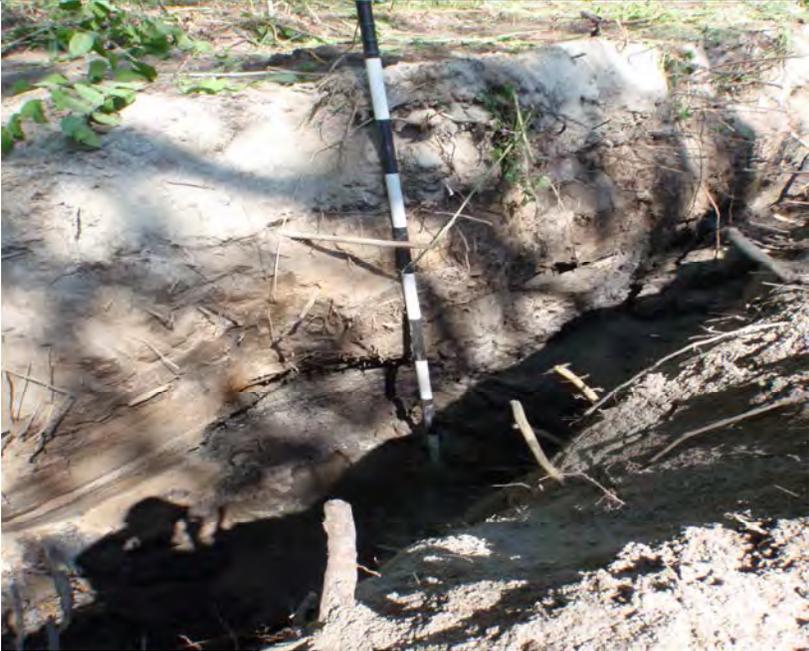
CLIENT NAME: Honeywell		SITE LOCATION: HB-TP-55BS		PROJECT NO. 49362
PHOTO NO. 87	DATE: 6/7/12

DESCRIPTION East wall of excavation at 35 ft south of intersecion of HB-TP-55 and HB-TP-55BS

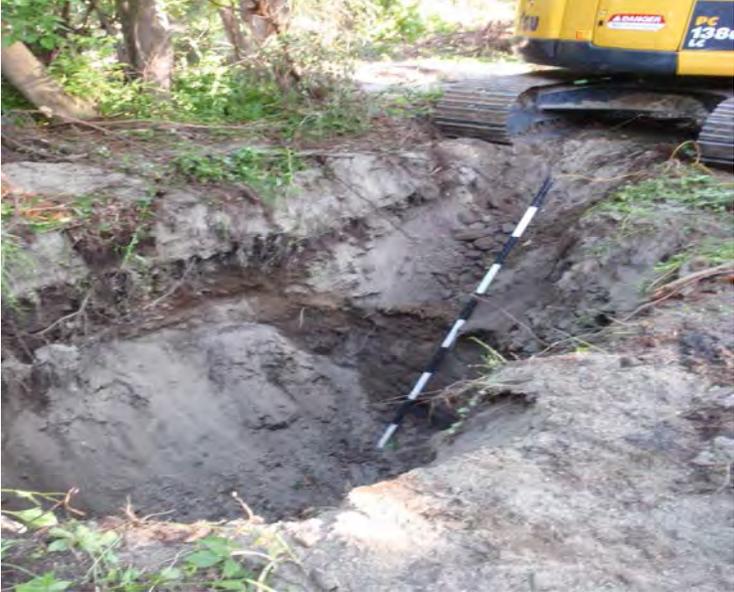
CLIENT NAME: Honeywell		SITE LOCATION: HB-TP-56		PROJECT NO. 49362
PHOTO NO. 89	DATE: 6/8/12

DESCRIPTION Southwest end of HB-TP-56 noting cobbles and gravel backfill.

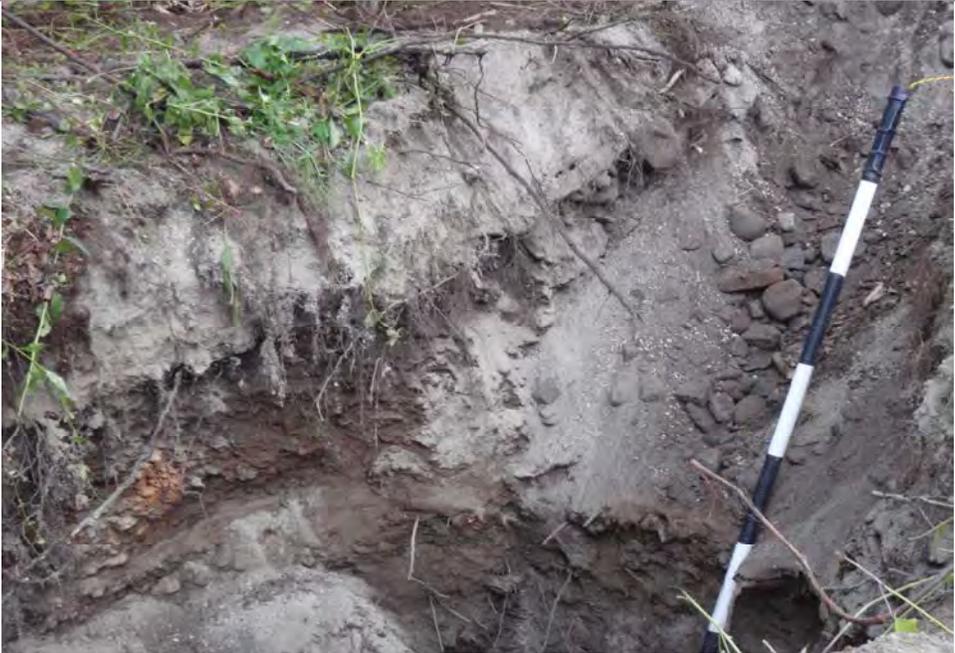
CLIENT NAME: Honeywell		SITE LOCATION: HB-TP-56		PROJECT NO. 49362
PHOTO NO. 90	DATE: 6/8/12

DESCRIPTION Southwest end of HB-TP-56 noting cobbles and gravel backfill.

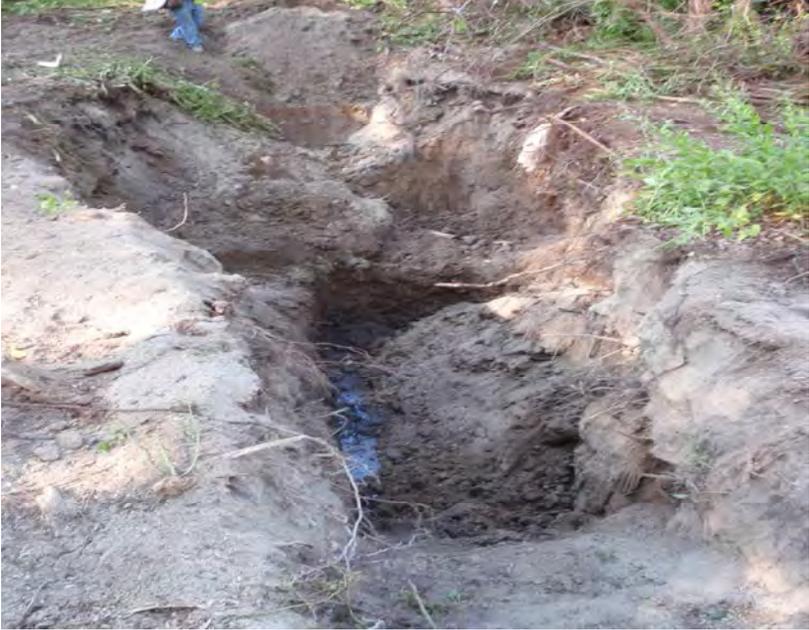
CLIENT NAME: Honeywell		SITE LOCATION: HB-TP-56	PROJECT NO. 49362
PHOTO NO. 91	DATE: 6/8/12

DESCRIPTION Collapsing trench wall on HB-TP-56.

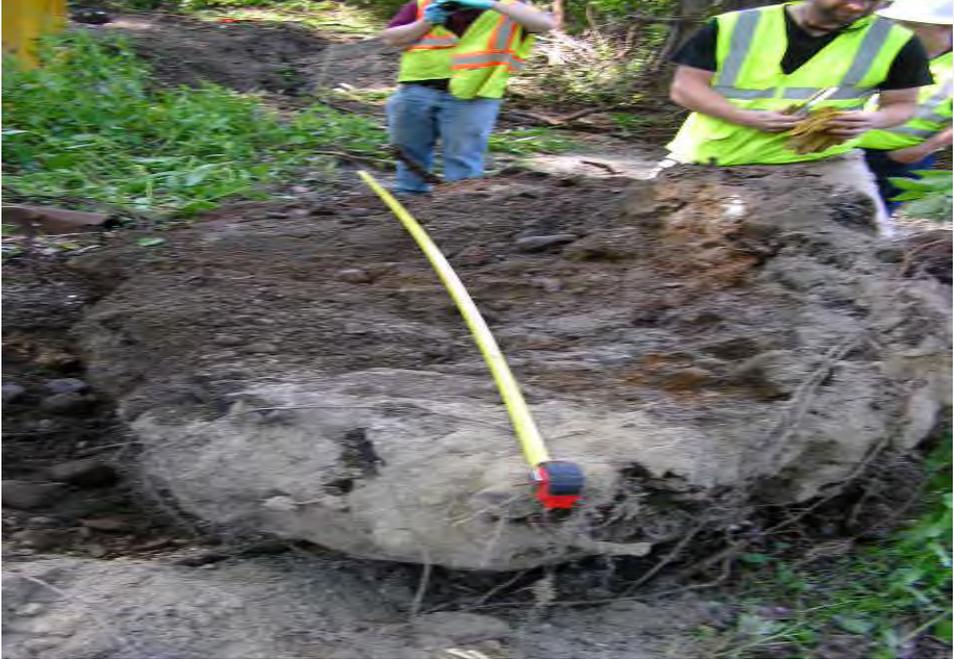
CLIENT NAME: Honeywell		SITE LOCATION: HB-TP-56	PROJECT NO. 49362
PHOTO NO. 92	DATE: 6/8/12

DESCRIPTION Large concrete like structure, potentially part of former Onondaga Creek Bank removed at approximately 25 ft from South West end of HB-TP-56.

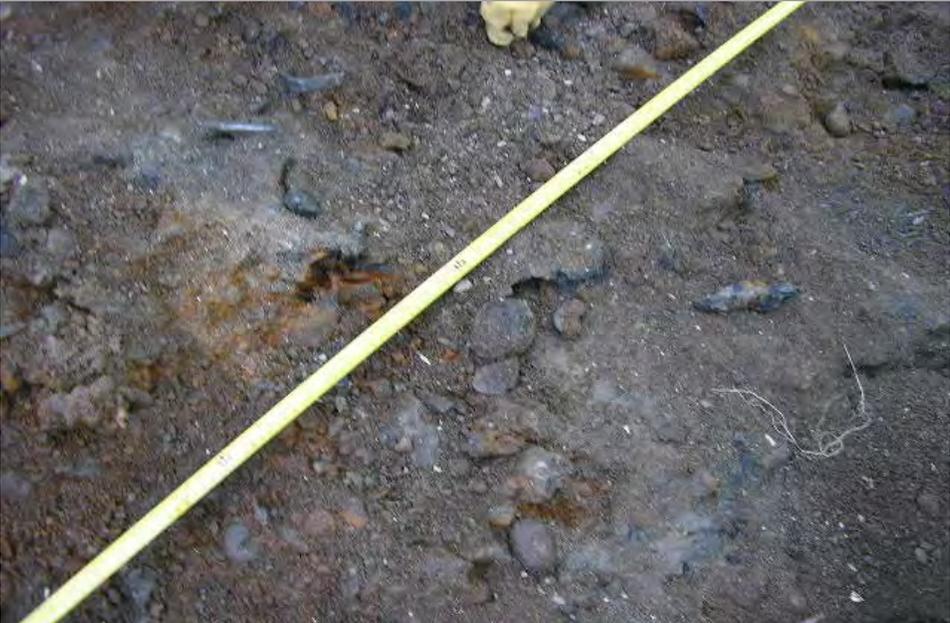
CLIENT NAME: Honeywell		SITE LOCATION: HB-TP-56	PROJECT NO. 49362
PHOTO NO. 93	DATE: 6/8/12

DESCRIPTION Large concrete like structure, potentially part of former Onondaga Creek Bank removed at approximately 25 ft from South West end of HB-TP-56.

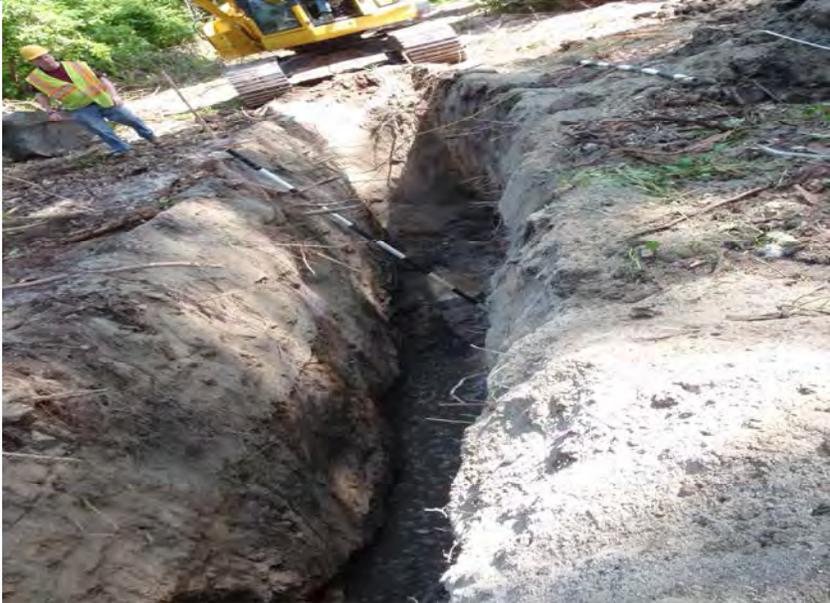
CLIENT NAME: Honeywell		SITE LOCATION:	PROJECT NO. 49362
PHOTO NO. 94	DATE: 6/8/12

DESCRIPTION HB-TP-56 section 40-100 ft east of western starting point. Fill noted to at least 7 ft. Water present at 8 ft bgs. Frequent collapses of trench wall.

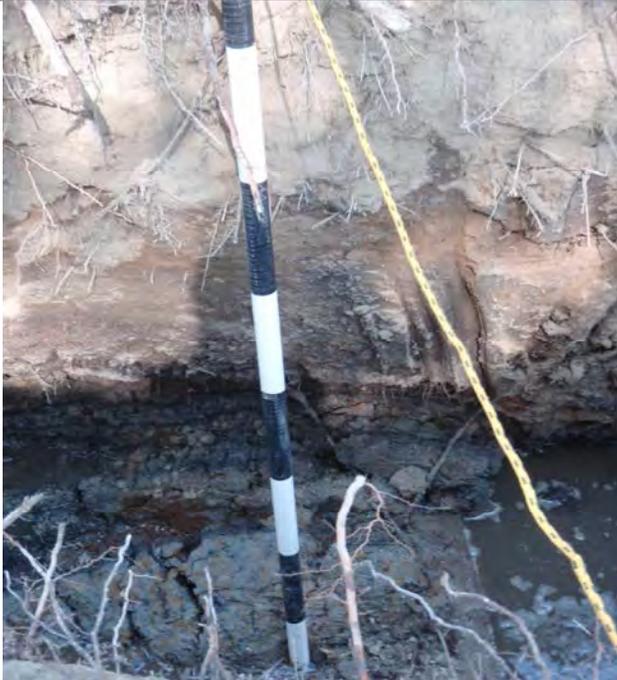
CLIENT NAME: Honeywell		SITE LOCATION:		PROJECT NO. 49362
PHOTO NO. 95	DATE: 6/8/12

DESCRIPTION HB-TP-56 section 40-100 ft east of western starting point. Close-up of fill/lake sediment/black stained material interface.

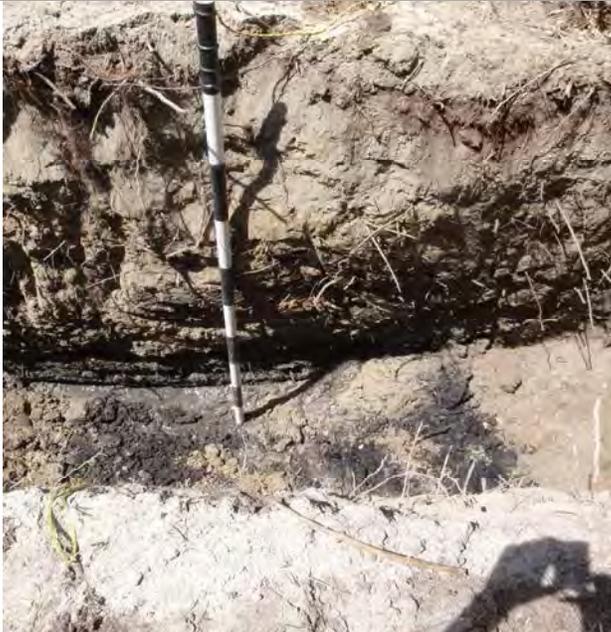
CLIENT NAME: Honeywell		SITE LOCATION: HB-TP-56		PROJECT NO. 49362
PHOTO NO. 96	DATE: 6/8/12

DESCRIPTION HB-TP-56 section 100-150 ft east of western end. Wooden and metal structure noted in excavation at 145 ft.

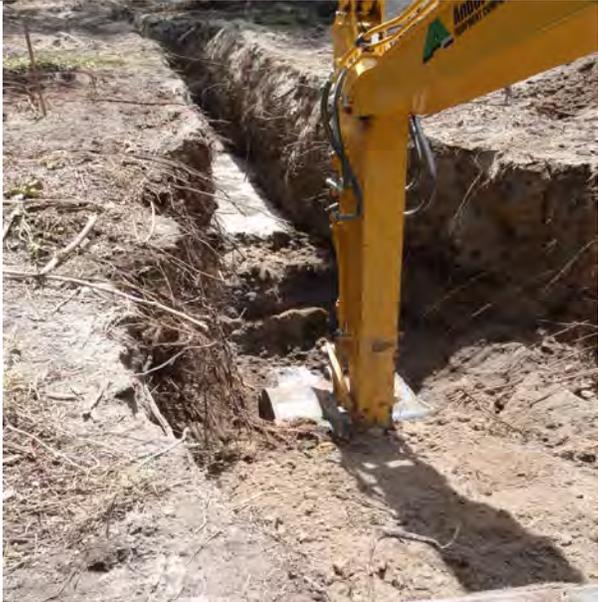
CLIENT NAME: Honeywell		SITE LOCATION: HB-TP-56		PROJECT NO. 49362
PHOTO NO. 97	DATE: 6/11/12

DESCRIPTION HB-TP-56 section 100-150 ft east of western end. Wooden and metal structure noted in excavation at 145 ft.

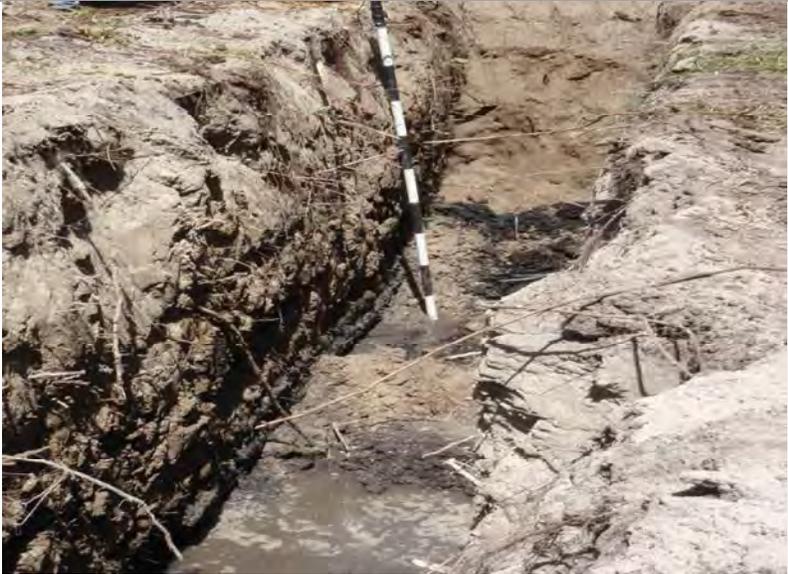
CLIENT NAME: Honeywell		SITE LOCATION: HB-TP-56		PROJECT NO. 49362
PHOTO NO. 98	DATE: 6/11/12

DESCRIPTION HB-TP-56 section 100-150 ft east of western end. Wooden and metal structure noted in excavation at 145 ft.

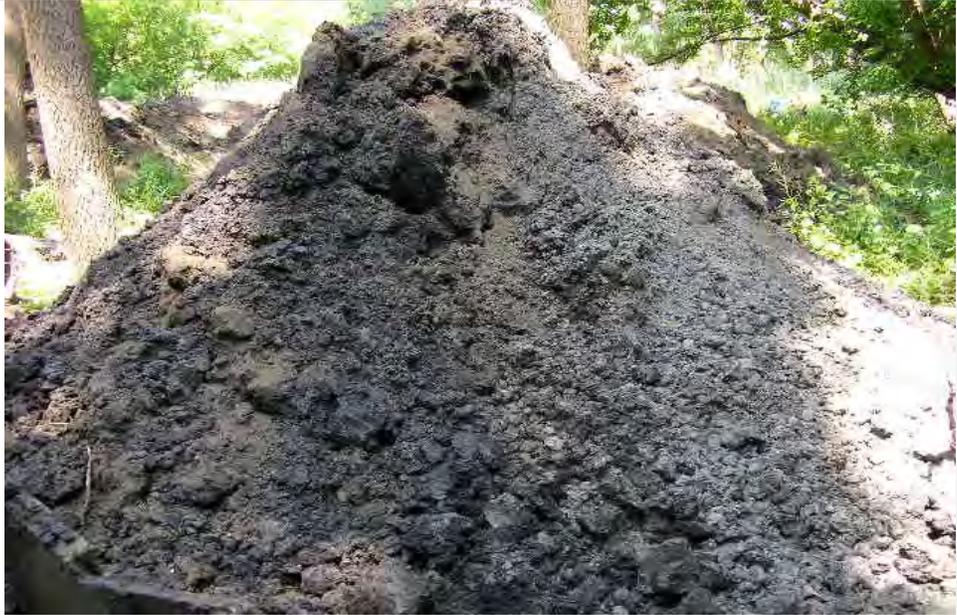
CLIENT NAME: Honeywell		SITE LOCATION: HB-TP-56	PROJECT NO. 49362
PHOTO NO. 100	DATE: 6/11/12

DESCRIPTION Spoils from test pit HB-TP-56 from approximately 410 ft to 400 ft from the South West Corner of HB-TP-56.

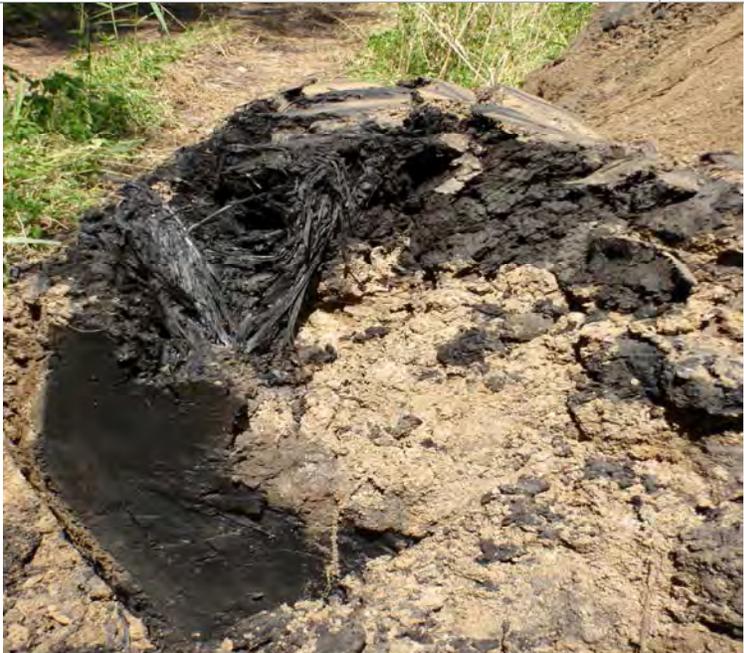
CLIENT NAME: Honeywell		SITE LOCATION: HB-TP-56.		PROJECT NO. 49362
PHOTO NO. 102	DATE: 6/11/12

DESCRIPTION Black stained spoils from HB-TP-56 from 508 ft Northeast of southwestern starting point.

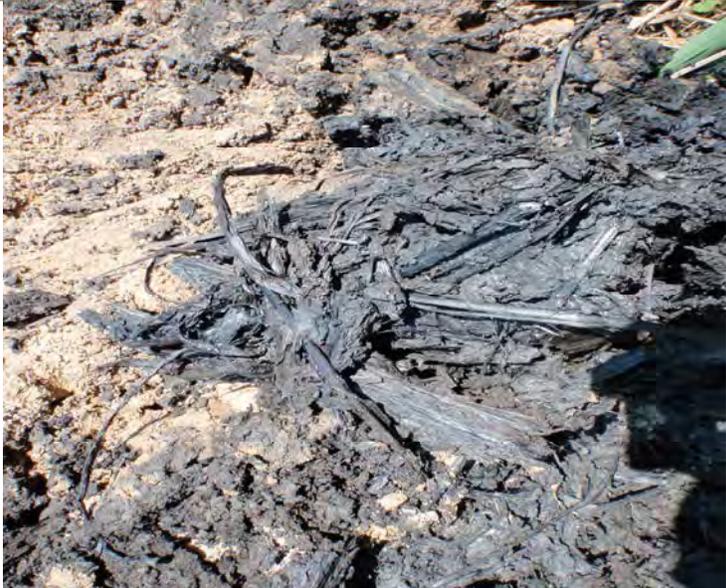
CLIENT NAME: Honeywell		SITE LOCATION: HB-TP-56.		PROJECT NO. 49362
PHOTO NO. 103	DATE: 6/11/12

DESCRIPTION Black stained reed-like material and vegetation mat from stained soils horizon on HB-TP-56 @ 508 ft east of western end.

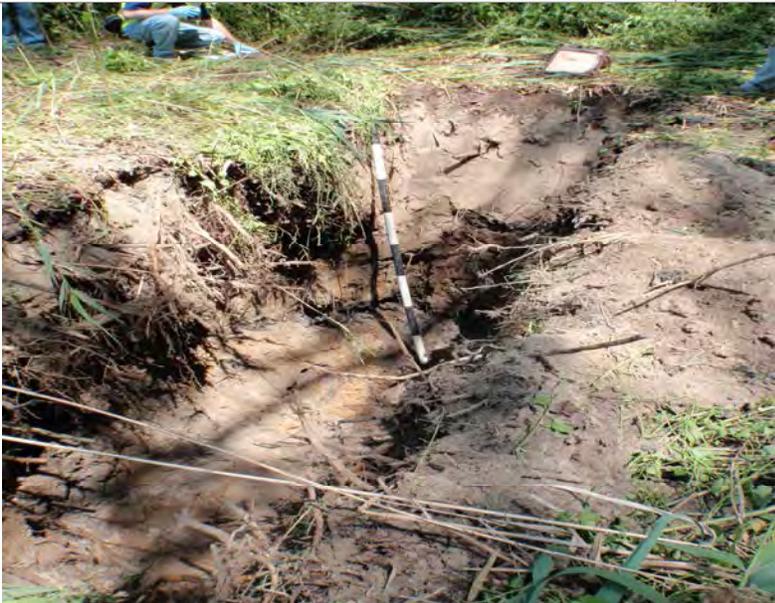
CLIENT NAME: Honeywell		SITE LOCATION: HB-TP-56.		PROJECT NO. 49362
PHOTO NO. 104	DATE: 6/11/12

DESCRIPTION Start of section 620 ft Northeast of the Southwestern starting point of HB-T-56. Coarse material causing trench instability.

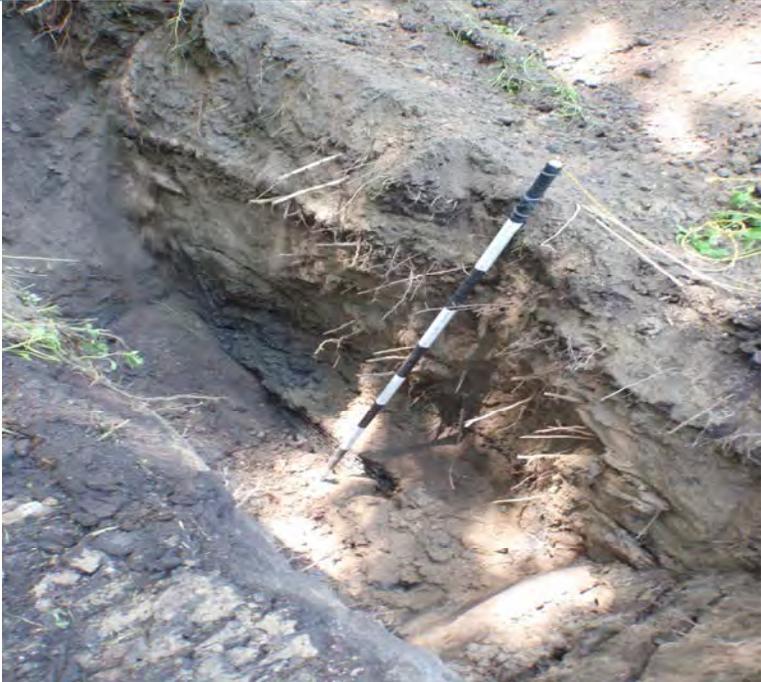
CLIENT NAME: Honeywell		SITE LOCATION: HB-TP-56.		PROJECT NO. 49362
PHOTO NO. 105	DATE: 6/11/12

DESCRIPTION Start of section 467 ft Northeast of the Southwestern starting point of HB-T-56. Coarse material causing trench instability.

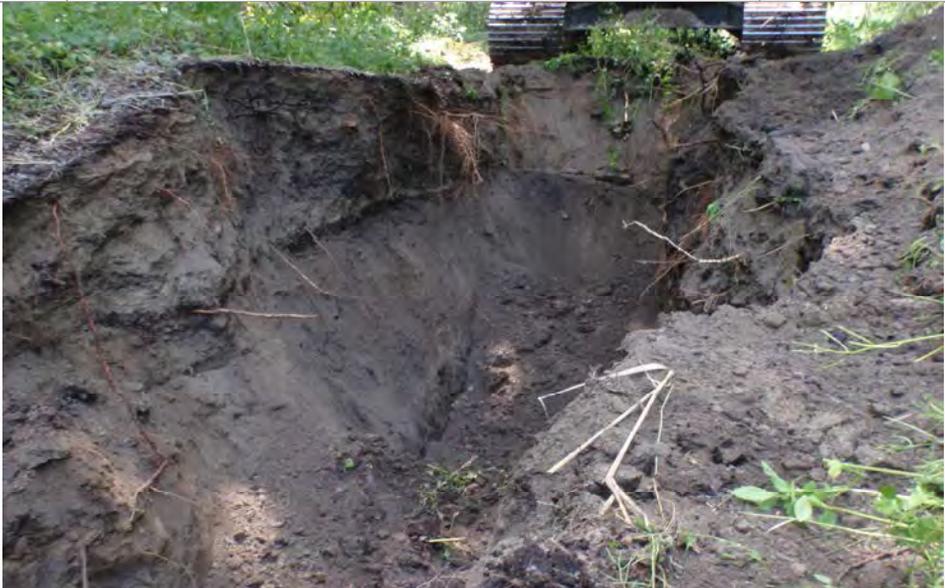
CLIENT NAME: Honeywell		SITE LOCATION: HB-TP-56.		PROJECT NO. 49362
PHOTO NO. 106	DATE: 6/11/12

DESCRIPTION Start of section 467 ft Northeast of the Southwestern starting point of HB-T-56. Caved section due to coars material in berm.

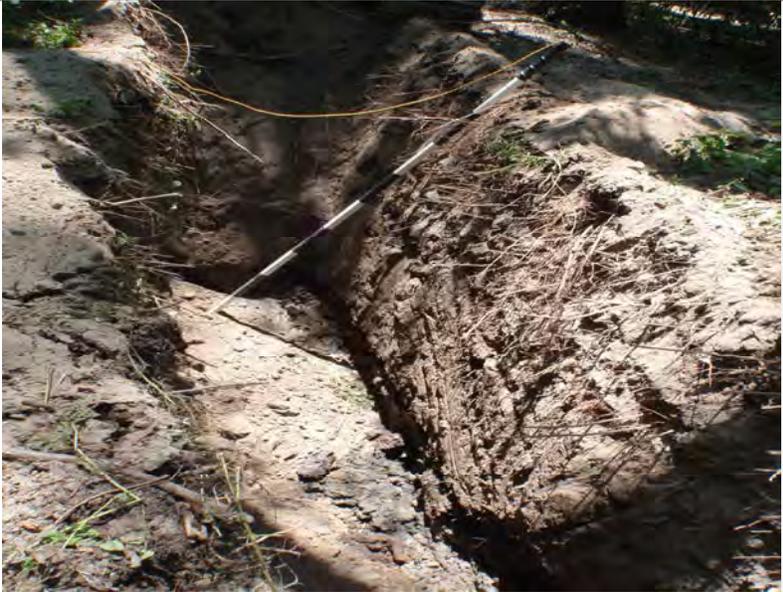
CLIENT NAME: Honeywell		SITE LOCATION: HB-TP-56.		PROJECT NO. 49362
PHOTO NO. 107	DATE: 6/11/12

DESCRIPTION HB-TP-56 section 467-400 ft Northeast of the Southwestern starting point, noting fill material

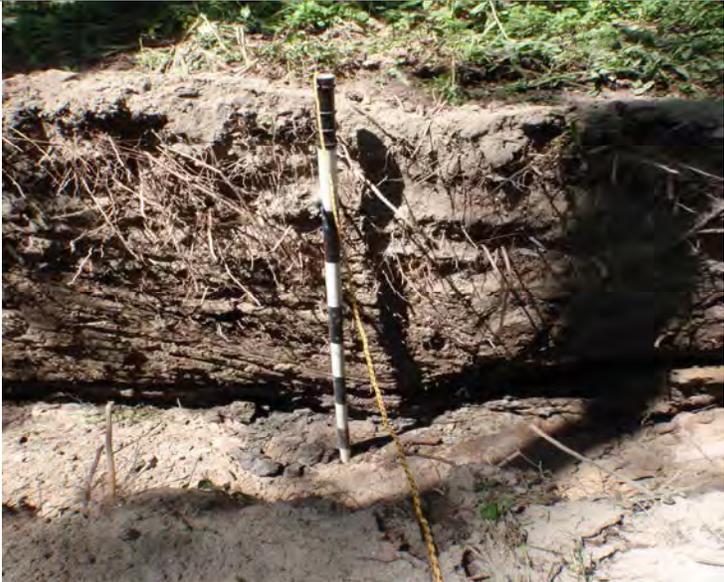
CLIENT NAME: Honeywell		SITE LOCATION: HB-TP-56.		PROJECT NO. 49362
PHOTO NO. 108	DATE: 6/11/12

DESCRIPTION HB-TP-56 section 467-400 ft Northeast of the Southwestern starting point, noting fill material

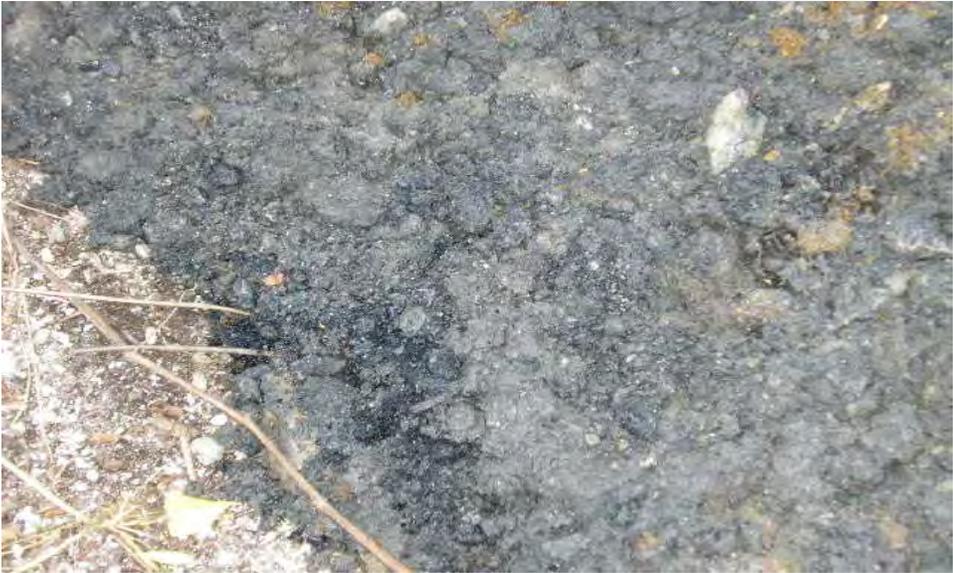
CLIENT NAME: Honeywell		SITE LOCATION: HB-TP-57		PROJECT NO. 49362
PHOTO NO. 112	DATE: 6/11/12

DESCRIPTION Spoils with dark stained soil and coal tar like material from HB-TP-57

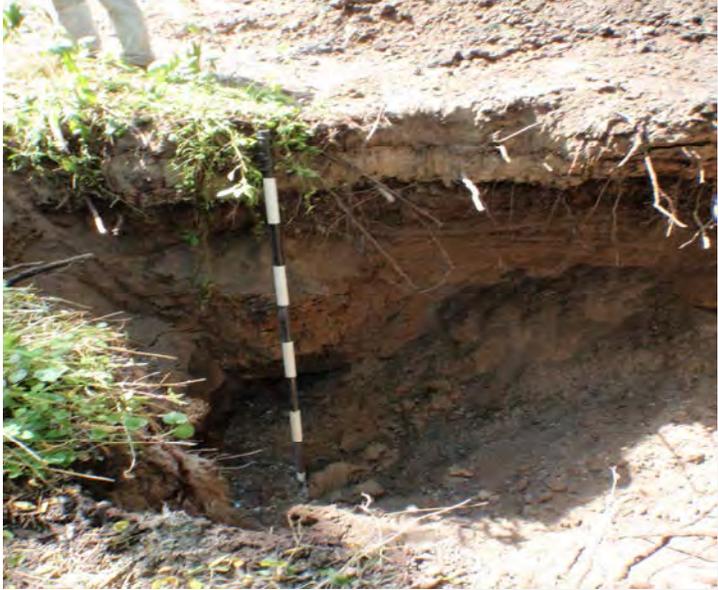
CLIENT NAME: Honeywell		SITE LOCATION: HB-TP-57	PROJECT NO. 49362
PHOTO NO. 113	DATE: 6/11/12

DESCRIPTION Section 267 ft east of west end of trench HB-TP-57. Trench section caved quickly making strata identification difficult.

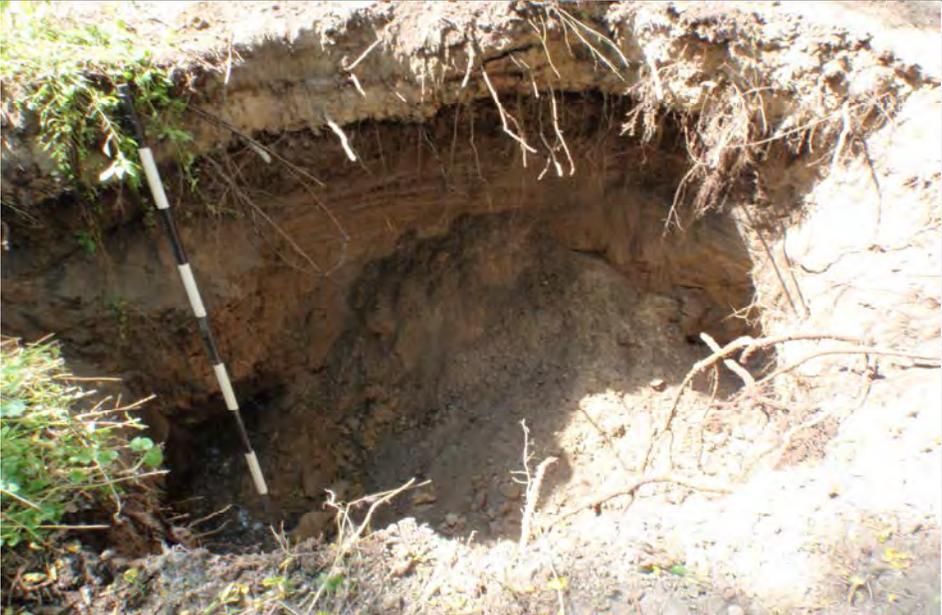
CLIENT NAME: Honeywell		SITE LOCATION: HB-TP-57	PROJECT NO. 49362
PHOTO NO. 114	DATE: 6/11/12

DESCRIPTION 267 ft east of west end of trench HB-TP-57. Trench section caved quickly making strata identification difficult.

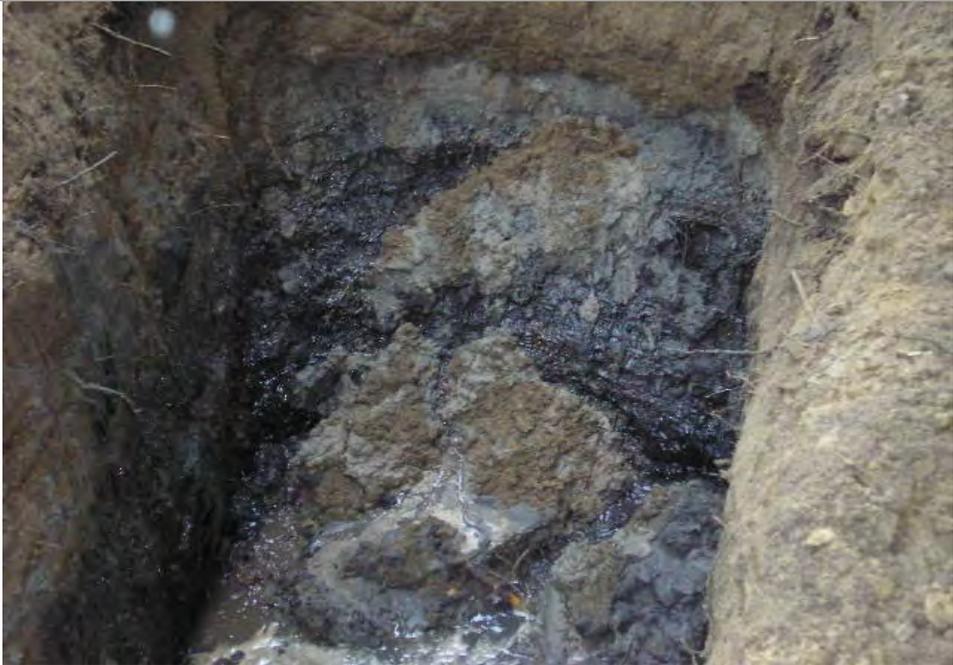
CLIENT NAME: Honeywell		SITE LOCATION: HB-TP-57	PROJECT NO. 49362
PHOTO NO. 115	DATE: 6/12/12

DESCRIPTION Coal tar like material and stained soil at approximately 560 ft. Northeast of the Southwestern starting point.
