CLIENT NAME: Honeywell		SITE LOCATION: HB-TP-55		PROJECT NO. 49362
PHOTO NO. 59	DATE: 6/6/12

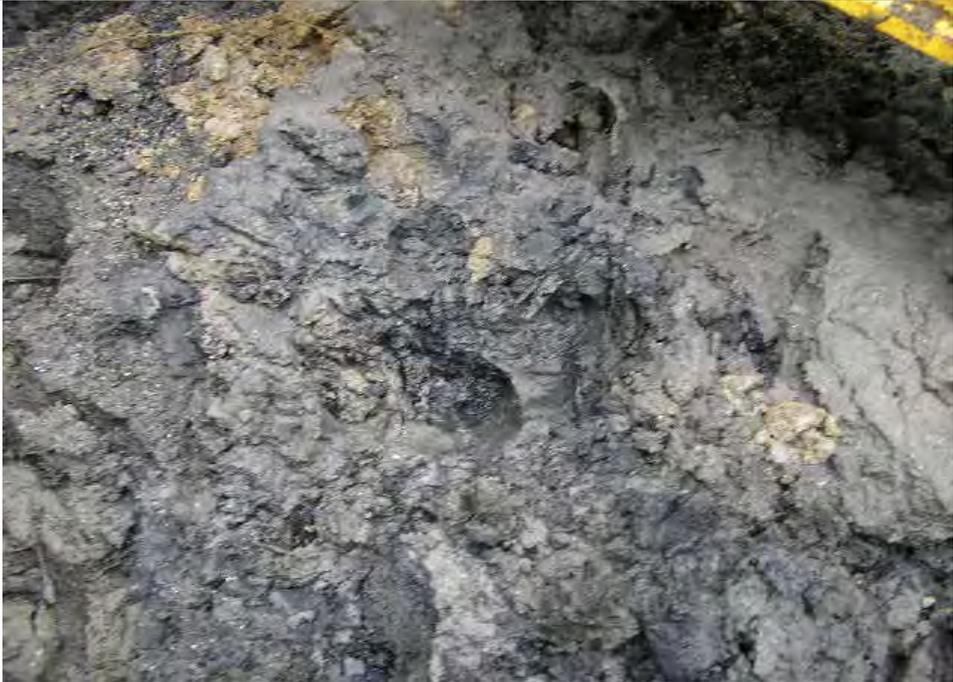
CLIENT NAME: Honeywell		SITE LOCATION: HB-TP-57	PROJECT NO. 49362
PHOTO NO. 116	DATE: 6/12/12

DESCRIPTION Stained soil spoils at approximately 560 ft. Northeast of the Southwestern starting point of HB-TP-57.

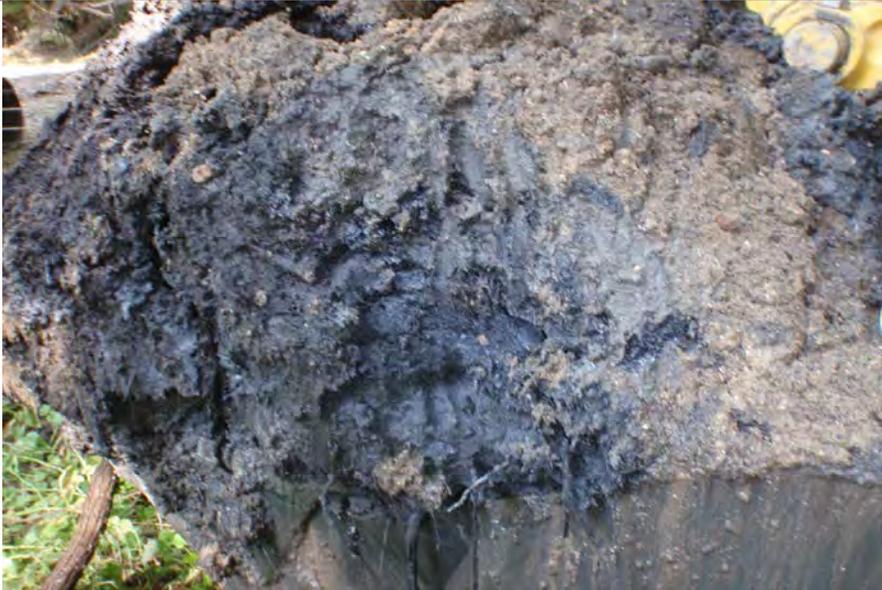
CLIENT NAME: Honeywell		SITE LOCATION: HB-TP-57		PROJECT NO. 49362
PHOTO NO. 117	DATE: 6/12/12

DESCRIPTION Dark Stained marl material from section 267 ft Northeast of the Southwestern starting point of trench HB-TP-57. Estimated depth of material ~11-11.5 ft bgs.

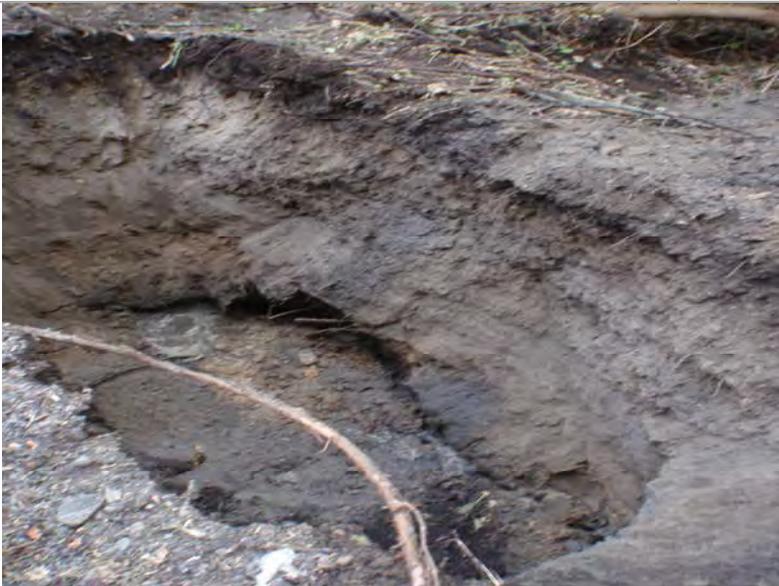
CLIENT NAME: Honeywell		SITE LOCATION: HB-TP-55		PROJECT NO. 49362
PHOTO NO. 118	DATE: 6/12/12

DESCRIPTION Section 360 ft Northeast of the Southwestern starting point of trench HB-TP-57. Trench section caved quickly making strata identification difficult

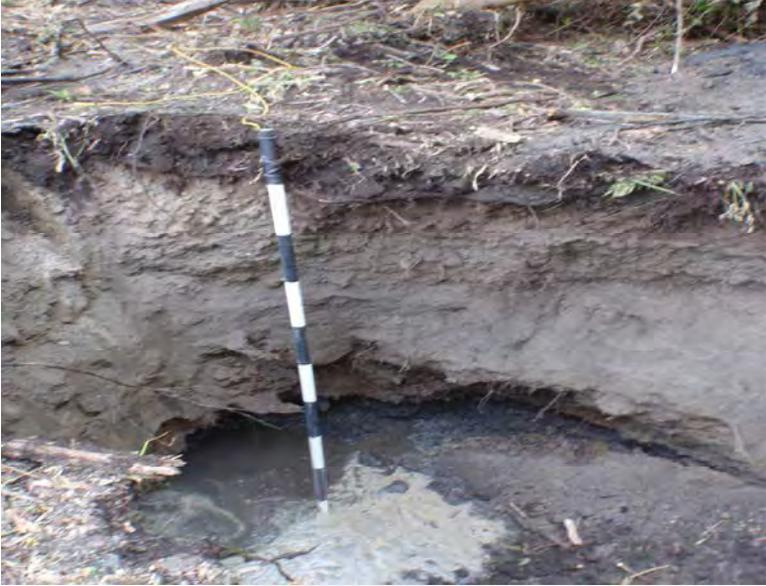
CLIENT NAME: Honeywell		SITE LOCATION: HB-TP-55	PROJECT NO. 49362
PHOTO NO. 119	DATE: 6/12/12

DESCRIPTION Section 360 ft Northeast of the Southwestern starting point of trench HB-TP-57. Trench section caved quickly making strata identification difficult.

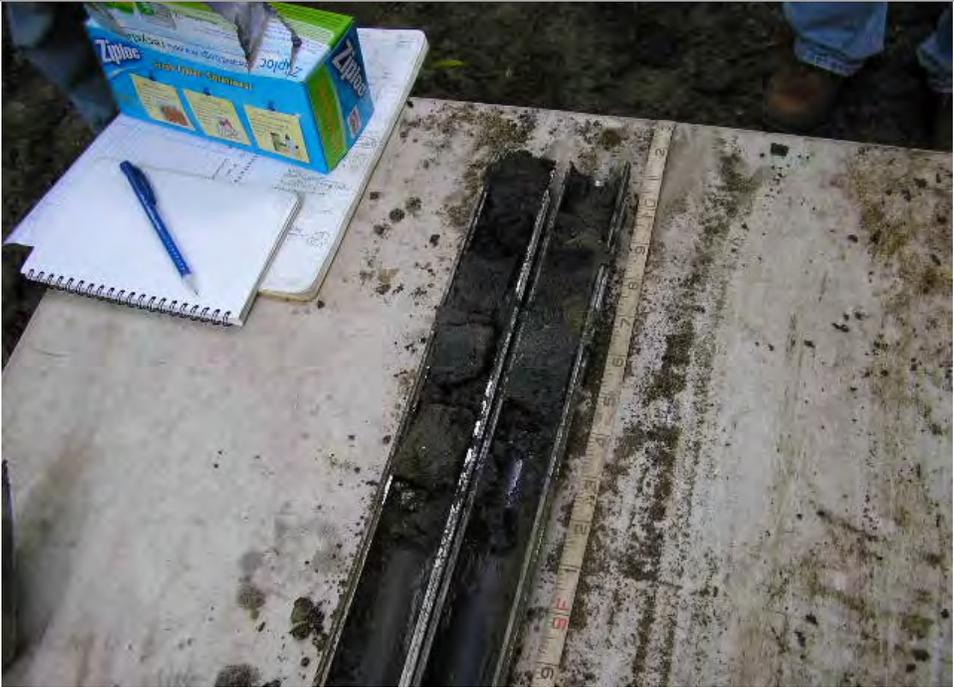
CLIENT NAME: Honeywell		SITE LOCATION: HB-SB-253	PROJECT NO. 49362
PHOTO NO. 120	DATE: 6/13/12

DESCRIPTION Dark stained soil at 8-10 ft. bgs at HB-SB-253

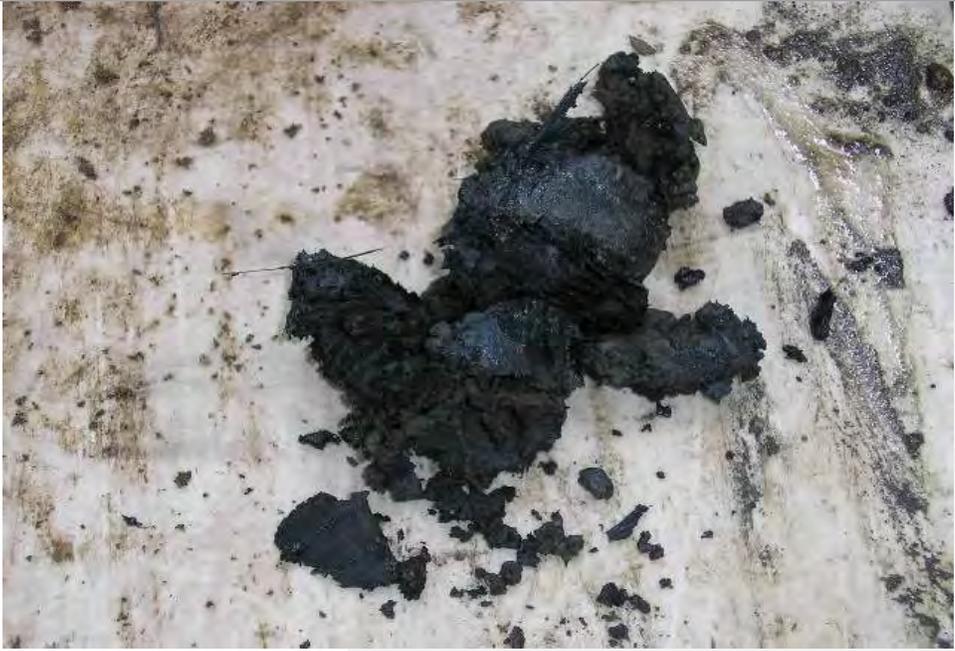
CLIENT NAME: Honeywell		SITE LOCATION: HB-SB-253	PROJECT NO. 49362
PHOTO NO. 121	DATE: 6/13/12

DESCRIPTION Very Dark stained soil and vegetative mat with sheen 10-12 ft bgs at HB-SB-253

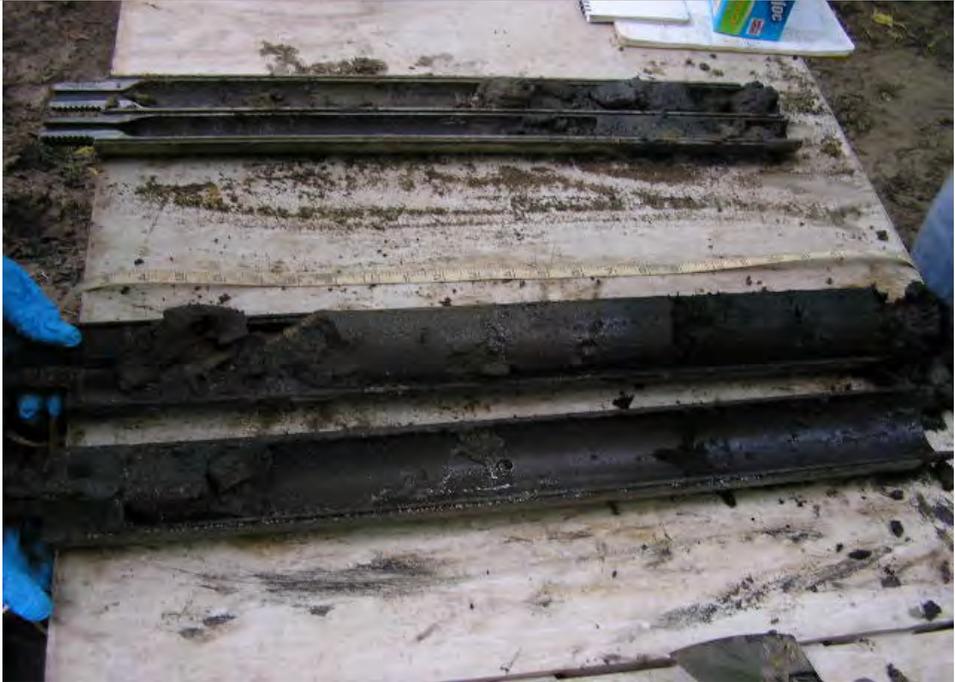
CLIENT NAME: Honeywell		SITE LOCATION: HB-SB-253	PROJECT NO. 49362
PHOTO NO. 122	DATE: 6/13/12

DESCRIPTION Very Dark stained soil and vegetative mat with sheen 10-12 ft bgs at HB-SB-253

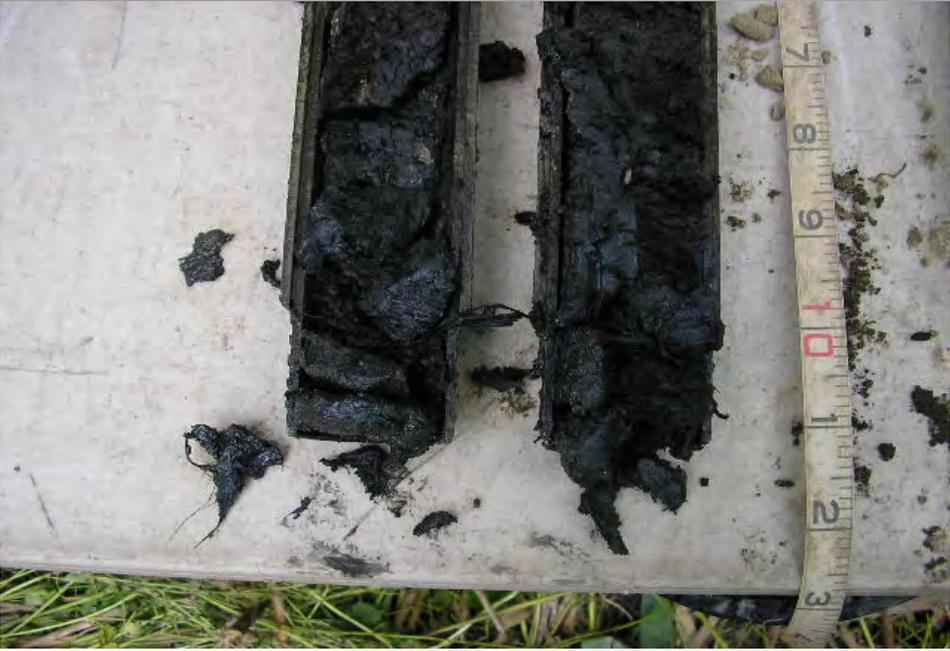
CLIENT NAME: Honeywell		SITE LOCATION: HB-SB-254	PROJECT NO. 49362
PHOTO NO. 123	DATE: 6/13/12

DESCRIPTION Very Dark stained soil and coal tar like material with sheen and NAPL, 9-10 ft bgs at HB-SB-254

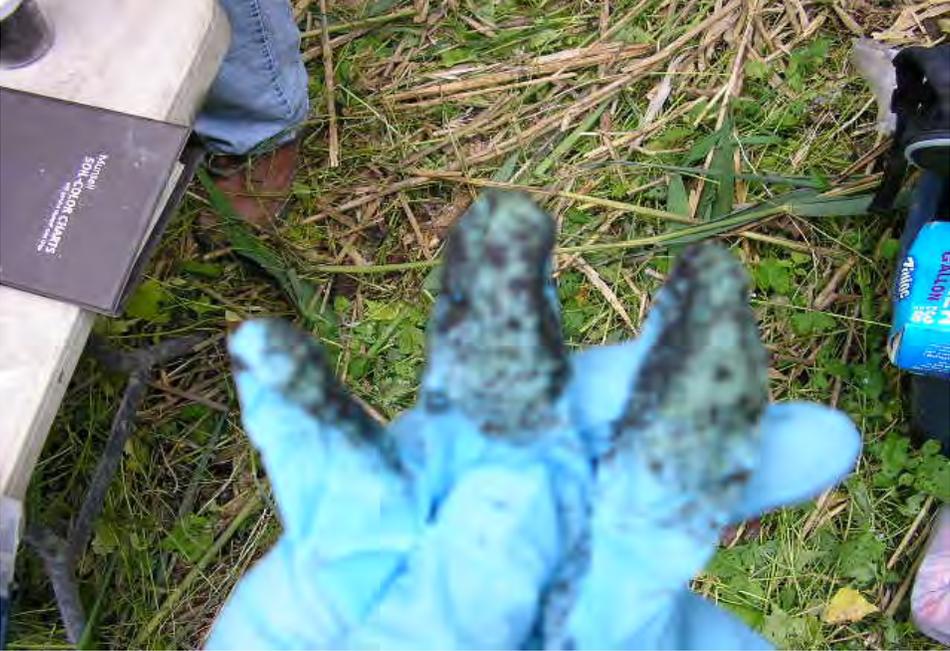
CLIENT NAME: Honeywell		SITE LOCATION: HB-SB-254	PROJECT NO. 49362
PHOTO NO. 124	DATE: 6/13/12

DESCRIPTION Staining left on glove from material 9-10 ft bgs at HB-SB-254

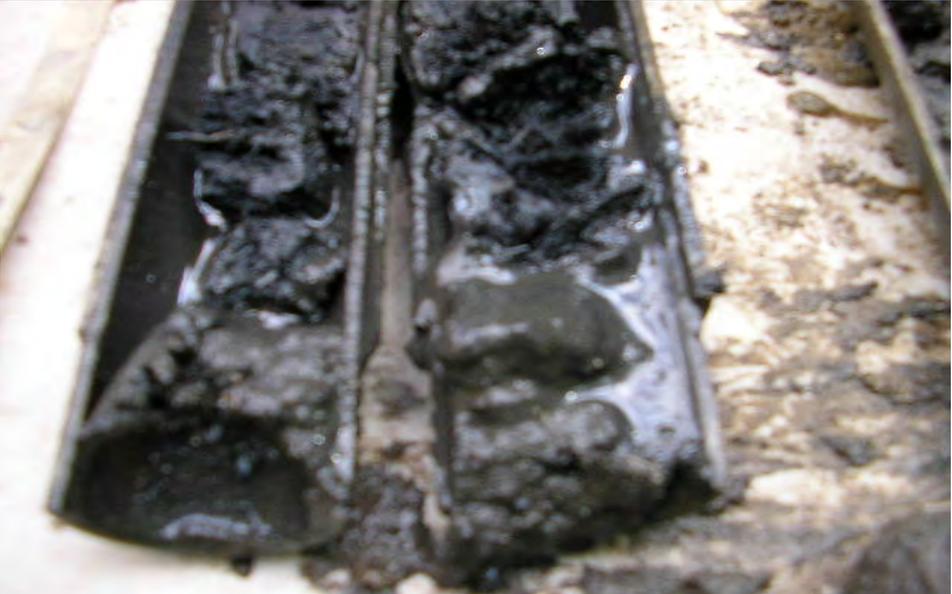
CLIENT NAME: Honeywell		SITE LOCATION: HB-SB-256	PROJECT NO. 49362
PHOTO NO. 126	DATE: 6/13/12

DESCRIPTION Very dark stained soil and coal tar like material with colorful (orange and blue) sheen, 14-16 ft bgs at HB-SB-256.

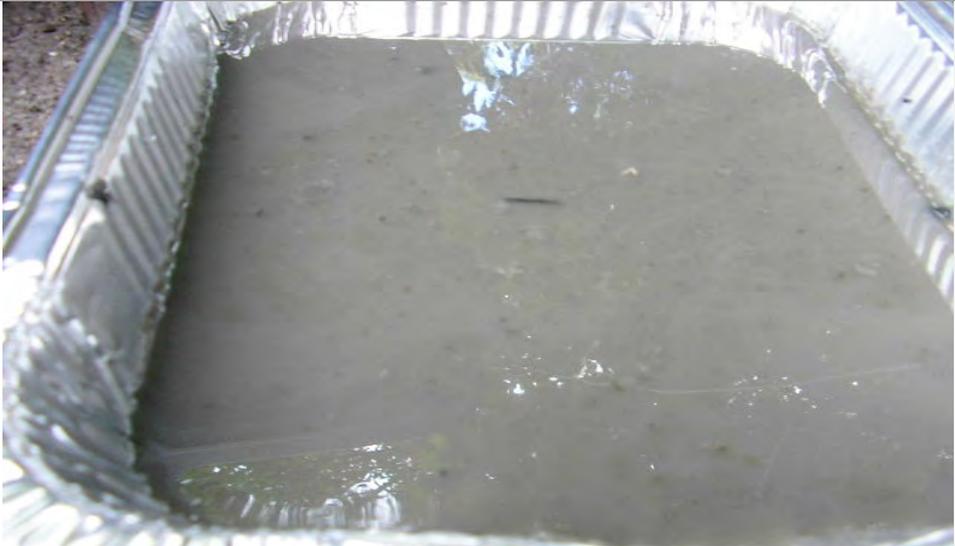
CLIENT NAME: Honeywell		SITE LOCATION: HB-SB-256	PROJECT NO. 49362
PHOTO NO. 127	DATE: 6/13/12

DESCRIPTION Sheen generated in pan with brown dollops of NAPL from material collected at 14-16 ft bgs at HB-SB-256.

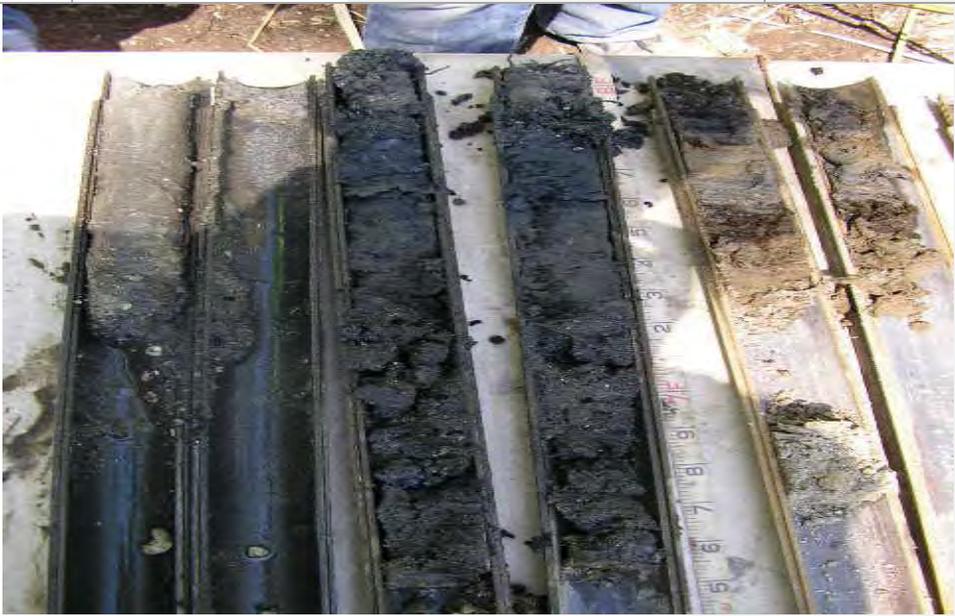
CLIENT NAME: Honeywell		SITE LOCATION: HB-SB-262	PROJECT NO. 49362
PHOTO NO. 128	DATE: 6/14/12

DESCRIPTION Very dark stained soil and coal tar like material with sheen and NAPL at 6-8 ft bgs (center), 4-6 ft bgs interval (right), 8-10 ft bgs interval left at HB-SB-262.

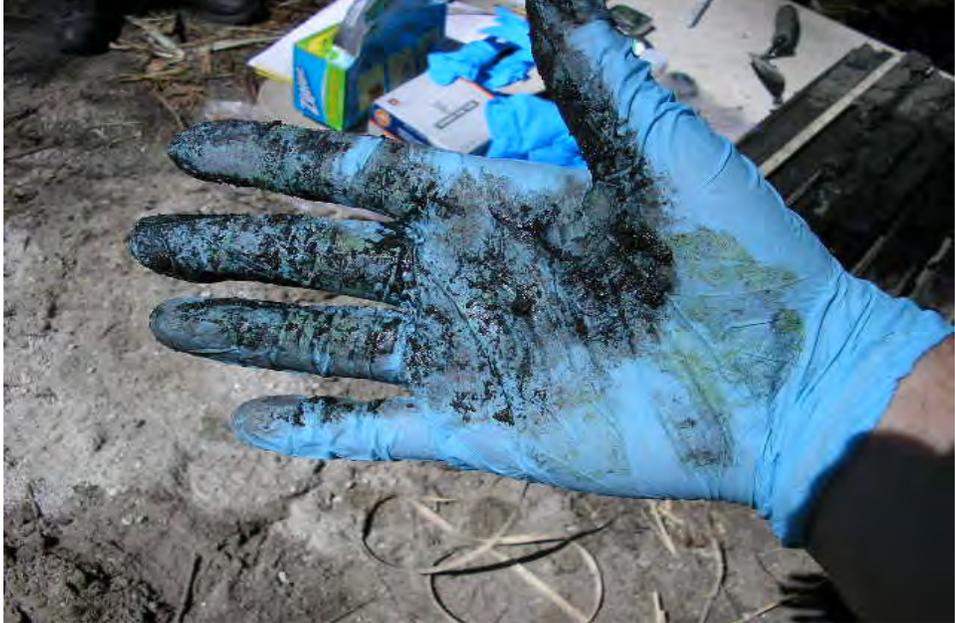
CLIENT NAME: Honeywell		SITE LOCATION: HB-SB-262	PROJECT NO. 49362
PHOTO NO. 129	DATE: 6/14/12

DESCRIPTION NAPL staining on glove from material 6-8 ft bgs at HB-SB-262.

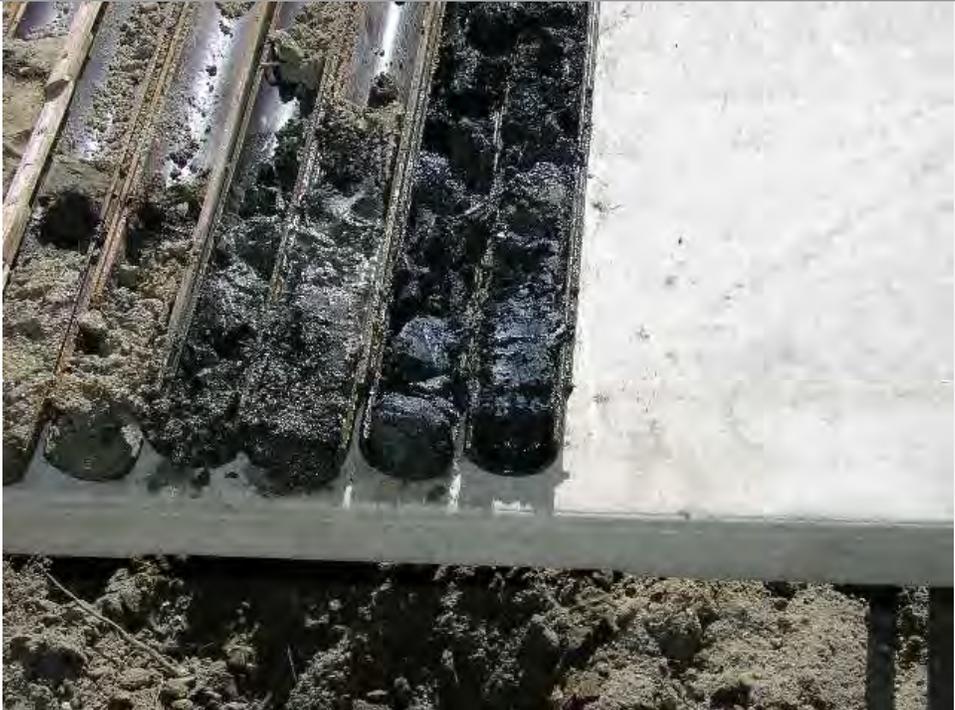
CLIENT NAME: Honeywell		SITE LOCATION: HB-SB-261	PROJECT NO. 49362
PHOTO NO. 132	DATE: 6/15/12

DESCRIPTION Dark stained soil and coal tar like material with sheen at 8-10 ft. bgs (right), 6-8 ft bgs interval (center), 4-6 ft bgs interval (left) at HB-SB-261.

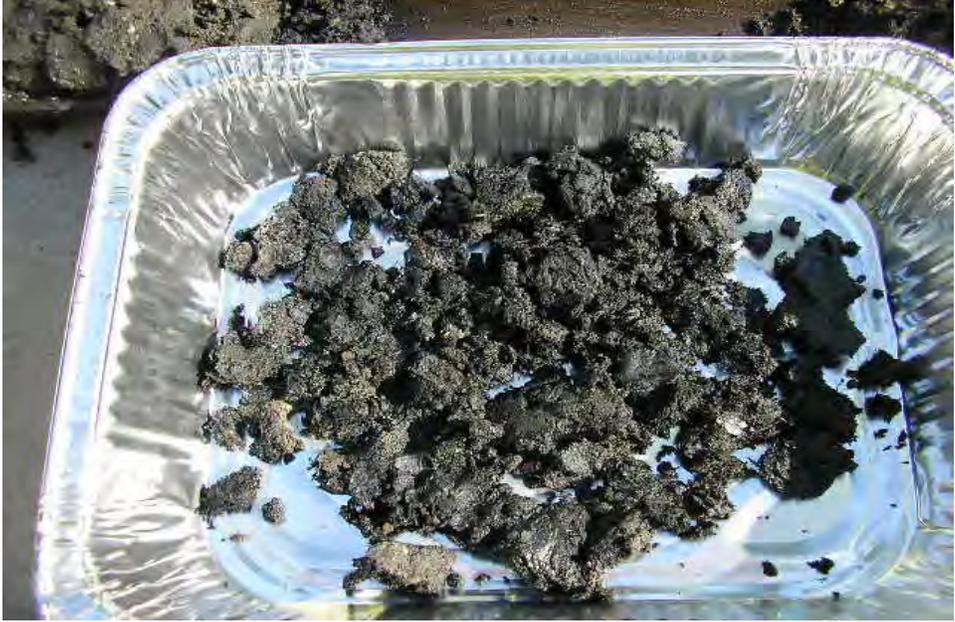
CLIENT NAME: Honeywell		SITE LOCATION: HB-SB-261	PROJECT NO. 49362
PHOTO NO. 133	DATE: 6/15/12

DESCRIPTION Dark stained soil used to generate sheen in pan from 10-12 ft bgs at HB-SB-261.

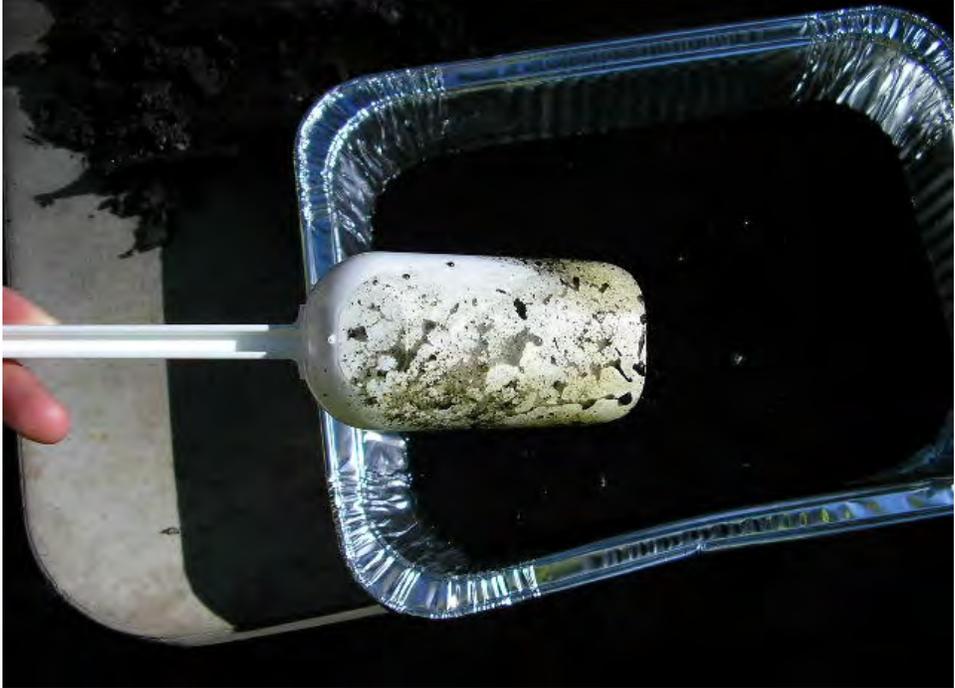
CLIENT NAME: Honeywell		SITE LOCATION: HB-SB-261	PROJECT NO. 49362
PHOTO NO. 134	DATE: 6/15/12

DESCRIPTION Sheen in pan with staining on plastic scoop generated from 10-12 ft bgs material at HB-SB-261.

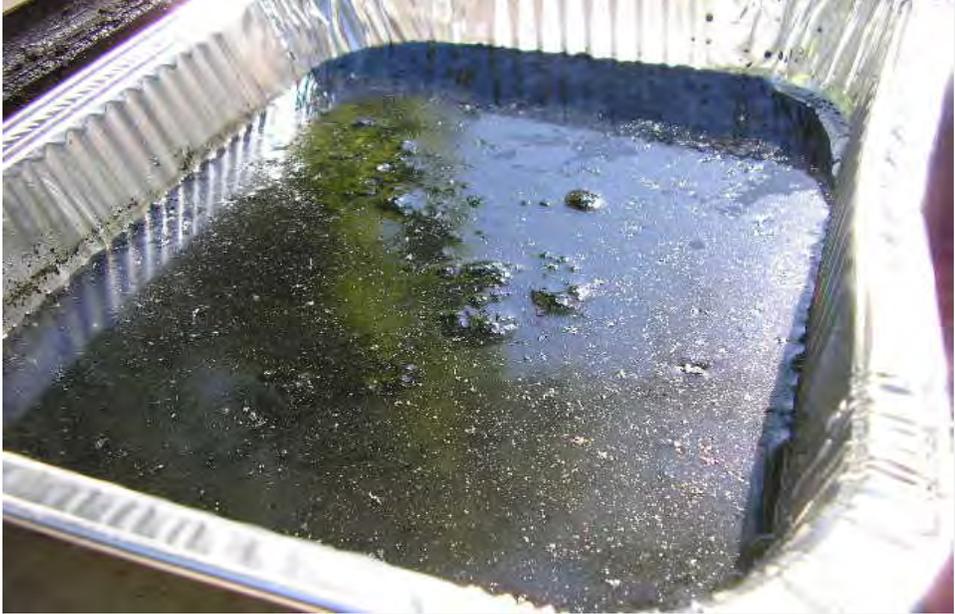
CLIENT NAME: Honeywell		SITE LOCATION: HB-SB-261	PROJECT NO. 49362
PHOTO NO. 135	DATE: 6/15/12

DESCRIPTION Colorful (blues, purples, greens) sheen in pan generated from 10-12 ft bgs material at HB-SB-261.

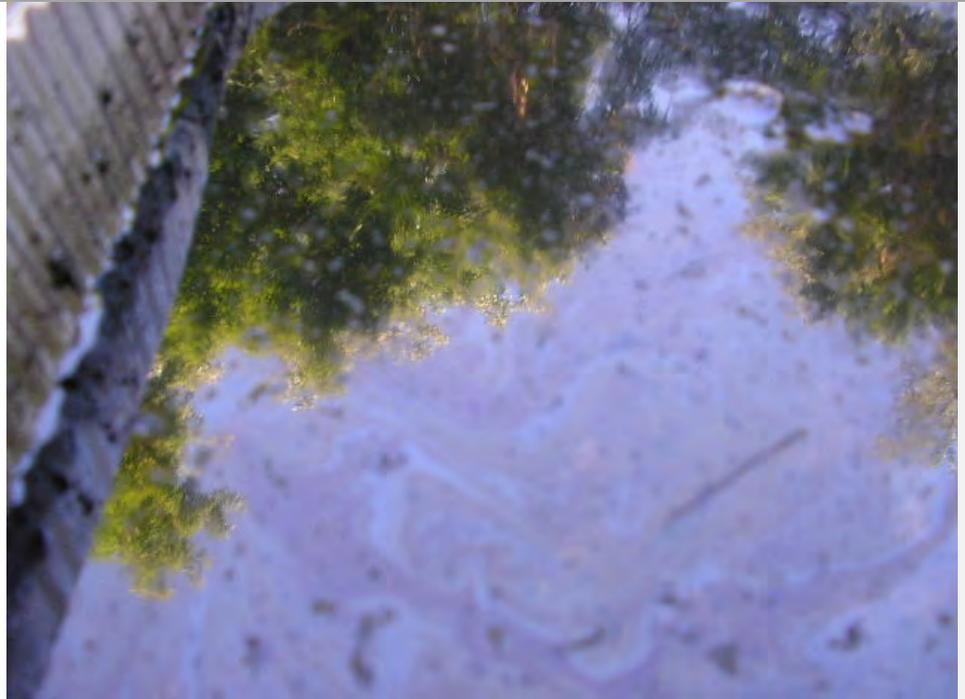
PHOTO NO. 136	DATE: 6/15/12
DESCRIPTION Colorful (blues, purples, greens) sheen in pan generated from 10-12 ft bgs material at HB-SB-261.

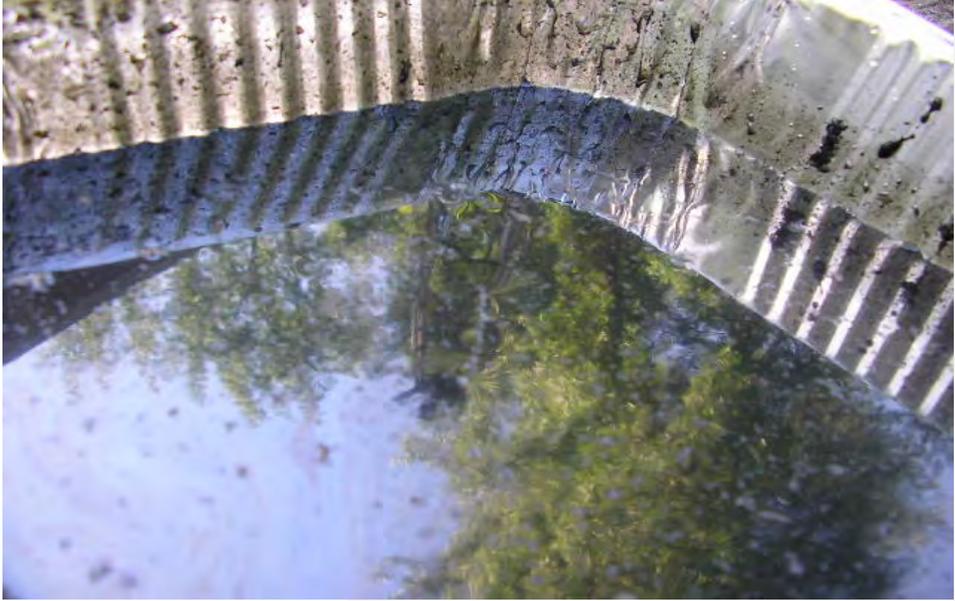
CLIENT NAME: Honeywell		SITE LOCATION: HB-SB-261	PROJECT NO. 49362
PHOTO NO. 137	DATE: 6/15/12

DESCRIPTION Colorful (blues, purples, greens) sheen in pan generated from 10-12 ft bgs material at HB-SB-261.

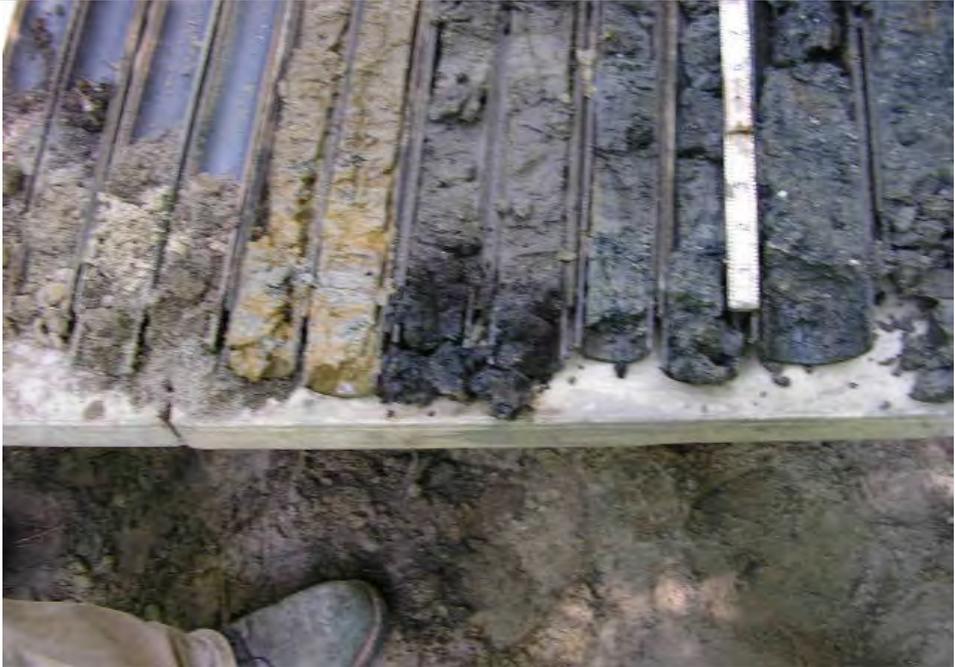
CLIENT NAME: Honeywell		SITE LOCATION: HB-SB-260	PROJECT NO. 49362
PHOTO NO. 138	DATE: 6/15/12

DESCRIPTION Lined up from left to right are 0-12 ft bgs in two foot intervals. Thin layer of stained soil from 7.5-8 ft bgs at HB-SB-260.

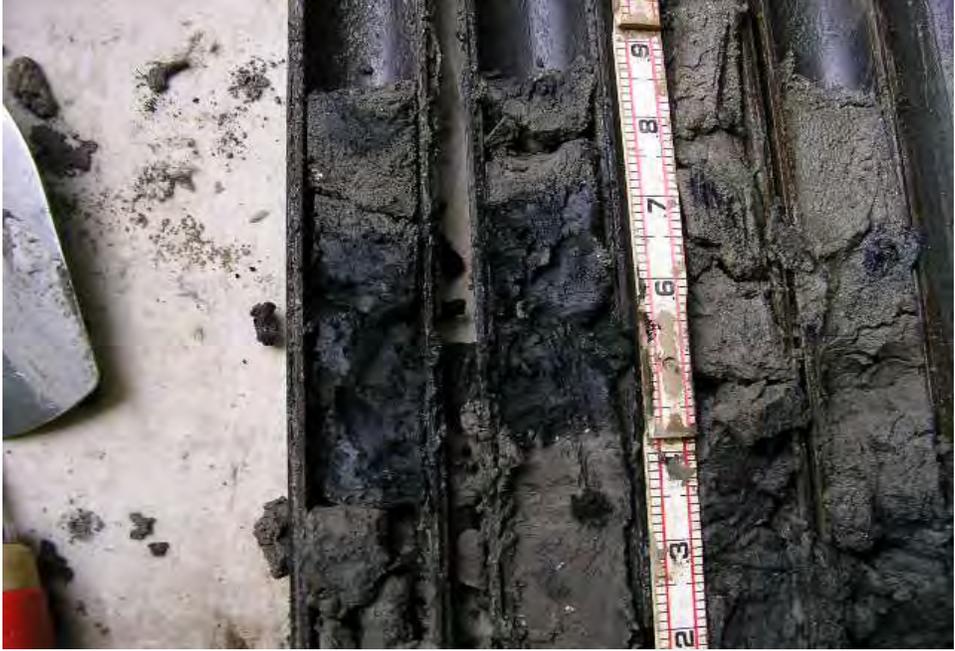
CLIENT NAME: Honeywell		SITE LOCATION: HB-SB-257	PROJECT NO. 49362
PHOTO NO. 139	DATE: 6/18/12

DESCRIPTION Stained soil from 10-12 ft bgs at HB-SB-257.

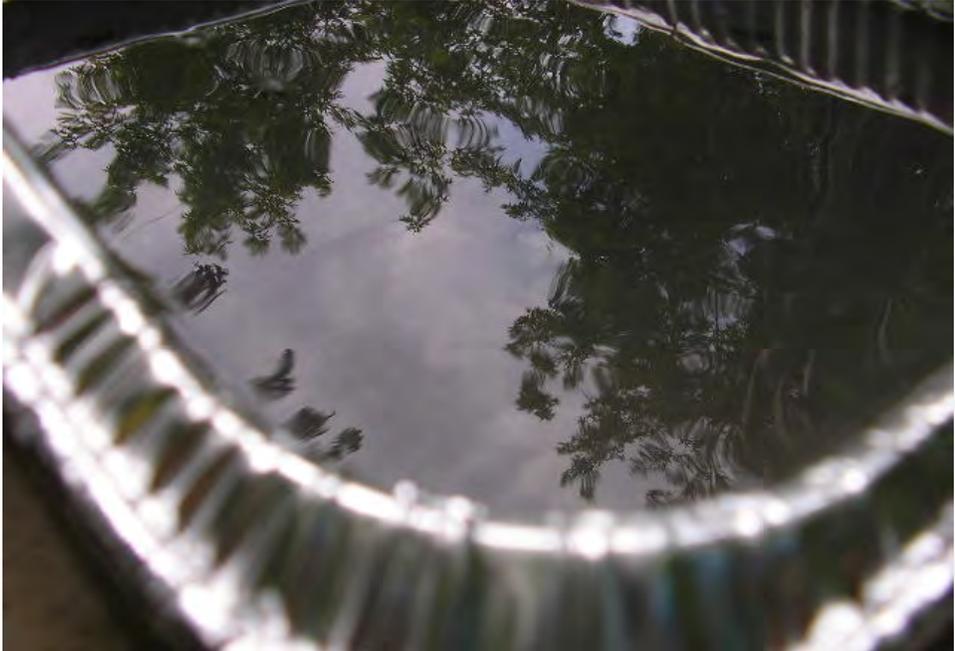
CLIENT NAME: Honeywell		SITE LOCATION: HB-SB-257	PROJECT NO. 49362
PHOTO NO. 140	DATE: 6/18/12

DESCRIPTION Slight sheen generated in pan using material from 12-14 ft bgs at HB-SB-257.
