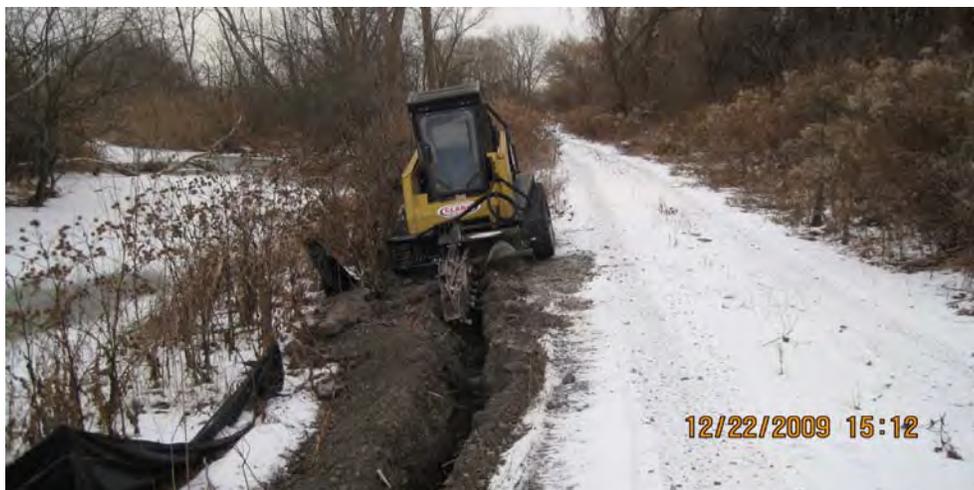
**Title:** IMG-0230

**Description:** Skid Steer trenching for silt fence installation

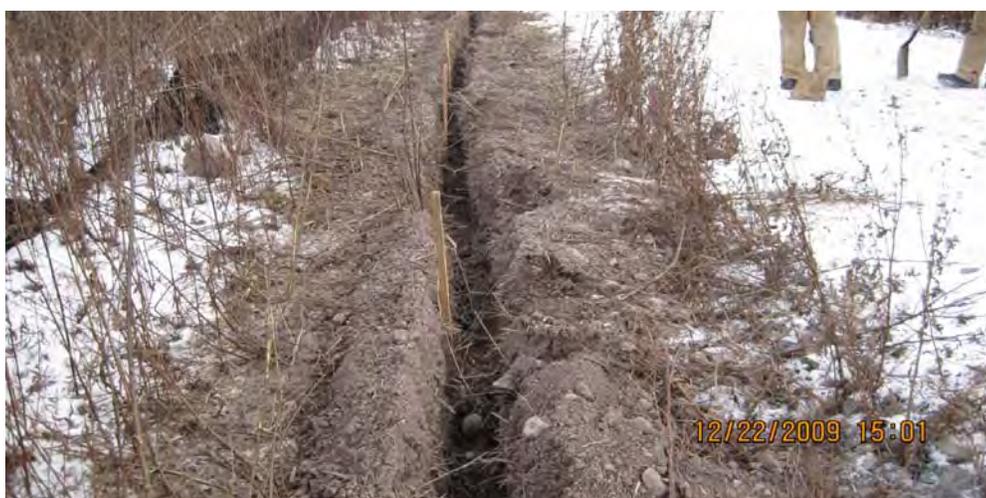
**Title:** IMG-0227

**Description:** Trench for north silt fence on western end

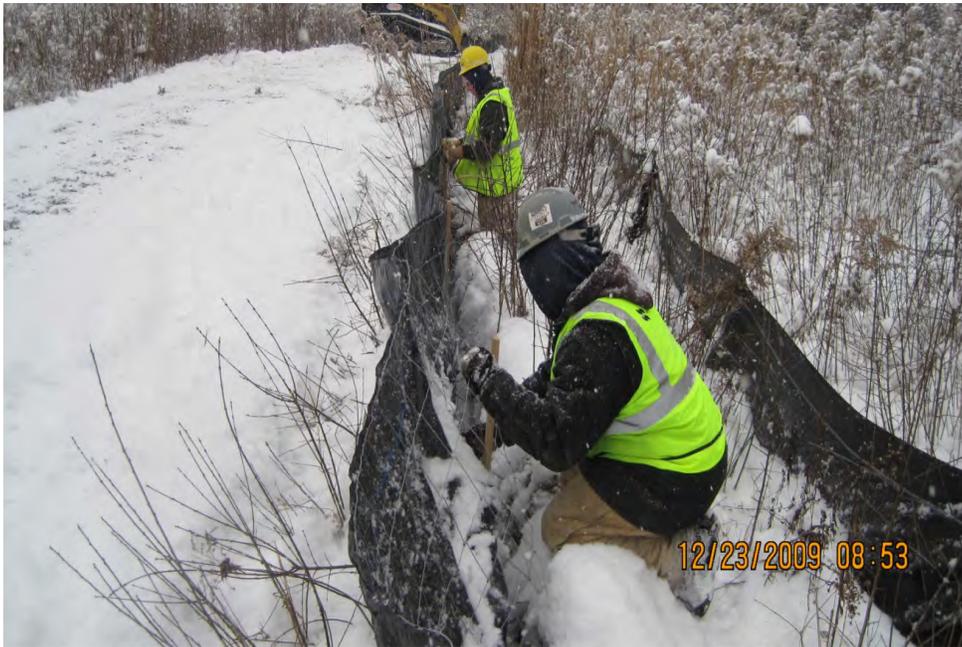
**Title:** IMG-0233

**Description:** Op-Tech installing north silt fence

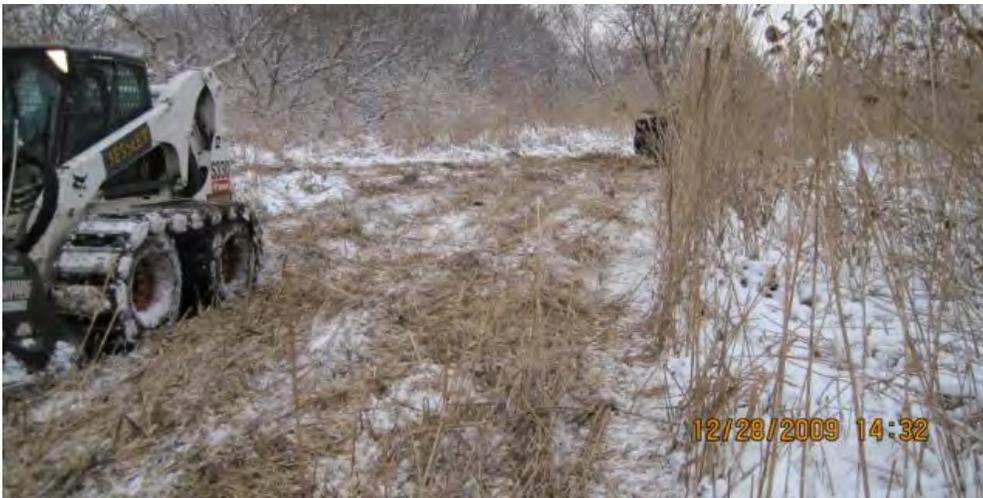
**Title:** IMG-0255

**Description:** Clearing of work area

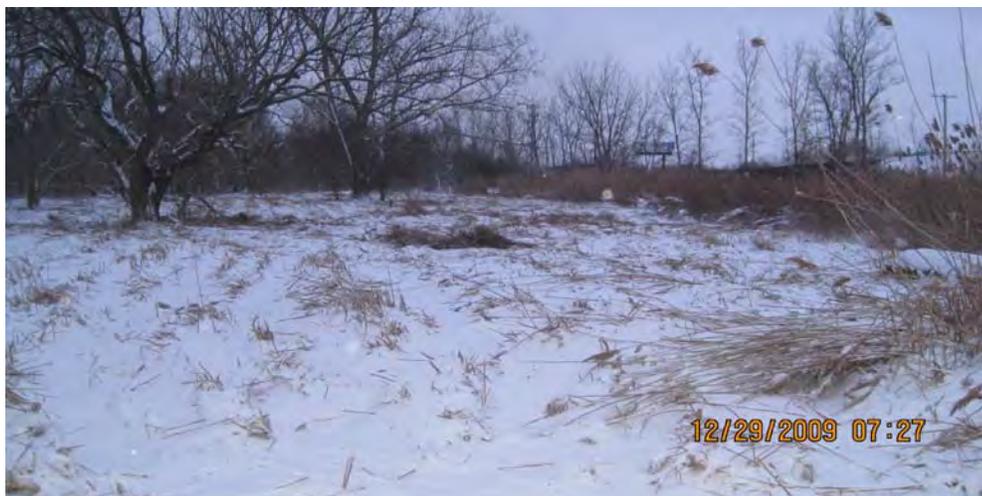
**Title:** IMG-0256

**Description:** Clearing of stockpile area

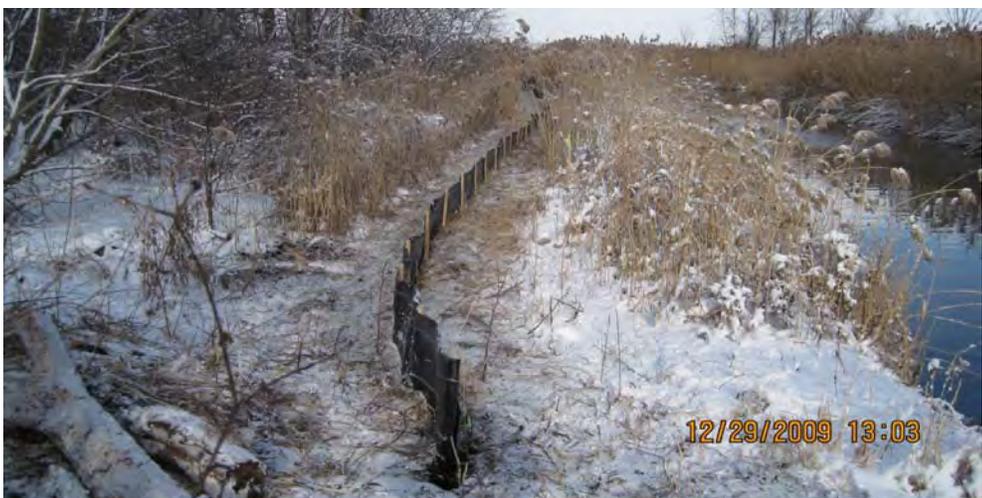
**Title:** IMG-0262

**Description:** Installed silt fence around harbor brook

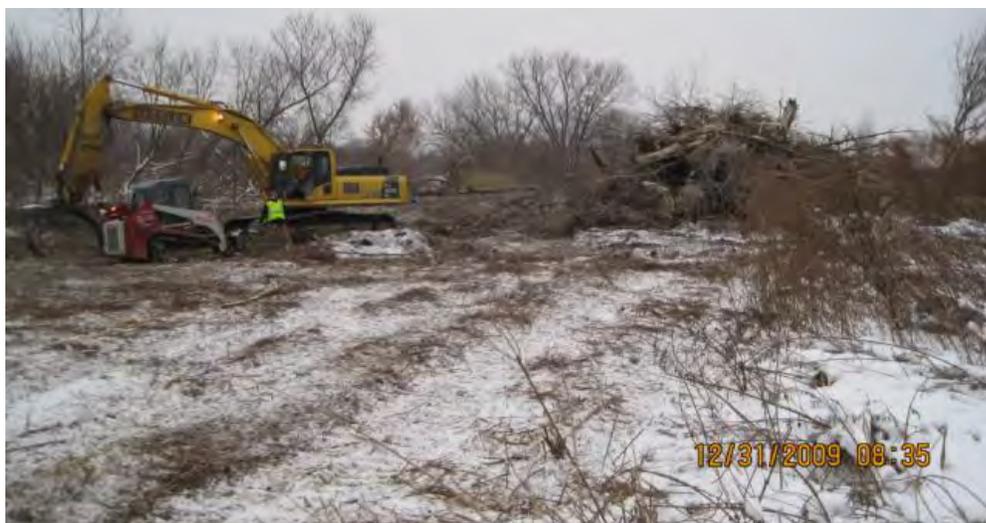
**Title:** IMG-0288

**Description:** Area clearing in west stockpile area

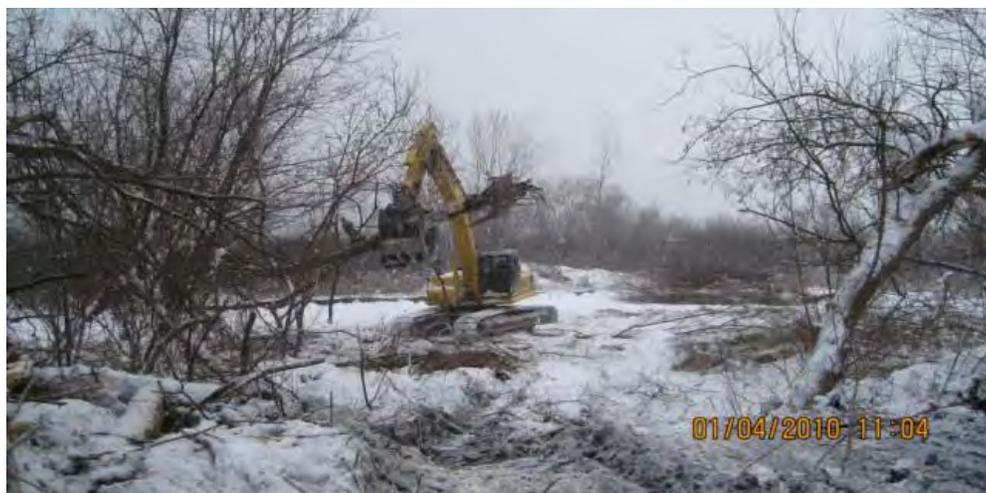
**Title:** IMG-0302

**Description:** Excavator with grapple attachment clearing trees in west wall work area.

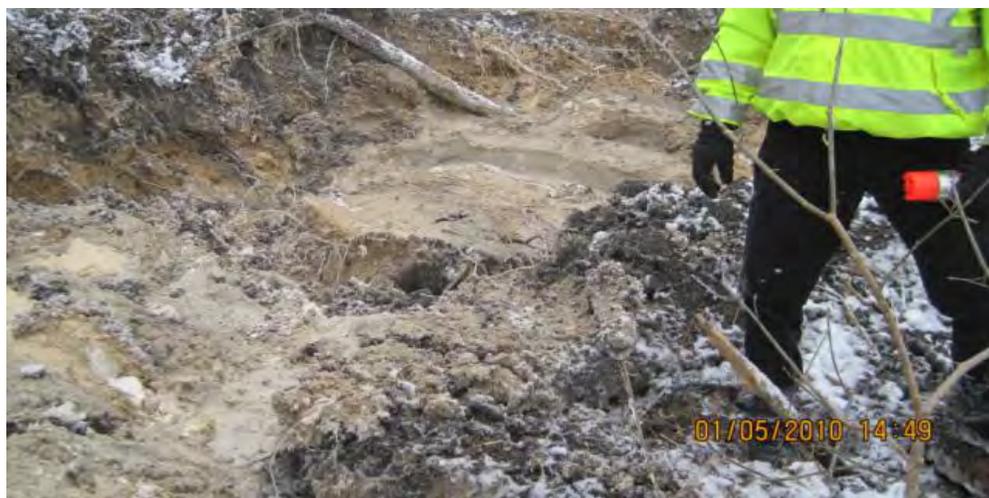
**Title:** IMG-0337

**Description:** Exposed Solvay waste material in clearing area

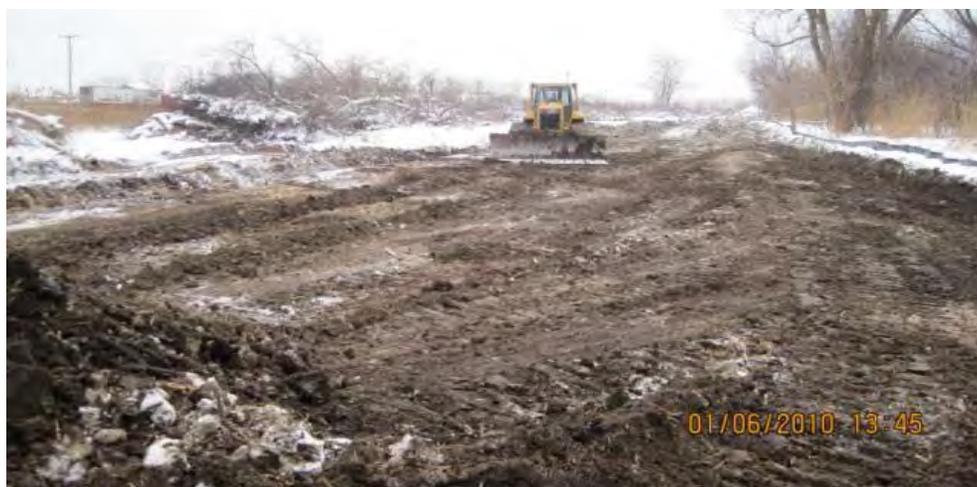
**Title:** IMG-0360

**Description:** Dozer grading east stockpile area

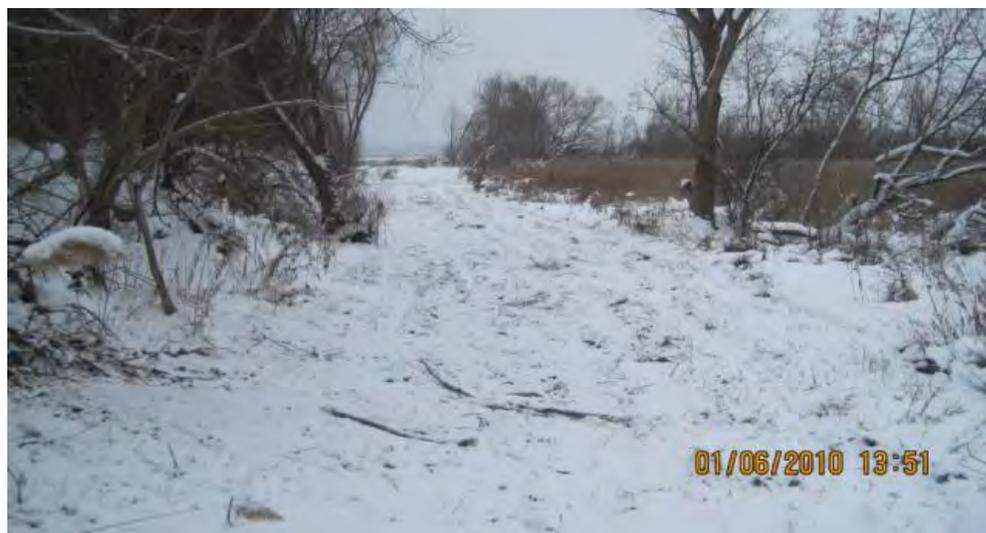
**Title:** IMG-0361

**Description:** Area cleared for addition of haul road at east end of site.

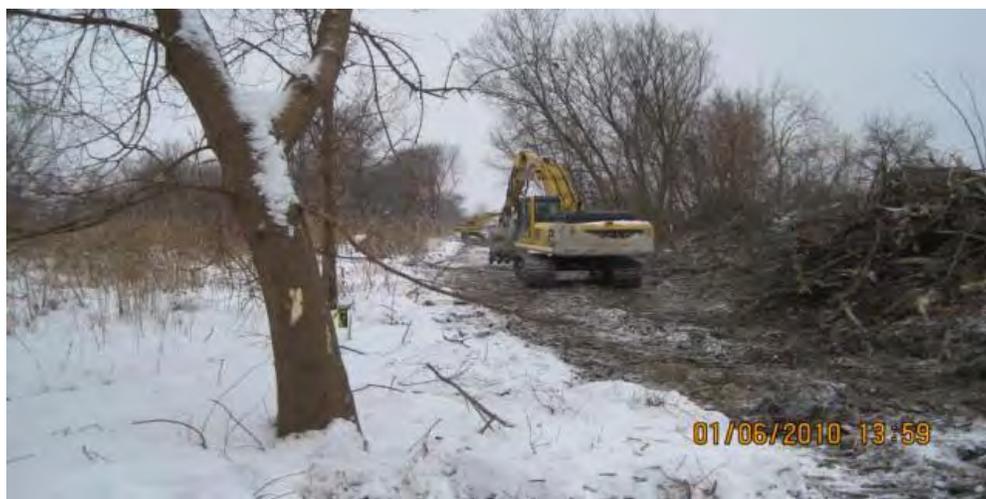
**Title:** IMG-03604

**Description:** Clearing trees in east wall work platform area.

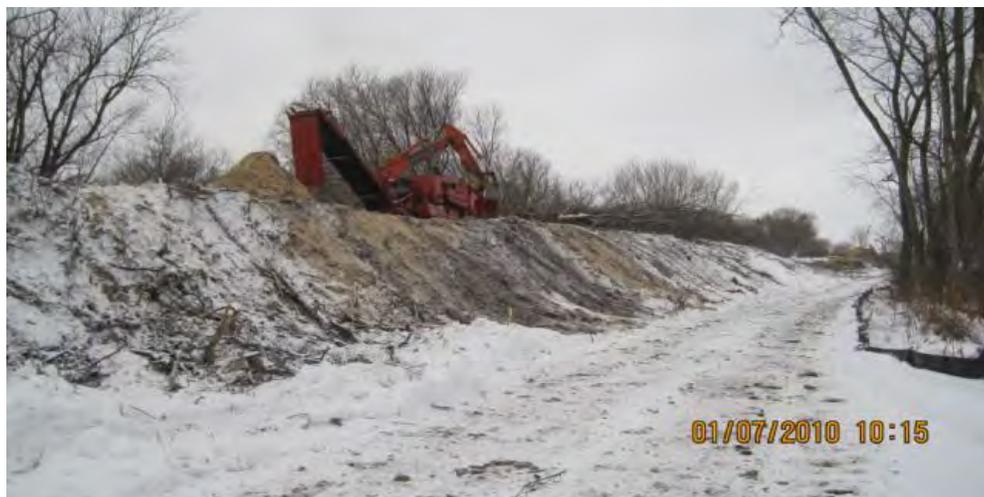
**Title:** IMG-0374

**Description:** Chipping in central wall work platform area.

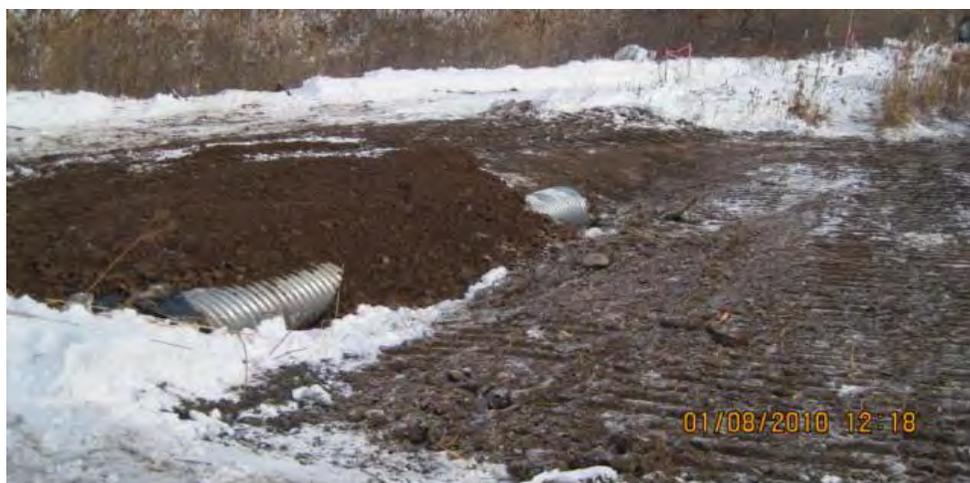
**Title:** IMG-0420

**Description:** Extension of drain pipe to widen road at the corner of project trailer area.

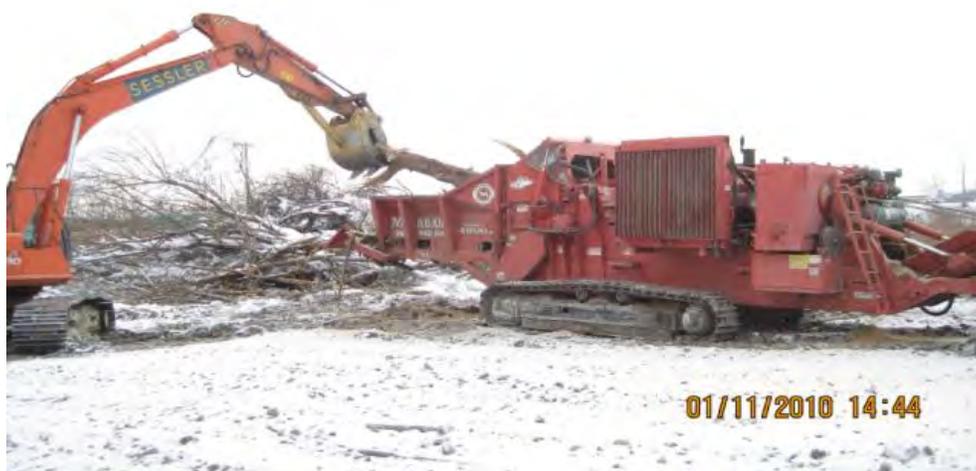
**Title:** IMG-0445

**Description:** Loading the wood grinder.

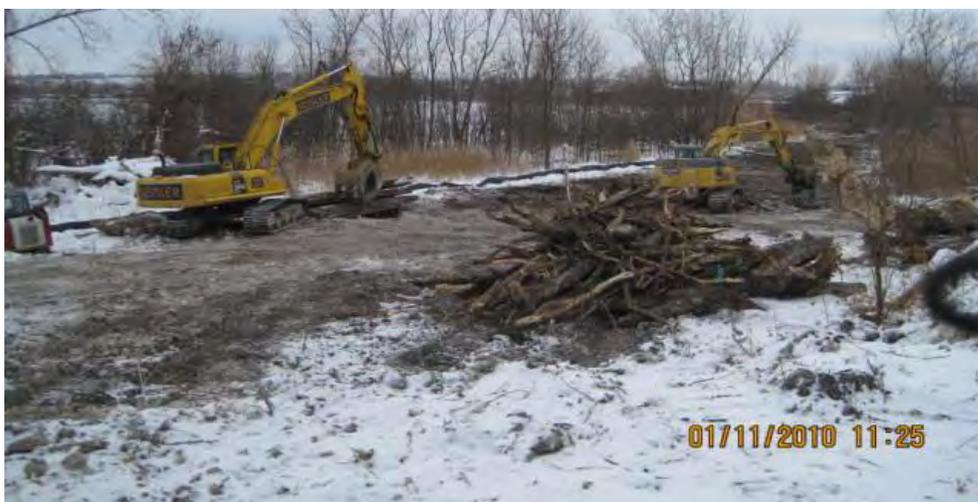
**Title:** IMG-0445

**Description:** Collecting wood debris to be piled for the grinder.

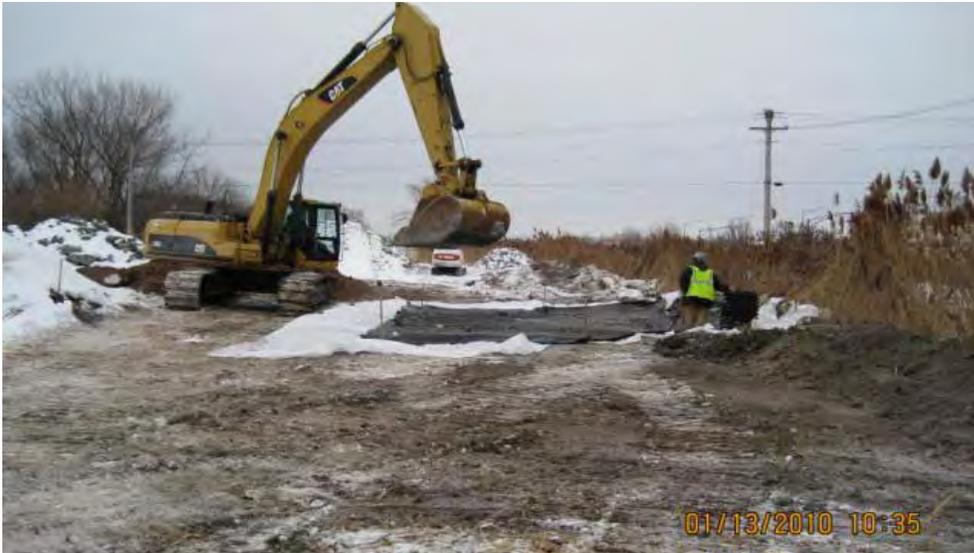
**Title:** IMG-0009

**Description:** Decontamination pad installation.

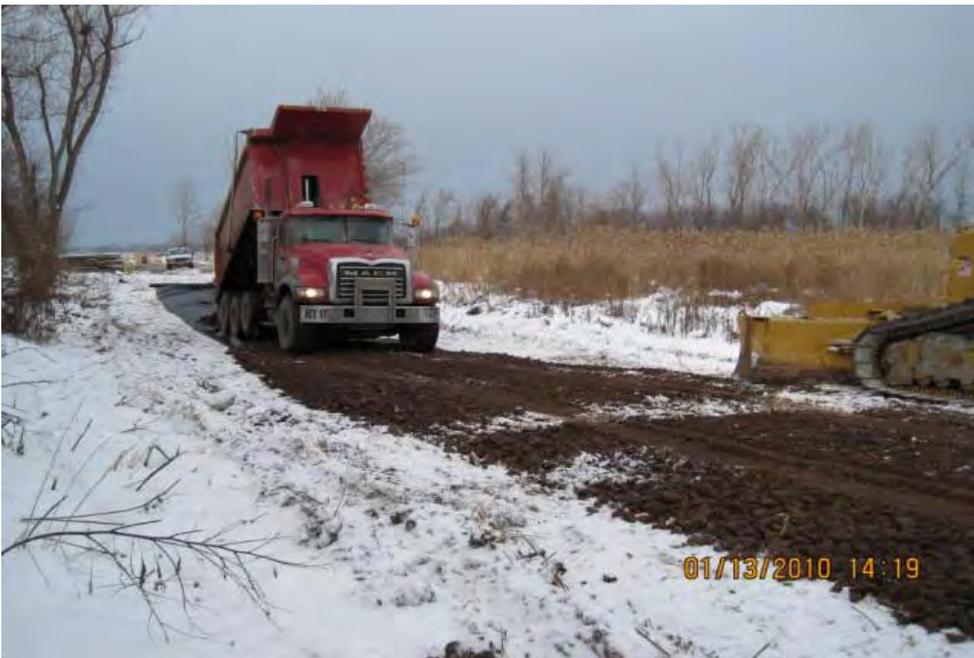
**Title:** IMG-0017

**Description:** Placing geotextile fabric and gravel to create the haul road.

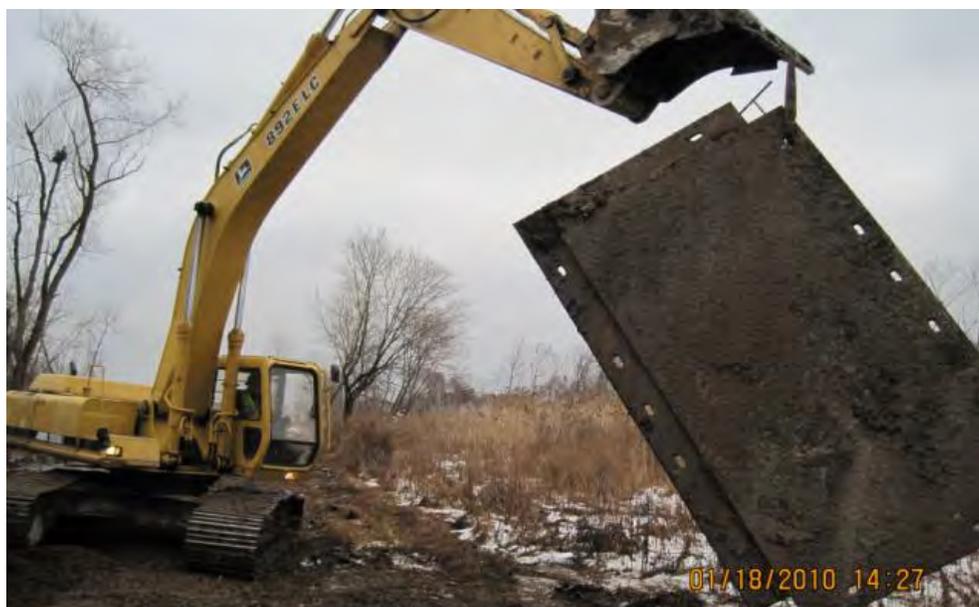
**Title:** IMG-0042

**Description:** Lifting swamp mats in haul road

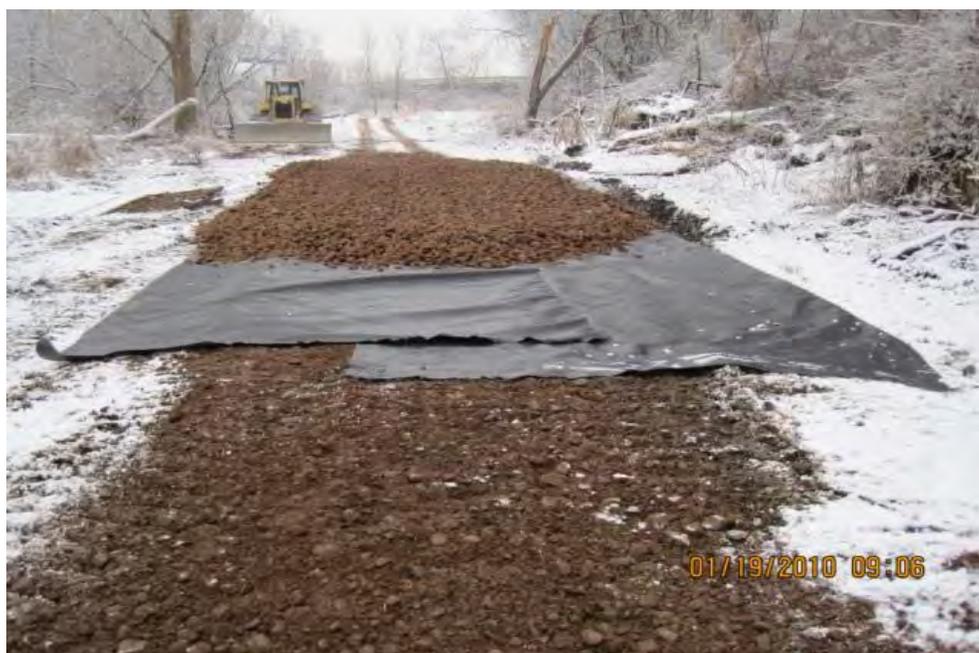
**Title:** IMG-0045

**Description:** Installation of geotextile and gravel for the haul road.

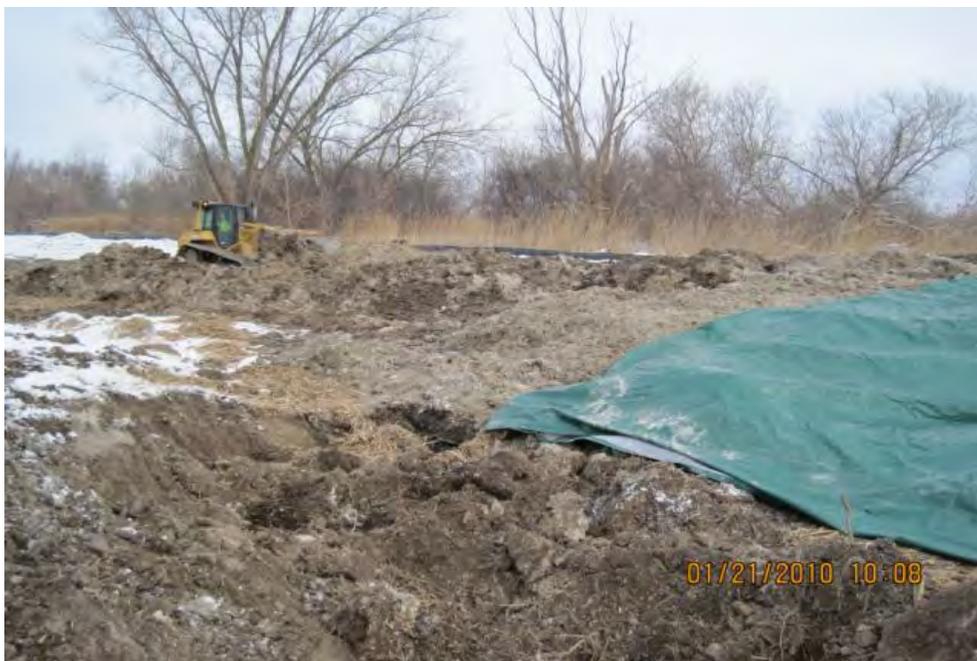
**Description:** Stockpile management.

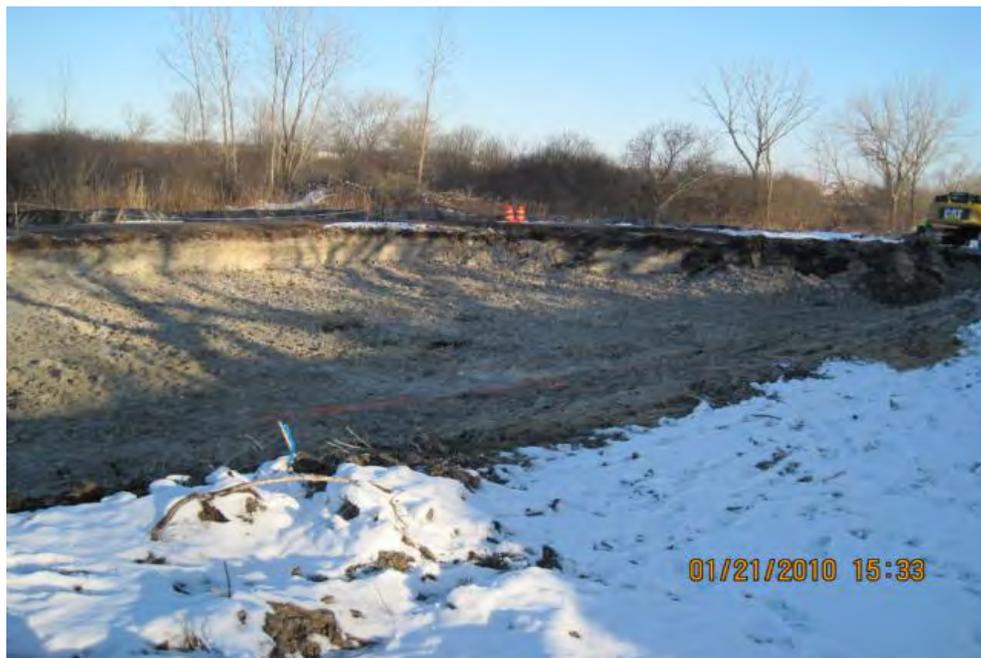
**Title:** IMG-0070

**Description:** Excavation area looking to the north.

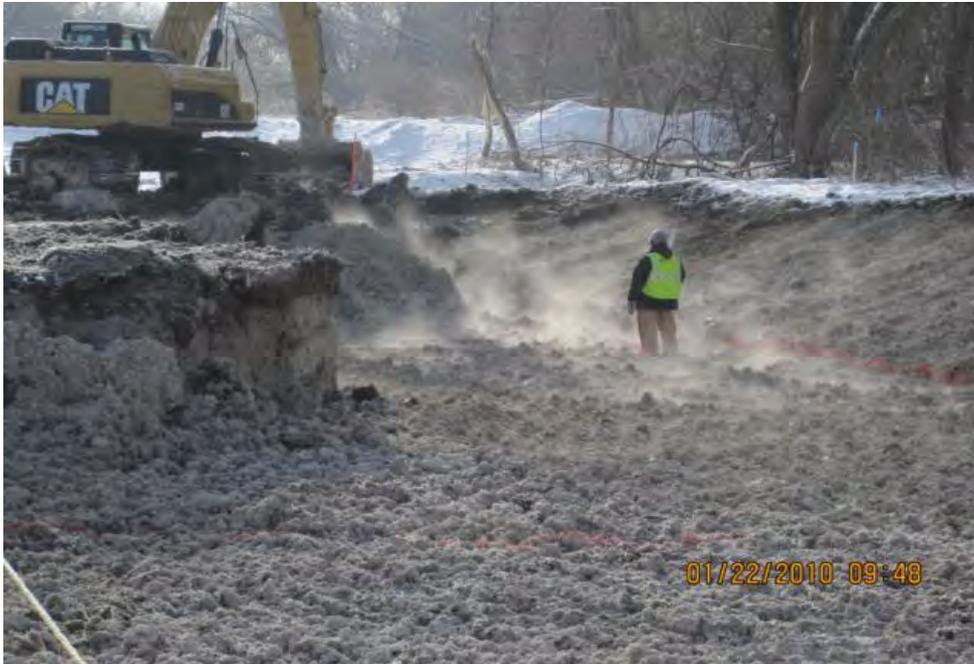
**Title:** IMG-0072

**Description:** Excavation of material for installation of the work platform.

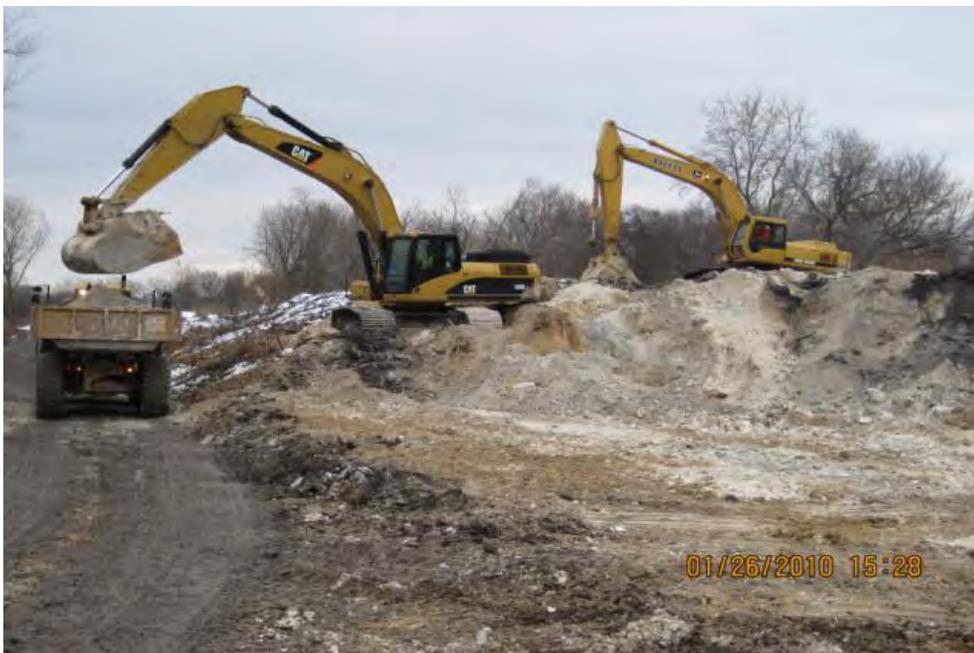
**Title:** IMG-0104

**Description:** Loading excavated material along the access road.

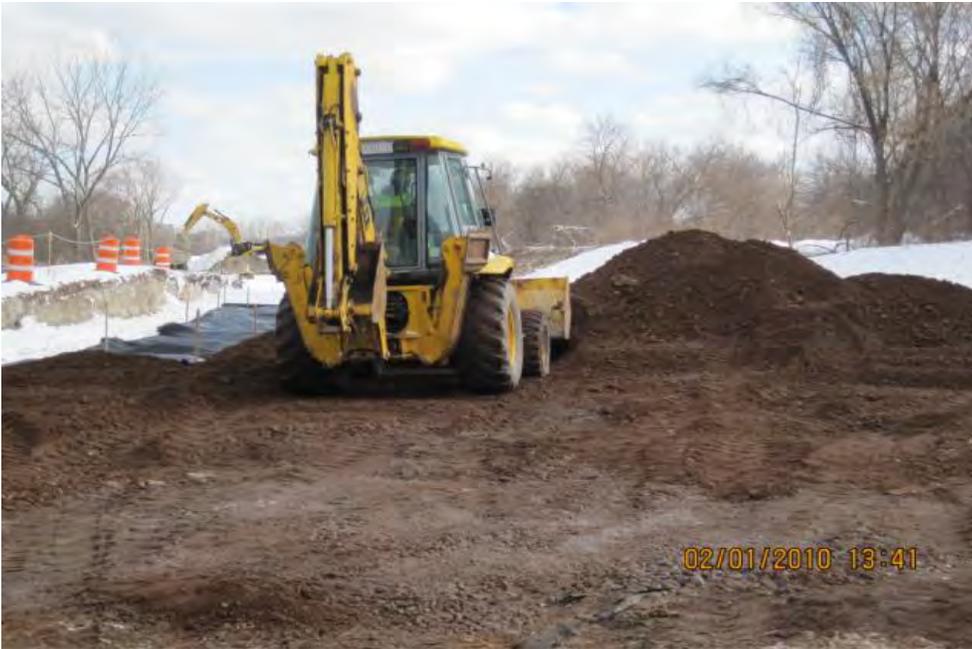
**Title:** IMG-0131

**Description:** Backhoe pushing road base material over geotextile fabric

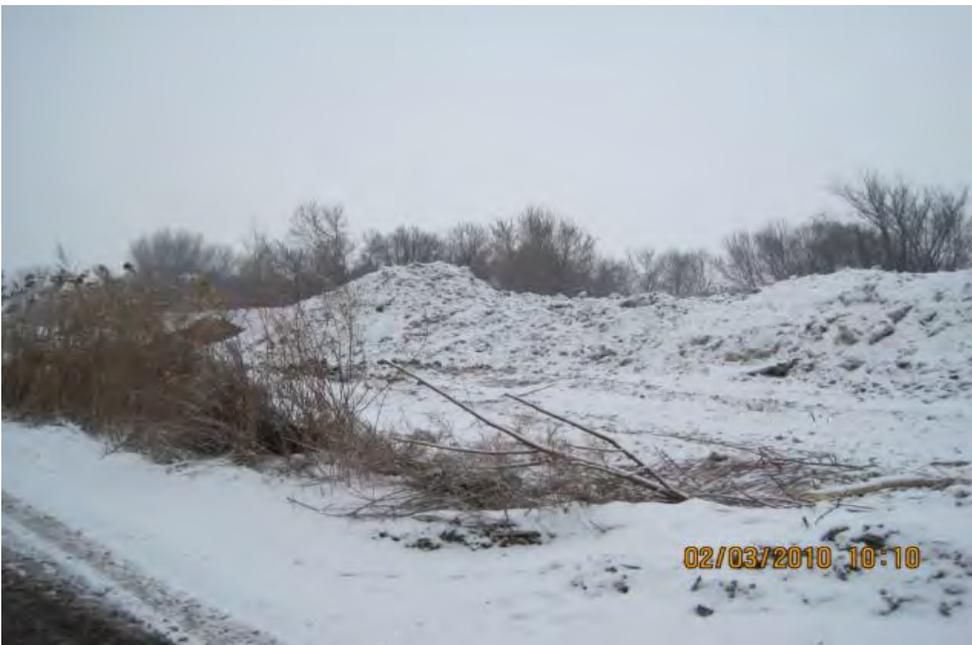
**Title:** IMG-0138

**Description:** Stockpiled material

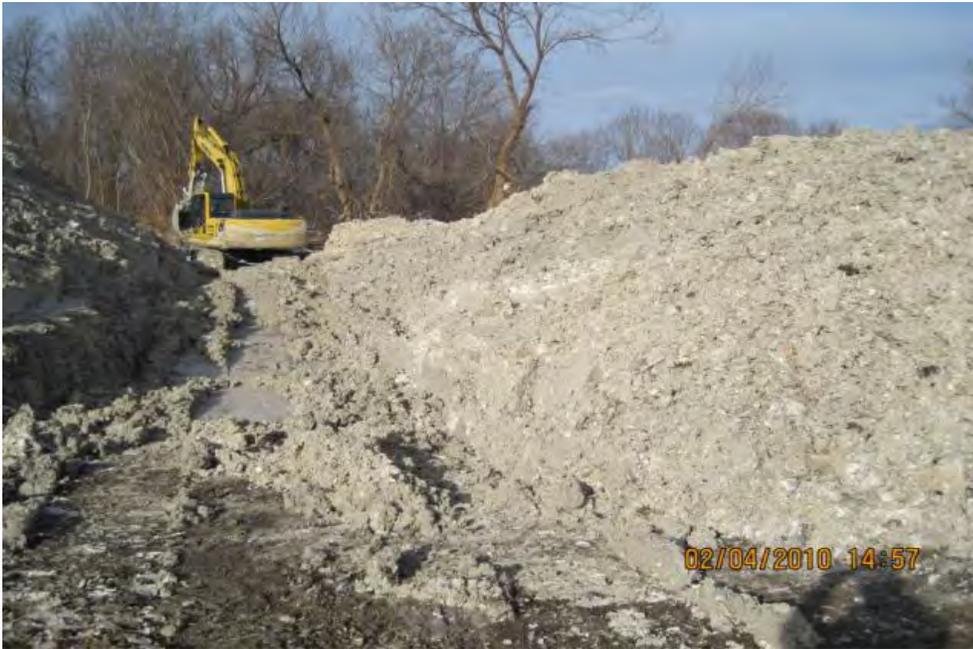
**Title:** IMG-0220

**Description:** Landscape features formed with stockpiled material.

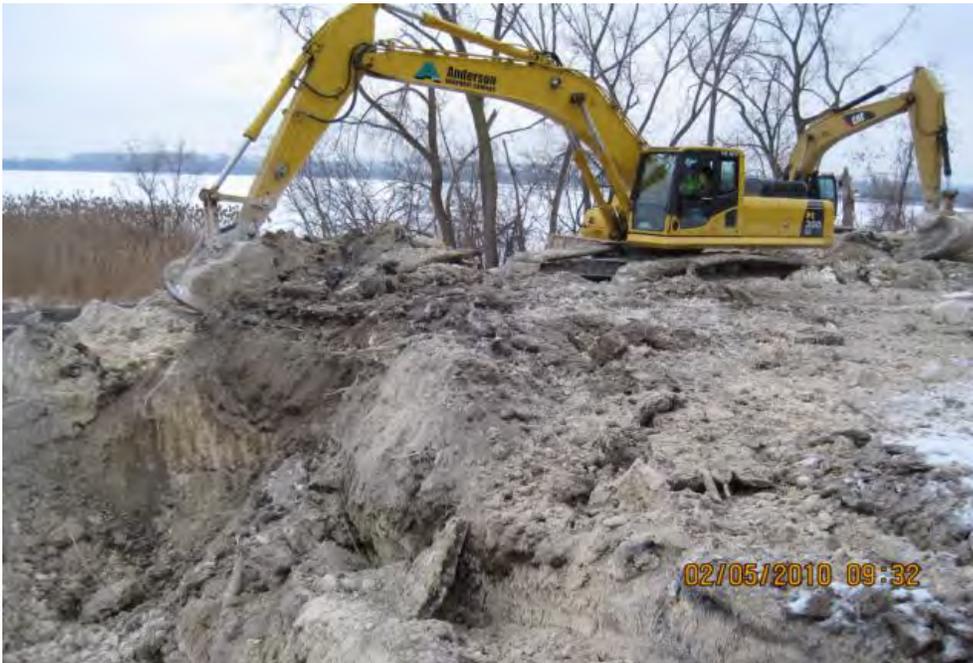
**Title:** IMG-0225

**Description:** Excavation of the 3:1 slope along the work platform looking north.

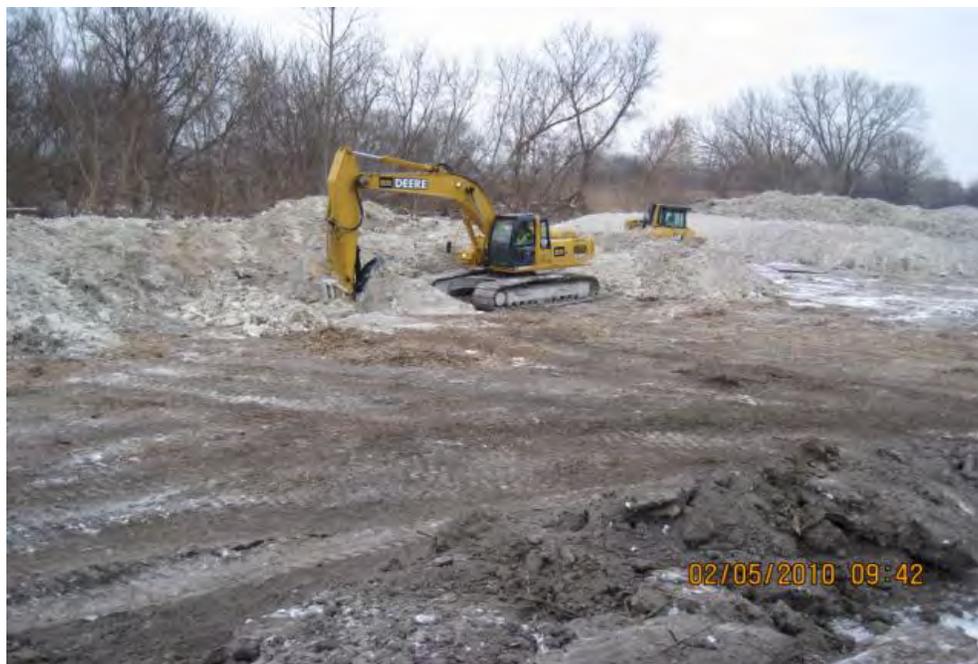
**Title:** IMG-0227

**Description:** Forming of stockpiles

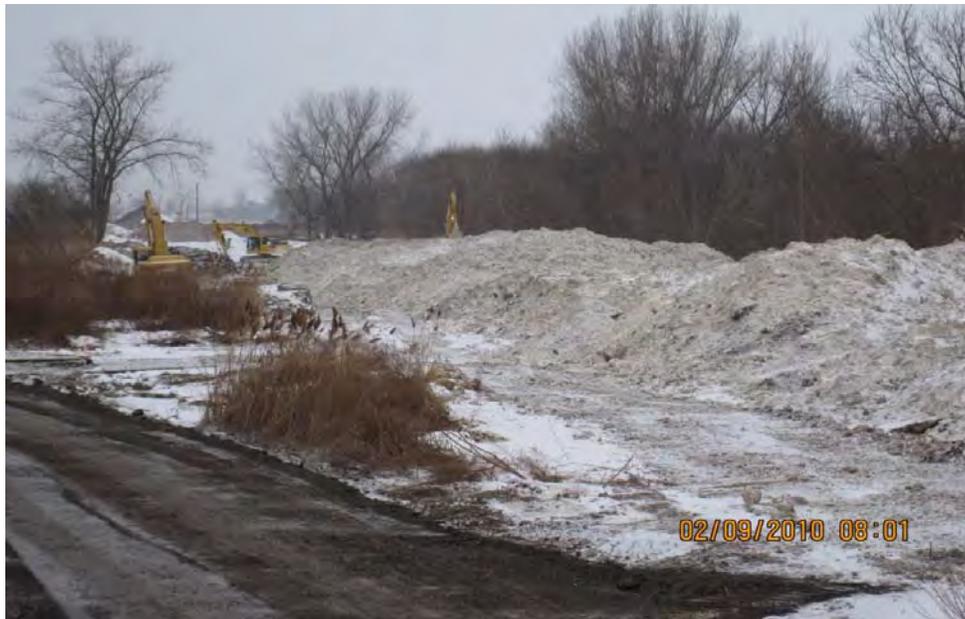
**Title:** IMG-0239

**Description:** Soil stockpile area drumlin formations seen to the west

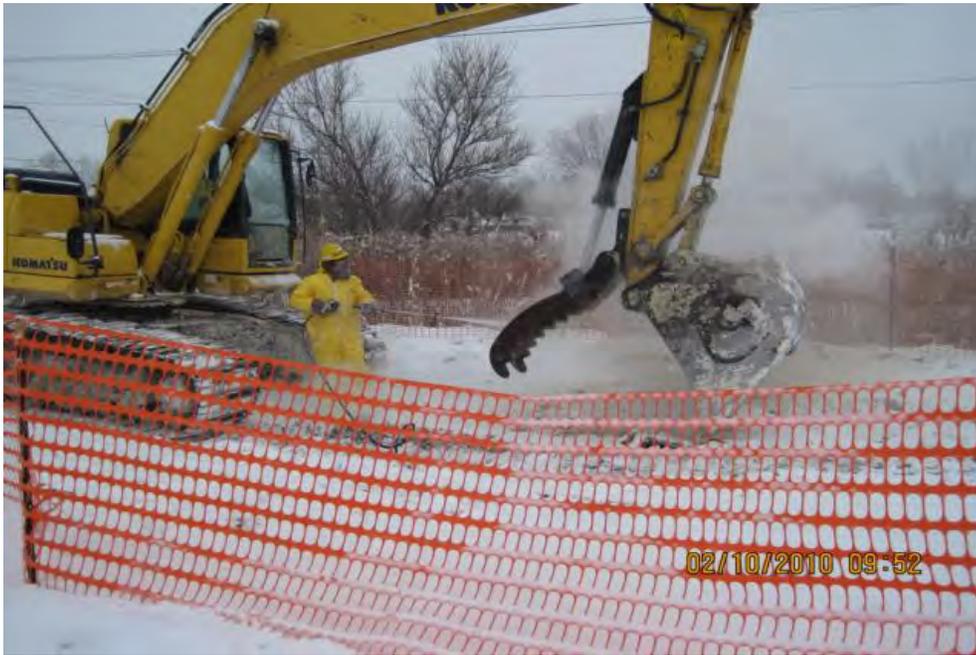
**Title:** IMG-0250

**Description:** Decontamination of excavator bucket on decon pad

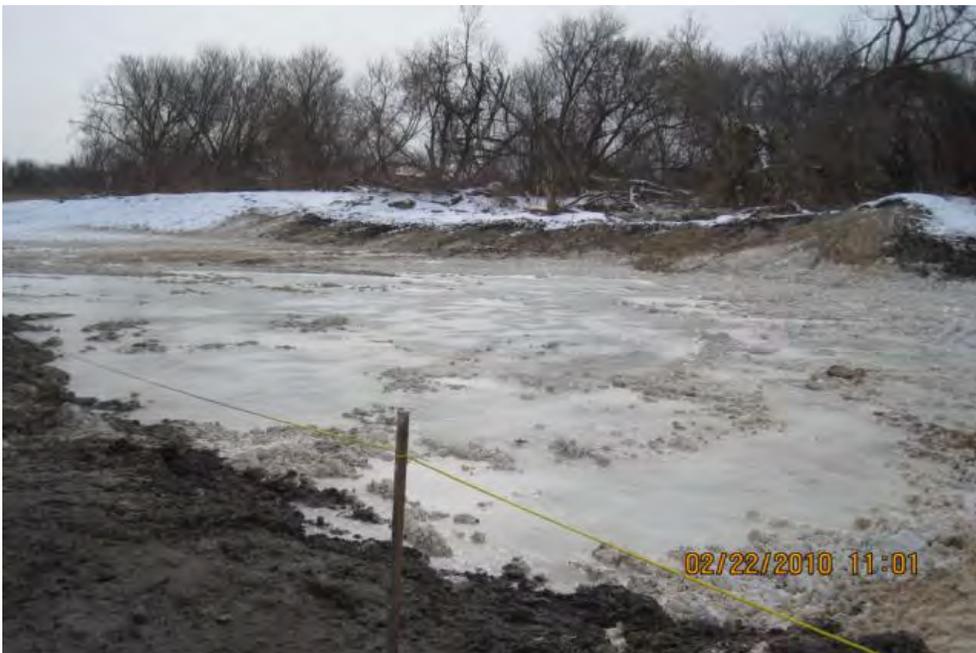
**Title:** IMG\_0303

**Description:** Excavation area

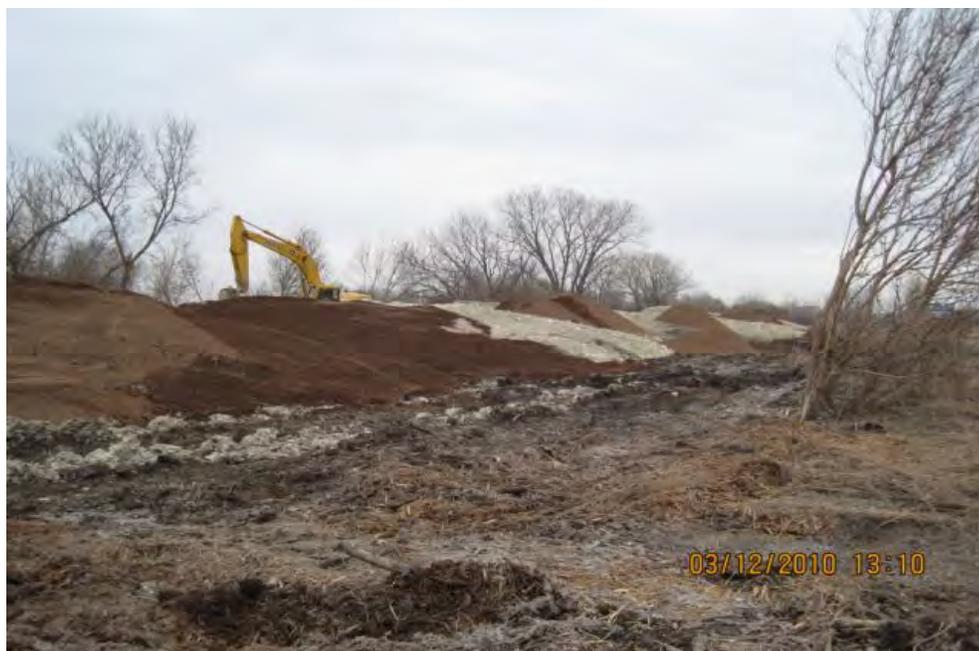
**Title:** IMG\_0343

**Description:** Placing topsoil over stockpiles

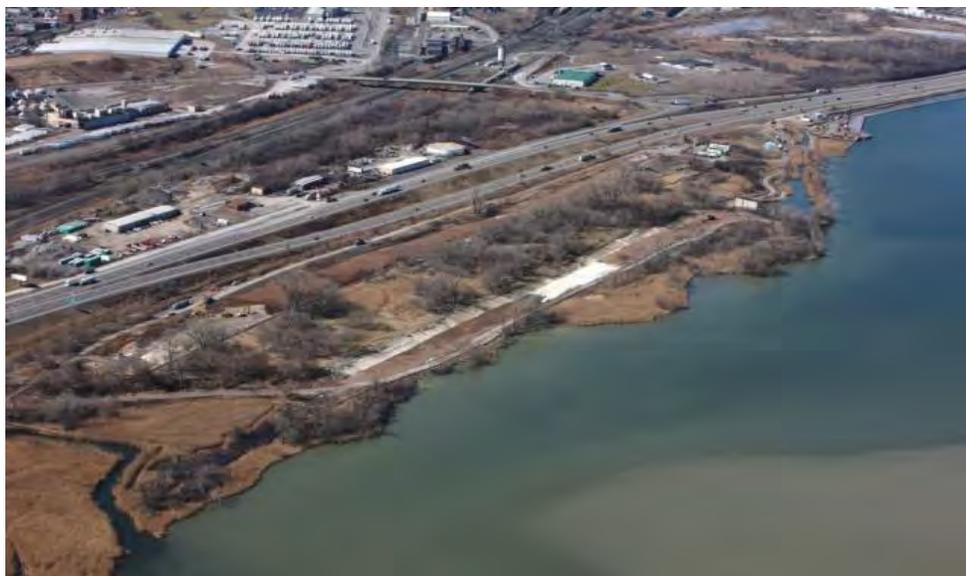
**Title:** 144

**Description:** Overhead view of the worksite, facing NW

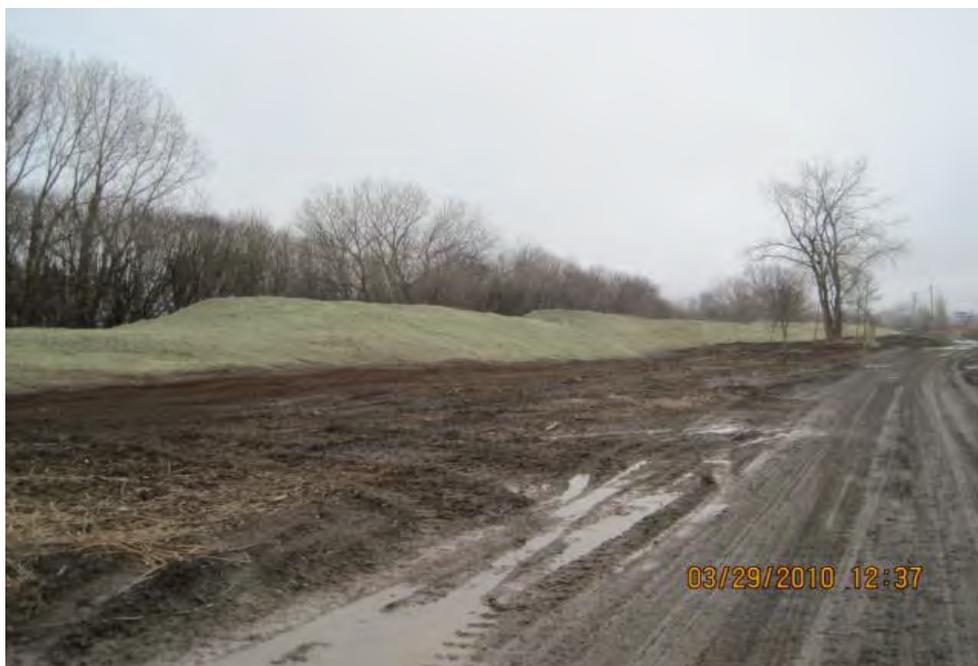
**Title:** IMG\_1429

**Description:** Stockpiles with topsoil, seed and mulch

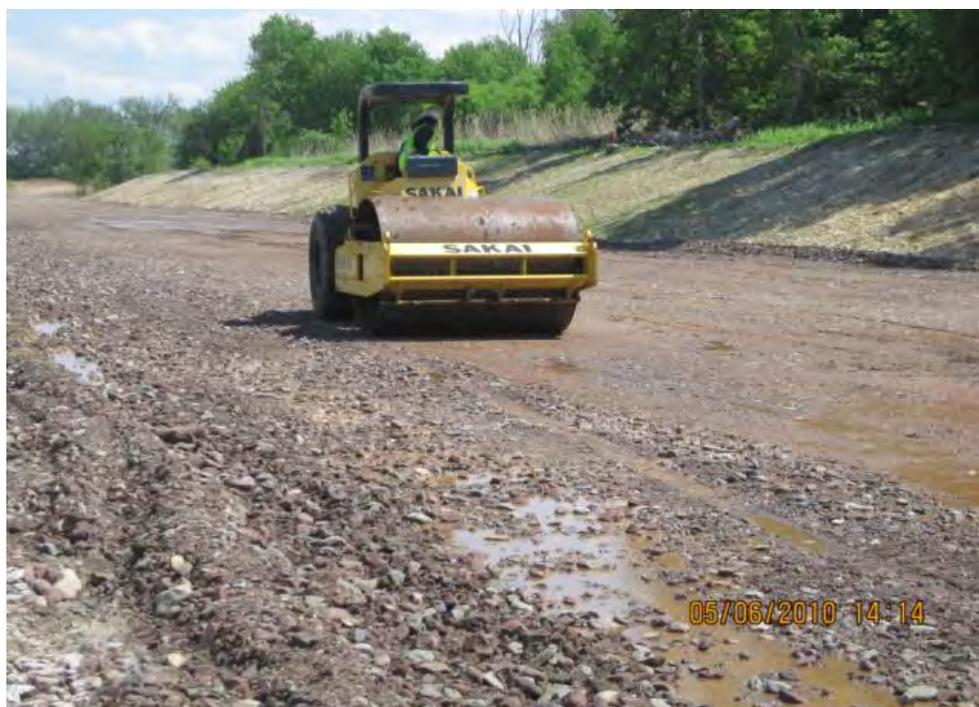
**Title:** IMG\_1581

**Description:** Final work platform compaction
