ARCHAEOLOGICAL RESULTS

Phase IB Underwater Archaeological Resources Report for Onondaga Lake Superfund Site

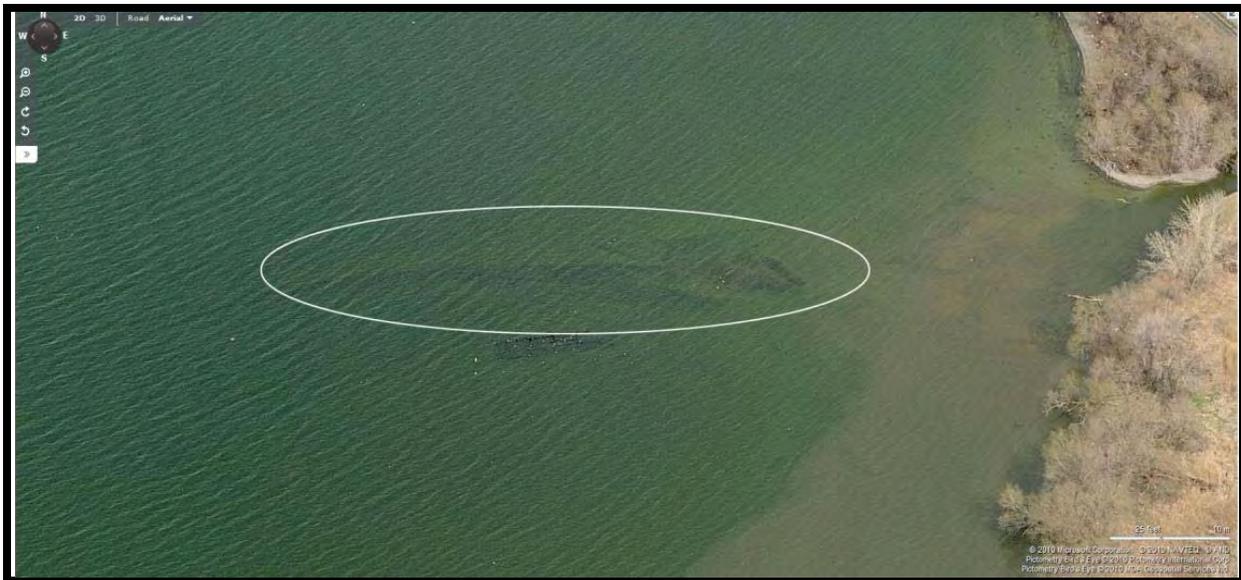
Anomalies A1 and A2 are parts of the remnants of the Salina Pier. The pier lies immediately north of A3, a barge wreck. The pier's location was known from historic accounts and charts, aerial images, and was located during CRE's 2005 remote sensing survey (Figure 38, Figure 39, and Figure 40). In the *Underwater Work Plan* two separate anomalies were identified for the pier location, but the fieldwork showed that they were separate parts of the larger pier structure. Salina Pier was a difficult site for recording good acoustic or visual imagery. The site is covered in a dense growth of aquatic vegetation, especially Eurasian milfoil, which obscured much of the structure.

Figure 39. Underwater structure faintly visible at the location of Anomalies 1 and 2 with Anomaly 3 in the foreground (courtesy Microsoft® Virtual Earth).

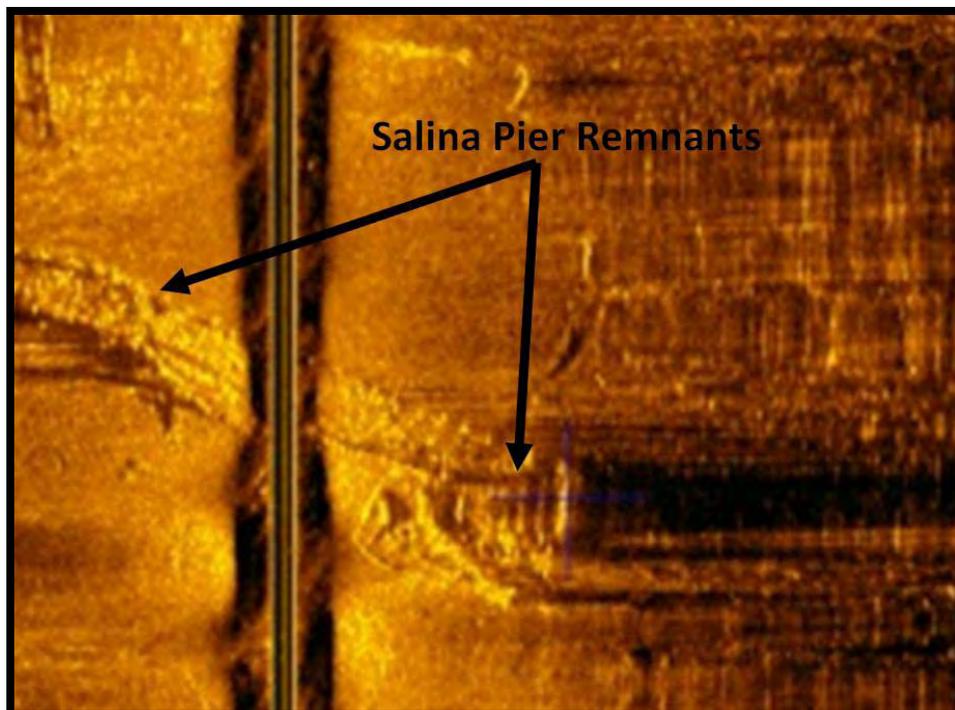
Figure 40. 2005 Sonar image of A1 and A2 (courtesy CRE).

At the shore side (eastern) end to the pier, the pier remnants were clearly visible in shallow water. The site consisted of two parallel vertical planking walls approximately 30 feet (9.14m) apart. The area between the walls was filled with stone. The area inspected was approximately 200 feet (61m) from shore, with 1 to 2 feet (.30m to .61m) of water on top of the pier and 5 to 6 feet (1.52m to 1.83m) of water next to the pier. The northwestern end of the pier was constructed out of stone blocks with some wooden structure of undetermined nature. In one location at least four vertical posts were viewed in a row.

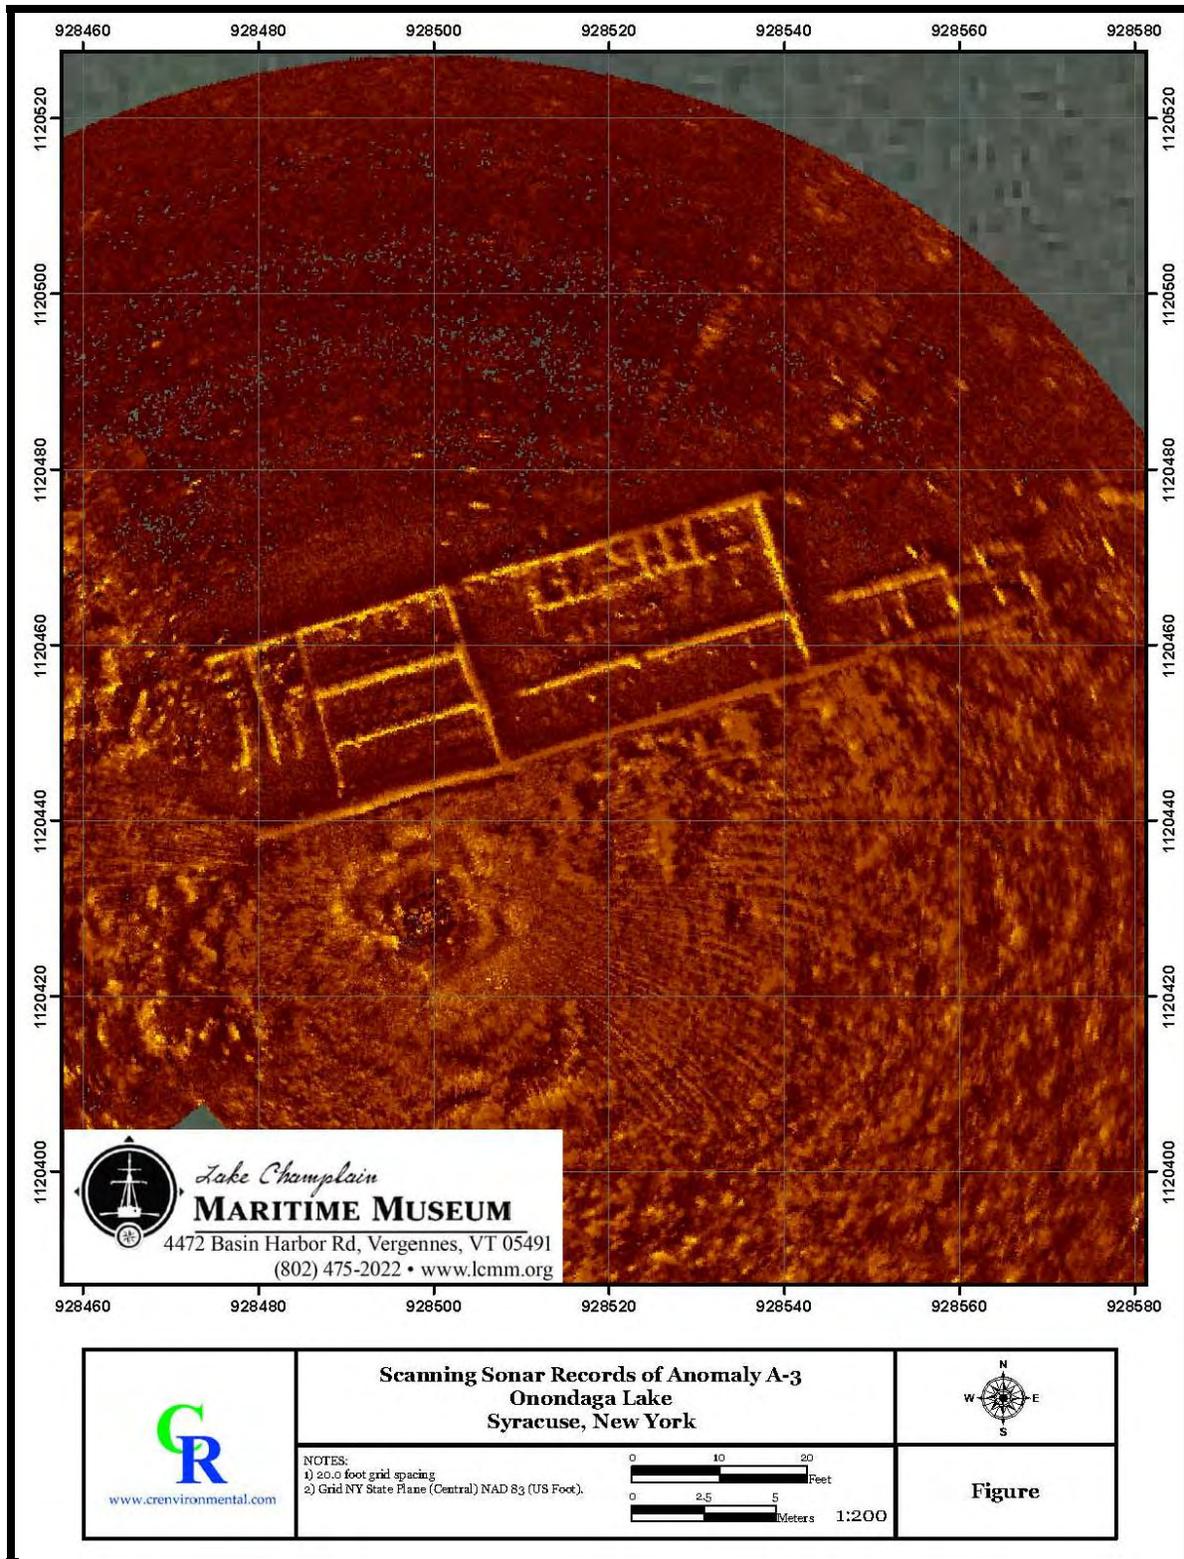
A3 is an edge-fastened, scow-ended wooden barge which is preserved up to deck level, although the deck is no longer present. The vessel is 94 feet (28.65m) long by 22 feet (6.71m) wide. A3 first appears on the 1942 navigational chart, and Phase 1B data suggests the barge’s build date is in the early twentieth century. The vessel rests in shallow water immediately south of Salina Pier. The uppermost portions of the wreck are just above the water’s surface (see Figure 39). The barge is heavily built with its construction pattern suggesting a scow barge designed to carry heavy bulk cargoes on deck.

During the Phase 1B fieldwork, excellent surface visibility conditions allowed for a detailed visual inspection of the barge’s interior structure. The barge’s principal extant members are its vertical, edge-fastened sides, scow ends, longitudinal solid-wall bulkheads, stringers and transverse beams. The interior is divided by two longitudinal bulkheads which run the length of the barge, compartmentalizing the hull into three long sections (see Figure 41 and Figure 42). The hull’s interior is further reinforced by two longitudinal stringers in each hull-compartment, which are in turn overlaid by transverse beams spanning the breadth of the hull. The internal structures are so robust as to suggest that the interior of the hull had no use other than supporting the heavily loaded deck. The internal partitions would have precluded any type of cargo being loaded below deck.

Figure 41. Scanning sonar image of A3.

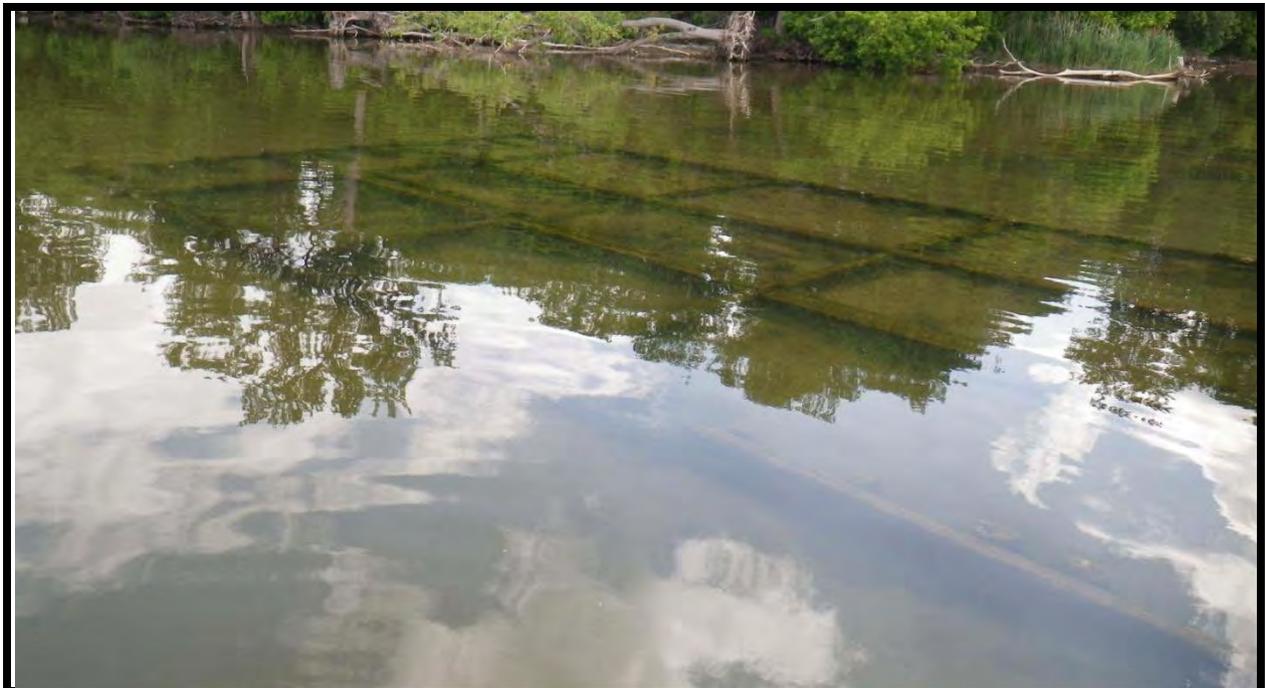
A4-1 is an edge-fastened scow barge which is preserved up to the deck level, although the deck is no longer present. The vessel is 78 feet (23.77m) long and 27 feet (8.23m) wide. A wreck marker appears in the vicinity of A4-1 on a 1942 navigational chart (see Figure 37). The barge rests in shallow water just off shore, and adjacent to another barge, A4-2 (Figure 43, Figure 44 and Figure 45). The archaeological data suggests that the barge’s build date is in the early twentieth century. The uppermost portions of the vessel are just below the water’s surface. The vessel’s hull structure suggests that it is a dump scow.

During the Phase 1B fieldwork, excellent surface visibility conditions allowed a detailed visual inspection of the barge’s interior structure. The barge’s principal extant members are its vertical, edge-fastened sides; longitudinal bulkheads; scow ends; transverse bulkheads; and framing. The barge’s interior is divided by two longitudinal bulkheads which run the length of the barge, compartmentalizing the vessel in to three sections. The hull is further split up by three transverse bulkheads which span the breadth of the hull. Three shorter transverse bulkheads which span only the outboard longitudinal compartment were also noted. Framing is placed every +/- 4 feet (1.22m) with futtocks approximately 6 inches (15.24cm) moulded and sided. The two longitudinal bulkheads are about 8 inches (20.32cm) thick, the transverse bulkheads are 6 inches (15.24cm) thick, while the sides are only 4 inches (10.16cm) thick. The discrepancy between the thickness of the sides and bulkheads suggests there was considerable stress in the middle of hull and less at the sides.

Figure 44. Photograph of Anomaly A4-1 during a period of excellent underwater visibility (LCMM Collection).

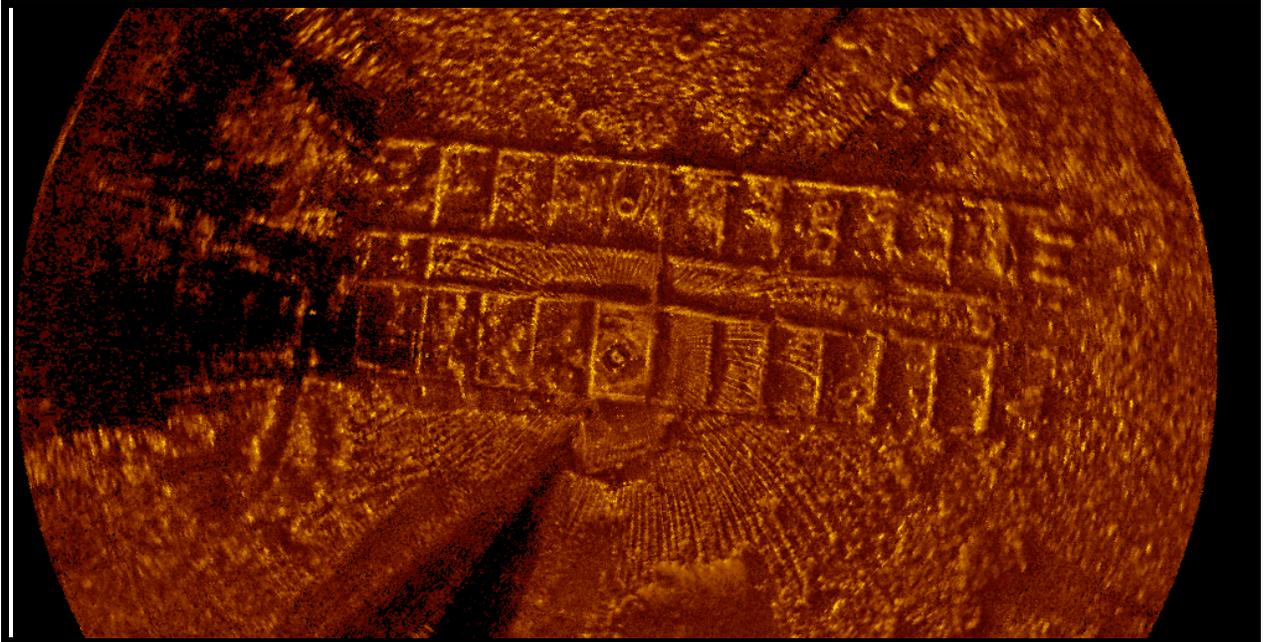
A4-2 is a scow barge with its eastern (shore) end partially broken up, but the remainder of the structure is preserved to just below deck level. The uppermost portions of the vessel are just below the water’s surface, and the remains are largely buried. The vessel is 73 feet (22.25m) long and 25 feet (7.62m) wide (Figure 47). A wreck marker appears in the vicinity of A4-2 on a 1942 navigational chart (see Figure 37). The barge rests in shallow water abutting the shoreline and adjacent another barge, A4-1 (see Figure 43 and Figure 45). The archaeological data suggests that the barge’s build date is in the early twentieth century. The arrangement of longitudinal and transverse bulkheads resembles that of the adjacent barge (A4-1), suggesting that A4-2 may also be a dump scow.

During the Phase 1B fieldwork, excellent surface visibility conditions allowed for a detailed visual and videographic inspection of the barge’s interior structure. However, the lower two thirds of the vessel is buried, limiting the extent to which the site could be evaluated. The barge has two longitudinal bulkheads which divide the hull into three longitudinal compartments. Three transverse bulkheads which span the entire breadth of the vessel were recorded, and at least 11 smaller transverse bulkheads which span only the outboard longitudinal compartments were noted. With the exception of the bulkhead arrangement, the barge lacked diagnostic features. The bulkheads were similar in their arrangement to the adjacent barge (A4-1), which was identified as a dump scow. Although not conclusive, it is likely that A4-2 is also a dump scow. The proximity of such similar vessels suggests that they were deposited contemporaneously.

Figure 47. Sector scan image of Anomaly A4-2.

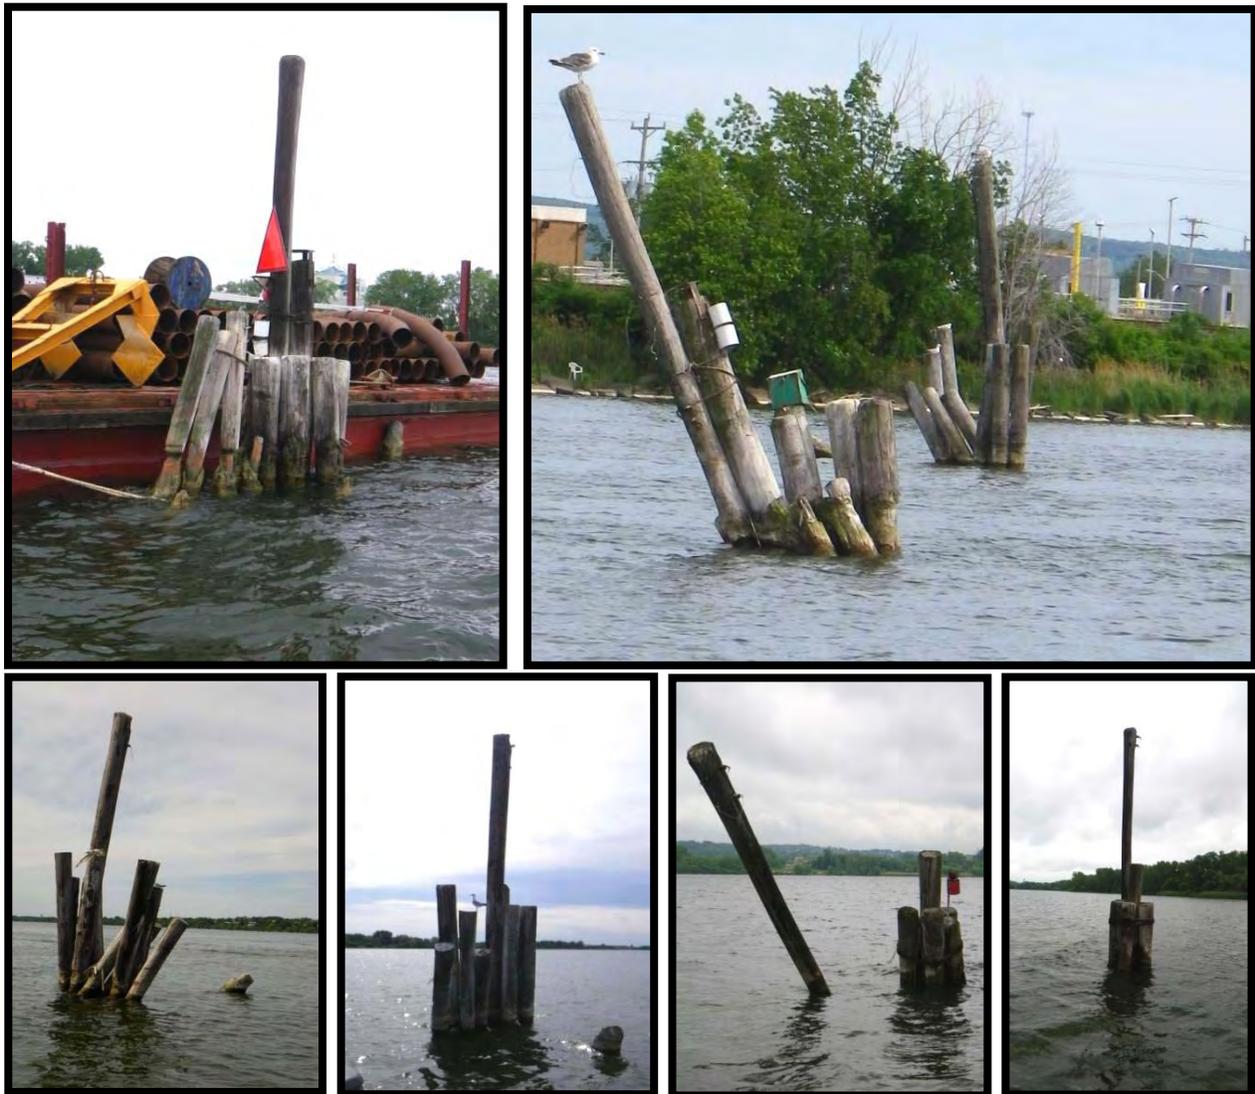
Anomaly A7 was identified from aerial images and the 2005 remote sensing survey (Figure 48). The anomaly is a series of six piling clumps marking the entrance into Syracuse’s inner harbor. The clumps consist of between three and ten pilings driven into the lakebed and held together with cables and/or iron bands. The clumps are visible above the surface, and were documented with side scan sonar, sector scan sonar and photographs (Figure 49 and Figure 50).

Figure 49. Photographs showing the piling clumps which comprise A7 (LCMM Collection).

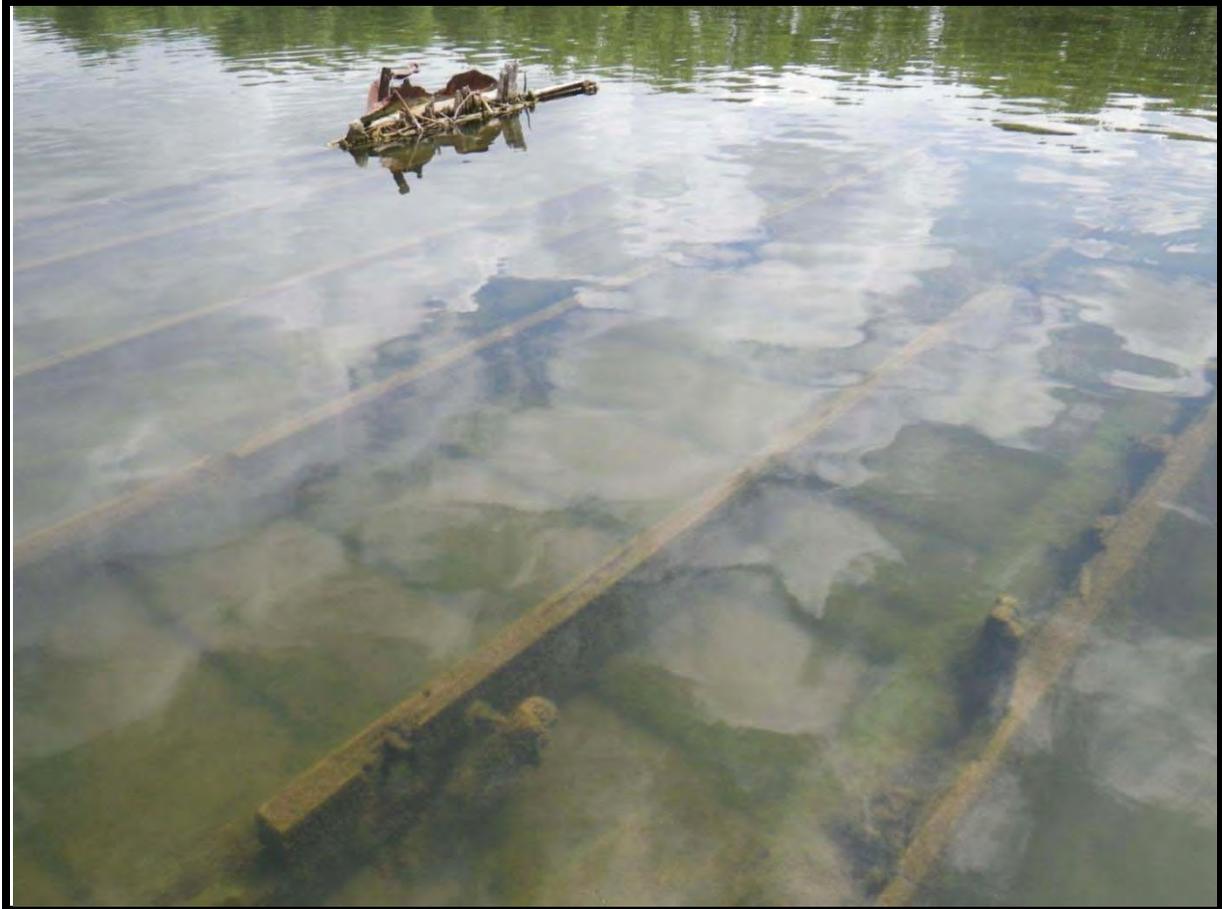
During the Phase 1B fieldwork, site conditions were ideal for recording sector scan (Figure 52) and side scan imagery (Figure 53), as well as a detailed visual inspection due to excellent water clarity. The barge’s principal extant members are its vertical edge-fastened sides, vertical ends, four longitudinal bulkheads, floors, framing, spud holders, and mast step. The vessel is 88 feet (26.82m) long and 32 feet (9.75m) wide. A12 is edge-fastened every +/- 18 inches (45.72cm) along the 4in (10.16cm) thick sides with framing every 3 to 4 feet (.91m to 1.22m). There are 4 bulkheads, also edge-fastened (Figure 54). The framing system consists of futtocks with a clamp holding the joint between futtock/floor. The original use of the barge as a derrick lighter spud barge is defined by the spud holders and mast step.

Figure 54. Photograph showing Anomaly A12's longitudinal bulkheads with the spud holder in the background (LCMM Collection).

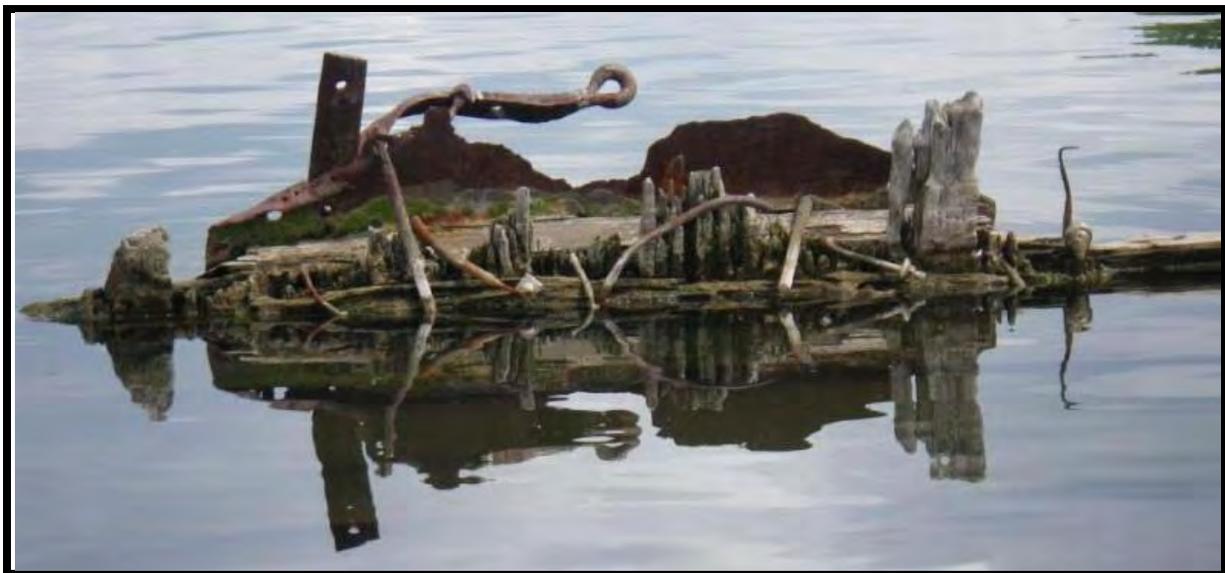
The spud holders are located on both sides of the vessel on the eastern end of the barge (Figure 55). Spuds are vertical posts which could be raised and lowered to hold a vessel in place, and were commonly used on barges that required maintaining a stationary position in shallow water such as pile drivers, crane barges, derrick lighters and dredge barges. The spud holder is composed of two iron horizontal knees which reinforced a vertical wooden channel in which the spud was housed. The side of the hull around the spud holder was protected with sheet iron and framed more heavily than the rest of the hull. Iron chain plates were noted along the sides of the barge adjacent to the spud holder. Chainplates, straps used to hold rigging to the boat’s side, secured the cable used to raise and lower the spuds.

Figure 55. Photograph showing the inboard side of Anomaly A12's spud holder (LCMM Collection).

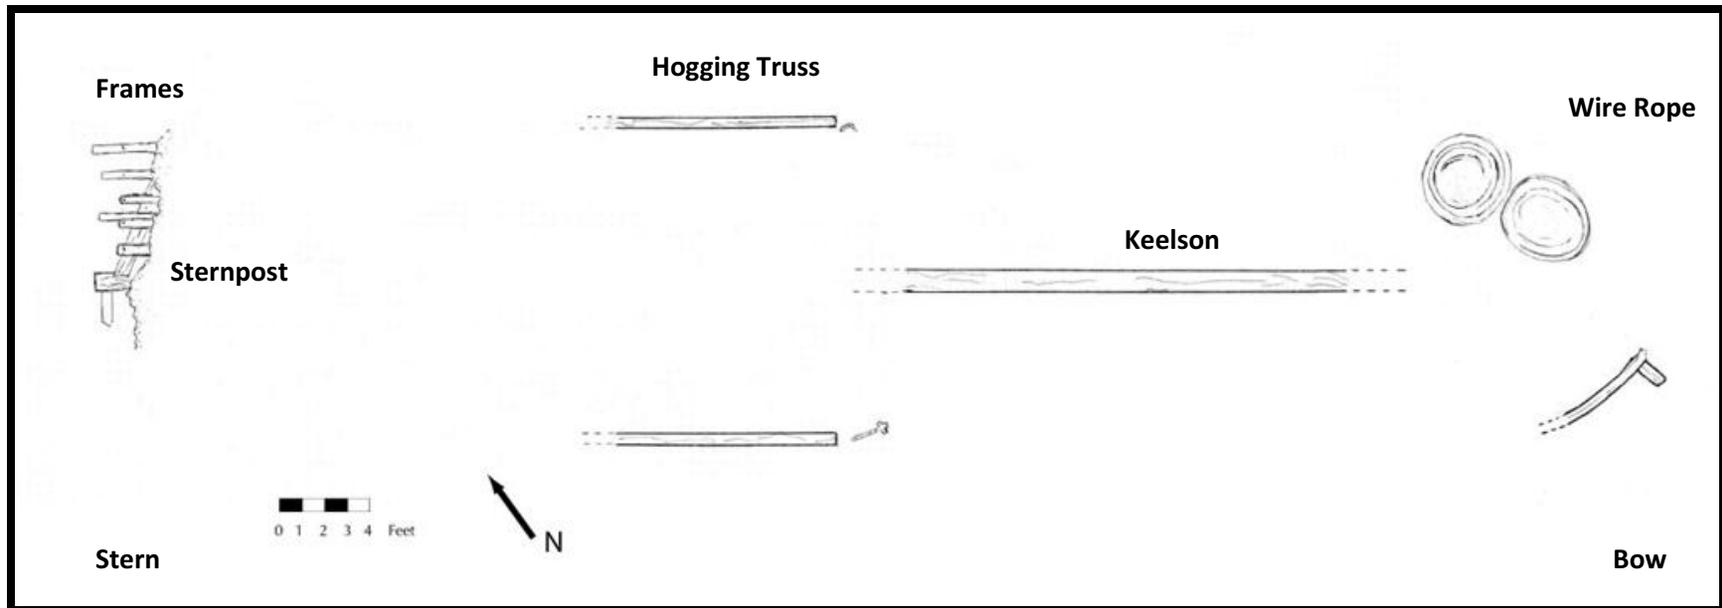
Anomaly A35 represents the remains of a watercraft that could not be conclusively identified due to its buried condition (Figure 58). The site was examined in June 2010 with sector scan and side scan sonar which yielded no returns suggesting the presence of a submerged cultural resource. The underwater videography recorded by the ROV showed a scatter of timbers which LCMM staff were unable to conclusively identify. Due to the lack of sufficient data to assess the nature and potential significance of the site, the anomaly was investigated by archaeological divers in October 2010. This inspection revealed the site to be the largely buried remains of a watercraft of unknown origin.

The site lies in approximately 4 feet (1.22m) of water, with an extant length and beam of 64 feet (19.51m) and approximately 14½ feet (4.42m), respectively. Very little of the site is exposed; however, the visible remains suggest that the bottom 2 to 4 feet (.61 - 1.22m) of the vessel is preserved under the lake bottom. The principal visible features include stern framing and planking, deadwood, keelson, sternpost, and a wooden hogging truss. The vessel’s stern is the most exposed portion of the remains consisting of a sternpost, frames, planking and deadwood. An iron rub rail was noted on the exterior of the port side at the stern. The planking goes from outboard of the frames to on top (interior) of the sternpost, which suggests that the sternpost is preserved to its original height. The stern post is vertical with an iron plate on the side and a gudgeon for securing the rudder. The sternpost is reinforced on its interior side with deadwood. The port side of the stern has five frames while the starboard side does not have any. The framing is light with moulded and sided dimensions of 3 inches (7.62cm). The form of the stern was difficult to determine given the paucity of exposed timbers, however, the shape is believed to be scow-like. The boat amidships had two 10 foot (3m) long longitudinal beams which were angled downward toward the stern with the bow end about 1 foot (.3m) above the lake bottom. These beams are believed to be the remains of a wooden hogging truss. The exposed remains at the bow consist of a 20 foot (6.1m) run of the keelson and the top of one frame. Probing in the bow showed the remains to be buried below only 6 to 12 inches (15 to 30cm) of sediment. The maximum length of the remains was 64 feet (19.51m); however, the stem was not located thus the true length of the boat is unknown. There is a large coil of wire rope amidships.

Figure 58. Preliminary scale drawing of A35 showing the scarcity of exposed vessel structure (Sarah Tichonuk, LCMM Collection).

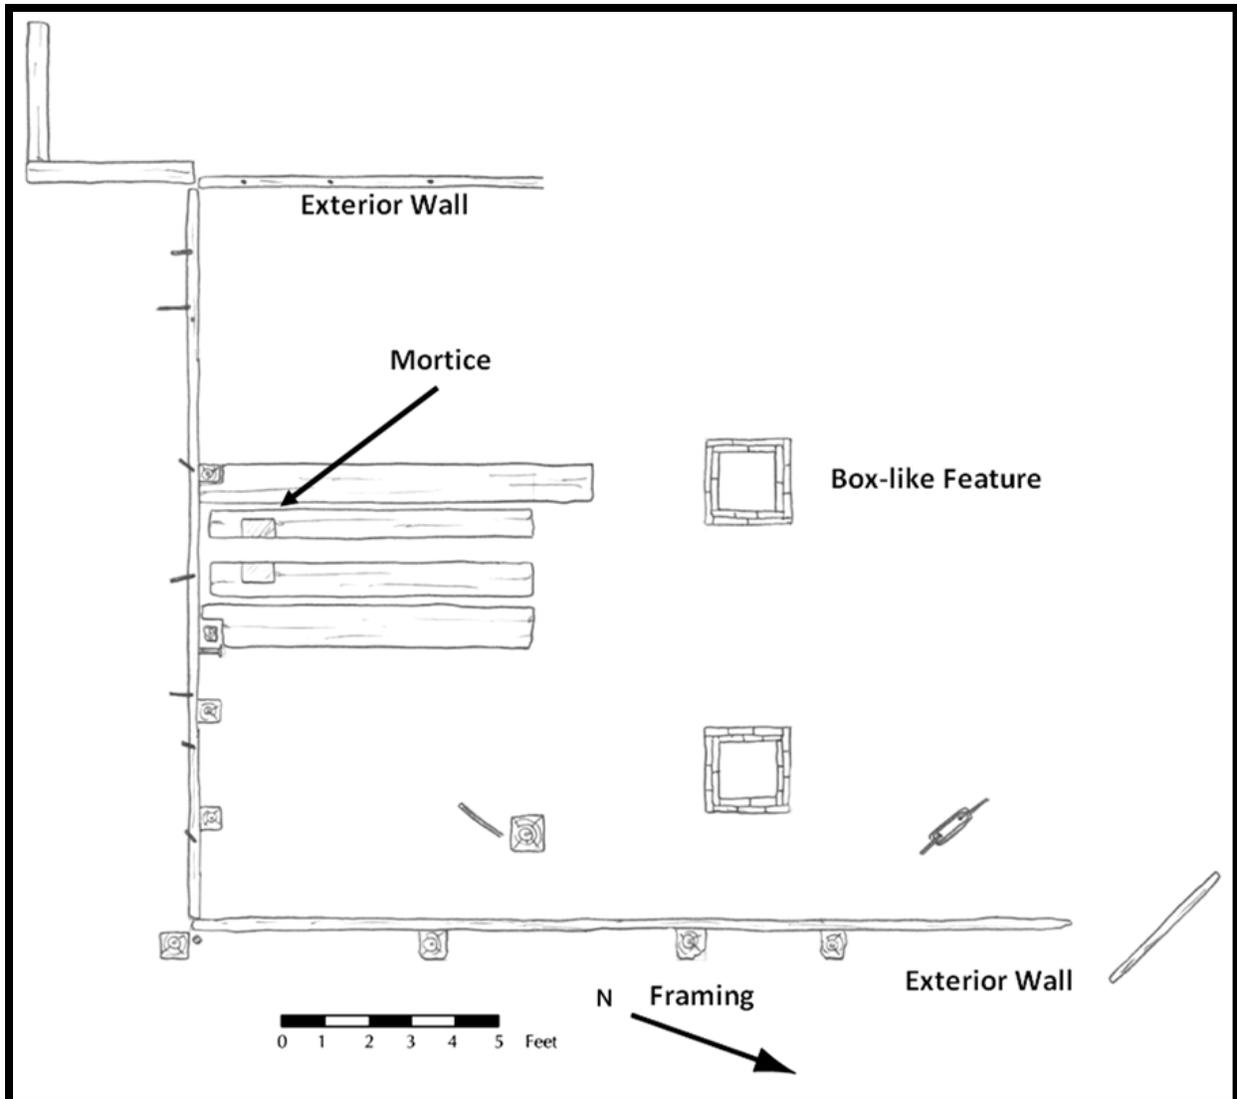
A38 was examined with side scan sonar, sector scan sonar and remotely operated vehicle with inconclusive results. The anomaly was selected for dive verification, which was undertaken on October 26 and 27, 2010. The site was identified as dock or pier remains based on archaeological and map data. The site consists of a 20 by 17 foot (6.1 by 5.2m) timber frame structure (Figure 59). The exterior walls are constructed of edge fastened planks reinforced with framing members every 3 to 5 feet (.91 to 1.5m). The remains appear to be preserved up to their original height based on the presence of four timbers forming a deck with a large mortice for the foot of a vertical timber. The pier has two box-like features constructed out of two layers of vertically oriented planking. The boxes are 2 feet by 2 feet (.61 by .61m) and stand 1½ feet (.46m) above the bottom. The function of the box features is unknown.

Figure 59. Plan view drawing of A38 (Sarah Tichonuk, LCMM Collection).
