Anomaly 53: Canal Boat

Anomaly 55: Canal Scow

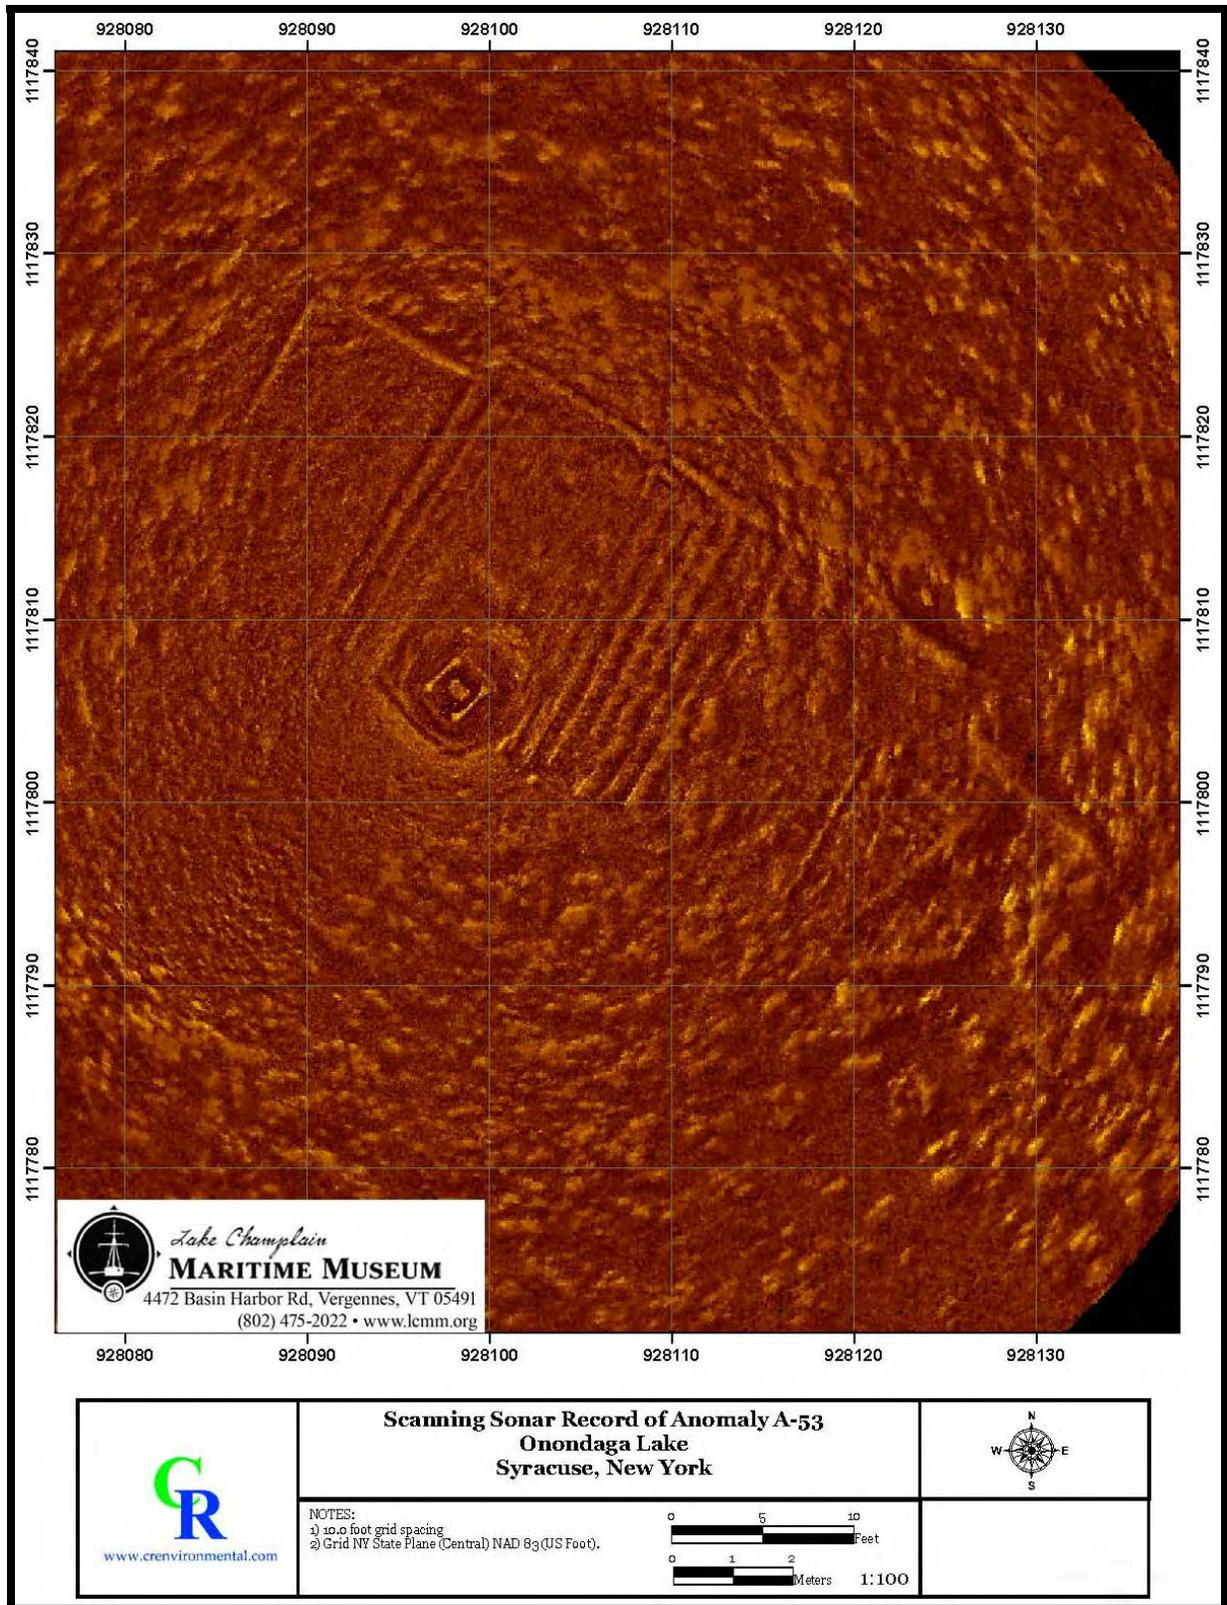
A53 was examined with side scan sonar, scanning sonar, visually from the surface and with the remotely operated vehicle (Figure 65) and verified with a diver. The site is the bottom of a canal boat with elements visually noted including floors, bow frames, stem and cocked hats. The vessel has a beam of approximately 17½ feet (5.33m) and an extant length of approximately 60 feet (18.29m). The boat’s stern is buried, but the overall length is likely 97 to 98 feet (29.57 to 29.87m) in accordance with the dimensions of the canal locks. These dimensions place the build date for the vessel between 1862 and 1915. The canal boat’s most interesting feature is the cocked hat construction technique used to tie the sides of the hull to the bottom. The vessel has flat floors with trapezoidal timbers (cocked hats) which connect the floors to the futtocks. This is a construction technique that has been documented on steamboats; however, LCMM researchers do not know of any canal boats that were built using this technique. The floors are completely flat with room and space of about 1 foot (30.5cm) with floors about 3 inches (7.6cm) sided. The vessel’s bow is located to the east and consists of a typical rounded canal boat bow as outlined by sporadic framing protruding six inches to one foot (15 to 30.5cm) above the bottom. The remains of the stem were noted standing approximately 1 foot (30.5cm) above the bottom. Numerous disarticulated pieces of A53 were located around the wreck, particularly to the southeast. These included several frame sections which were of cocked hat construction like the wreck itself; each disarticulated piece was examined in detail to make sure it was not a larger section or a new wreck.

Figure 65. Scanning sonar image of A53.

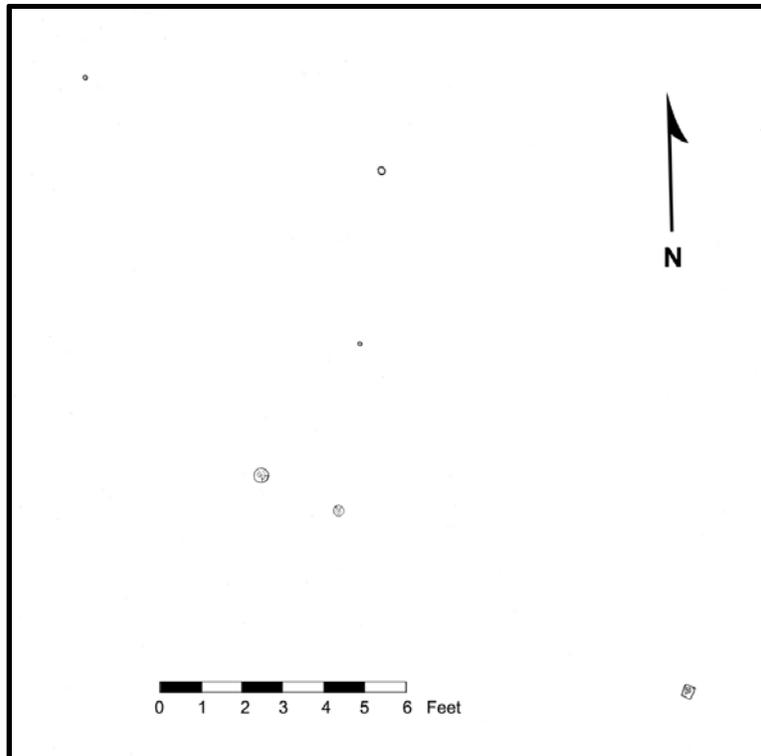
Anomaly 72 was located in 2011 and determined to be a series of six wooden pilings, each cut off 6in (15cm) above the bottom, and spread over an area 9ft (3m) by 17ft (5m). Five of the pilings are round, varying in diameter from 0.75in to 5in (2cm to 13cm); the inshore piling is 4in (10cm) square. This feature’s location close to shore and in shallow water indicates that it was a small pier or boathouse likely related to the Iron Pier. This area also contained scattered trash and tires.

Figure 67. Plan drawing of A72 Pilings (Sarah L. Tichonuk, LCMM Collection).

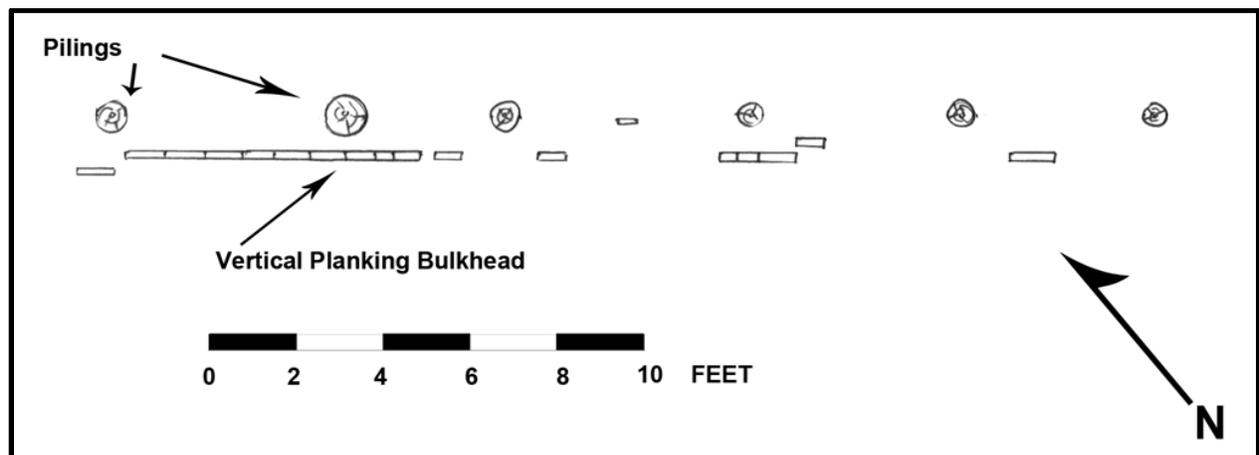
A bulkhead feature, Anomaly 73, was located in the northern corner of the survey area during dive verification in 2011. The pier consists of seven pilings each standing approximately 6in (15cm) above the bottom (Figure 68). The tops of the pilings were cut flat indicating that the upper surfaces are the tops of the pilings as exposed during its use life. There is a linear arrangement of vertically oriented planks paralleling the pilings, located 4in (10cm) south of the line of pilings. Probing indicated that stones fill the interior of the pilings behind the bulkhead. The structures (pilings and bulkhead) stand 2in to 8in (5 to 20cm) above the bottom. This feature is likely part of the shoreline stabilization infrastructure necessary for the basin shown in Figure 60, adjacent or related to the Iron Pier.

Figure 68. Plan drawing of A73 Pier (Sarah L. Tichonuk, LCMM Collection).

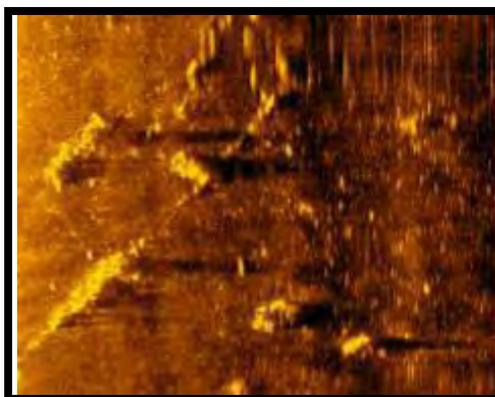
Figure 69. A5 sonar images showing linear acoustic anomalies which were identified as piping associated with water monitoring (courtesy CRE).

LCMM recommends no further work for A5.

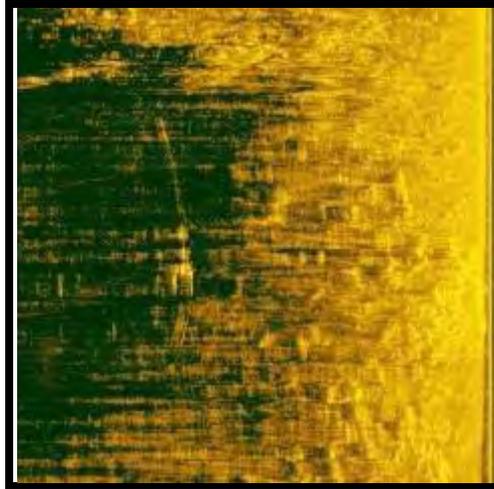
A19 is co-located with four magnetic anomalies digitized from CRE’s 2005 data: #182; #187; #1073; and #1078 (Figure 79). These anomalies were observed on four parallel survey transects spaced 25ft (8m) apart at a depth of approximately 3 to 6ft (1 to 2m). The magnitude of these anomalies was as high as approximately 100nT (Figure 80). Assuming a distance (range) of 7 to 16ft (2 to 5 m), the ferrous mass of this anomaly might be 35 to 551lb (16 to 250 kg).

Figure 79. Sonar image from 2005 showing Anomaly 19 (courtesy CRE).

LCMM recommends no further work for A19.

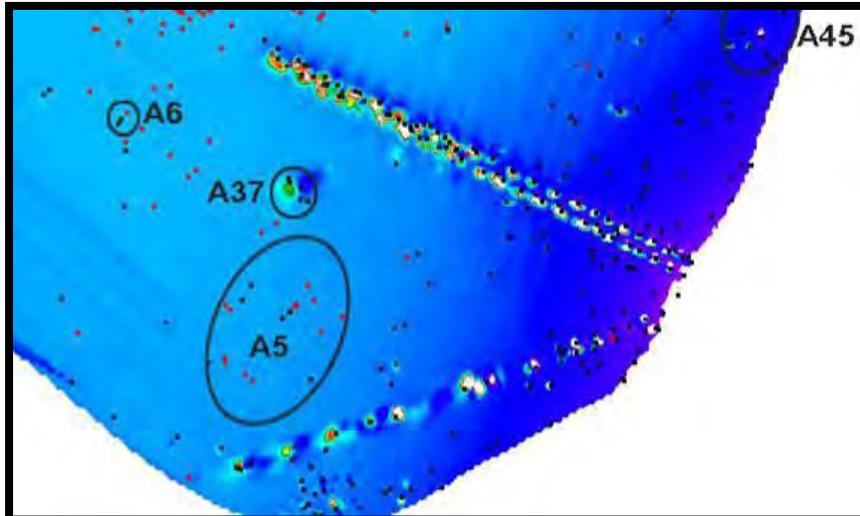
A37 is co-located with five magnetic anomalies digitized from CRE’s 2005 data: #276; #499; #500; #502; and #503 (Figure 82). These anomalies were observed on five parallel survey transects spaced 25 ft (8m) apart at a depth of approximately 10 to 12ft (3 to 4m). The magnitude of these anomalies was as high as approximately 400nT at the central dipolar anomaly #276 (Figure 83). Assuming a distance (range) of 7 to 16ft (2 to 5 m), the ferrous mass of this anomaly might be 141 to 2204lb (64 to 1000kg). Side scan sonar data collected in the vicinity of these anomalies in 2010 did not suggest the presence of surficial contacts (debris or structures). The anomaly was investigated using side scan sonar, sector scan sonar and ROV in 2010, and dive verification in 2011, with all results being inconclusive.

Figure 82. Magnetic intensity map of Onondaga Lake showing A37.

LCMM recommends no further work for A37.

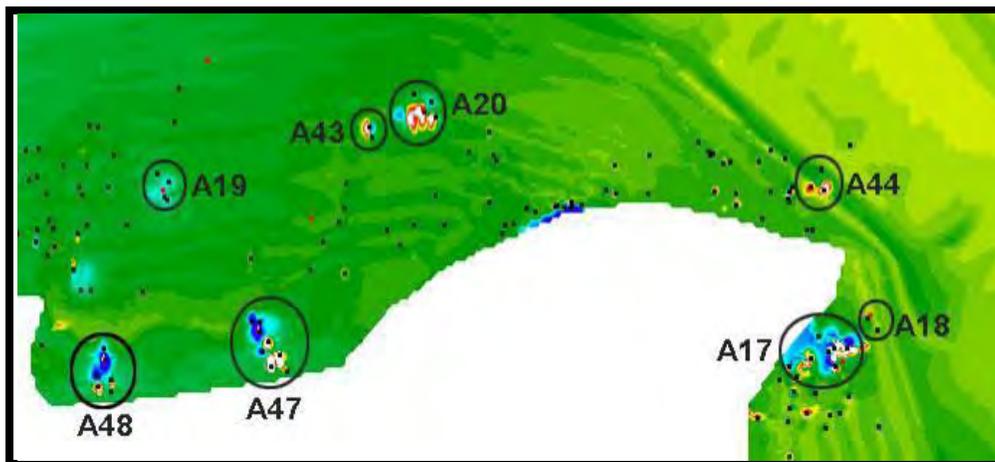
A47 was confirmed visually to be a 12 inch (30.5cm) diameter cast iron pipe running perpendicular to shore. The pipe is likely for draining leachate out of the onshore waste deposit.

Figure 85. Magnetic intensity map of Onondaga Lake showing A47.

LCMM recommends no further work for A47.

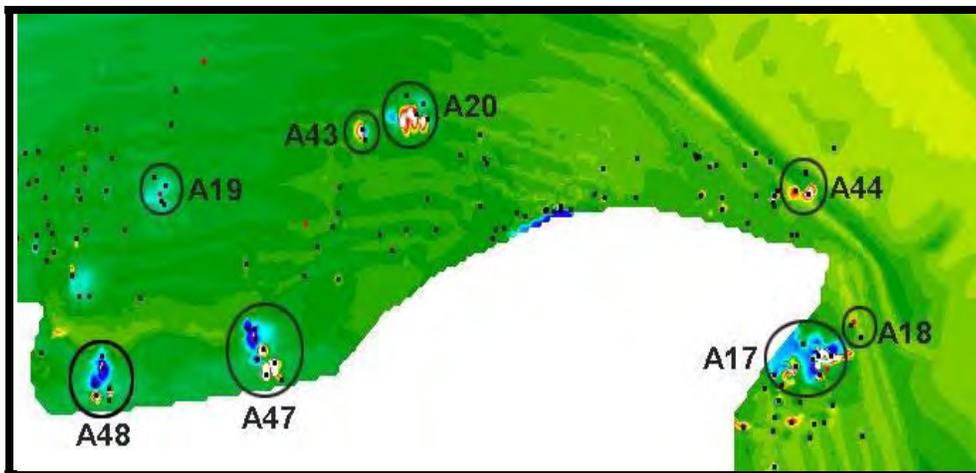
A48 is a linear magnetic anomaly located in 2005 with a signature similar to A47 (Figure 86). The source of the anomaly was searched for using side scan sonar and visually from the survey vessel. The source could not be located, however, A48's proximity and similarity to the pipeline at A47, strongly suggest that A48 is also a buried iron pipeline.

Figure 86. Magnetic intensity map of Onondaga Lake showing A48.

LCMM recommends no further work for A48.

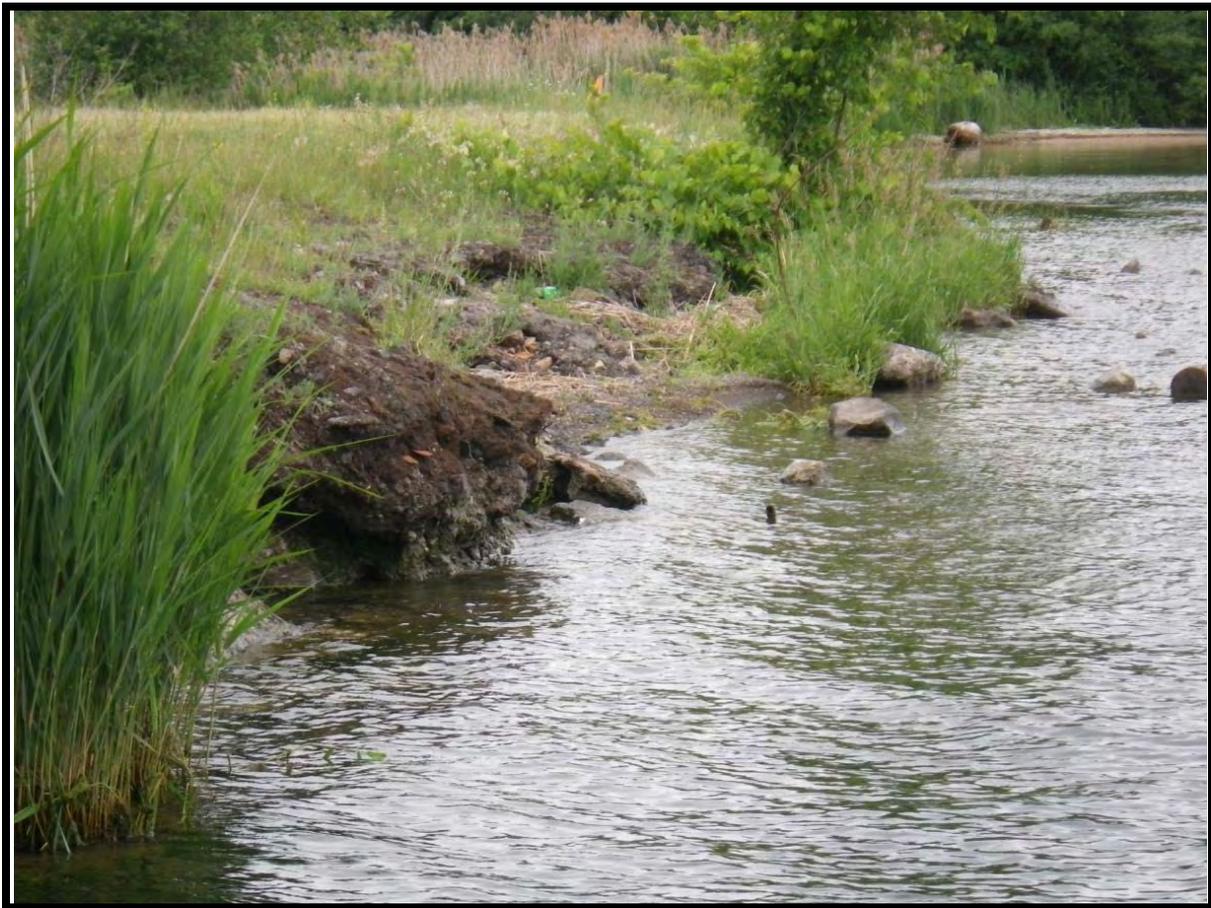
Figure 92. Photograph of the shoreline at A52 showing the slag fill (LCMM Collection).

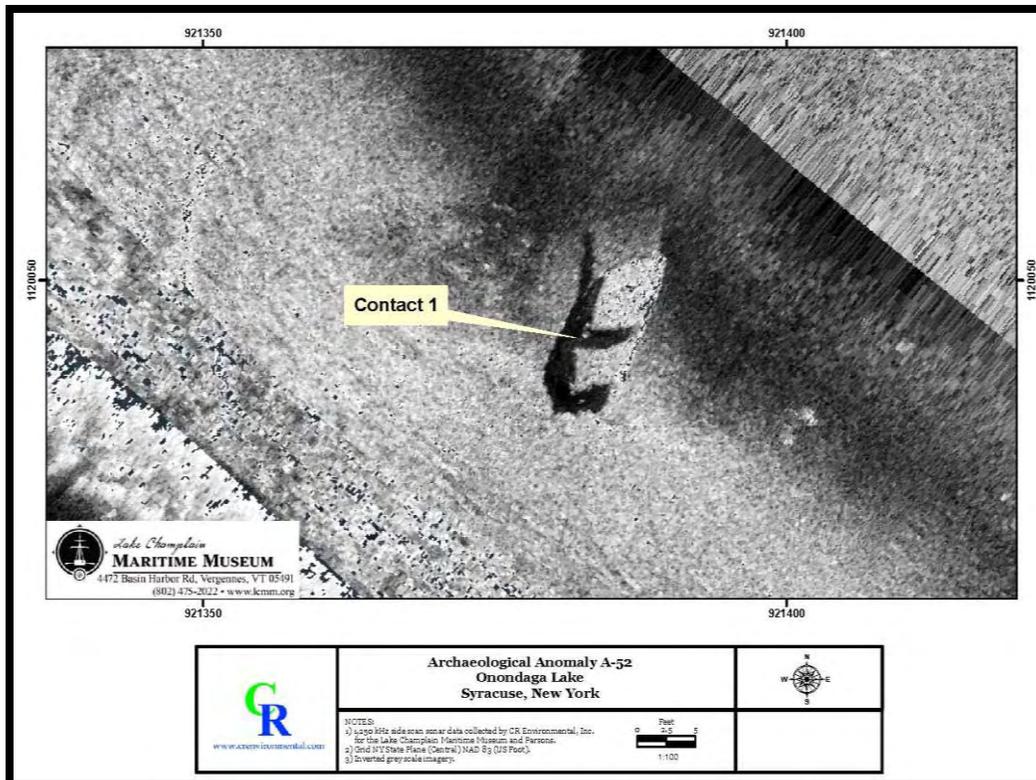
A sunken car is located off the northeastern side of the peninsula in approximately 30 feet (91.m) of water. The vehicle, which is heavily covered in zebra mussels, appears to be a 1970s vintage sedan (Figure 93).

Figure 93. Sonar mosaic from A52 showing a sunken car.

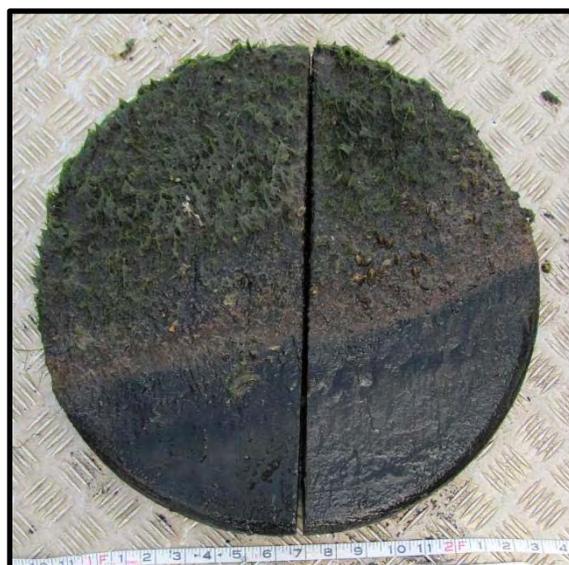
Figure 94. Anomaly 57, wooden barrel lid (LCMM Collection).

LCMM recommends no further work on A57.

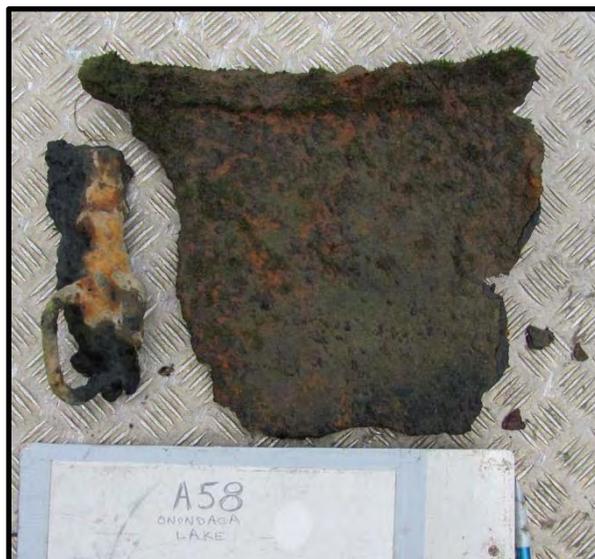
Anomaly 58 was investigated by a diver in 2011. A58 is a broken-up 55-gallon drum (Figure 95).

Figure 95. Anomaly 58, a fragmentary 55-gallon drum (LCMM Collection).

LCMM recommends no further work on A58.
