Lake Champlain Maritime Museum (LCMM) concluded that the Phase 1B underwater archaeological research undertaken in Onondaga Lake demonstrated that several archaeological remains still lie on the lake bottom. Overall, these properties tend to be well-preserved, although many lie partly or largely buried below the lake bottom. The Phase 1B survey examined 60 anomalies of which 20 are recommended as eligible for the NRHP, while 18 were culturally derived features which are recommended as ineligible for the NRHP. Three of the anomalies were non-cultural, 15 remain unidentified, and four are identified but their NRHP status remains unevaluated.

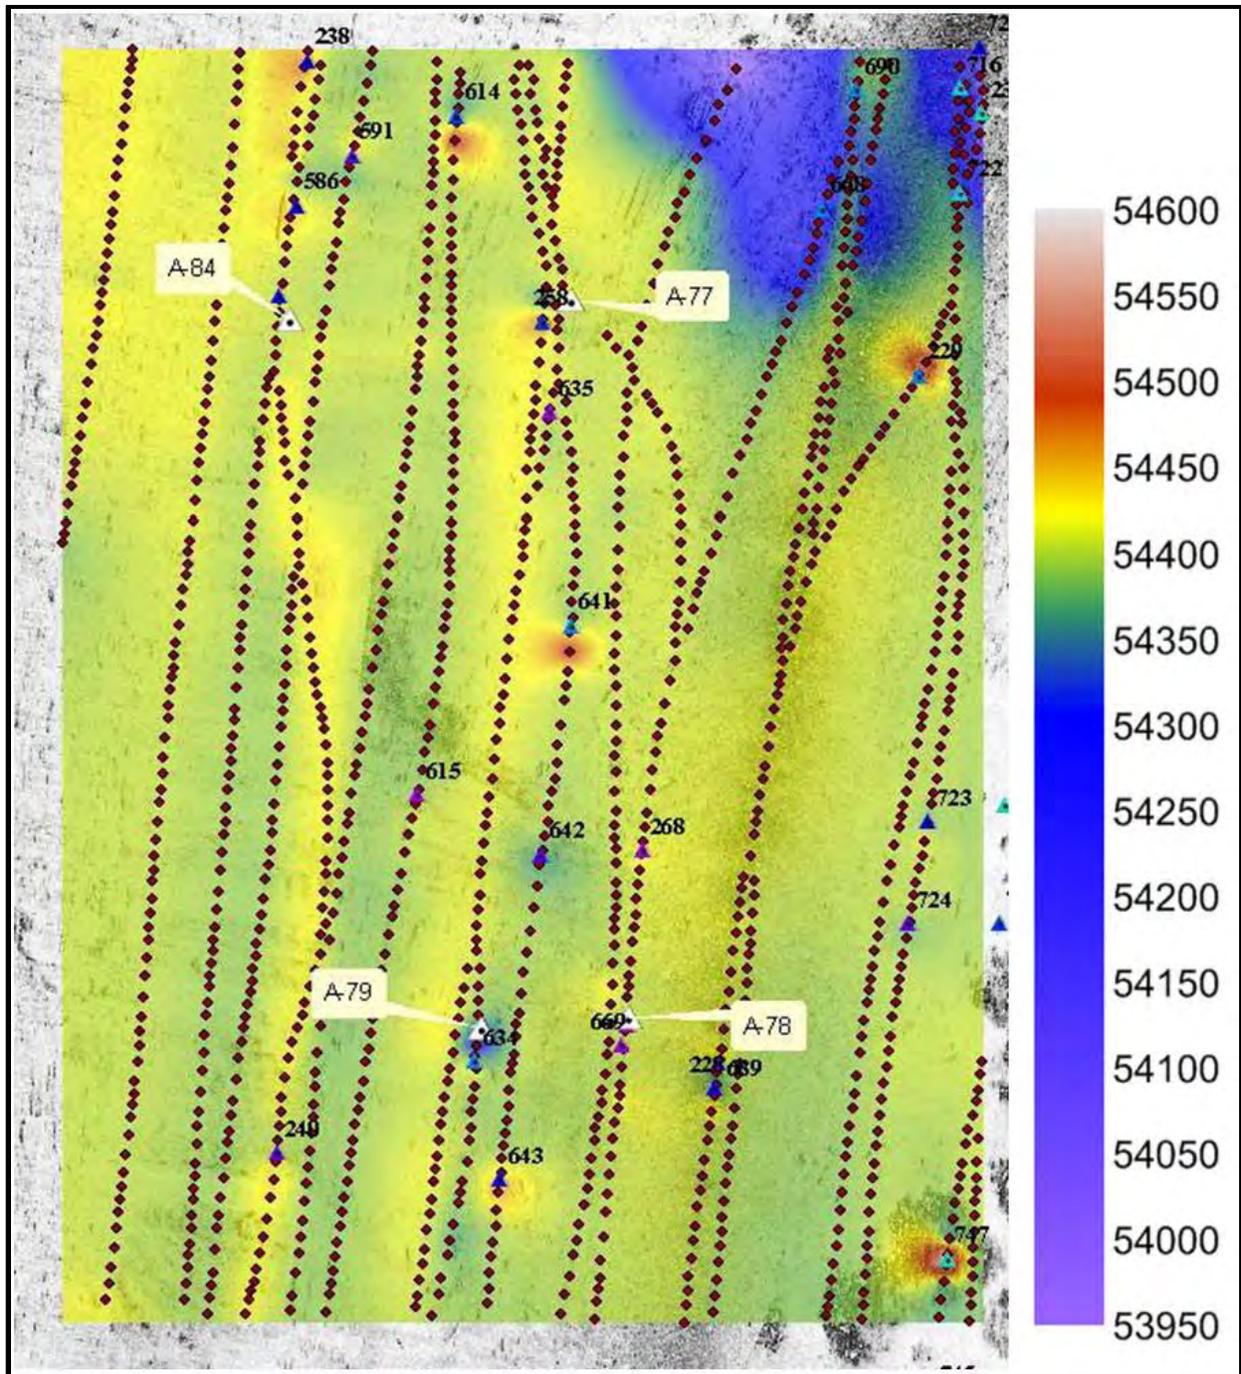
Figure 98. Graphical overlay of fine-scale magnetism and side scan data on A77 and A79 (courtesy CRE).

Anomaly 79 was co-located with 2005 magnetic anomaly #634, a 144nT dipole at a depth of approximately 5ft (2m) (see Figure 98). The ferrous mass estimate for this feature would range from 50 to 793lb (23 to 360kg) at an assumed range of 7 to 16ft (2 to 5m). The lakebed was obscured by aquatic vegetation in 2005 side scan sonar data. Anomaly 79 was not located despite extensive visual diver examination and metal detecting in 2011.

Although the specific origin of the magnetic anomaly is unknown, its signature lacks the complexity, intensity and spatial extent expected of a larger cultural resource. LCMM believes the collective data suggests that it is likely isolated ferrous debris.

LCMM recommends no further work for A79.

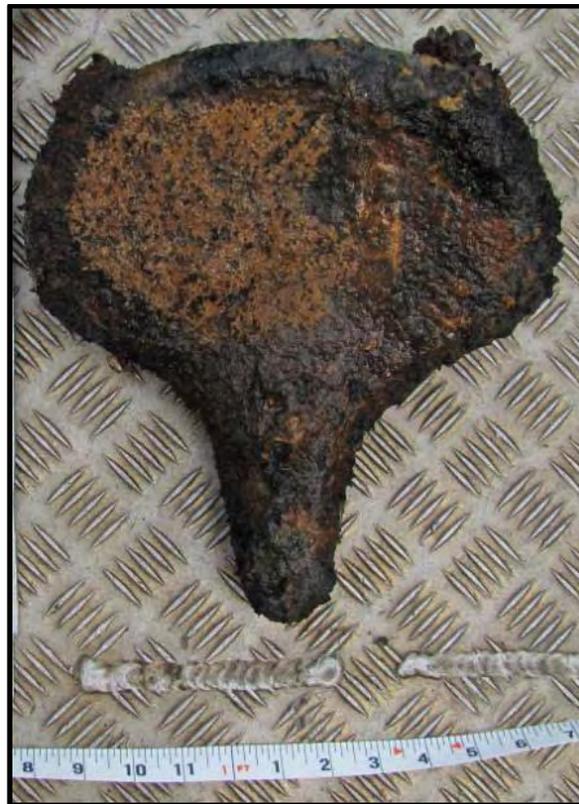
Anomaly 81 was investigated by a diver in 2011 and found to be heavily corroded fragments of a motorcycle. The seat was recovered, photographed and re-deposited (Figure 99).

Figure 99. Seat from a motorcycle - Anomaly 81 (LCMM Collection).

LCMM recommends no further work for A81.

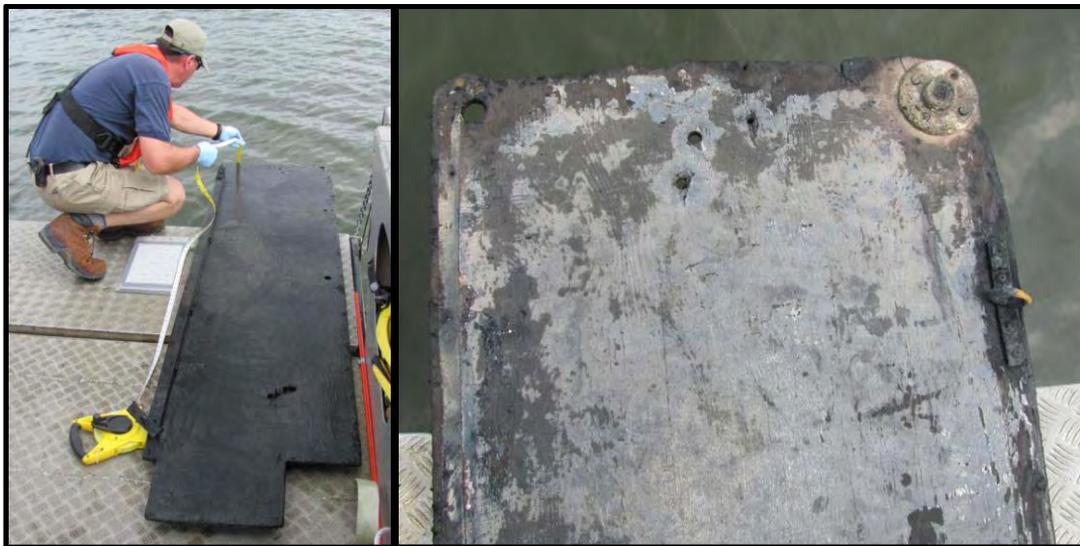
Anomaly 83 was investigated by a diver in 2011. The anomaly consists of a series of disarticulated wood and metal debris. A section of wooden debris was recovered and documented. It consisted of an 8ft (2.4m) sheet of plywood, one side of which has paint on it. There were many fasteners, including two ringbolts and two pipe fittings; it was fastened to adjacent pieces with sheetrock screws. It is likely a fragment from an ice shanty or shed.

Figure 100. LCMC archaeologist documents Anomaly 83 (left). Detail of Anomaly 83 showing a pipe fitting and a ring bolt (LCMM Collection) (right).

A second smaller, stout piece of wood was recovered, containing three fasteners. This timber is 37in (94cm) long and 3in (8cm) in width and thickness, and probably oak. This timber appears historic in nature, but is an isolated find.

LCMM recommends no further work on A83.

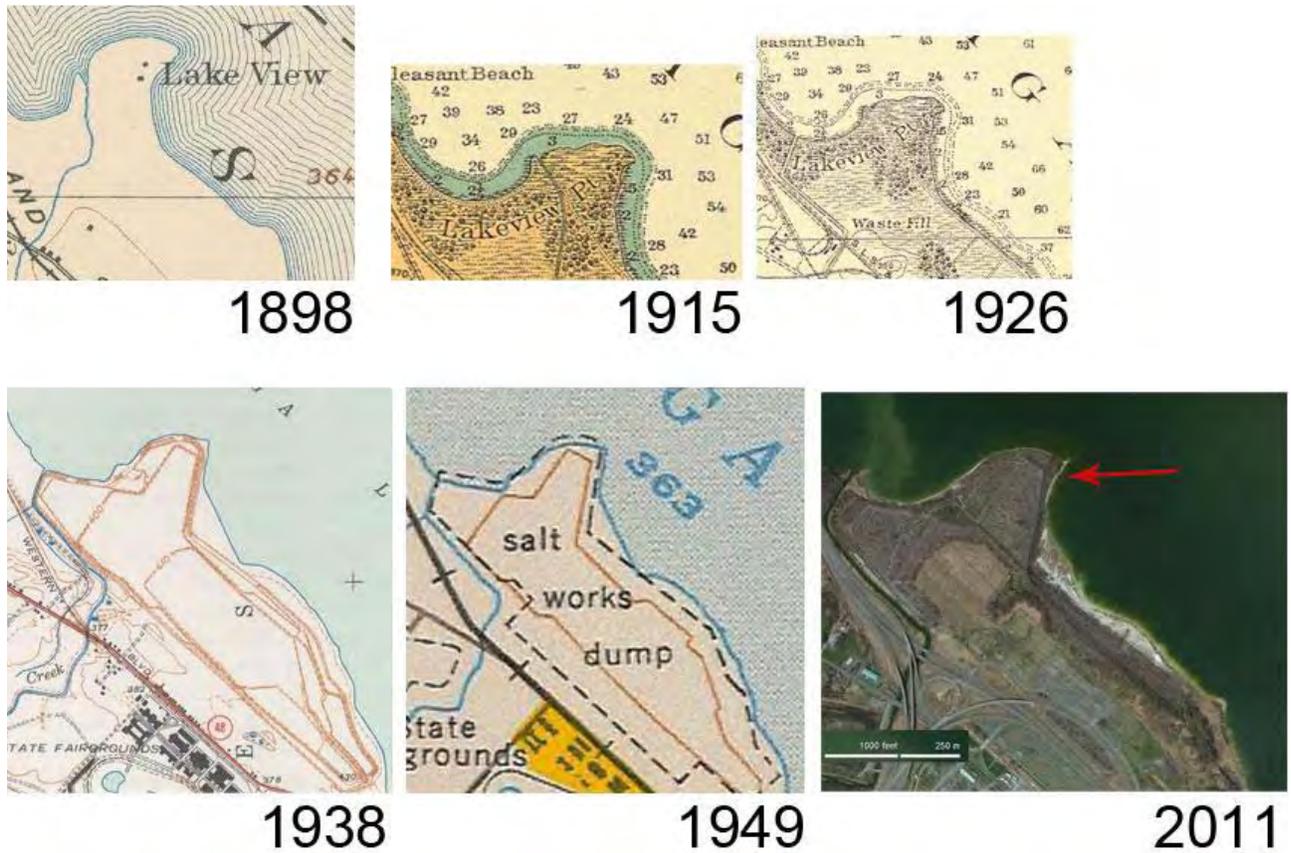
The historic maps show that the resort was located near the shore of Lake View Point. The surrounding land has been inundated with up to 80 feet (24 m) of waste. In addition, a pier may have been built along the shoreline or perpendicular to it. It was noted that a pier had been visible approximately 0.25mi (0.4km) north of the present boat launch near the area to the south of Lake View Point.<sup>146</sup>

Figure 101. Lake View Point on selected maps from 1898, 1915, 1926, 1938, 1949, and 2011<sup>147</sup> with the latter showing the location of A17.

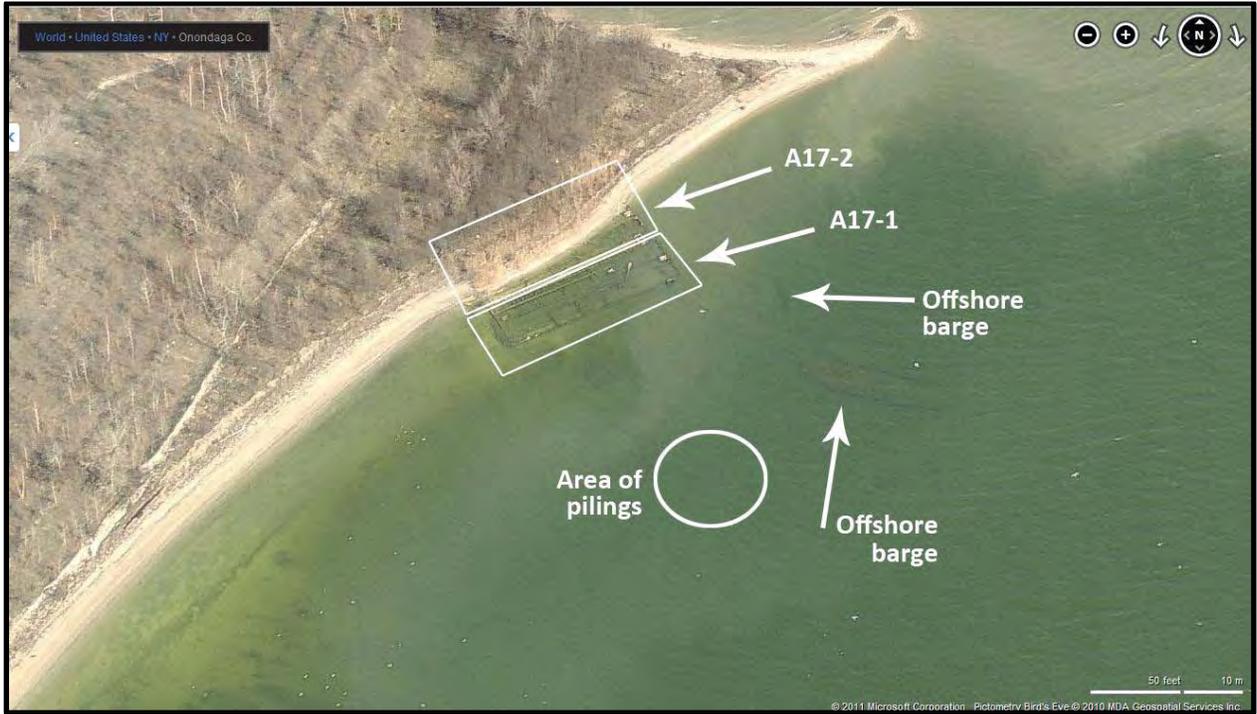
Figure 103. Aerial photograph of A17 spud barges (courtesy Microsoft® Virtual Earth).

LCMM recommends that the shoreline stabilization plan be revised to avoid any adverse effect to the spud barges A17-1 and A17-2.

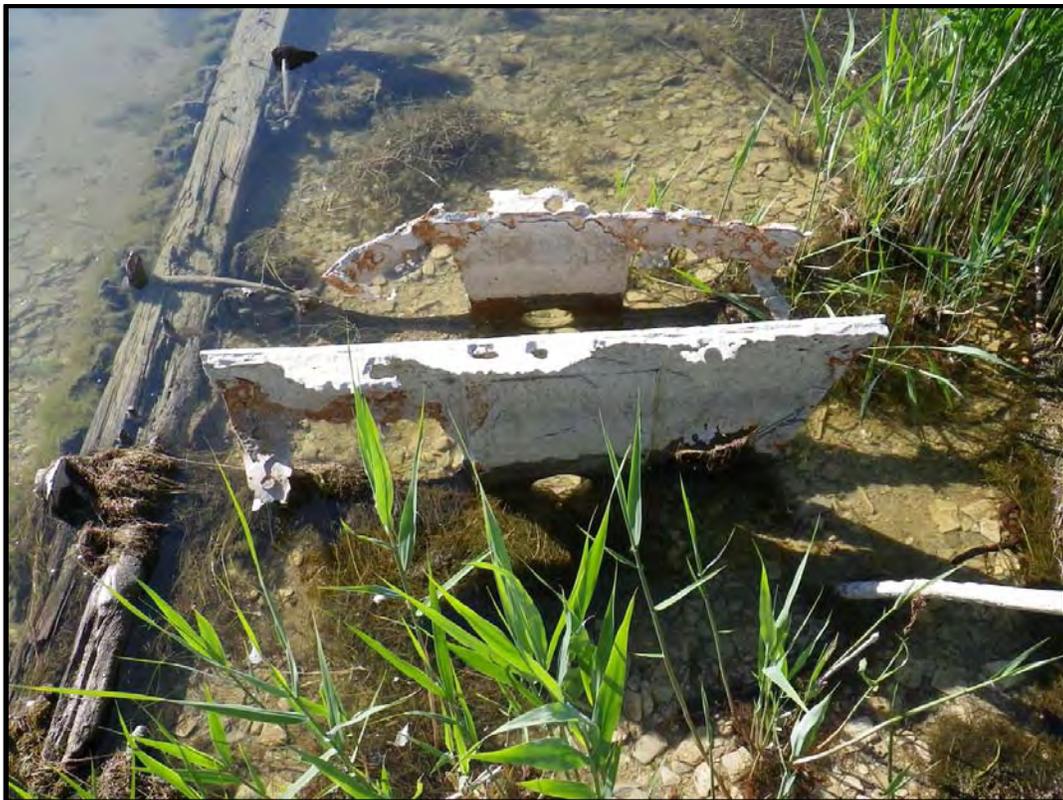
Figure 104. Flywheel mounting brackets from spud barge A17-2 (LCMM Collection).

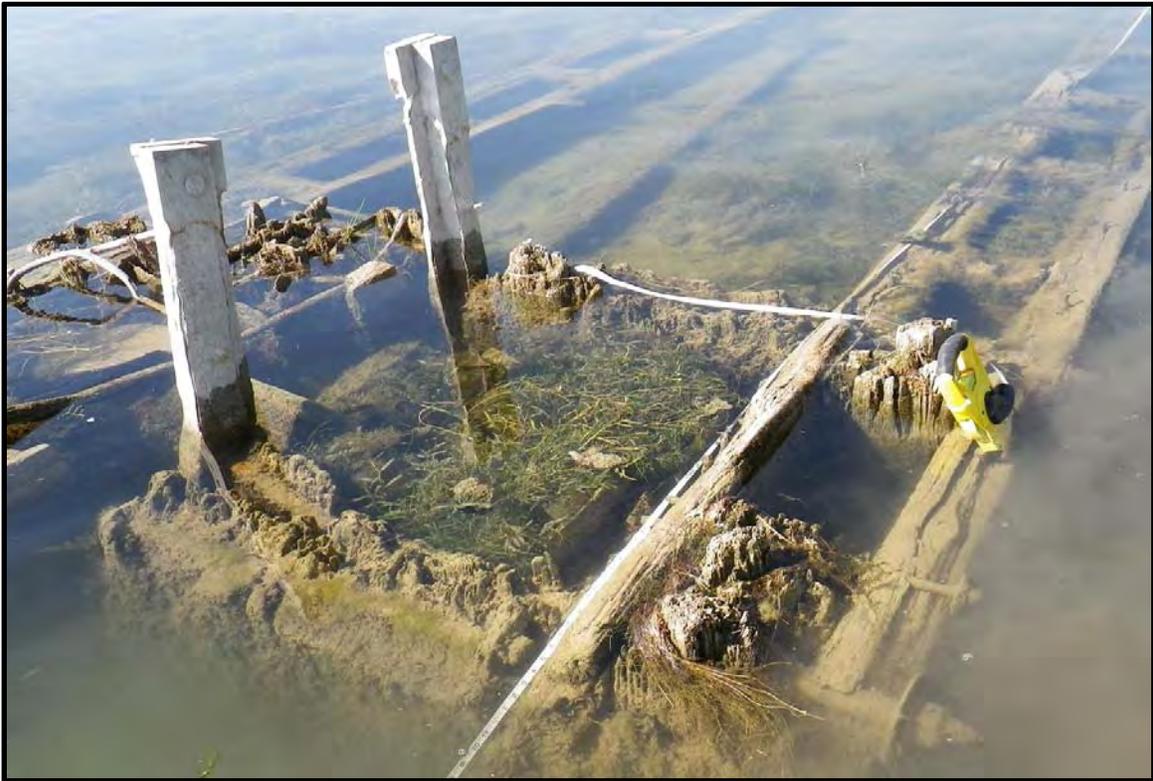
Figure 105. Spud holders on barge A17-2 (LCMM Collection).

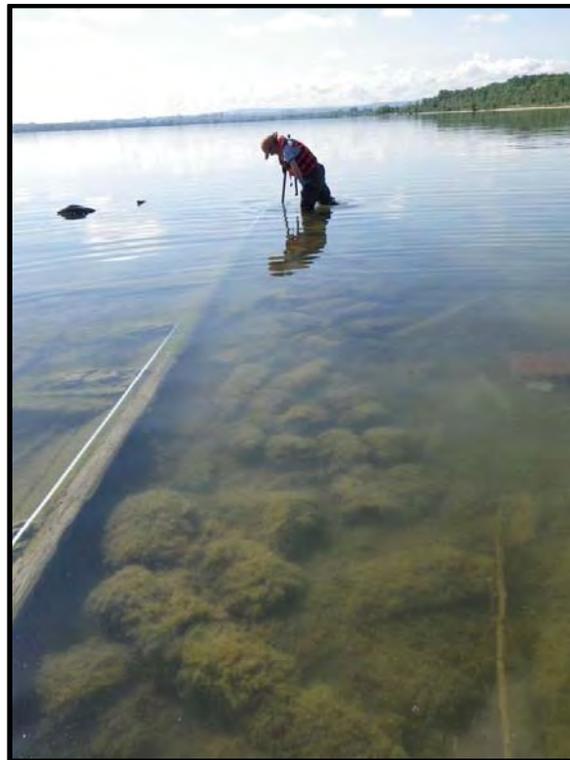
Figure 106. LCMM archaeologist wears waders to document the shallow site A17. Note the pile of concrete blocks outside A17-2 (LCMM Collection).

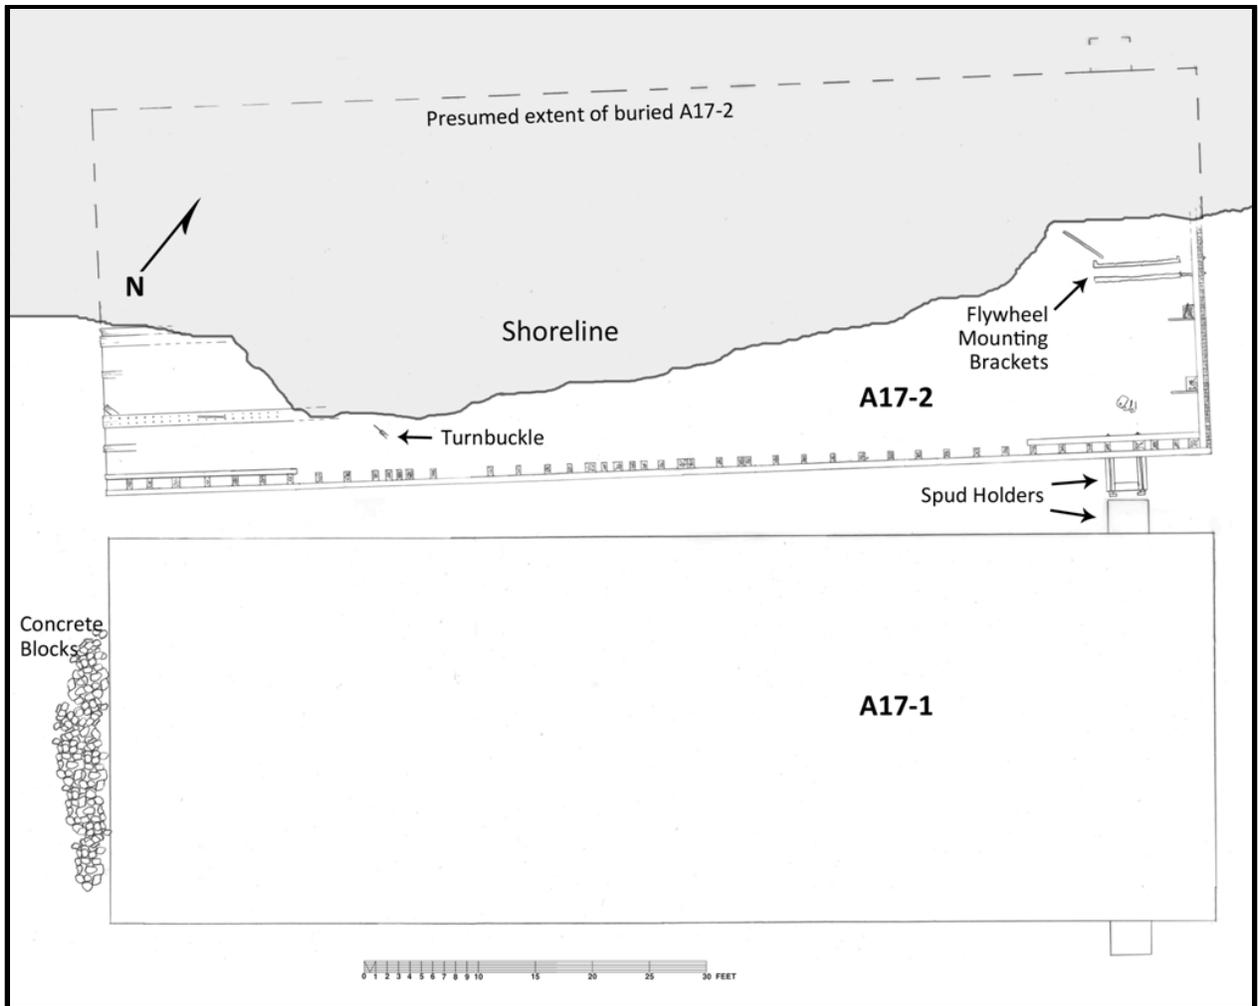
Figure 107. Scale drawing of spud barges A17-1 and A17-2 (Sarah L. Tichonuk, LCMM Collection).

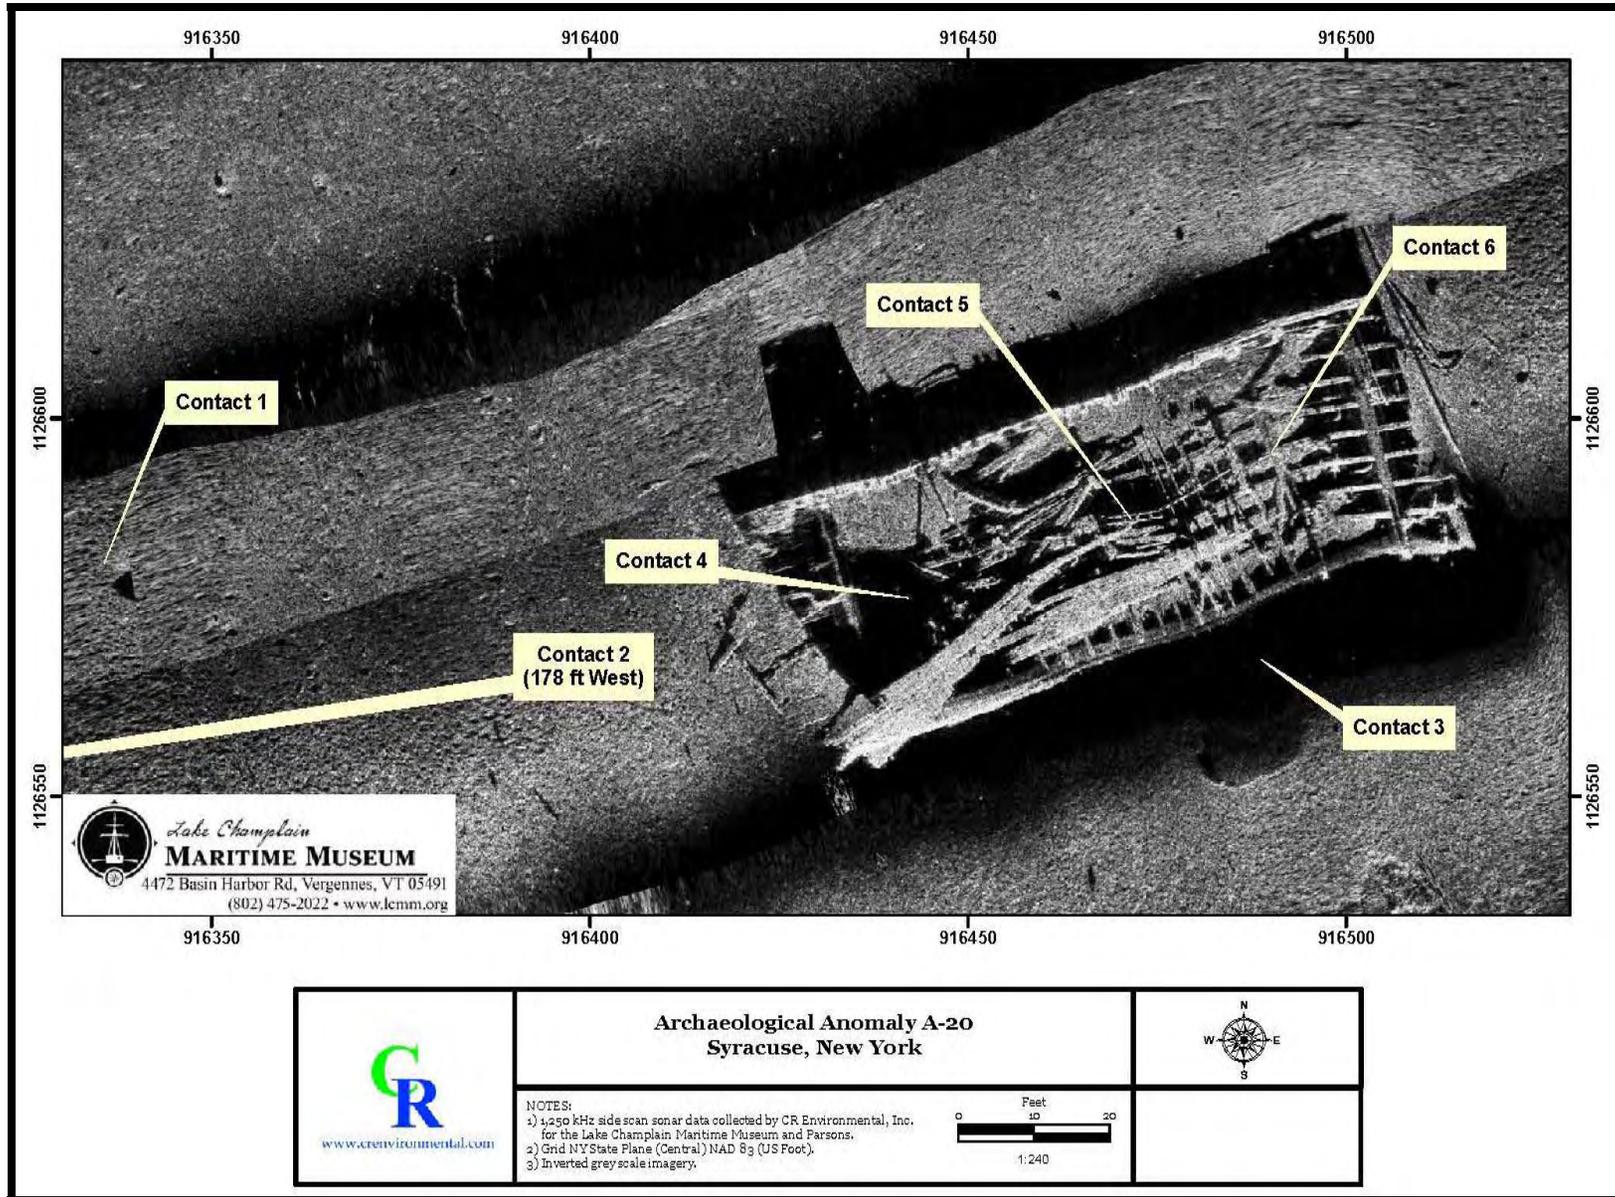
A20 is 91½ feet (27.89m) long by 32½ feet (9.91m) wide, with most of its principal members still extant including the sides, ends, deck beams, hanging and standing knees, stringers, and framing. The vessel also retains some decking and the high deck-end bulkheads and longitudinal retaining bulkheads are displaced, but lying near or on the wreck. The hull is characterized by vertical edge-fastened sides and scow ends. The ends are framed with rake timbers. Most of A20's deck beams are still in place with most still retaining vertical knees at the outboard ends for longitudinal retaining bulkheads. The high deck-end bulkheads are believed to be lying against the side of the hull at the scow's eastern end and on the bottom adjacent to the western end (Figure 111). A20 has a small section of intact decking amidships along its southern side. Overall the site retains approximately 90% of the vessel's original structure.

Figure 108. Side scan sonar mosaic showing A20.

LCMM's analysis suggests that A20 retains integrity and is eligible for the National Register of Historic Places under Criteria C and D. The remedial design for the area calls for capping. As per the Section 106 process, LCMM has recommended avoiding adverse impacts to A20. In response, the remedial design has been altered to avoid depositing cap materials on the site.

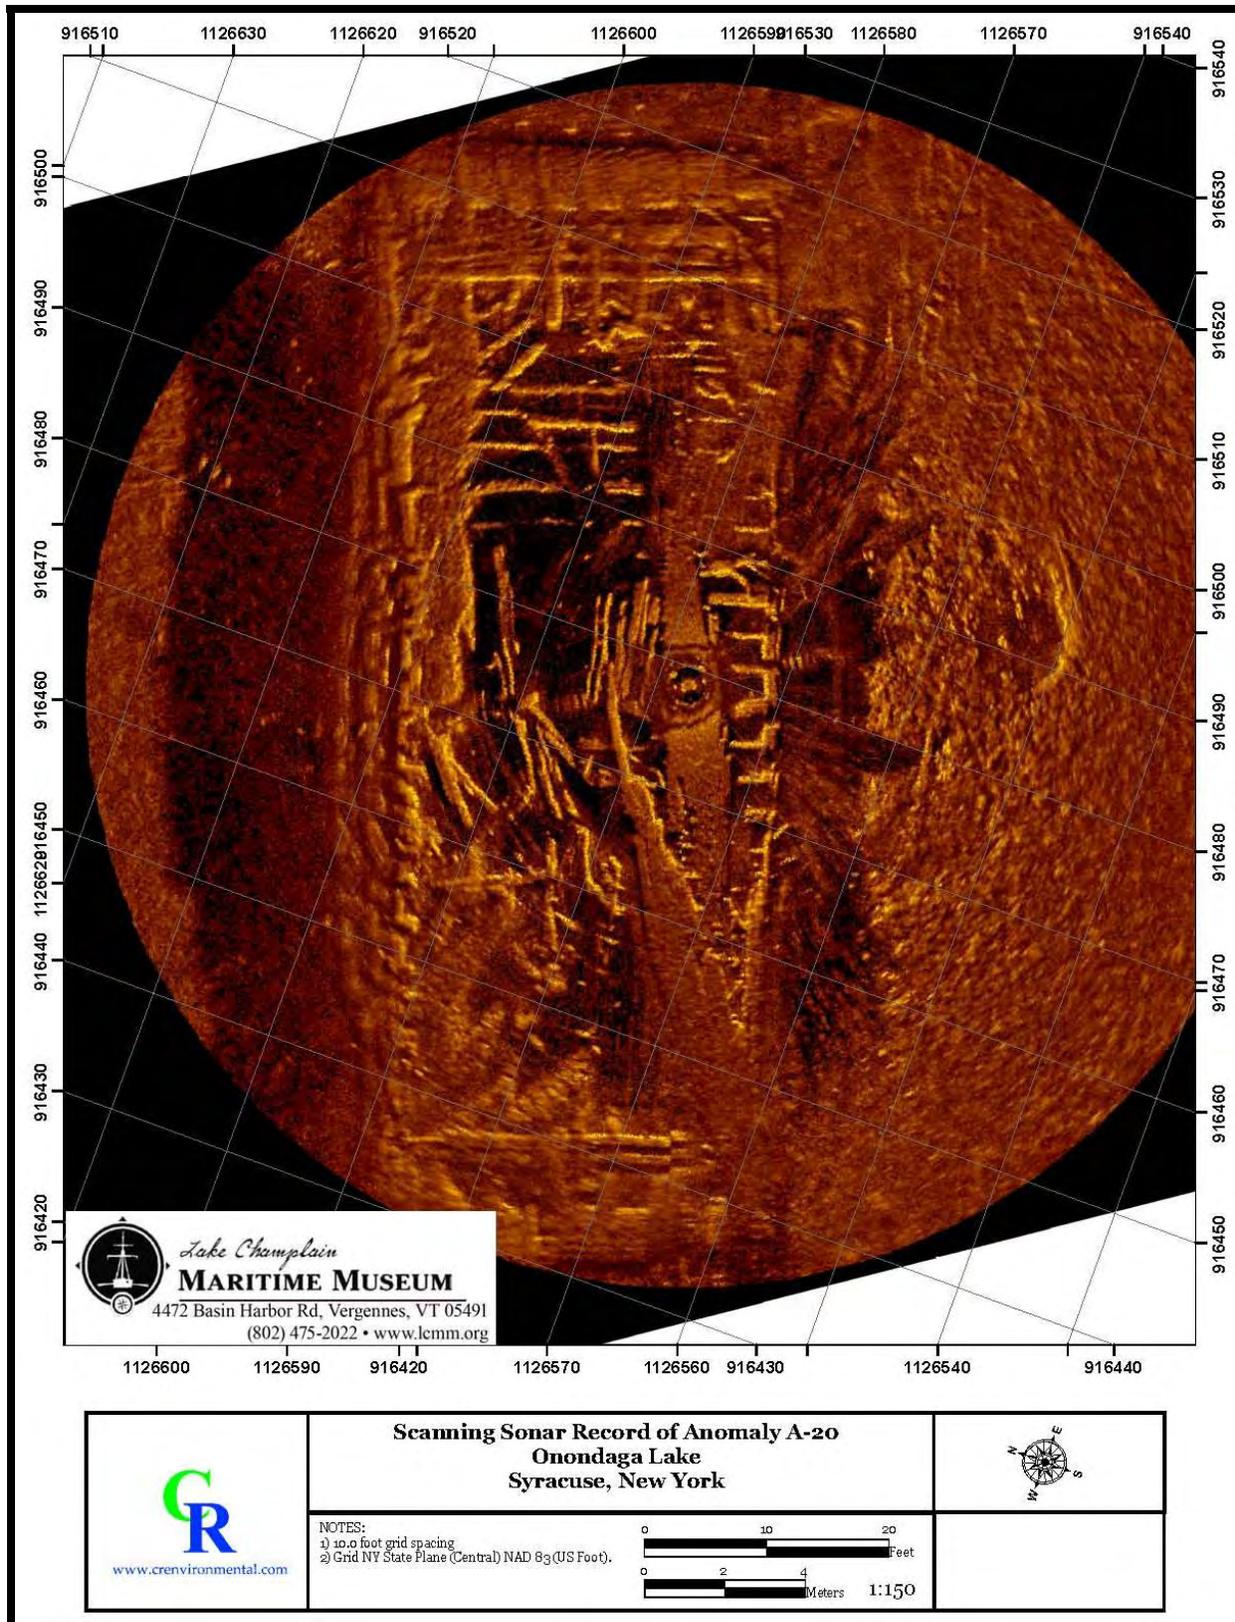
Figure 109. Scanning sonar image of A20.

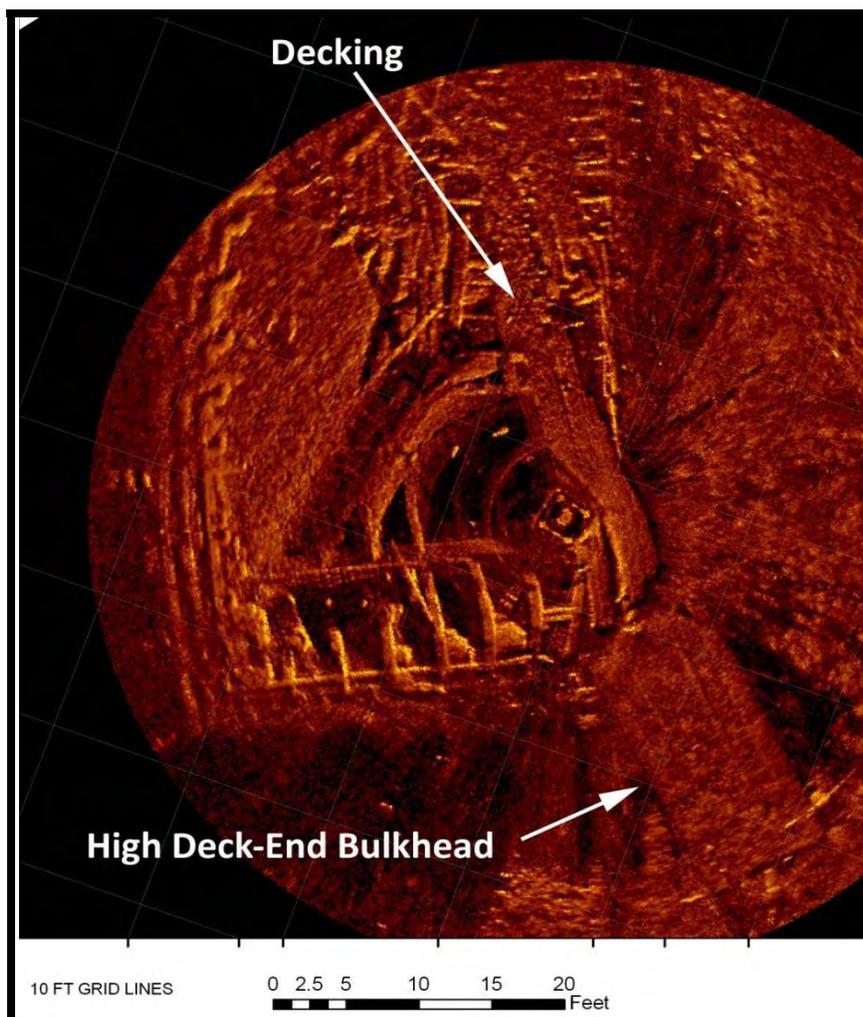
Figure 111. Sector scan sonar detail showing the displaced high deck-end bulkhead and the decking.

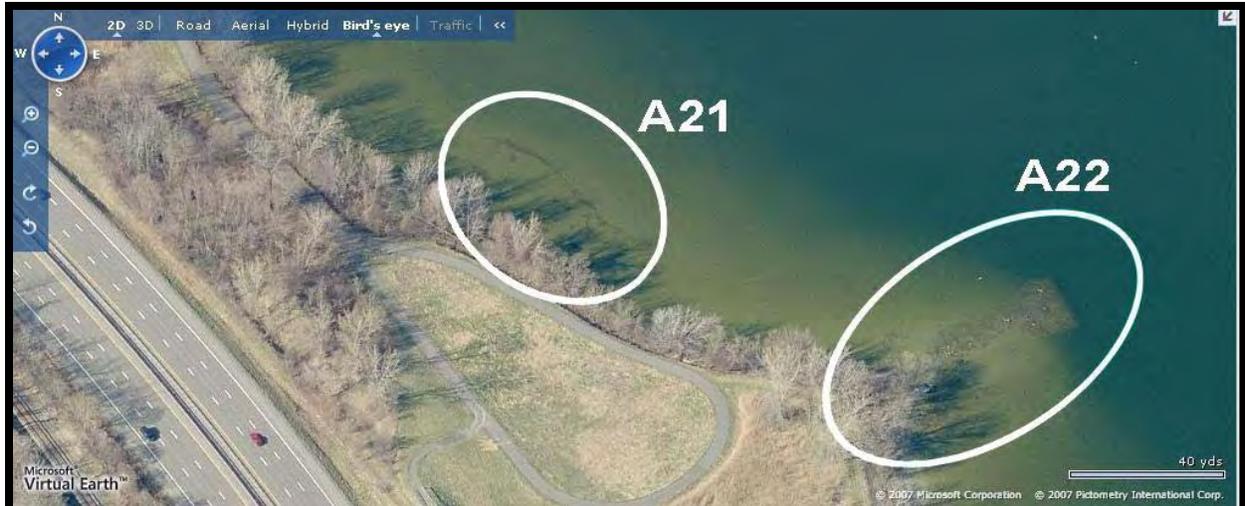
The pier 150 feet (45.7m) long and 20 feet (96.1m) wide with a 50 foot (15.2m) long T at the end (Figure 112). The pier was built using timber cribbing and rock fill. The structure is well preserved, with the portions of the end T retaining an original stone or concrete decking surface.

Figure 112. Aerial view showing pier remnants at Anomaly 22 (courtesy Microsoft® Virtual Earth).

The remedial design calls for capping in the area adjacent to the end of Pleasant Beach Pier with 2½ feet (76cm) of sand. This capping is unlikely to have an adverse effect on the pier remnants if capping material is not dropped specifically on the pier. LCMM recommends that capping be undertaken on the bottomlands surrounding the pier, with a 50-foot (15m) buffer around the pier buoyed during the remedial action and left uncapped.

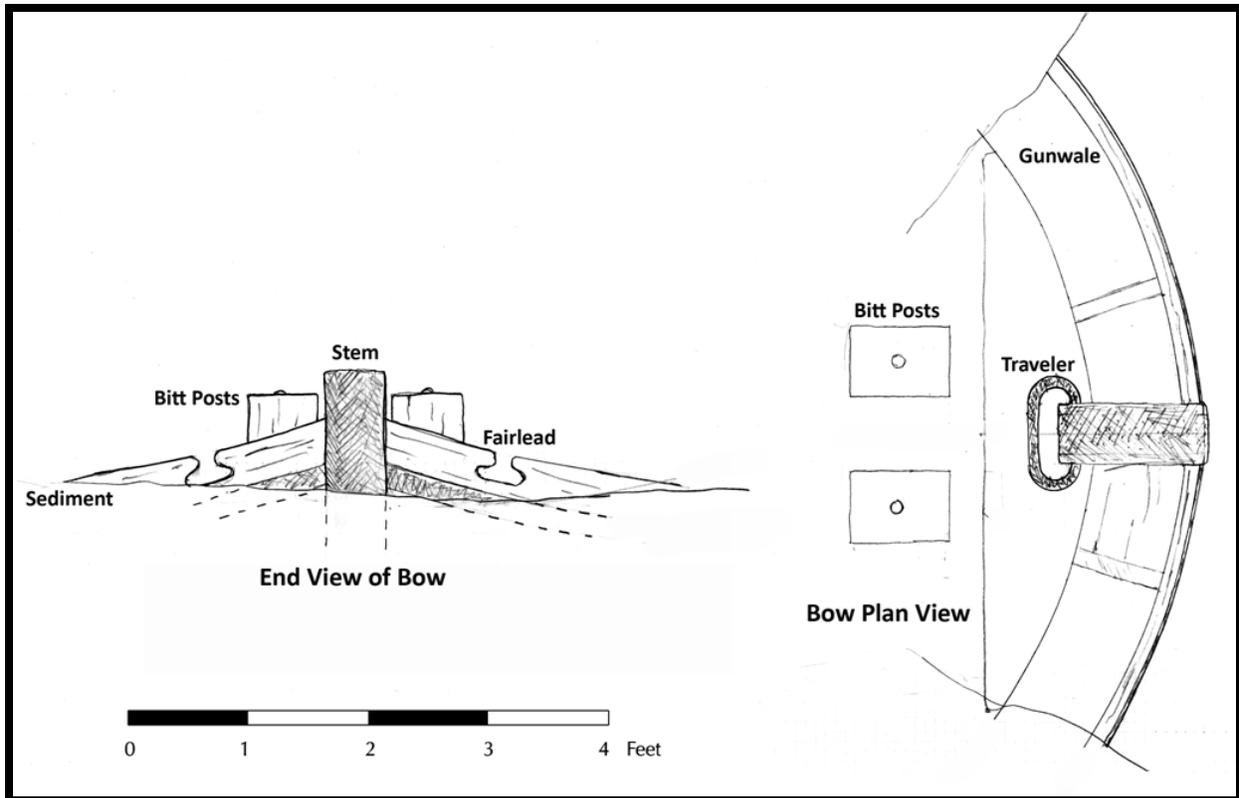
The upright timbers initially seen during the ROV work were determined to be the boat’s bitt posts and stem (Figure 113). The exposed portions of the stem, bitt posts and gunwale, although very limited, contained features diagnostic of a wooden nineteenth century canal boat. The vessel had a distinctively canal boat shaped bow with iron bands along the forward face of the stem, a rub strake in the bow and an iron traveler on the after face of the stem. The gunwale had fair leads, used to guide the boat’s towline, cut into it. The bitt posts were found immediately aft of the stem, with a buried windlass attached just below the sediment.

Figure 113. Scale drawing of A33 showing the visible bow remains (Adam Kane, LCMM Collection).

LCMM’s analysis suggests that A33 retains integrity and is eligible for the National Register of Historic Places under Criteria A and D. The remedial design for the area around A33 calls for capping, the impact of which is impossible to determine given the lack of information regarding the site’s structural composition. LCMM recommends that the remedial design be altered so that any potential adverse impacts to the site are avoided. Consultation with Parsons indicates that A33 is in an area where concentrations are relatively low. The area is net depositional, so concentrations will continue to decrease over time.

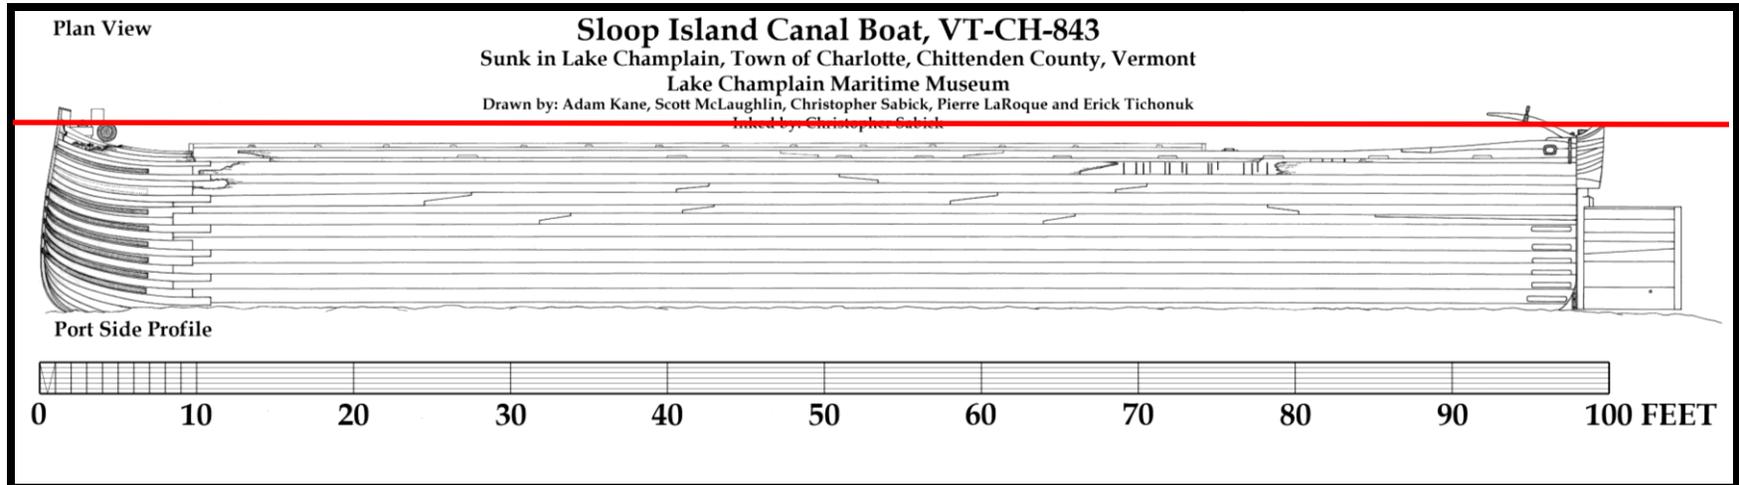
The archaeological data collected from A33, although limited due to the sediment deposition, conclusively illustrates that the site is a buried canal boat. The remains that are visible (stem, tiller) represent the highest points on the vessel, with the exception of the cabin trunk and roof. The preservation of these elements indicates that the buried portion of the site is intact. A canal boat the size of A33 was 8 to 10 feet (2.4 to 3.1m) tall, suggesting the bottom of the vessel rests below 10 to 12 feet (3.1 to 3.7m) of sediment (Figure 114).

Figure 114. Profile of a Lake Champlain canal boat similar in size to A33 with the red line illustrating the level of siltation over A33 (LCMM Collection).

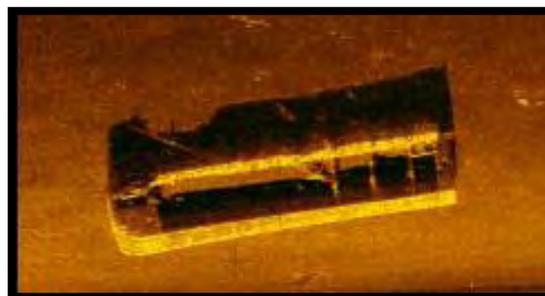
Figure 115. Sonar image from 2005 showing Anomaly 13 (courtesy CRE).

The eligibility of A13 for the NRHP remains unevaluated; however, given its intact nature it is likely eligible. Although the site is outside the remediation areas, LCMM recommends that additional steps be taken during the remediation to prevent any inadvertent impact to the site. A 50-foot (15m) buffer around the wreck site should be marked with seasonal buoys as a no anchorage site during the remediation, and watercraft operators on site should be informed of the site’s location and protocols.

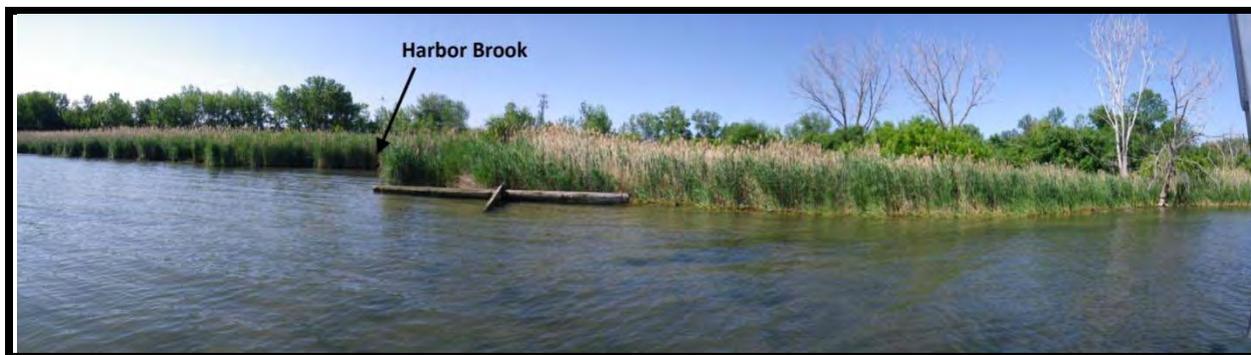
During the June 2010 fieldwork, an inspection of the shoreline near Harbor Brook revealed the presence of wooden structural remains (Figure 116). This structure, lying immediately west of the mouth of Harbor Brook, was designated A54.

Figure 116. Photograph of A54 with the mouth of Harbor Brook to the left (LCMM Collection).

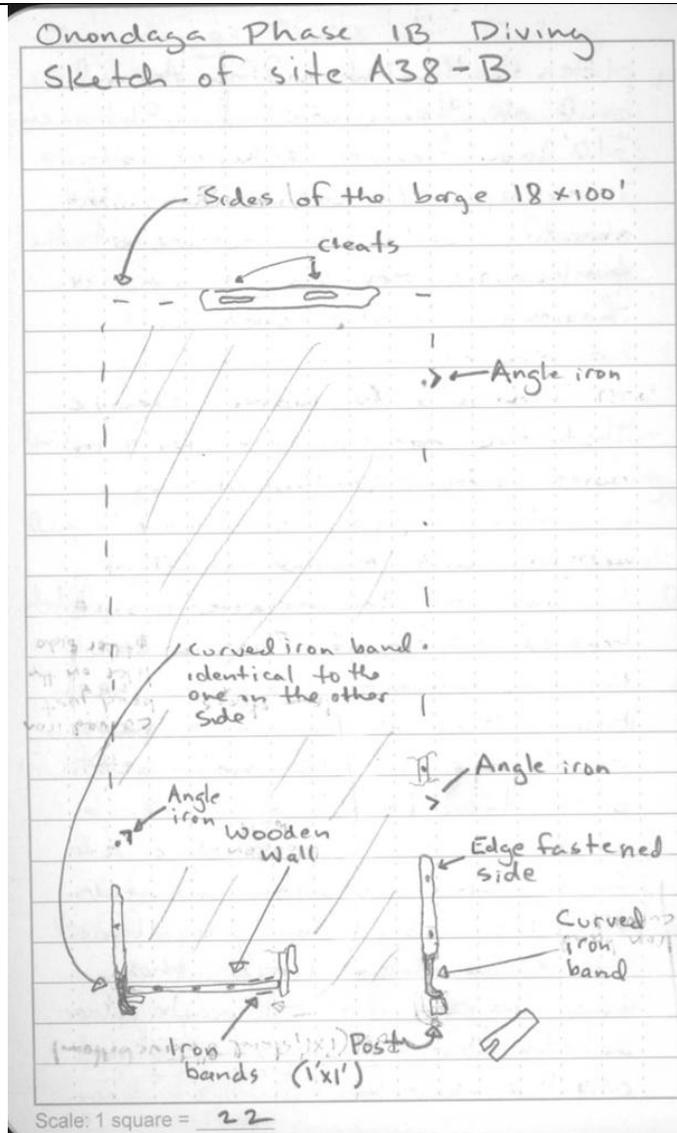
A55

The site located during AK's dive is designated A55. This is almost certainly an almost completely buried, edge fastened barge. The nature of the curved strapping is completely unknown at this point

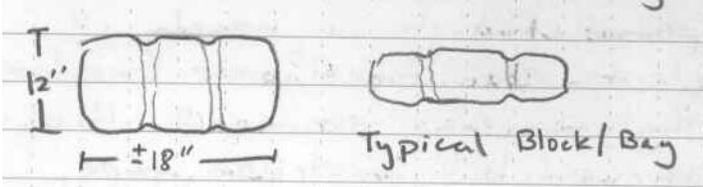
A45		<p>showed the site to be constructed of bags of concrete. Each concrete block was pillow shaped with two indentations from band that went around the bags.</p>

<p>The breakwater was clearly built by throwing bags of concrete into the water. A53 was found during the survey. The remains were consistent with what was shown during ROV/sonar work and what was stated in the report. Numerous pieces of A53 were located around the wreck, particularly to the southeast. Disarticulated pieces included several frame sections, which were of cocked hat construction like the wreck itself. Each disarticulated piece was examined in detail to make sure it was not a larger section or a new wreck.</p>
	1211	AK swaps out tanks so that this area can be completed.
	1217	AK back into the water. AK finishes the southeastern portion of the SMHD.
	1300	AK out of the water.
A74 A75	1310	Depart and go back to area of A74 & A75 to record locations. Three points taken for A75.
