# APPENDIX B

## TEST TRENCH PHOTO LOG

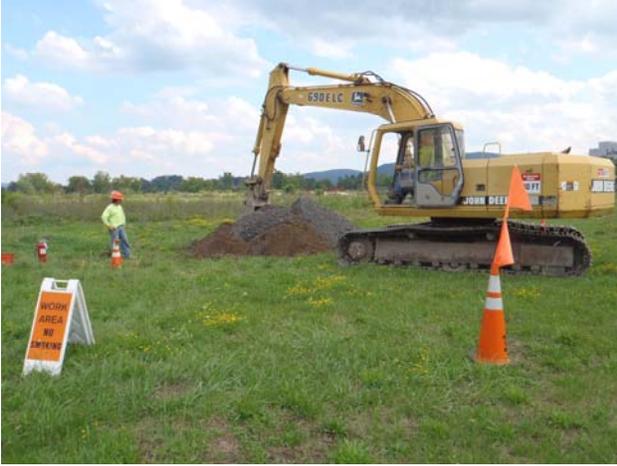
Photo 1: Test pit investigation at TT-10 (looking north east)

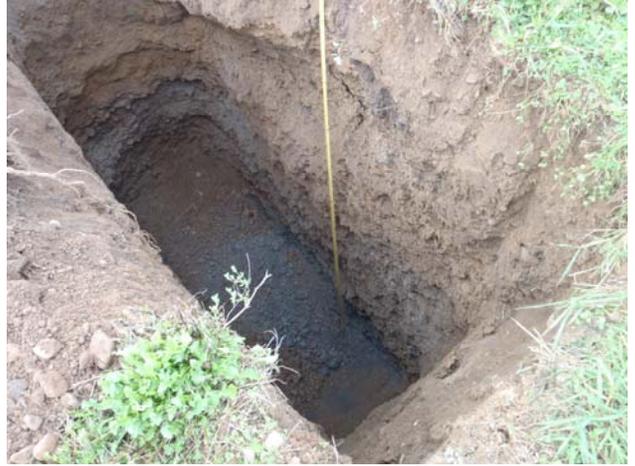
Photo 2: Test pit investigation at TT-10 showing brown silty sand with gravel underlain with gray sand and gravel

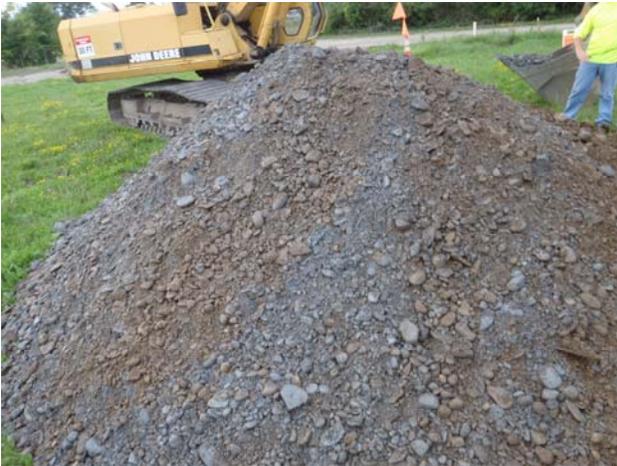
Photo 3: Test pit investigation at TT-10 showing sand and gravel stock pile

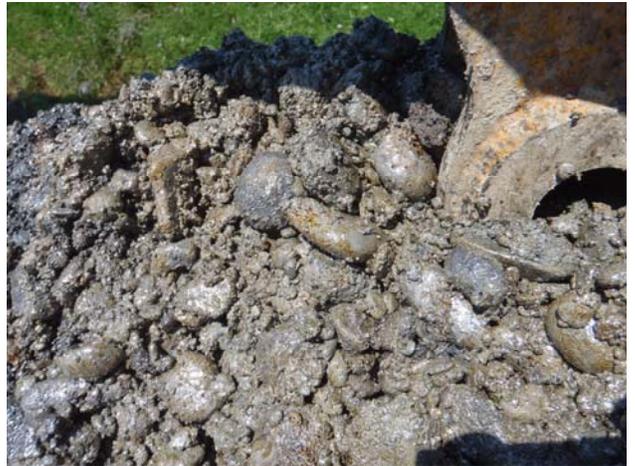
Photo 4: Test pit investigation at TT-50 showing sand and gravel with product

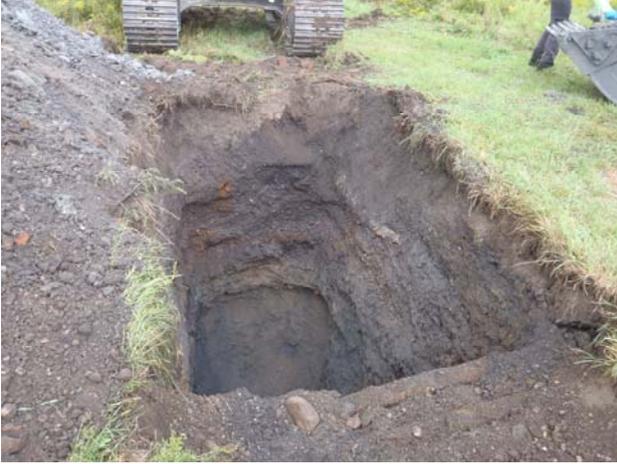
Photo 1: Test pit investigation at TT-44 showing cinder ash fill (0-6') underlain with gray and brown silty sand with gravel

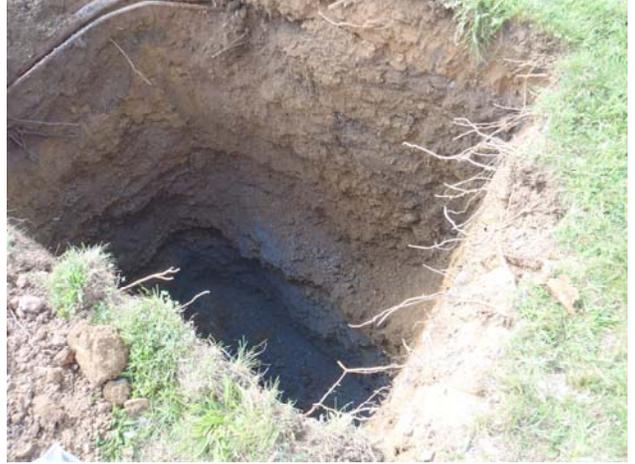
Photo 2: Test pit investigation at TT-13 showing brown silty sand with gravel underlain with gray sand and gravel

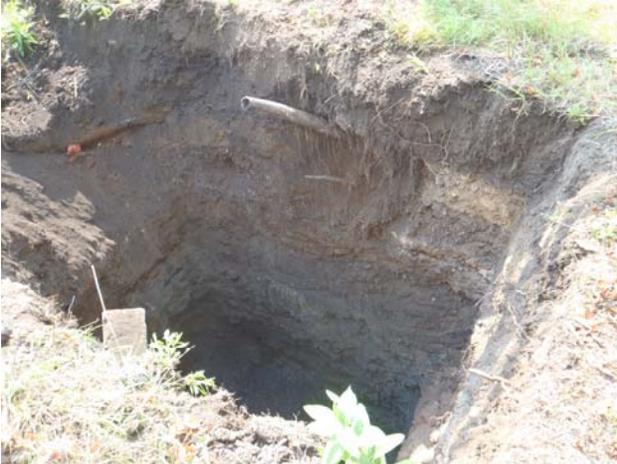
Photo 3: Test pit investigation at TT-40 showing brown silty sand with gravel and fill underlain with gray lean clay underlain with sand and gravel

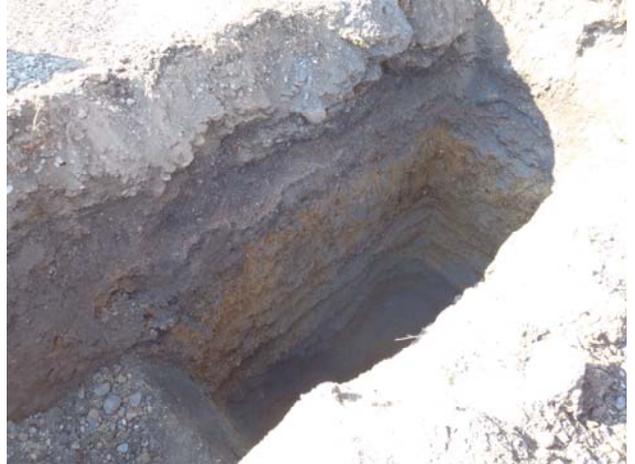
Photo 4: Test pit investigation at TT-79 showing cinder ash fill underlain with brown silty sand with gravel

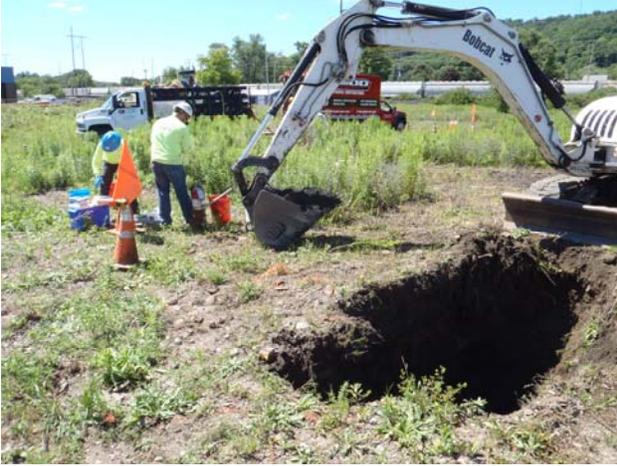
Photo 1: Excavating boring locations to 8' prior to drilling at PZ-2-2 (Looking northwest)

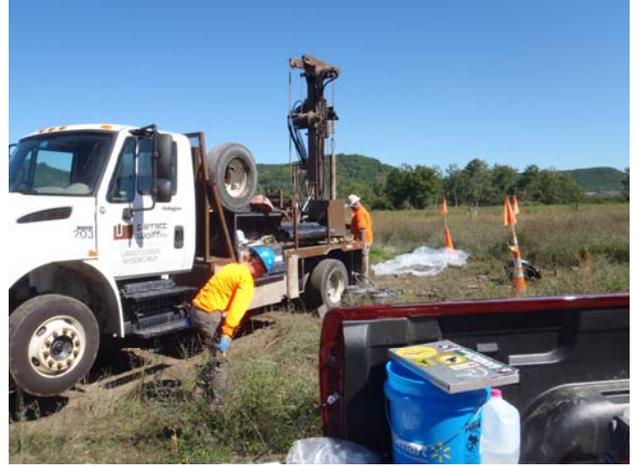
Photo 2: Drilling at Well W-29 (looking northeast)

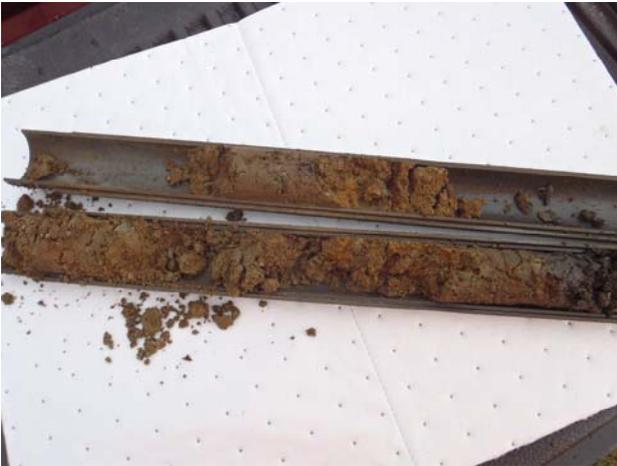
Photo 3: Brown silty sand with gravel at Well W-30

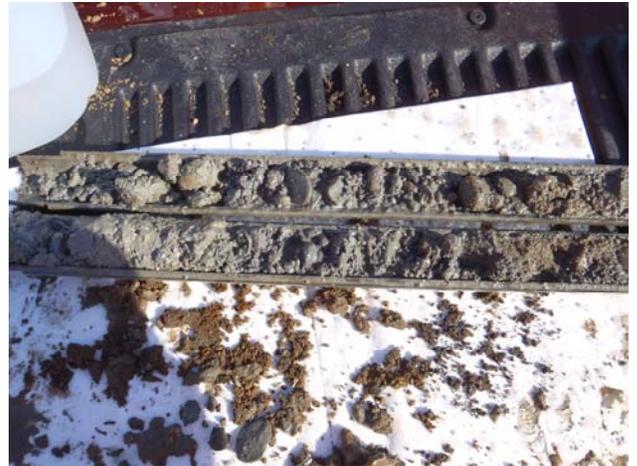
Photo 4: Gray gravel with silt and sand at Well W-30

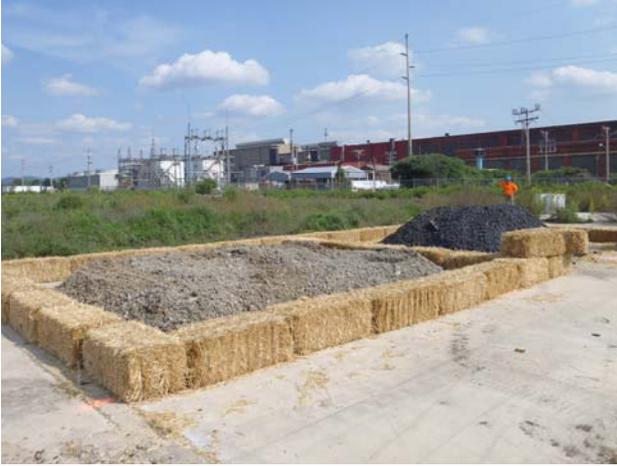
Photo 1: North and South Ex-situ Enhanced Bio-Remediation Test Pads on 8-16-12 (looking southeast)

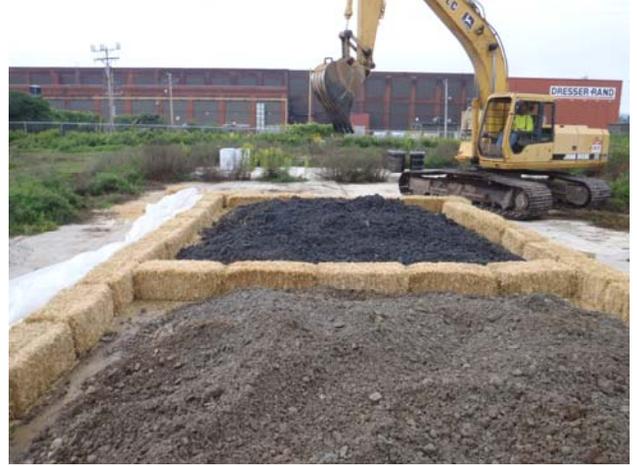
Photo 2: North and South Ex-situ Enhanced Bio-Remediation Test Pads on 8-20-12 (looking south)

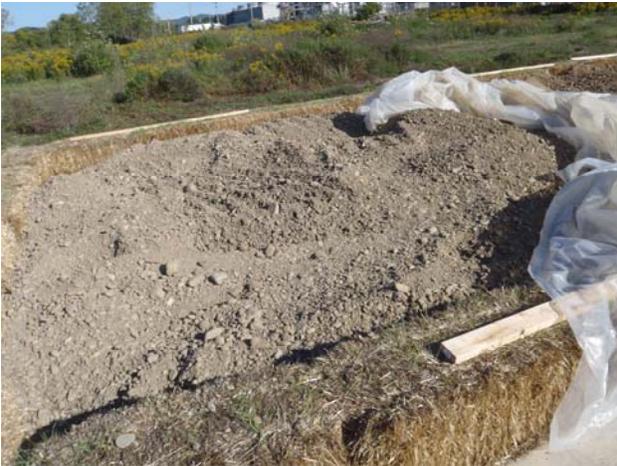
Photo 3: North Ex-situ Enhanced Bio-Remediation Test Pads on 9-20-12 (looking southeast)

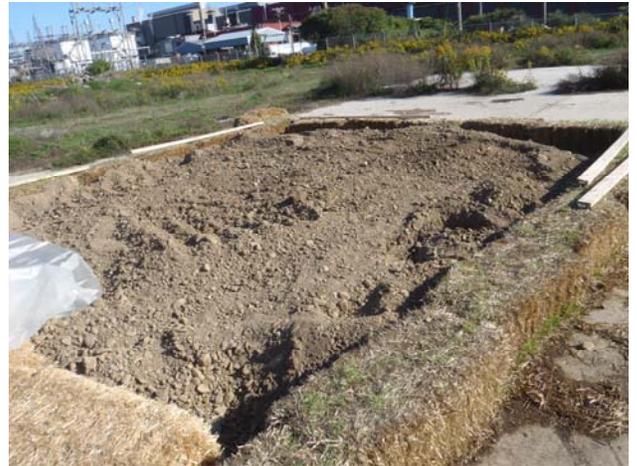
Photo 4: South Ex-situ Enhanced Bio-Remediation Test Pads on 9-20-12 (looking southeast)

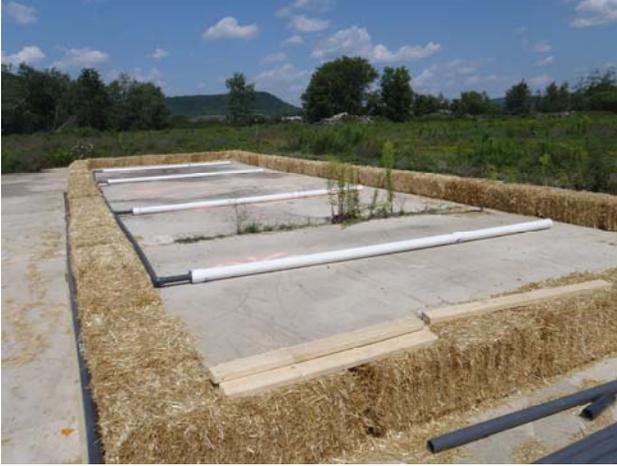
Photo 1: 8-16-12 Ex-Situ Forced Vented Bio-Pile Pad piping (looking north)

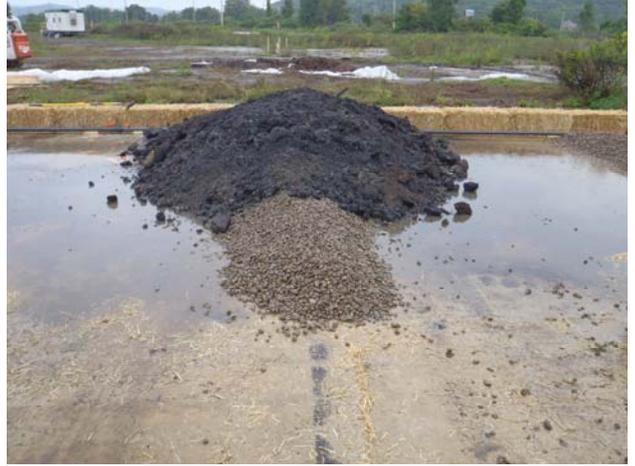
Photo 2: 8-20-12 North Ex-Situ Forced Vented Bio-Pile Pad piping covered in gravel with soil/fill (looking west)

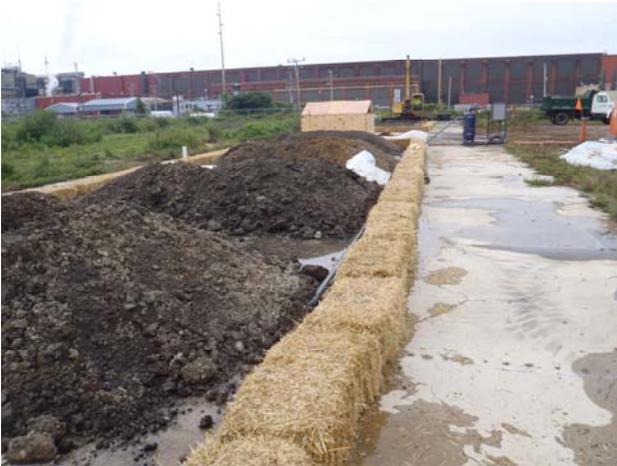
Photo 3: 8-20-12 North and south Ex-Situ Forced Vented Bio-Pile Pads (looking southeast)

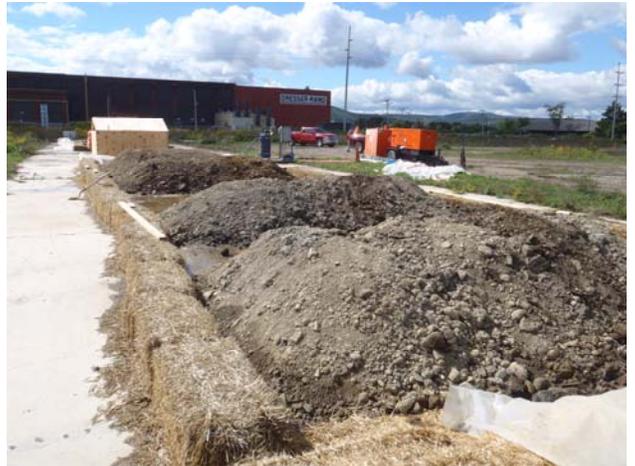
Photo 4: 9-10-12 North and south Ex-Situ Forced Vented Bio-Pile Pads (looking southwest)

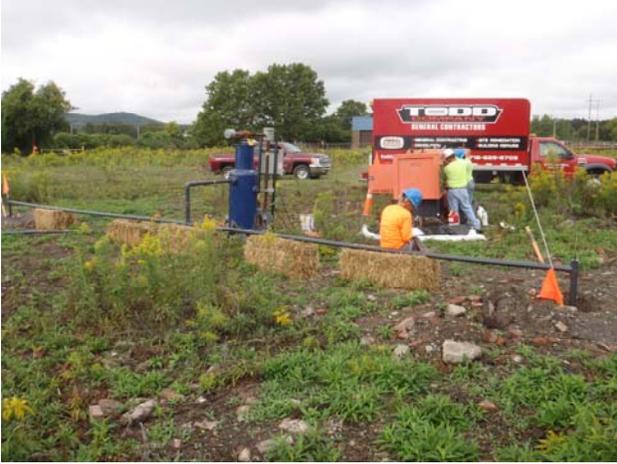
Photo 5: SVE System with SVE-2 well to the south and SVE-1 well to the north (looking southwest)

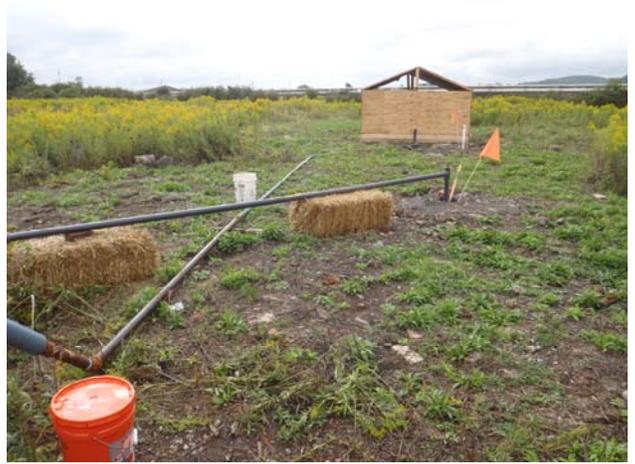
Photo 6: SVE System's Bio-Filter (looking southeast)

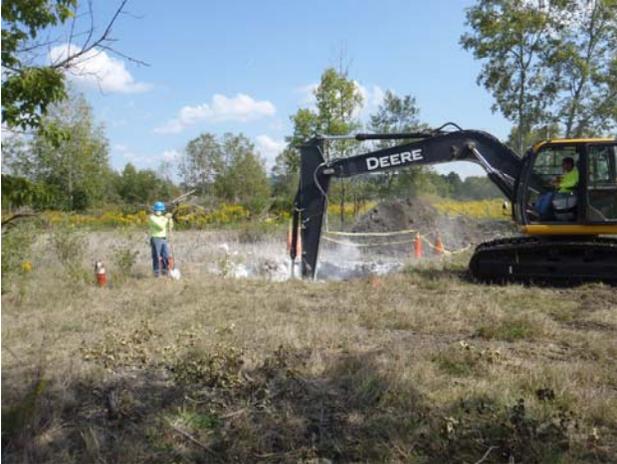
Photo 7: In-Situ Solidification/Stabilization at TPSB-46 (looking northeast)

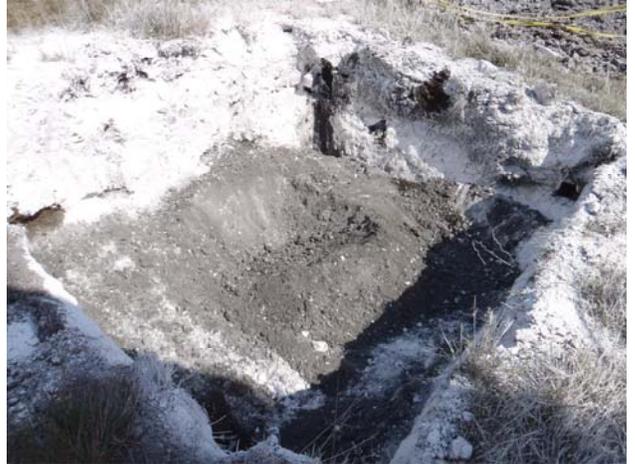
Photo 8: In-Situ Solidification/Stabilization at TPSB-46 soil/fill mixed with Lime
