Flood Damage Reduction Segment / System Inspection Report

Name of Segment / System: EJV-Vestal (Susquehanna River)

Corps of Engineers Inspector: Alfred Zarnoski, P.E.; Joseph Reed ; Larry Mathena Date of Inspection: 9/18/2008

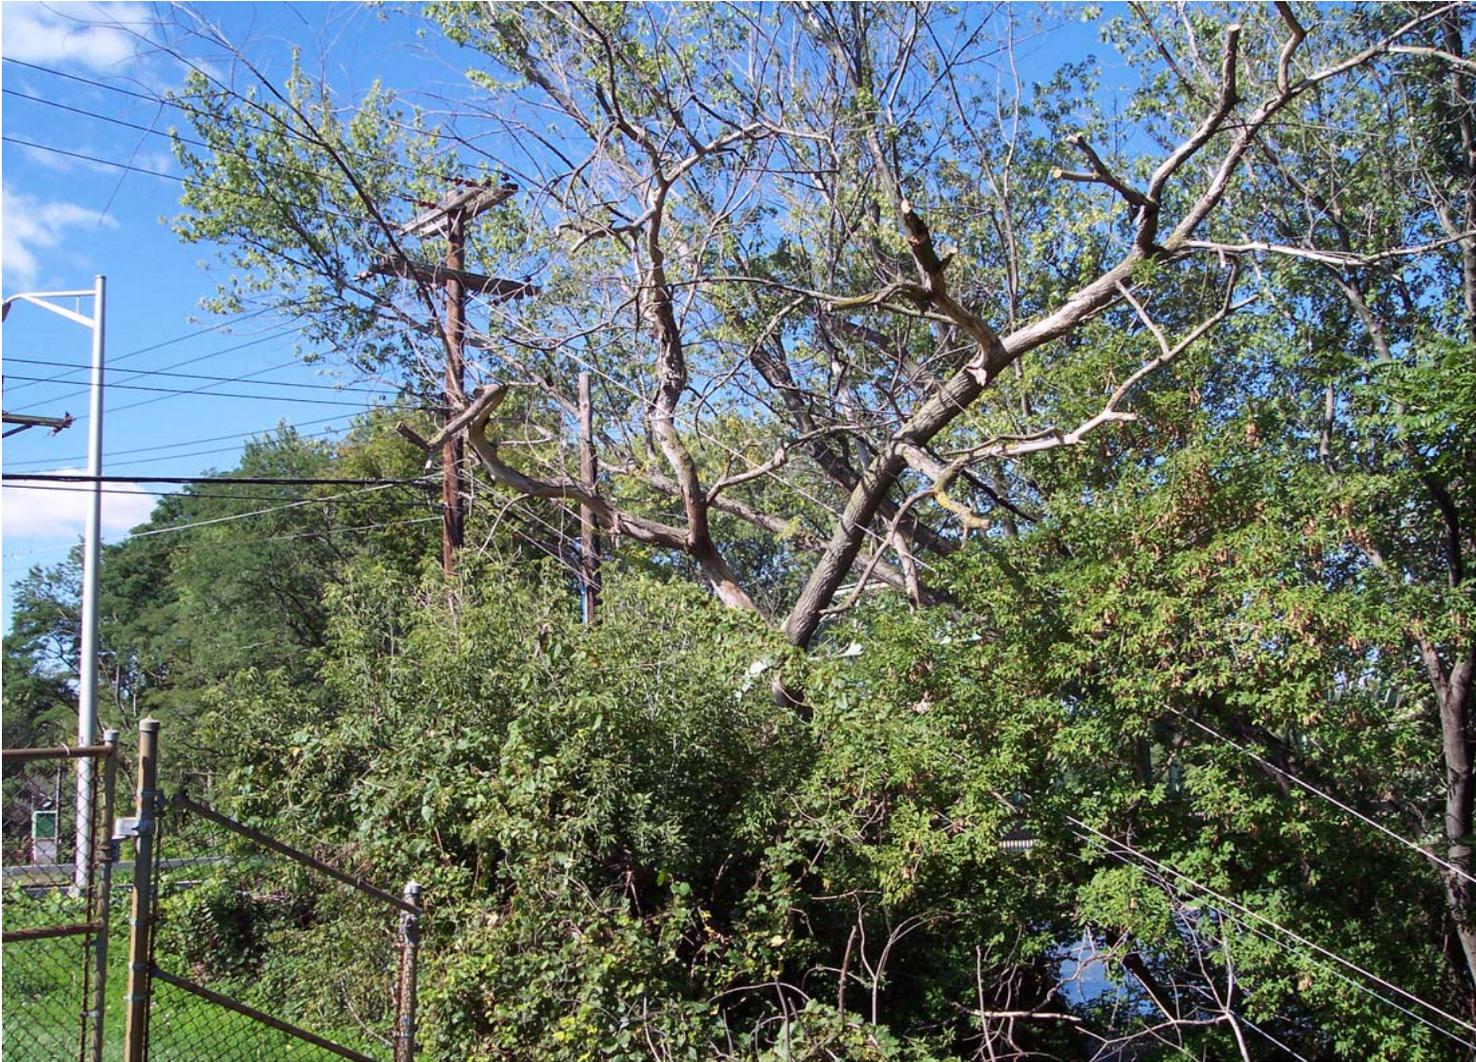
Inspect ID: EJVV_2008_a_0001 **Name:** Levee Embankments **Caption:** Vegetation in need of being removed just East of the Vestal Avenue Bridge.

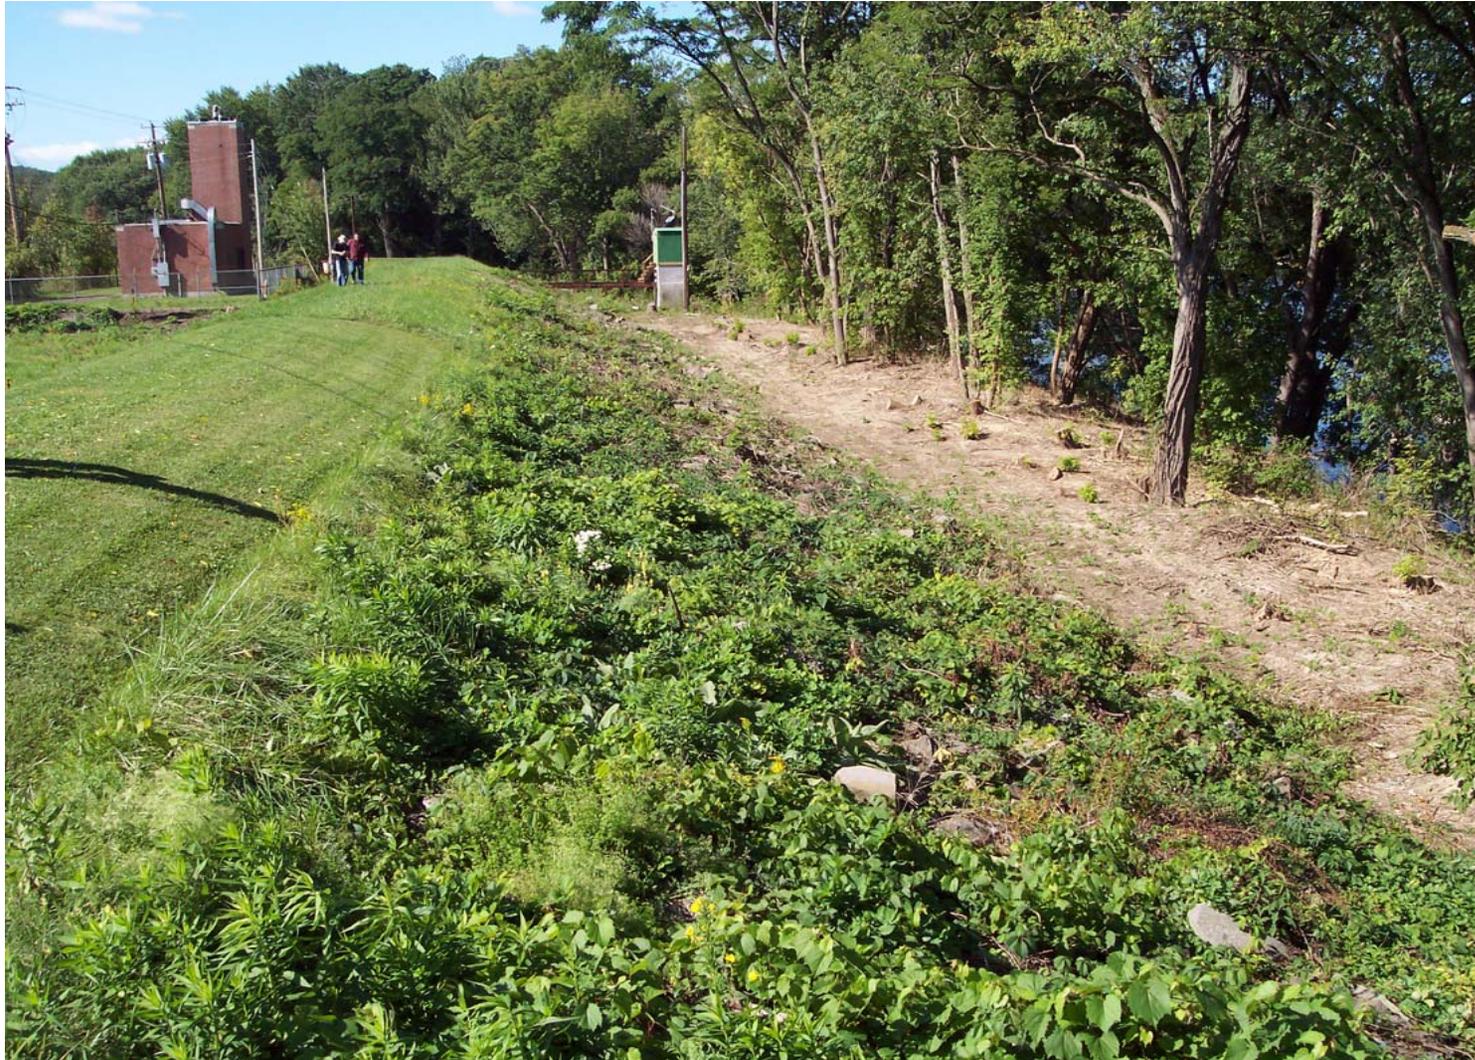
Inspect ID: EJVV_2008_a_0001 **Name:** Levee Embankments **Caption:** Trees removed just West of the Vestal Avenue Bridge.

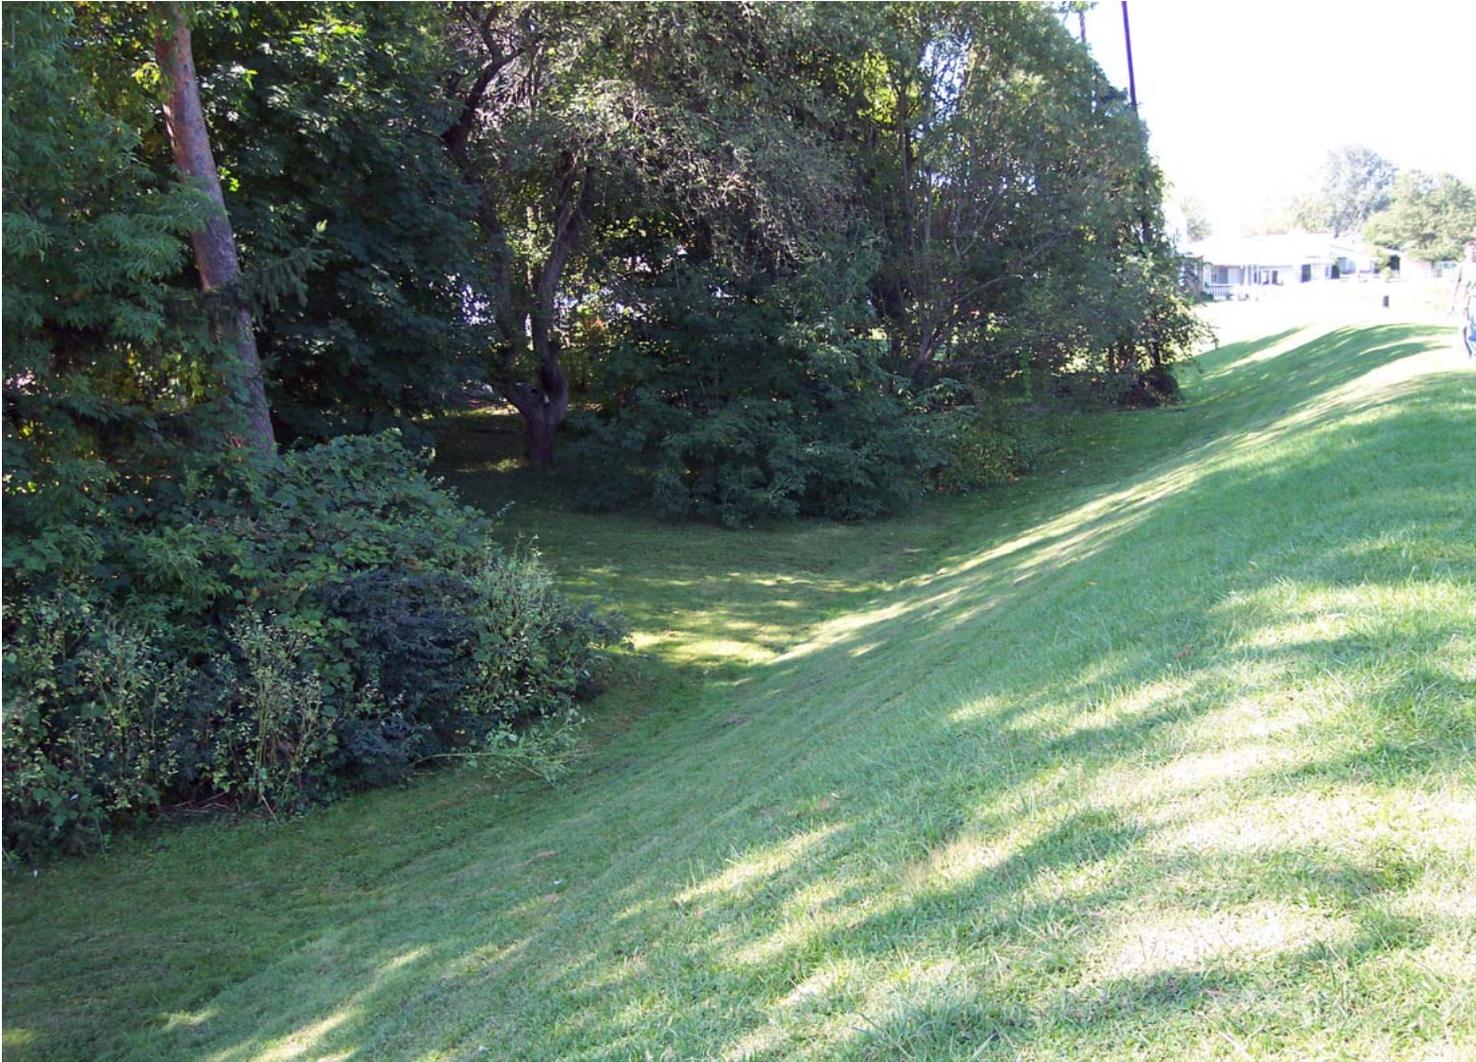
Inspect ID: EJVV_2008_a_0002 **Name:** Levee Embankments **Caption:** Vegetation in need of removal located just East of DS #5.

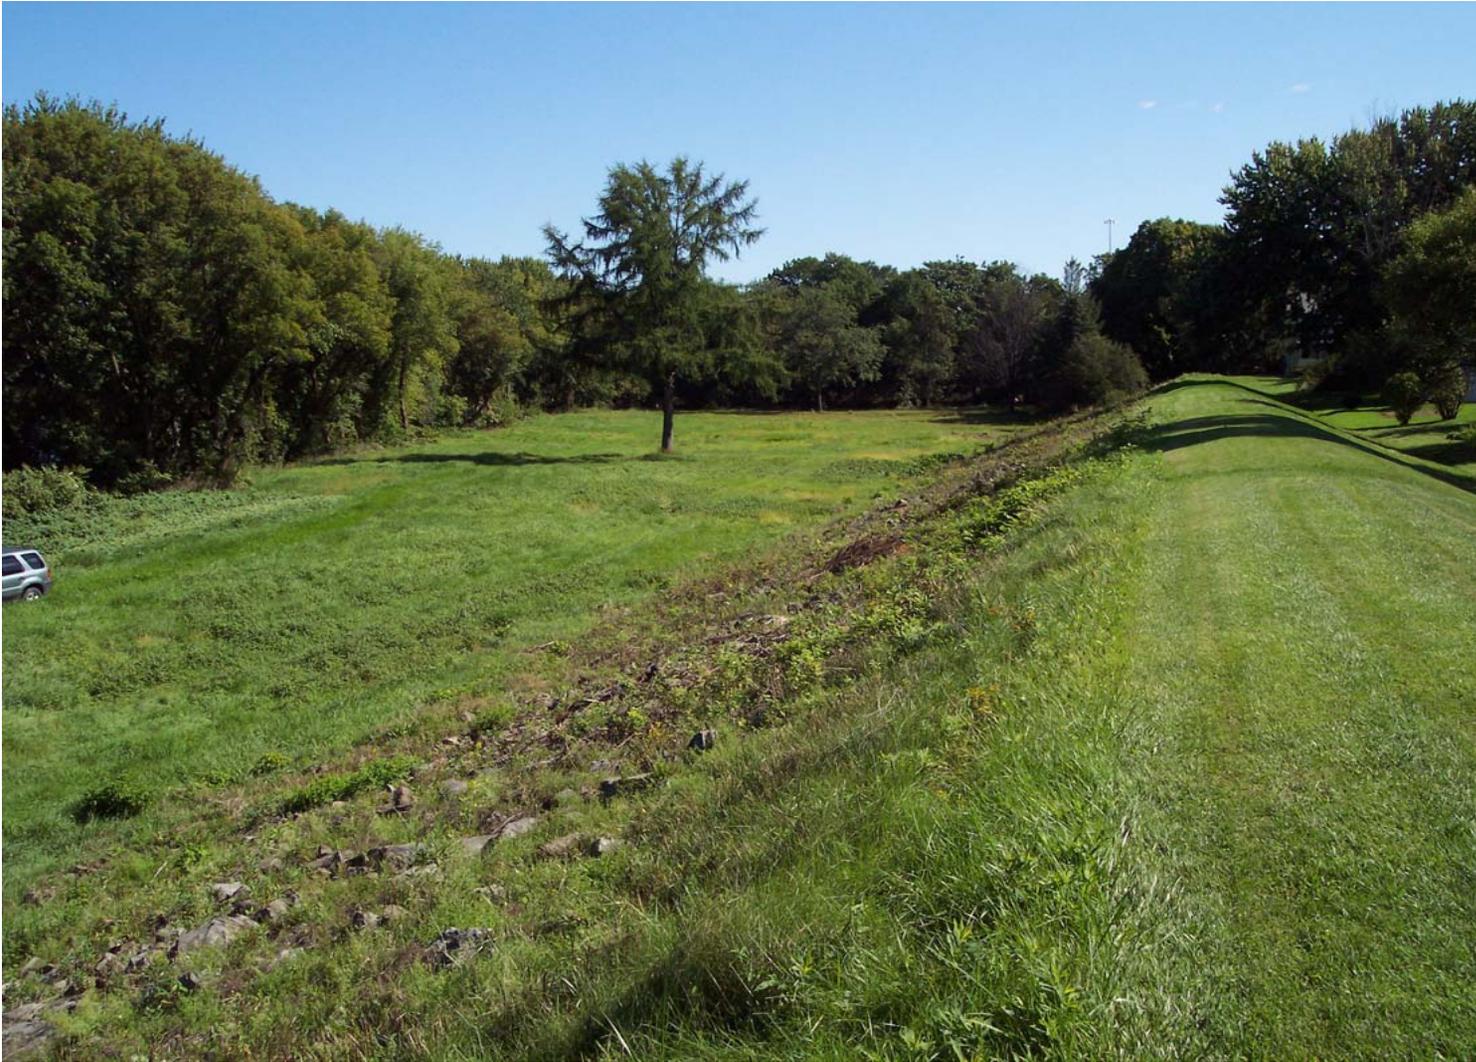
Inspect ID: EJVV_2008_a_0003 **Name:** Levee Embankments **Caption:** Vegetation removed from L/S of levee in riprap, just East of DS #5.

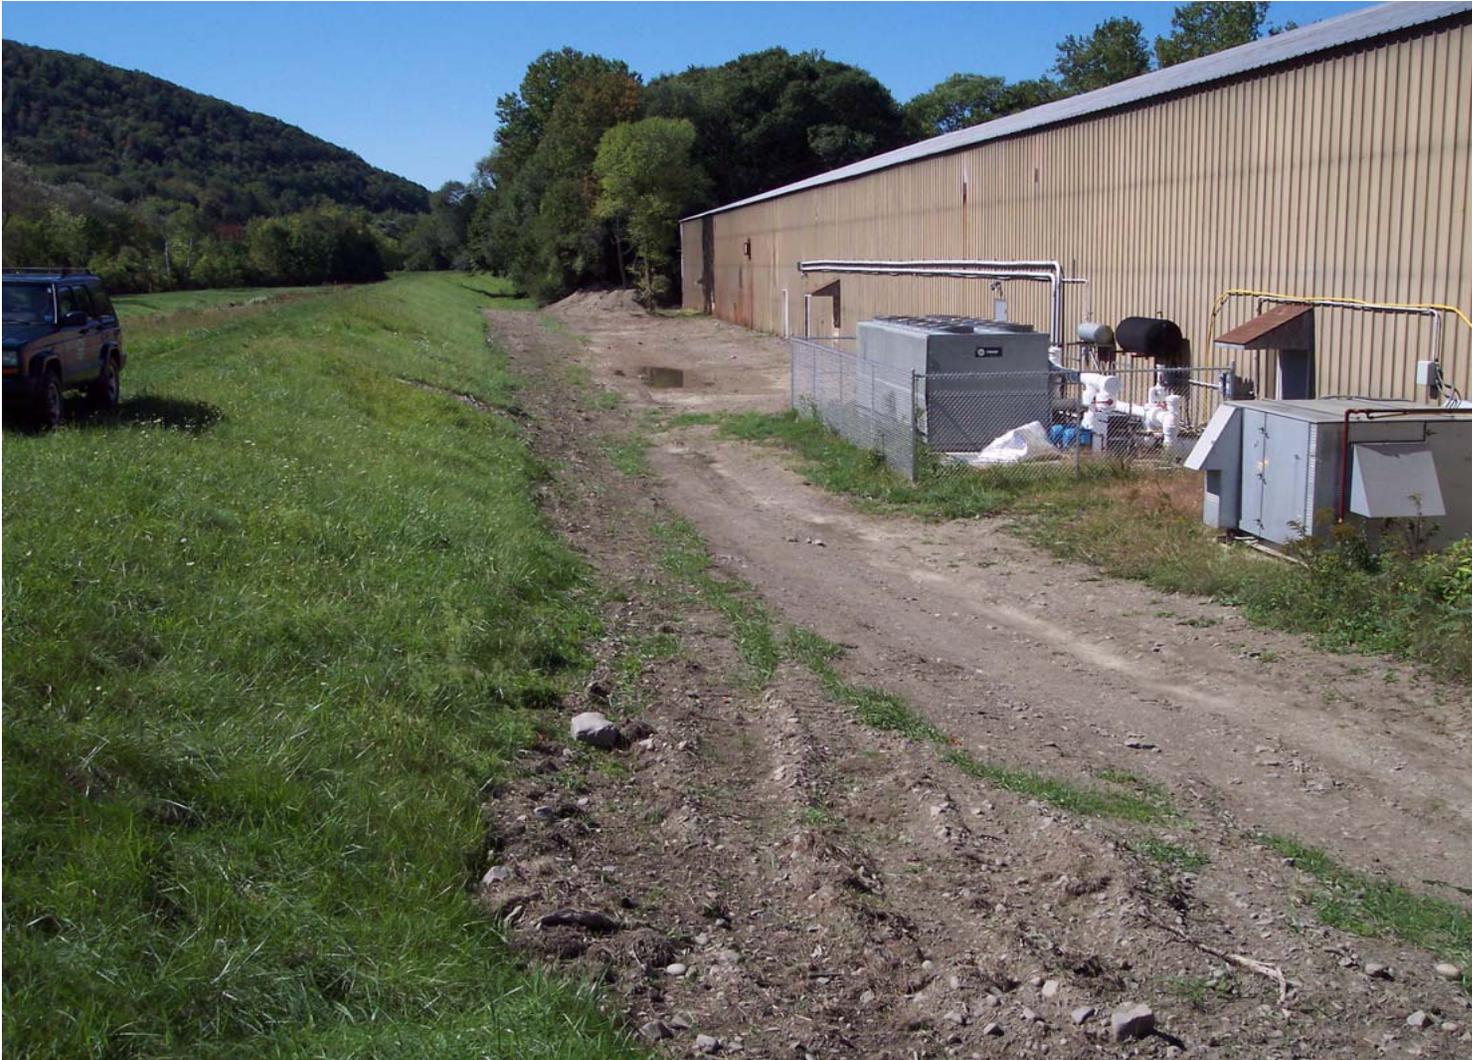
<p>EJVV_2008_a_0004: Recent clearing of brush that was in violation of the newly mandated guidance located behind the athletic complex on L/S of levee on Southeast side of project, has left exposed soil. Sponsor will contact land owner to reseed area to stabilize the soil.</p>

Inspect ID: EJVV_2008_a_0004 **Name:** Levee Embankments **Caption:** Sod cover in need of rehabilitation via reseedling (located in Southeast portion of project).

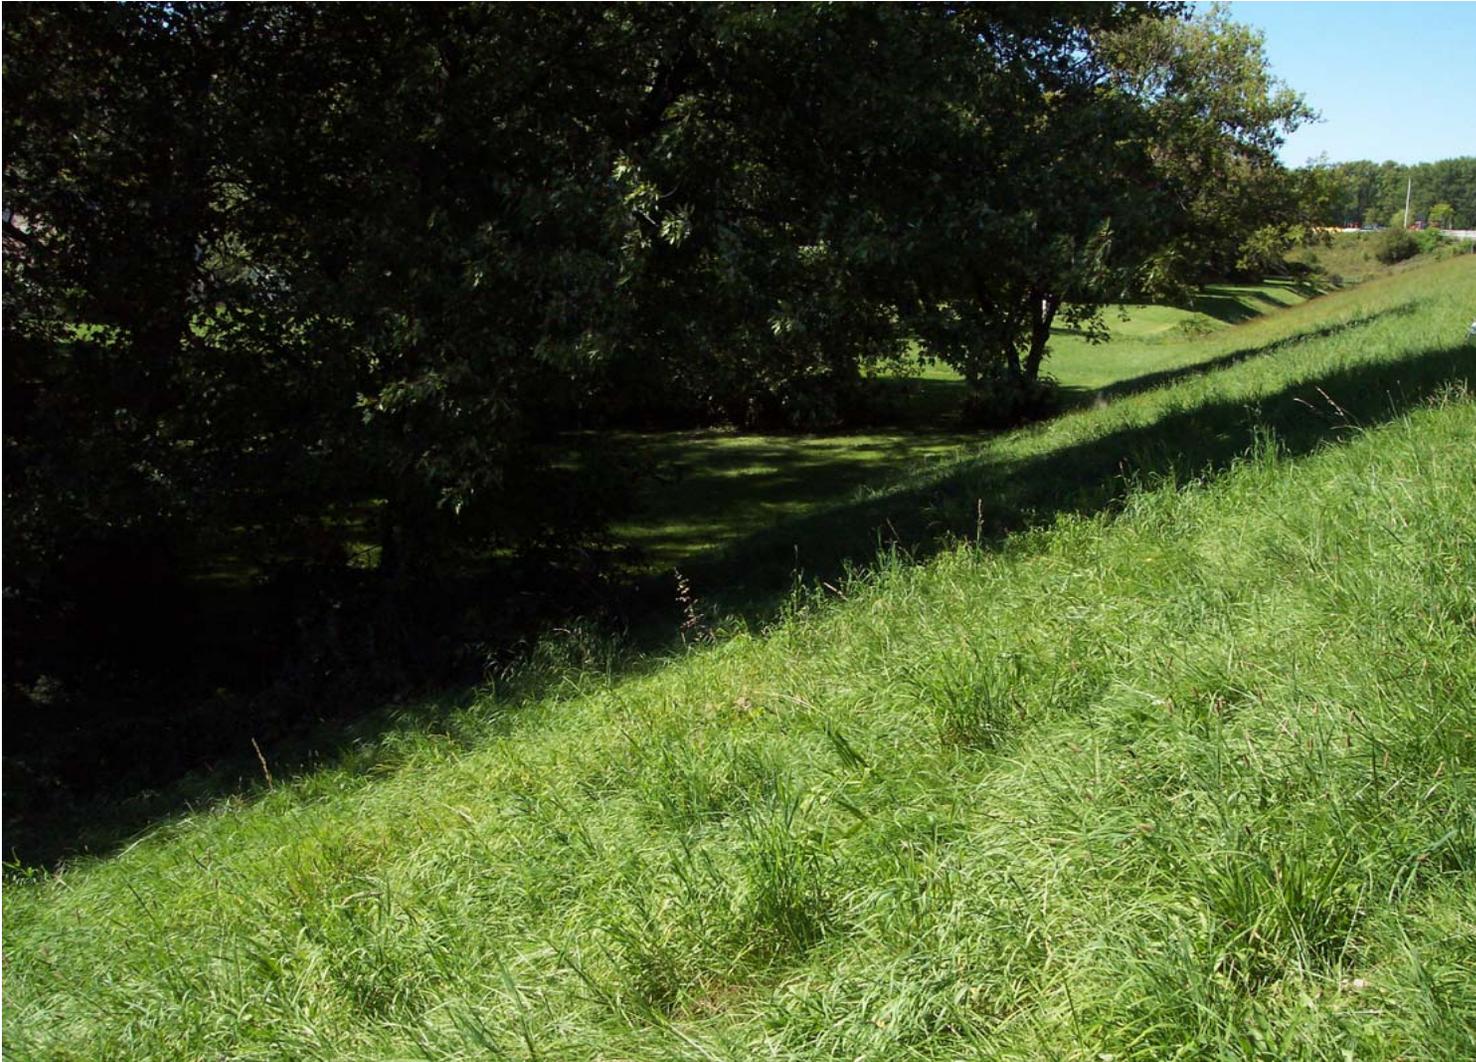
Inspect ID: EJVV_2008_a_0005 **Name:** Levee Embankments **Caption:** Trees in need of removal, on L/S of levee, located approximately 800' East of Rte. 17 Bridge.

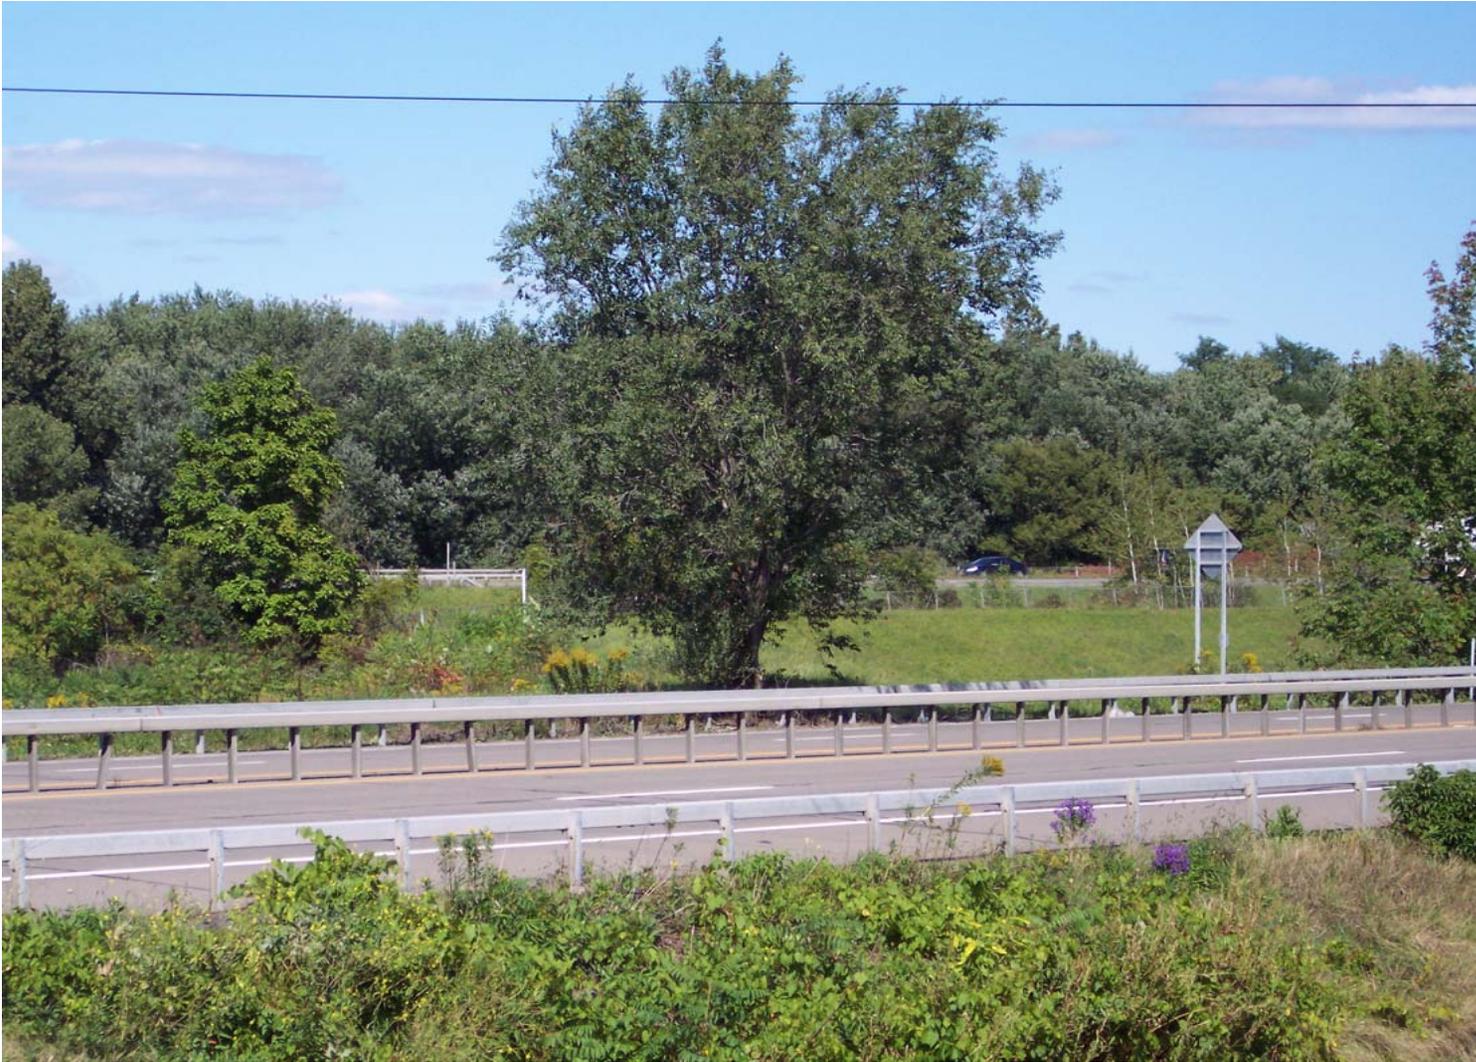
Inspect ID: EJVV_2008_a_0008 **Name:** Levee Embankments **Caption:** Tree in need of removal located just North of Rte. 434.

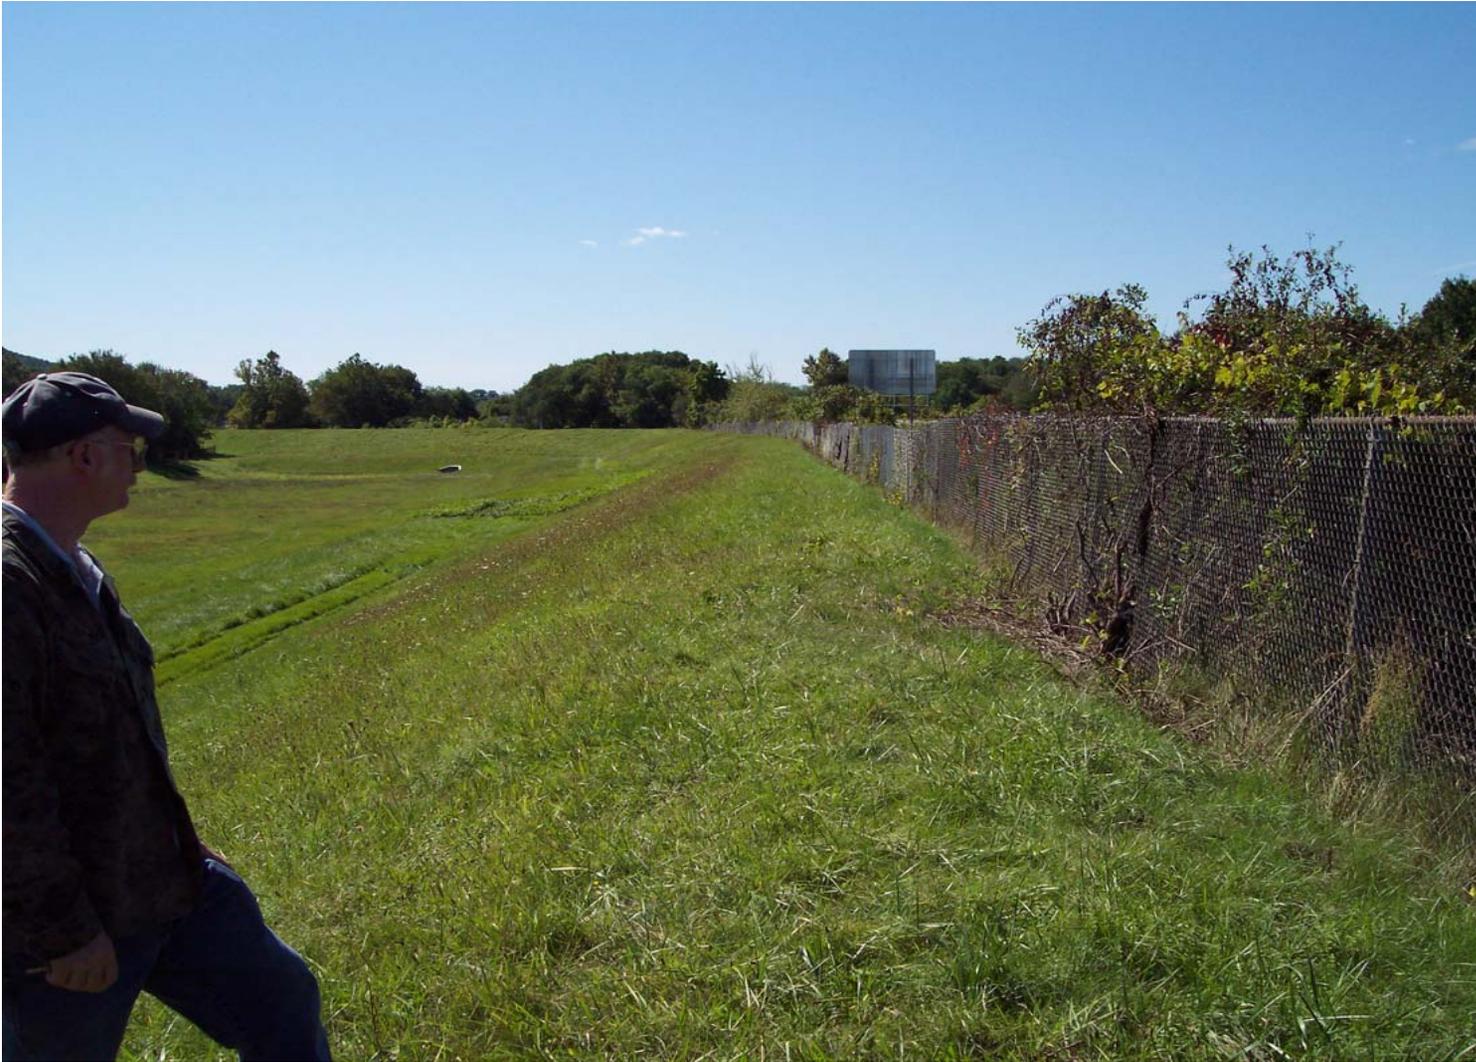
Inspect ID: EJVV_2008_a_0007 **Name:** Levee Embankment **Caption:** Brush is in need of removal on levee section adjacent to Rte. 17.

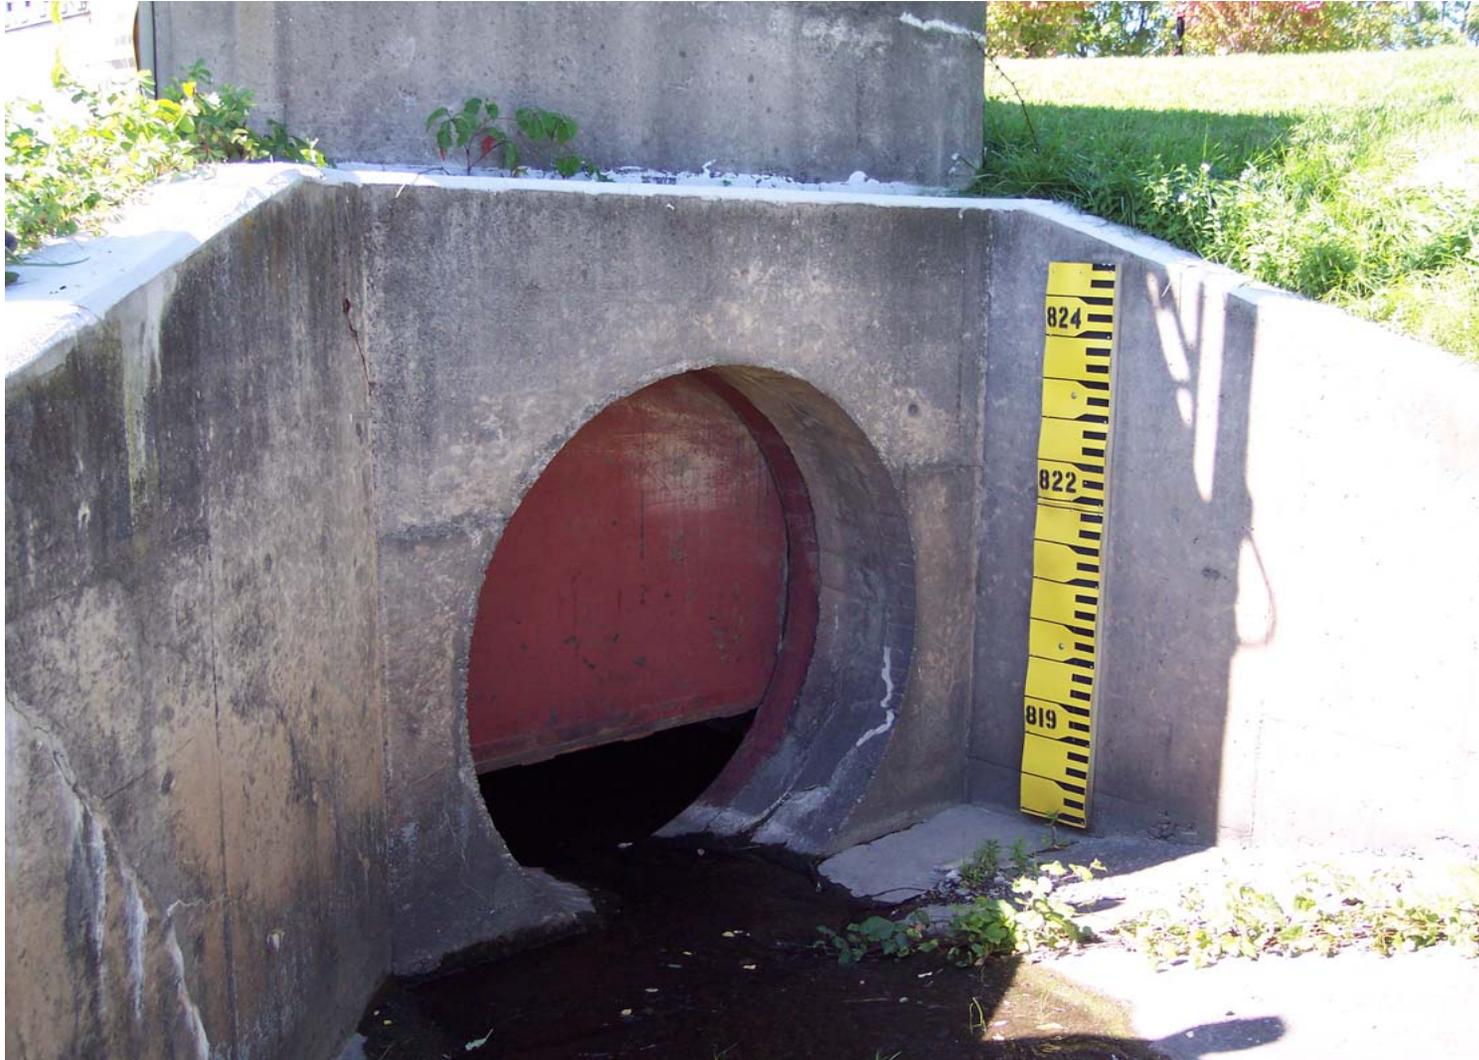
Inspect ID: EJVV_2008_a_0006 **Name:** Interior Drainage **Caption:** Sluice gate at Troopers Pond which was operated at time of inspection.
