SUBJECT: FY07 Joint Routine Inspection of Completed Works, Flood Damage Reduction Project, Cayuga Inlet, New York (9/11/07)

Subject: FY07 Joint Inspection of Completed Works, Flood Damage Reduction Project, Cayuga Inlet, Ithaca, New York (9/11/07)

Attachment “A” - Project Inspection Photographs

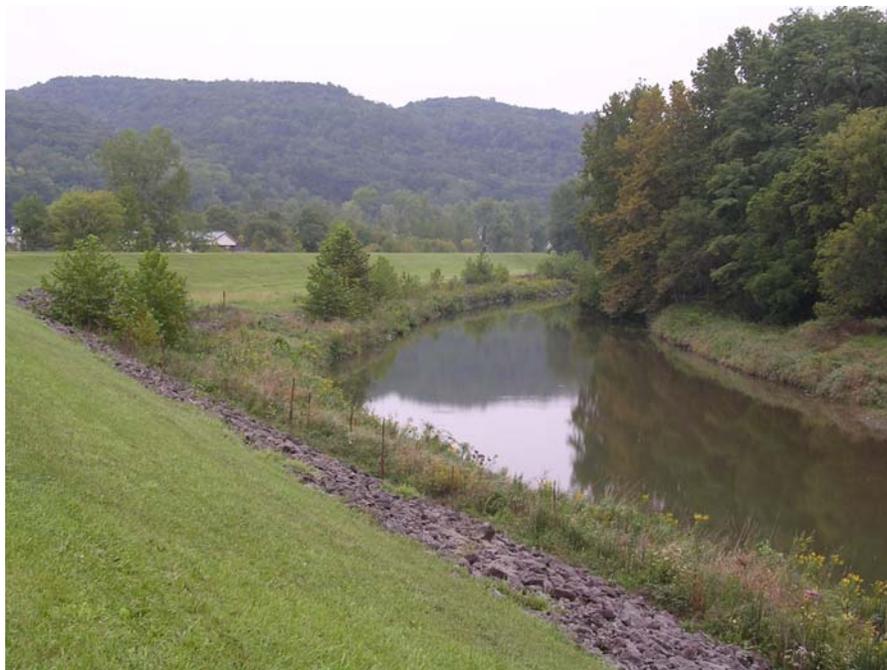
Photo 2: Vegetation in riprap along right bank – looking upstream from approx. Sta. 152+00.

(3) Vegetation needs to be removed from all riprapped areas as noted in Section 7.b. above.

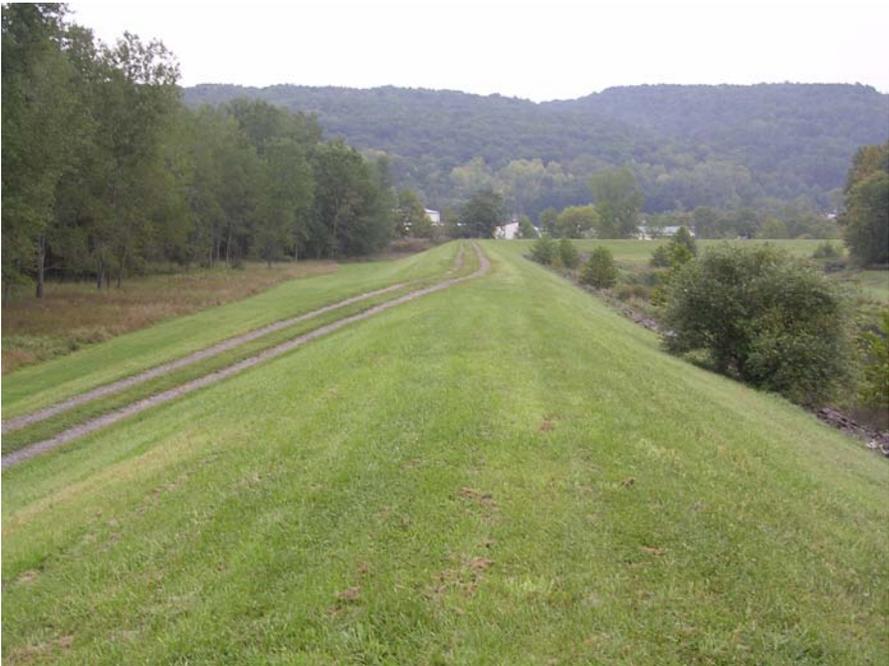
Photo 3: Right bank levee looking upstream from approx. Sta. 146+00. Vegetation in riprap.

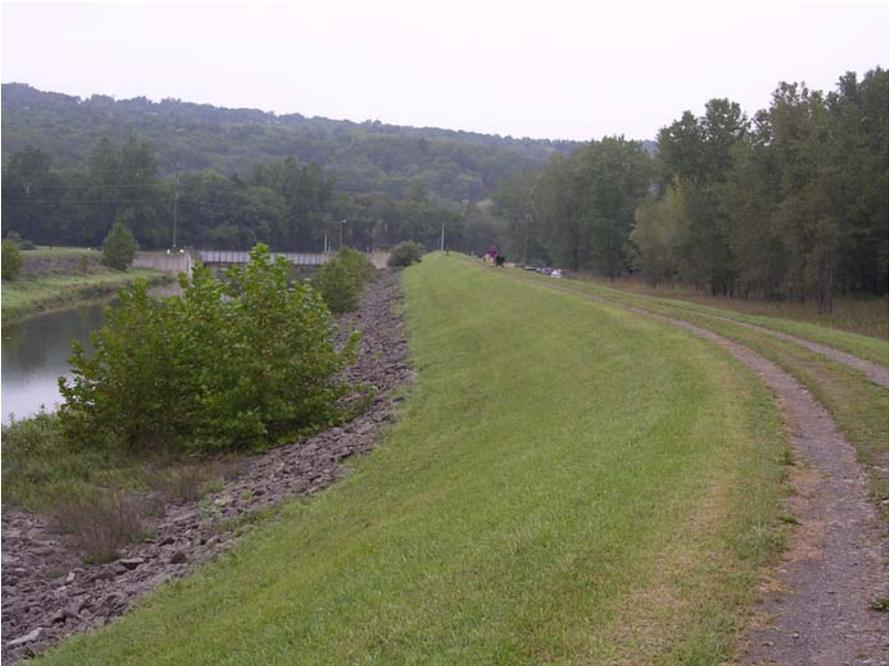
Photo 4: Right bank levee and channel upstream of railroad bridge. Vegetation in riprap.

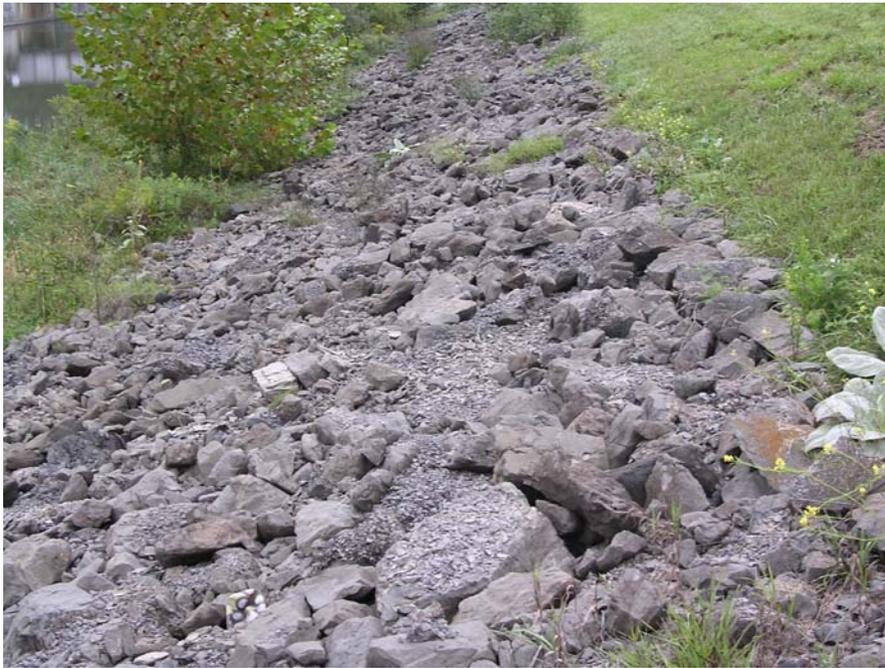
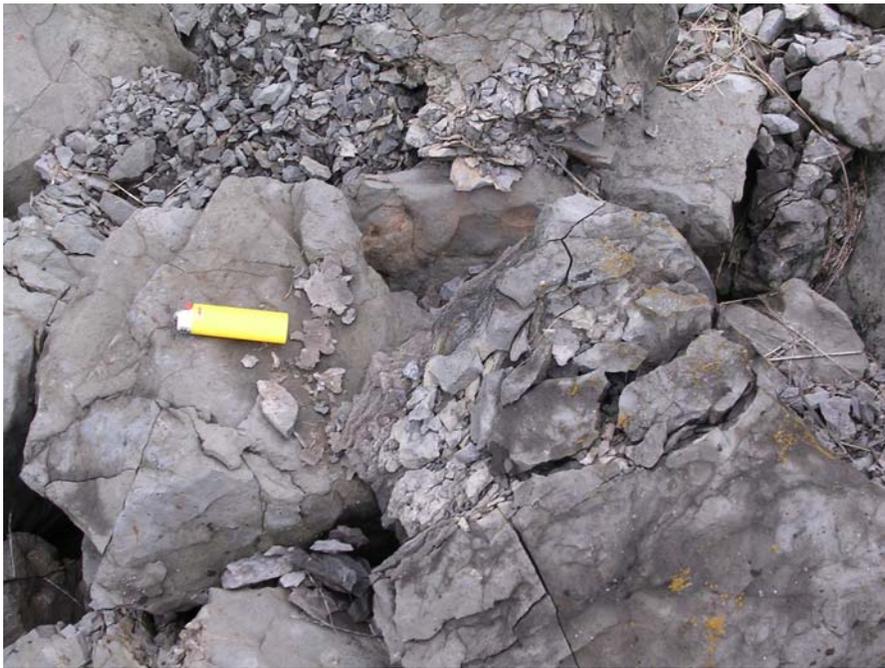
- (1) Riprap along right bank channel and levee from approx. Sta. 160+00 to the railroad bridge is showing signs of deterioration - cracking and disintegration is evident but no eroded areas or wash outs present. Riprap is still functional. See photos 5 & 6.

Photo 5: Riprap along right bank upstream of railroad bridge.

Photo 6: Close-up of riprap along right bank, upstream of railroad bridge.

(2) All riprapped areas, including along the right and left bank levees/channel upstream of the railroad bridge, in and around Coy Glen, and along the left and right banks of the Cayuga Inlet channel between the State St. bridge and Coy Glen, need to be closely monitored for further deterioration, especially after a storm event. Any erosion areas or washouts which may form, should be repaired immediately. Riprap is still functional but is showing signs of deterioration.

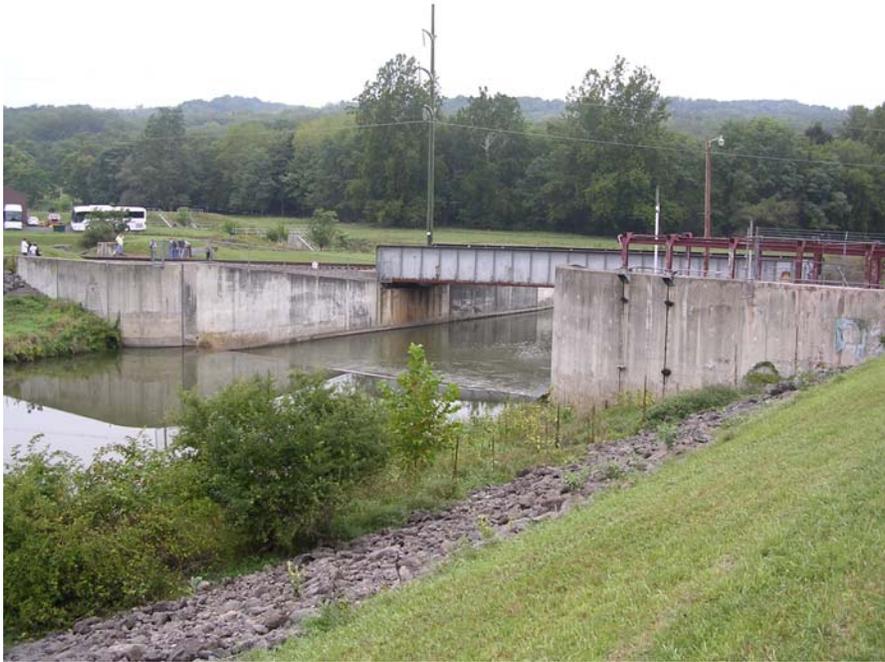
(3) The stop-log closure structure and stop-logs were in good condition (see photo 11 for closure structure). The railroad bridge was also in satisfactory condition - no signs or erosion around abutments (see photos 7, 9, & 10)

Photo 7: Fishway (right bank), low head dam, and railroad bridge, looking downstream. Vegetation in riprap along right bank.

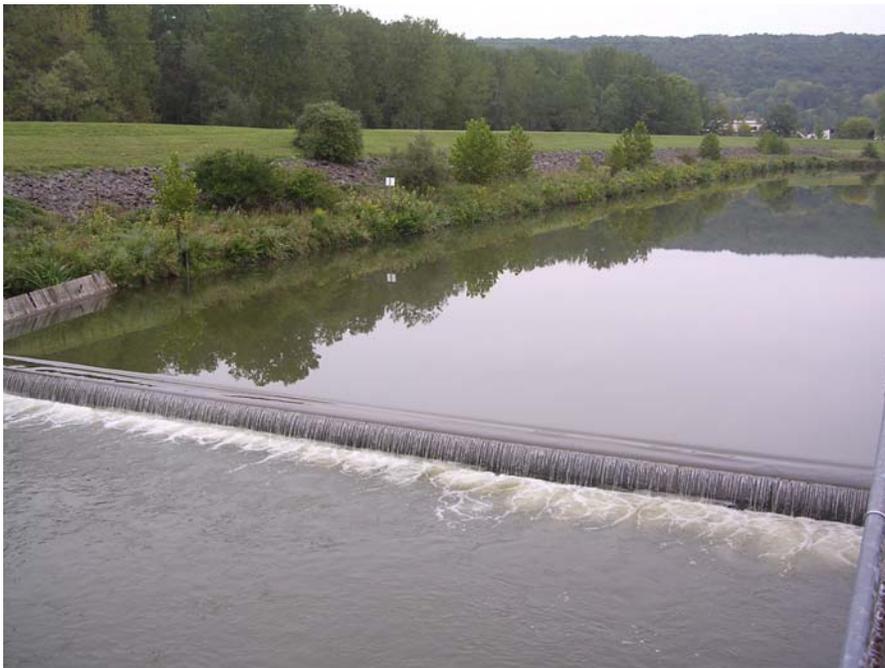
Photo 8: Low head dam just upstream of railroad bridge. Vegetation in riprap along right bank.

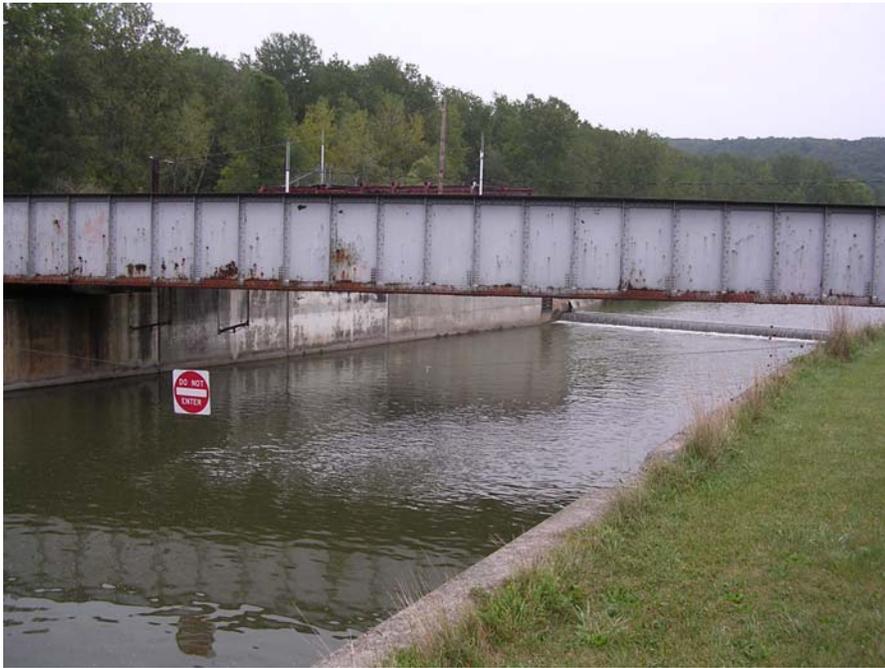
Photo 9: Railroad bridge over Cayuga Inlet, looking upstream.

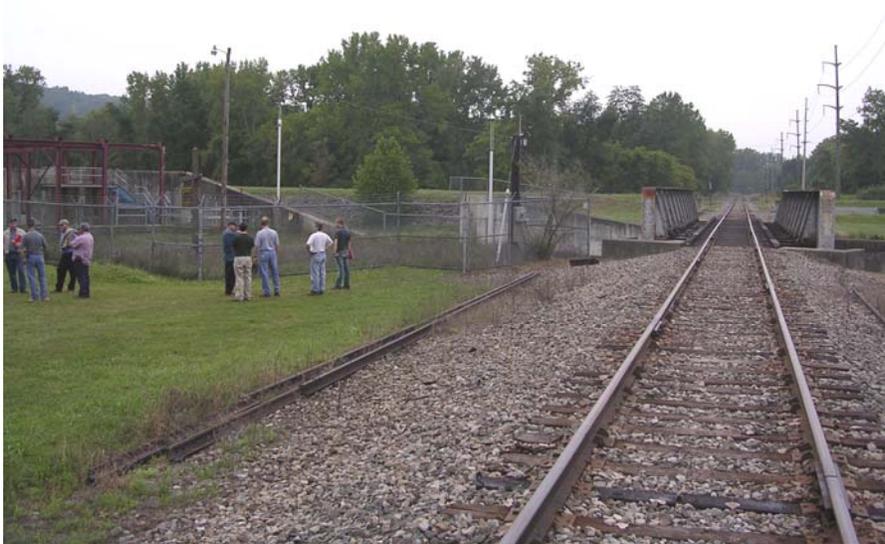
(2) The right bank levee appears to drop down prematurely just upstream of the railroad bridge. The project was apparently designed this way, however, the Buffalo District Corps should review this design as to why the levee doesn't fully tie into high ground and, what the impacts might be in regards to potential flooding of the adjacent area. It is noted that the left bank levee and railroad stop-log closure is higher than the right bank levee in this location. See photo 10.

Photo 10: Fishway (right bank) and railroad bridge over Cayuga Inlet (looking toward railroad stoplog closure).

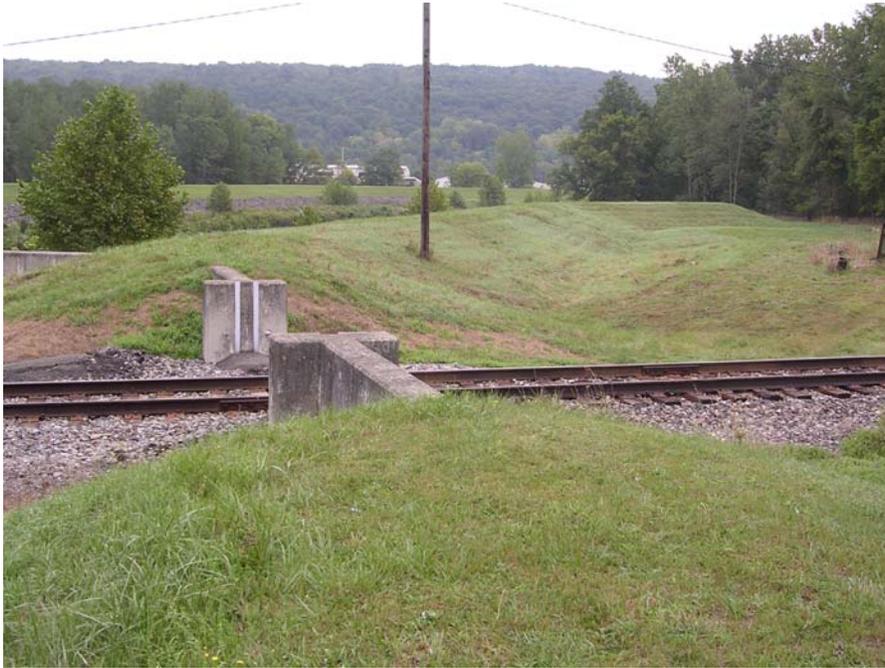
Photo 11: Railroad stoplog closure and left bank levee, looking upstream.

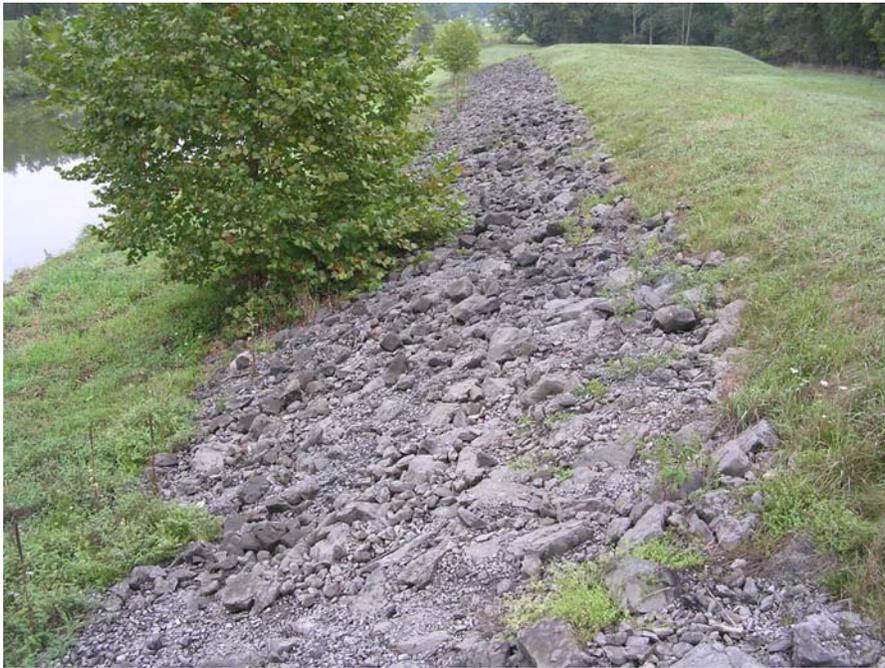
- (2) Riprap along left bank levee from approx. Sta. 150+00 to the railroad bridge is showing signs of deterioration - cracking and disintegration is evident but no eroded areas or wash outs present. Riprap is still functional. See photos 13.

Photo 13: Vegetation in riprap along left bank levee, just upstream of railroad bridge.

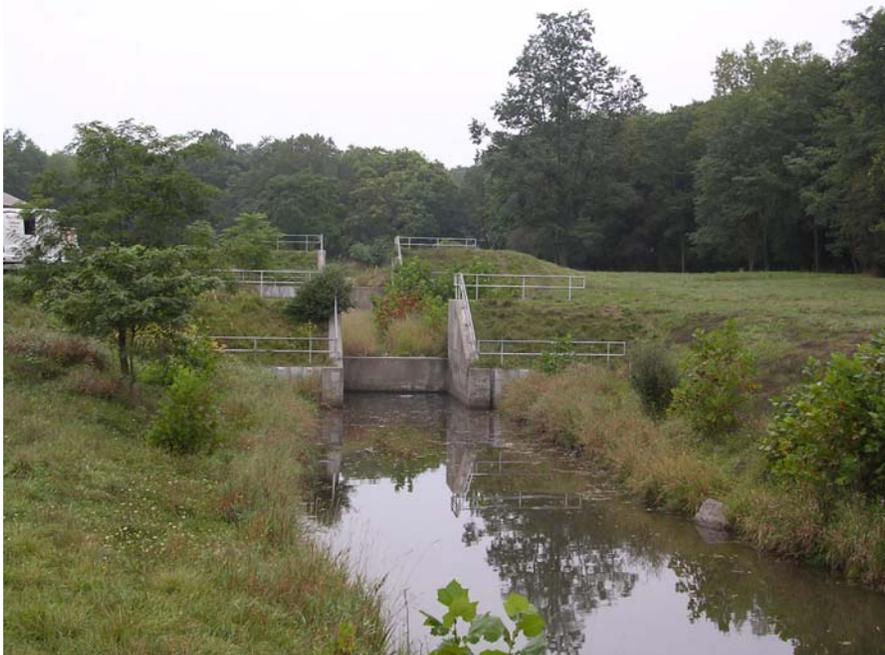
Photo 14: Coy Glen drop structures. Vegetation along sideslopes and between structures.

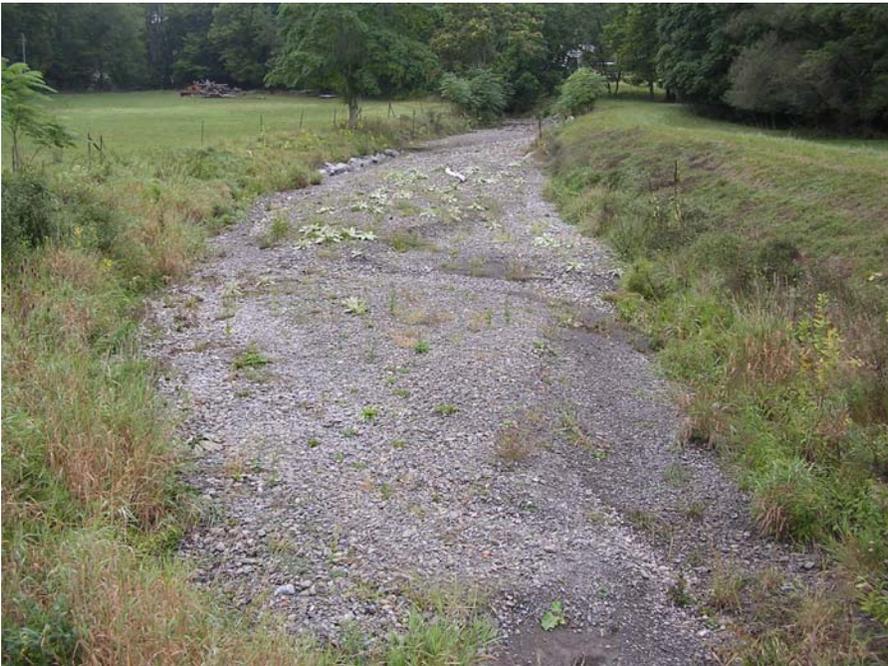
Photo 15: Shoaling in Coy Glen just upstream of Coy Glen drop structures.

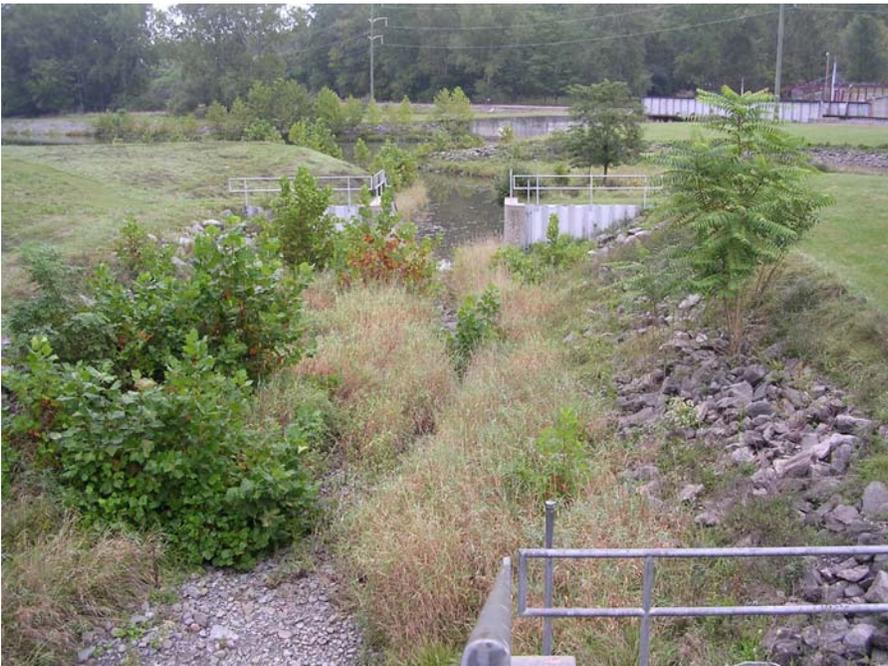
Photo 16: Heavy vegetation and shoaling between Coy Glen upstream and downstream drop structures.

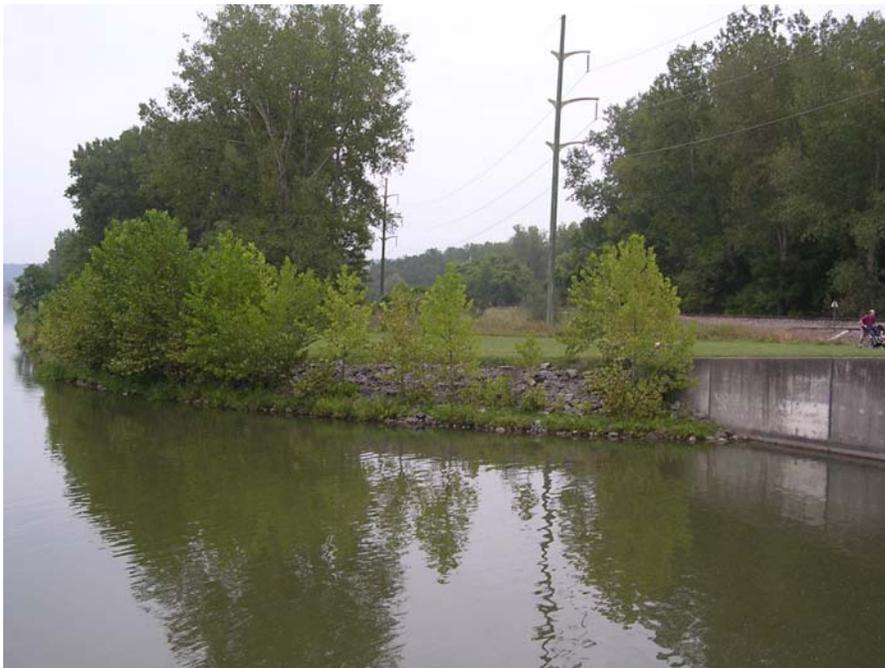
Photo 20: Right bank Cayuga Inlet, just downstream of railroad bridge. Vegetation in riprap.

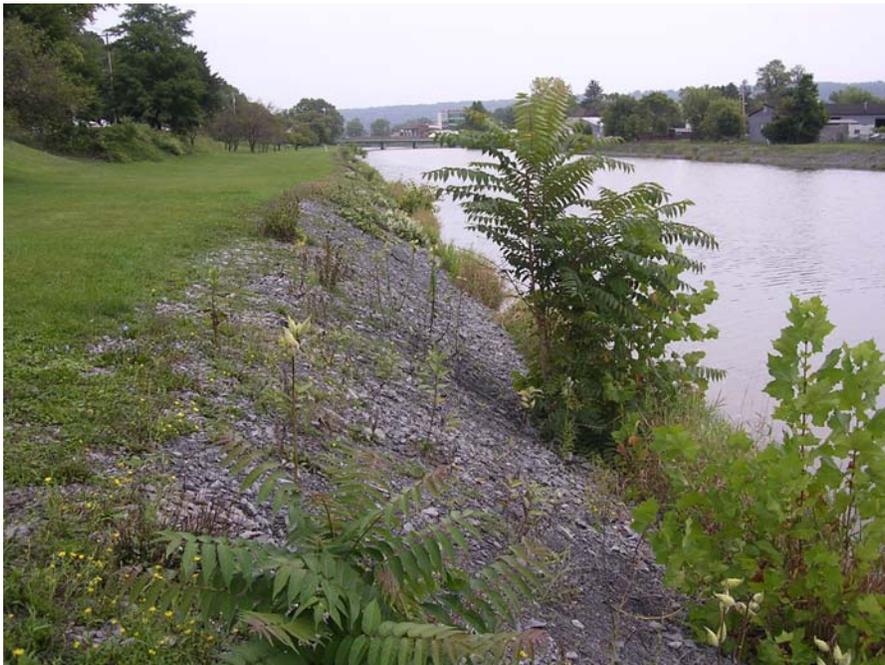
- (3) Small-sized graded riprap along left and right banks of Cayuga Inlet between the State St. bridge and Coy Glen is showing signs of deterioration - some washing out/displacement of the coarser stones is evident but no washouts are evident. Riprap is still functional (see photos 22-24).

Photo 22: Left bank of Cayuga Inlet channel, looking downstream from approx. Sta. 110+00. Vegetation in riprap.

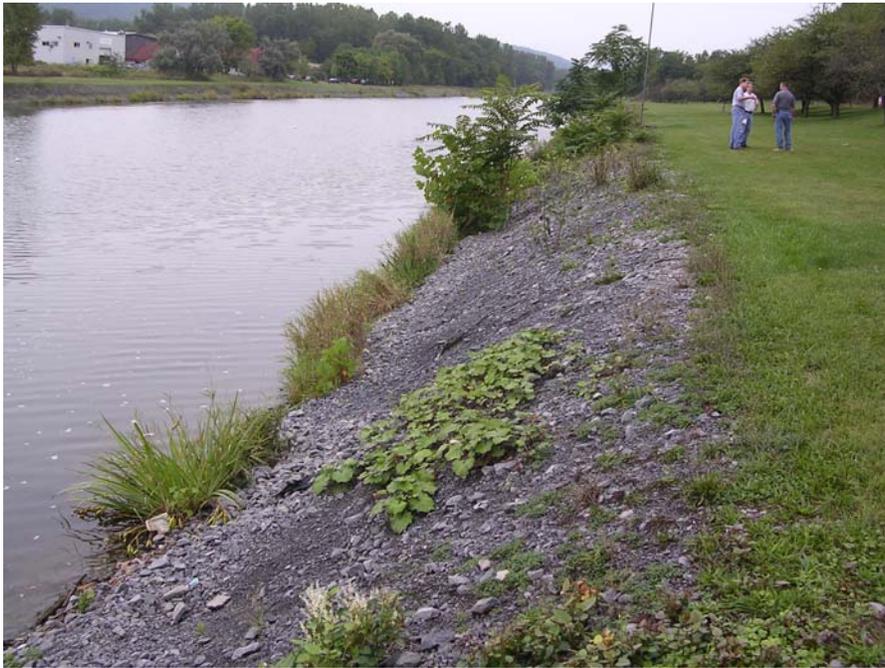
Photo 23: Left bank of Cayuga Inlet channel, looking upstream from approx. Sta. 110+00. Vegetation in riprap.

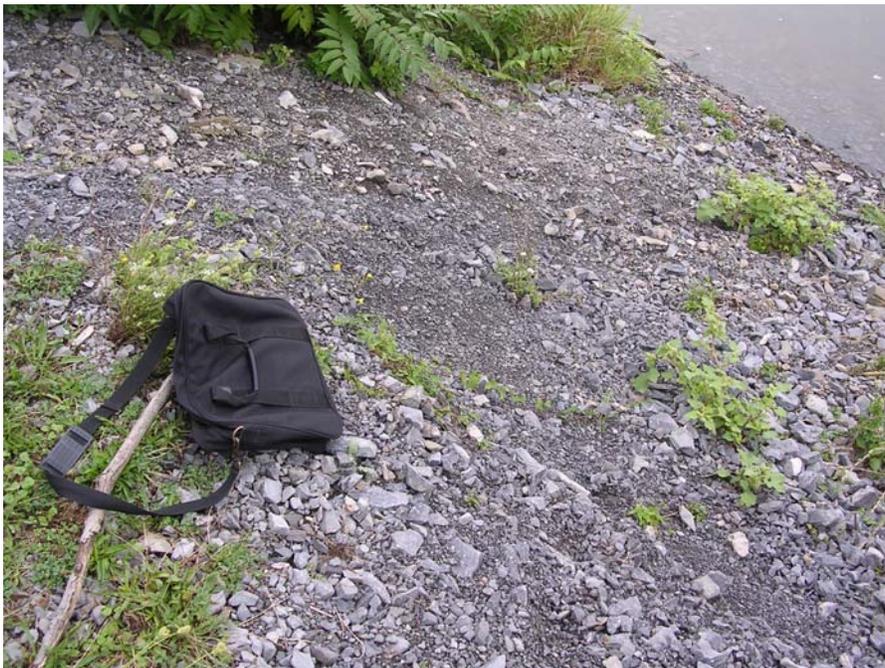
Photo 24: Close-up of deteriorated riprap along left bank; approx. Sta. 110+00.

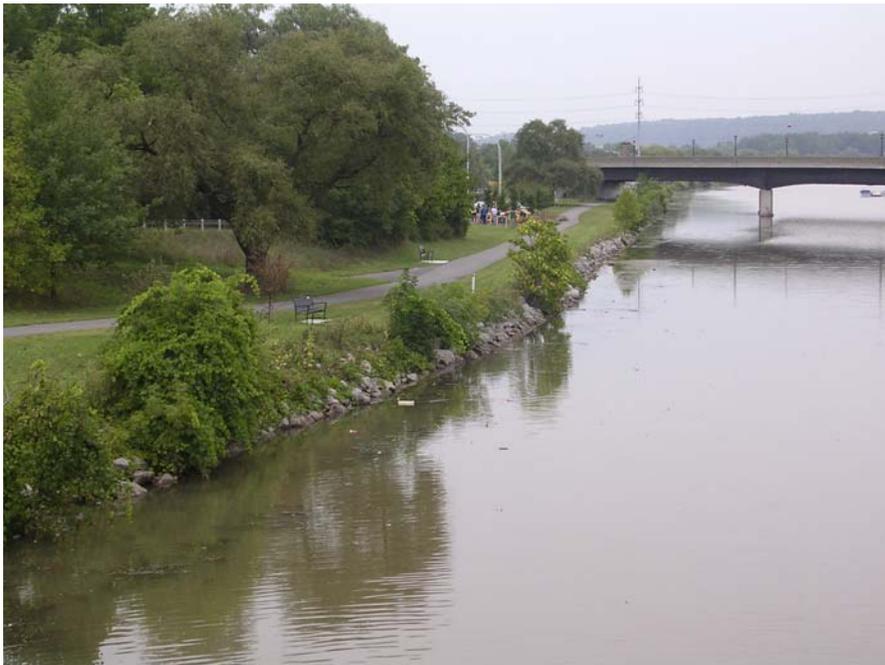
Photo 28: Cayuga Inlet channel upstream of Taughannock Boulevard bridge, looking downstream. Vegetation in riprap.

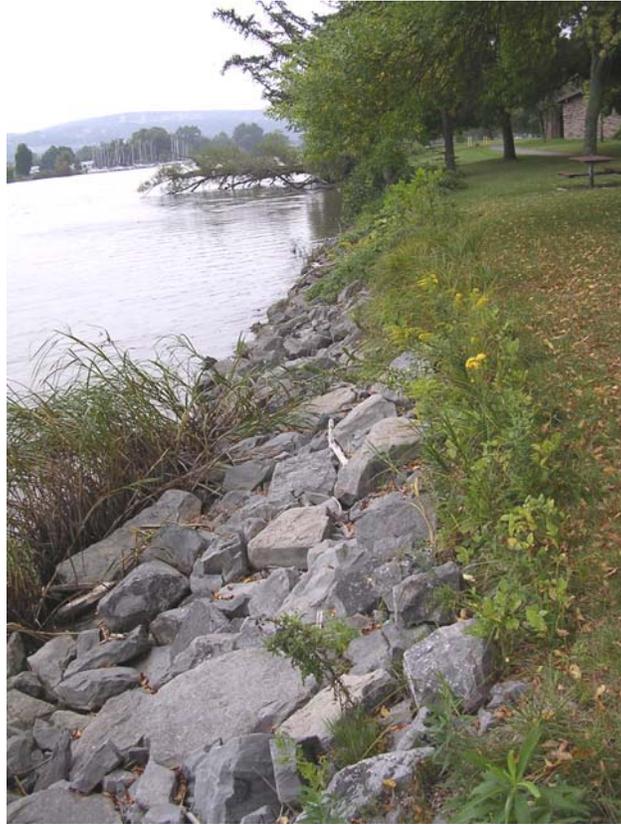
Photo 29: Left bank of Cayuga Inlet at Allan Treman State Park. Vegetation in riprap and tree overhanging channel

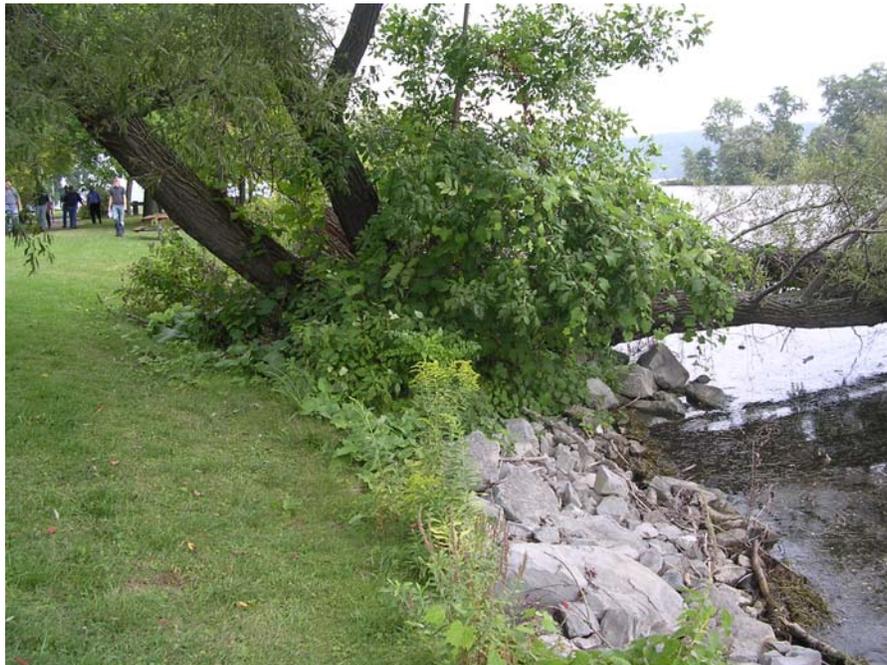
Photo 30: Left bank of Cayuga Inlet at Allan Treman State Park – large tree growing through riprap.

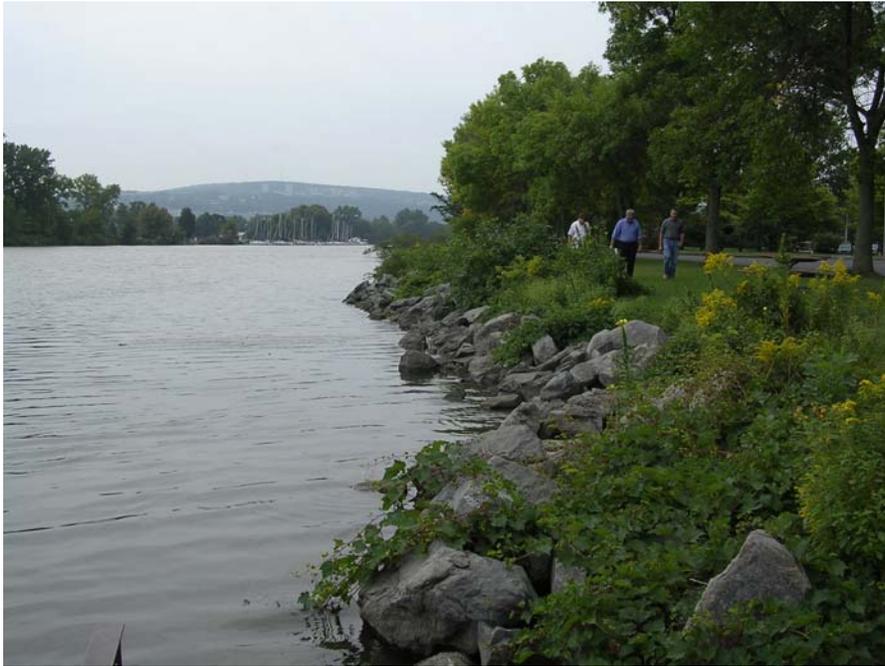
Photo 31: Left bank of Cayuga Inlet at Allan Treman State Park – vegetation in riprap.
