SUBJECT: FY07 Joint Routine Inspection of Completed Works, Flood Damage Reduction – Clearing and Snagging, Skaneateles Creek, Jordan, New York (9/12/07)

Transmitted herewith is the FY07 Inspection of Completed Works (ICW) inspection report for the Flood Damage Reduction - Clearing and Snagging Project at Skaneateles, Jordan, New York. I would like to thank you for your participation in this inspection. The rating for this project as determined by the current inspection is **“MINIMALLY ACCEPTABLE” (M)**. Please refer to the enclosed inspection report, which includes an inspection checklist (Attachment "B"), for a description of project deficiencies requiring corrective action, if any.

Attachment “A” - Project Inspection Photographs

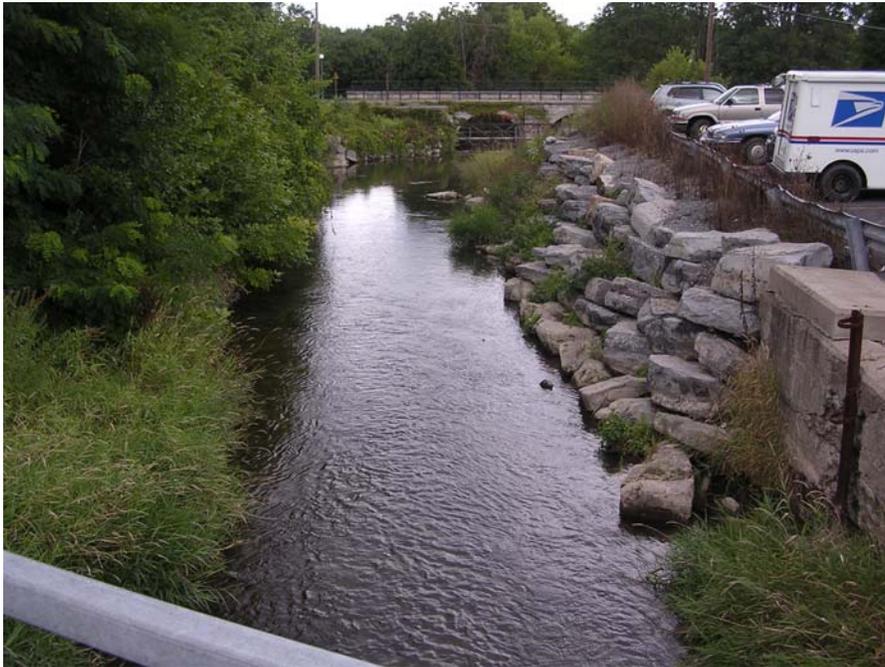
(1) The creek is for the most part clear of debris and obstructions (see photos 1, 2, 6, & 10-12).

Photo 1: Skaneateles Creek looking downstream from Mechanic Street bridge – no problems.

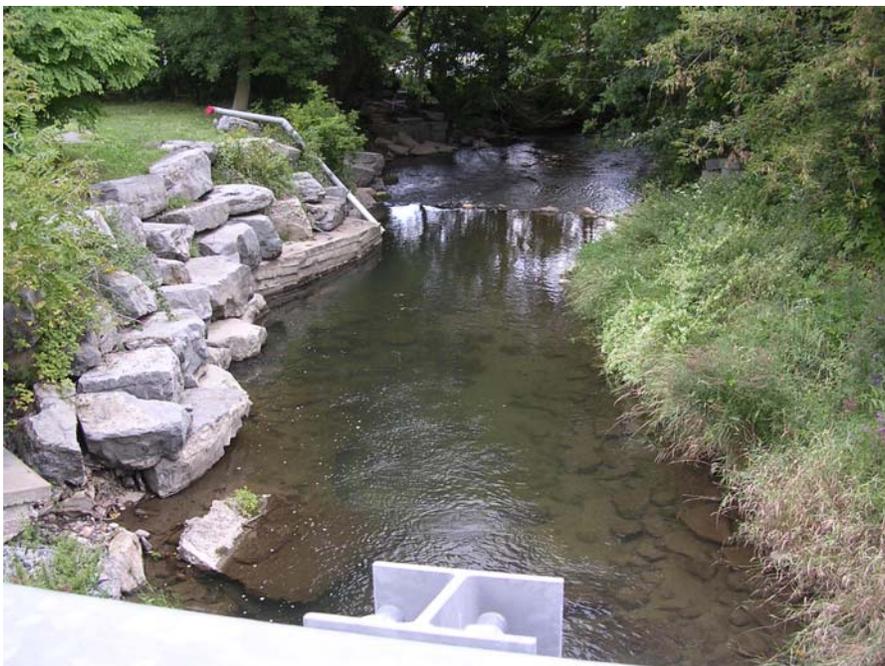
Photo 2: Skaneateles Creek looking downstream from Elbridge Street bridge – no problems.

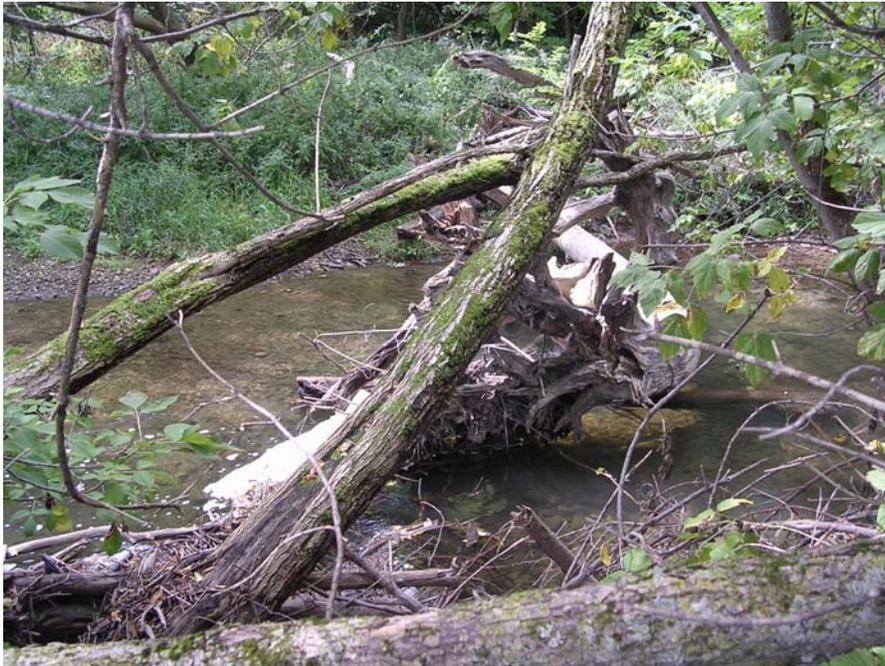
- (1) Tree jam upstream of Bennett Bolt Company (see photo 3).
- (2) Downed tree just upstream of Bennett Bolt Company (see photo 4).
- (3) Branches and downed trees on right bank on right bank near old historical marker (see photo7).
- (4) Metal barrel section in creek by right bank near historical marker (see photo 8).
- (5) Approximately 70 feet of metal railing has collapsed into the creek, right bank, at the upstream limit of the project (see photo 9).
- (6) Branch/tree debris jam just upstream of North Main St. bridge (see photo 14).
- (7) Several downed trees just downstream of the north end of the Diversion Channel at the downstream limit of the project (see photo 15).

Photo 3: Tree jam just upstream of Bennett Bolt Company.

(2) Remove all trees, branches, and debris from creek as noted in Sections 7.a. and 7.b. above, as well as any new obstructions.

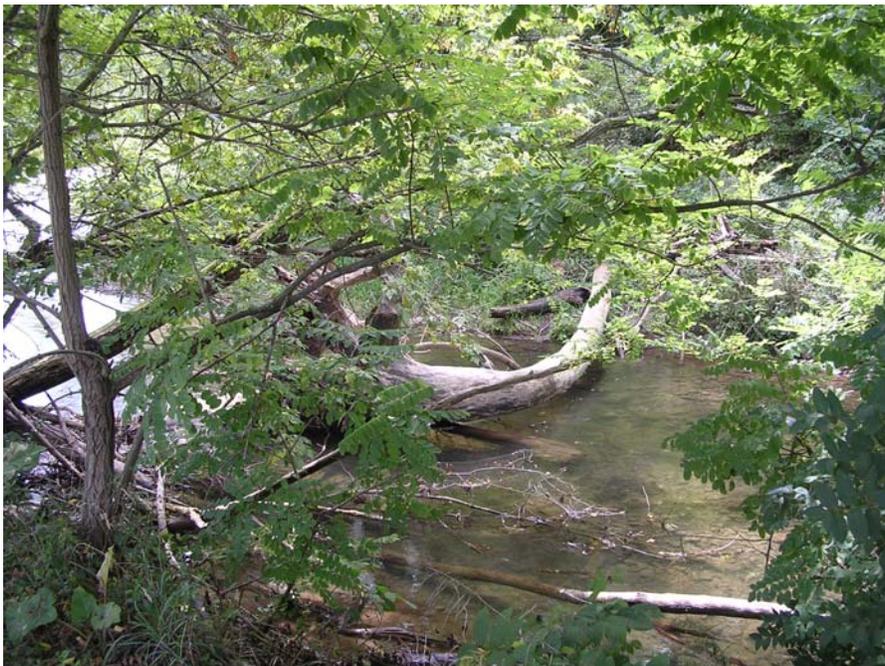
Photo 4: Downed tree just upstream of Bennett Bolt Company.

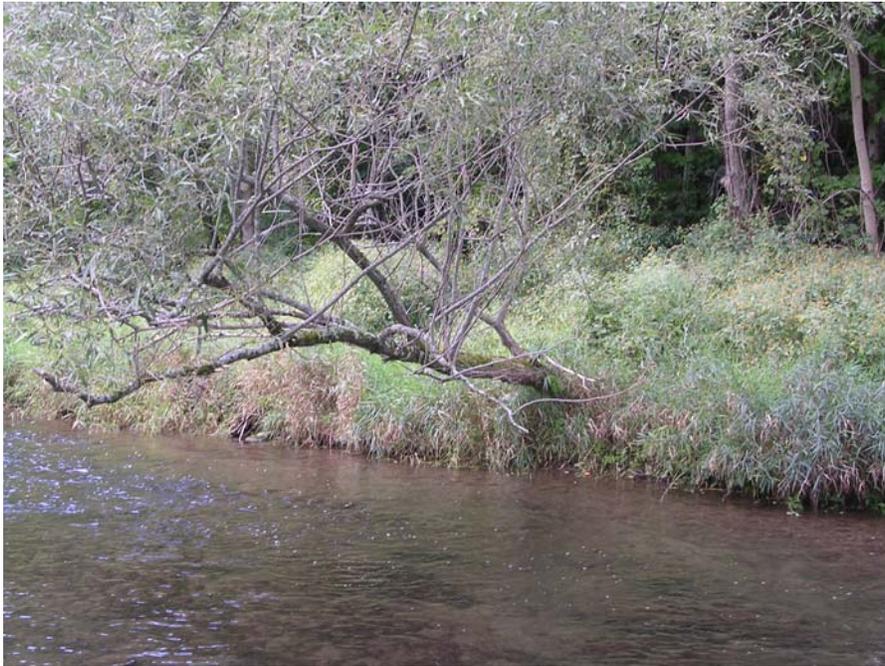
- (1) Hanging tree on left bank upstream of Bennett Bolt Company (see photo 5).
- (2) Hanging tree on left bank downstream of old Erie Canal bridge (see photo 13).
- (3) A number of smaller trees have been downed and are laying along the edges of or in the creek in several locations (see photo 16 for example).

Photo 5: Hanging tree, left bank upstream of Bennett Bolt Company.

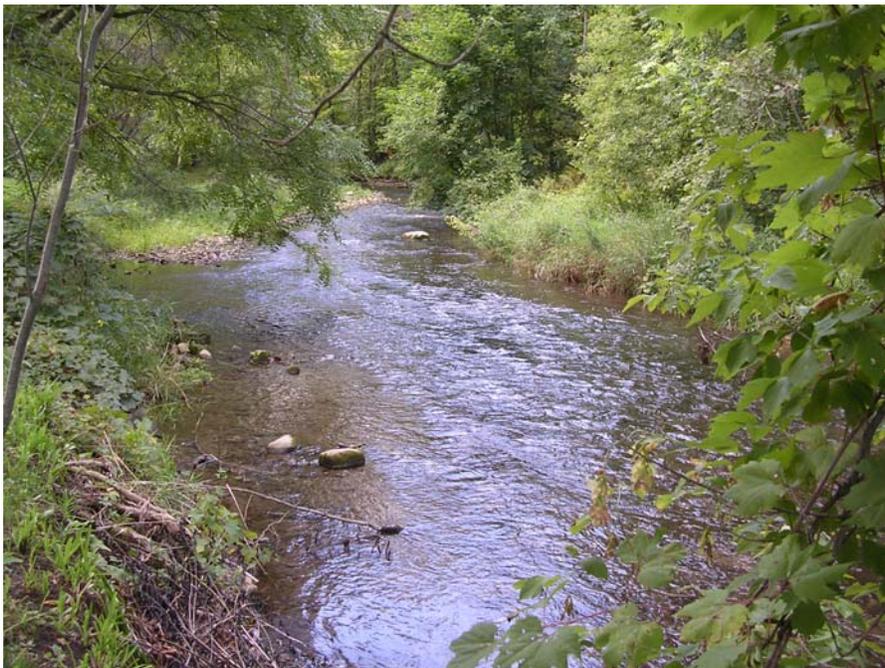
Photo 6: Skaneateles Creek in vicinity of South Main Street – no problems.

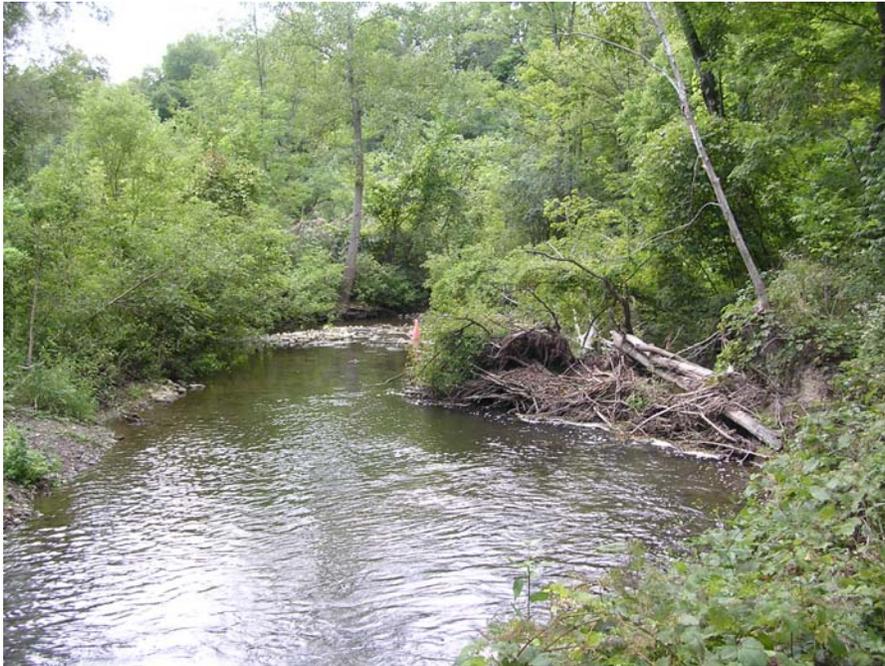
Photo 7: Branches and downed tree on right bank near old historical marker.

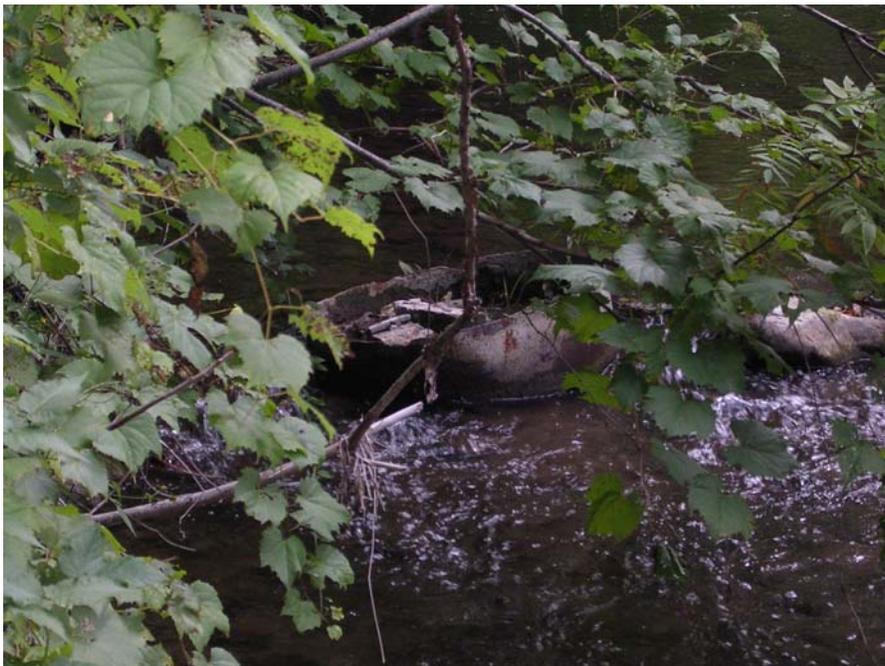
Photo 8: Metal barrel section in creek by right bank near historical marker.

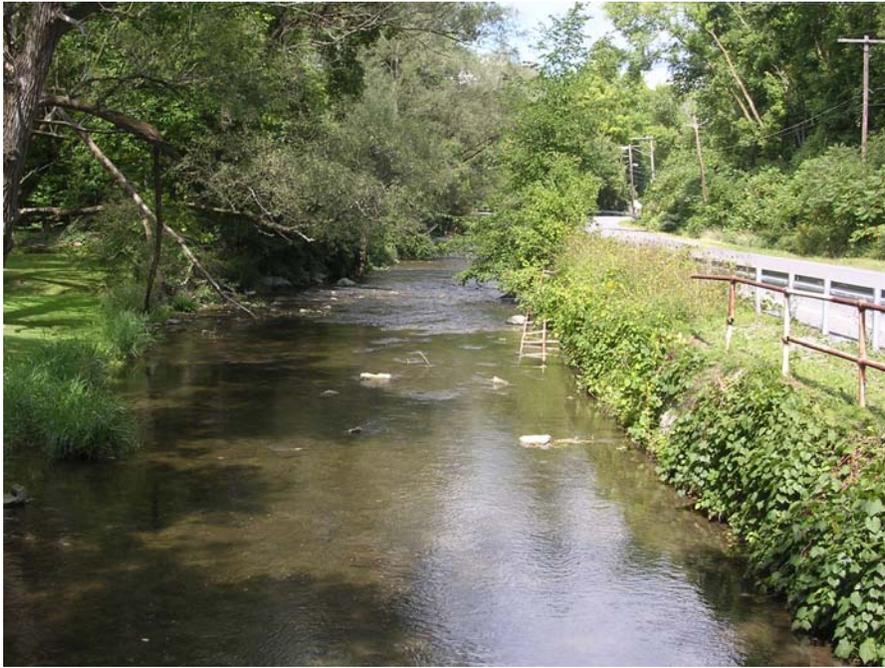
Photo 9: Skaneateles Creek at upstream limit of project – note damaged railing on right bank.

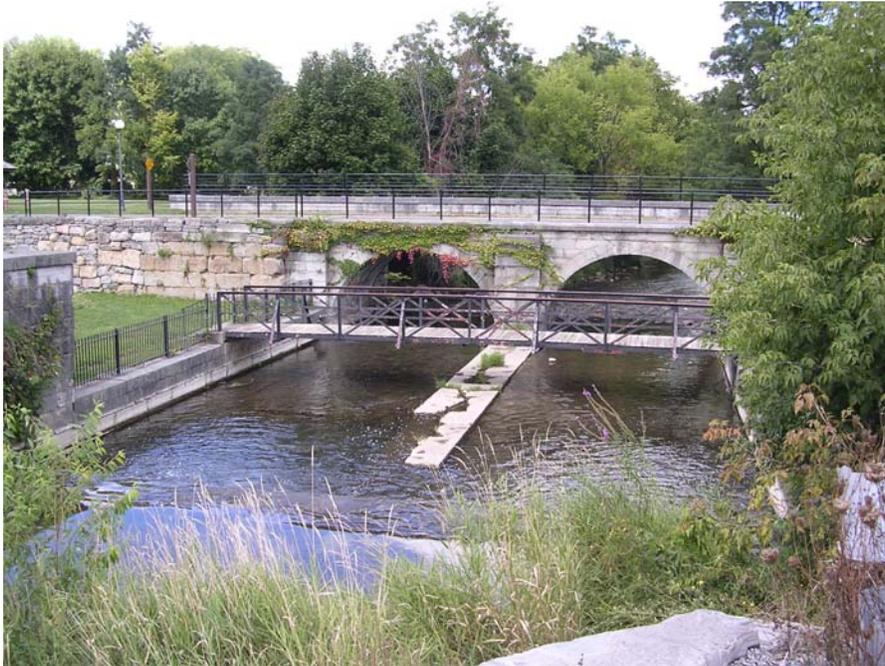
Photo 10: Old Erie Canal crossing Skaneateles Creek – no problems.

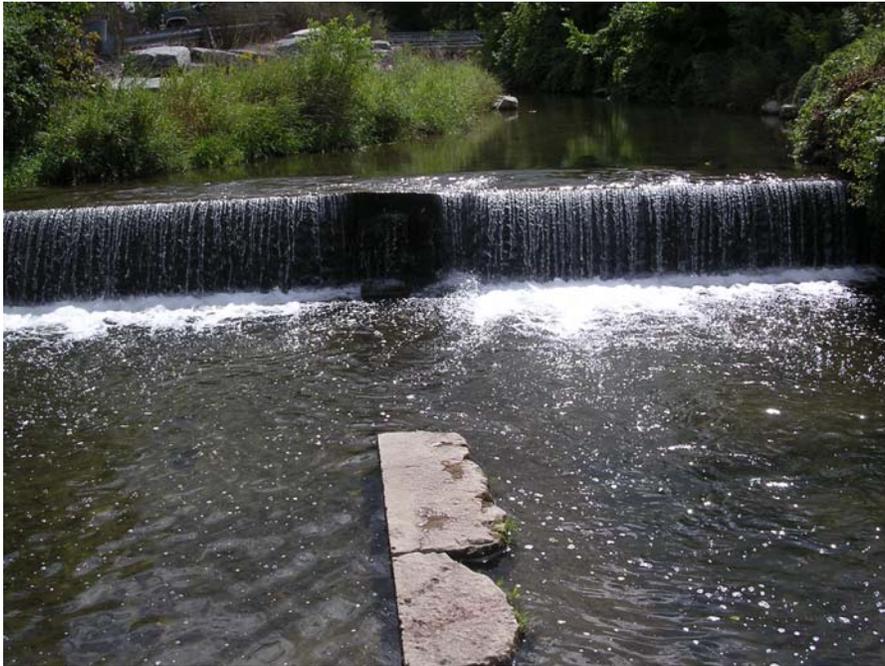
Photo 11: Low level dam upstream of old Erie Canal – no problems.

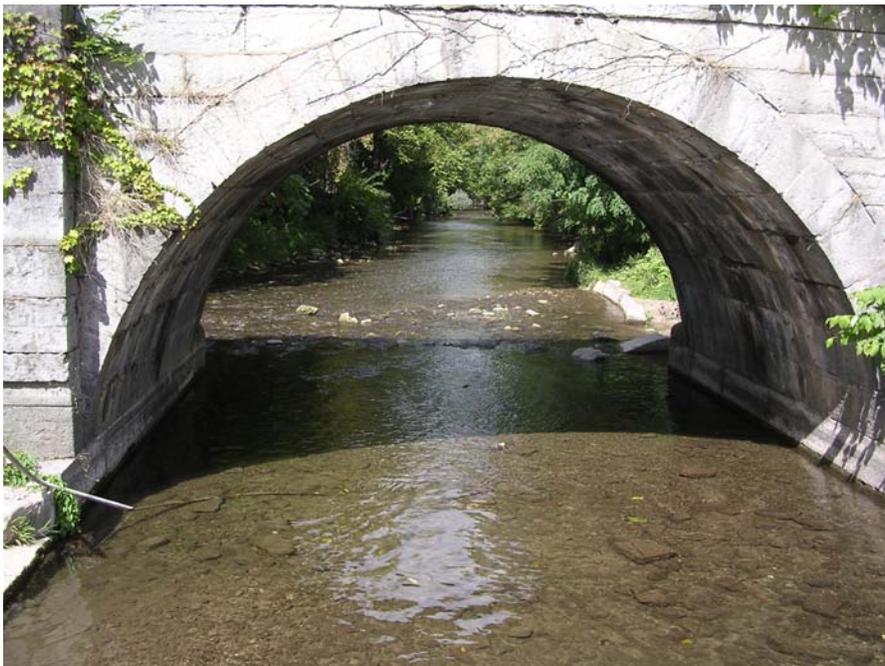
Photo 12: Skaneateles Creek looking downstream through old Erie Canal bridge – no problems.

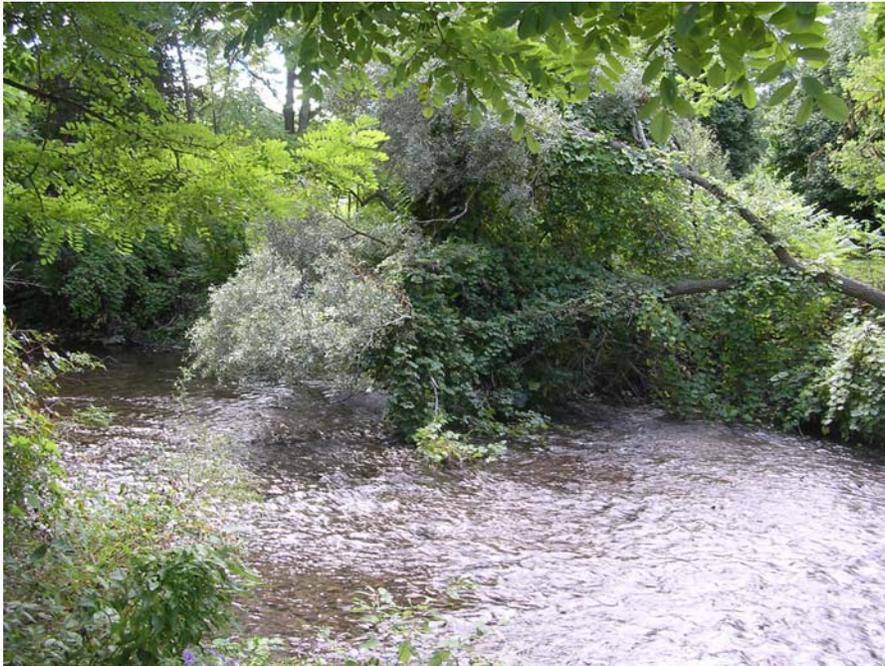
Photo 13: Hanging tree on left bank downstream of old Erie Canal bridge.

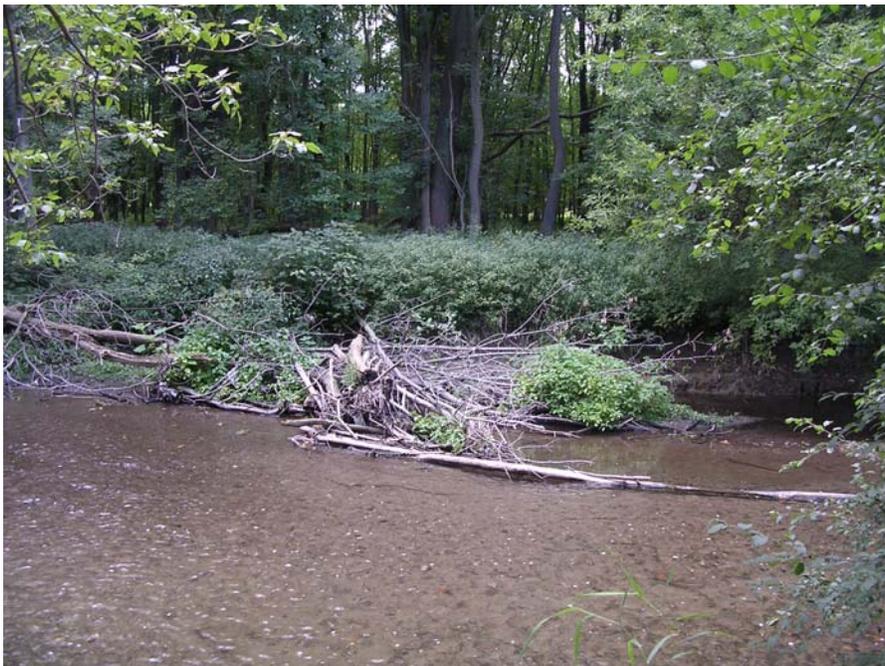
Photo 14: Branch/tree debris jam just upstream of North Main Street bridge.

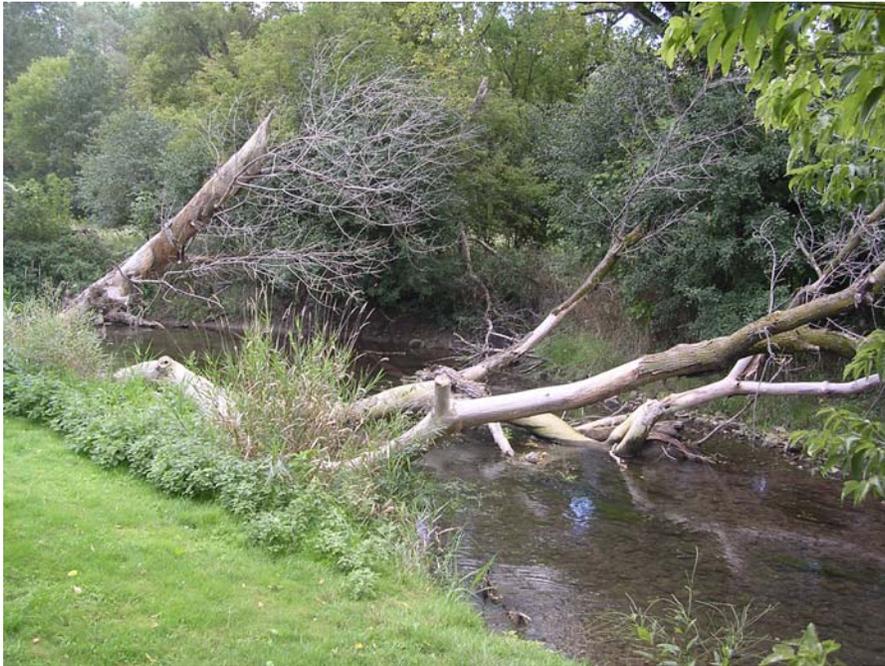
Photo 15: Downed trees just downstream of north end of Diversion Channel.

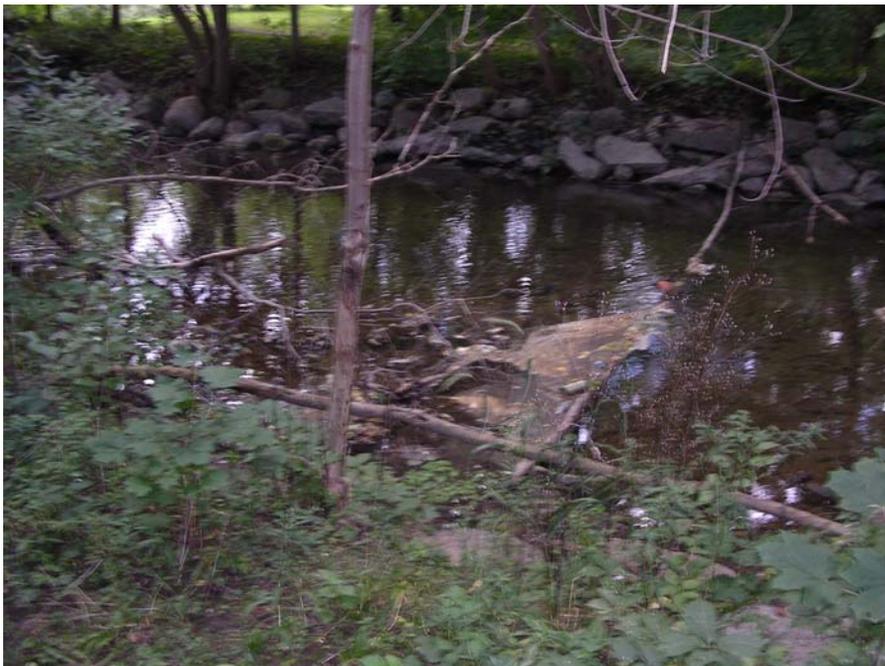
Photo 16: Small trees in creek and along edges – downstream of old Erie Canal bridge.
