SUBJECT: FY07 Joint Routine Inspection of Completed Works, Flood Damage Reduction Project, Owasco Inlet, Mill and Dry Creeks, Moravia, New York (9/11/07)

Attachment “A” - Project Inspection Photographs

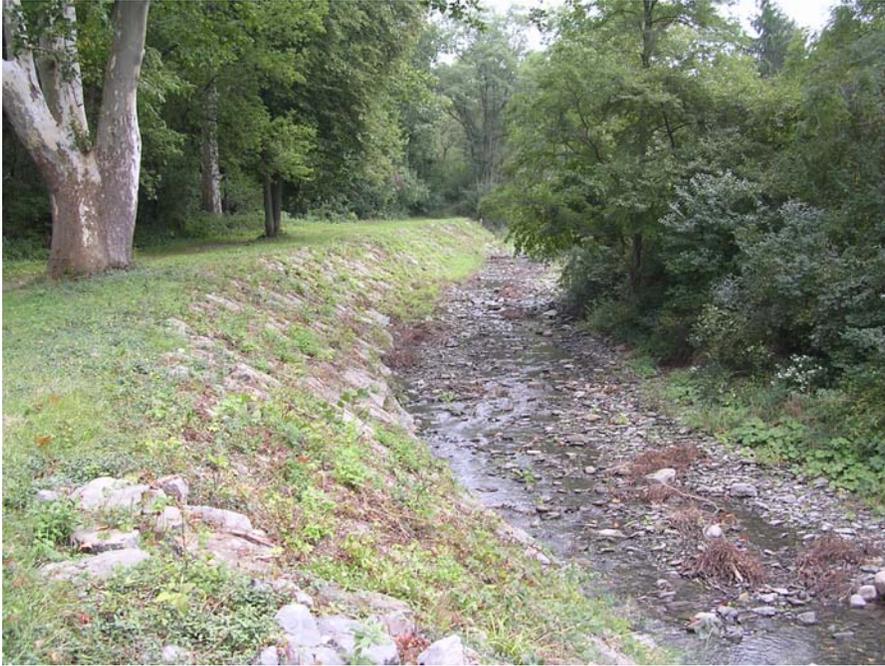
Photo 1: Upstream end of Dry Creek – no problems.

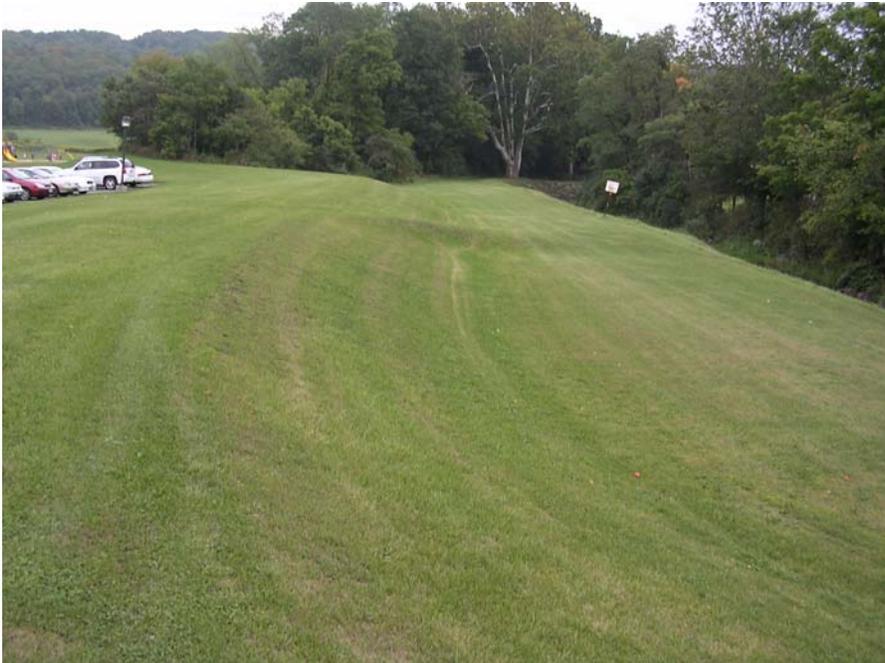
(1) Generally, the project's channels are in satisfactory overall condition. The levee along Dry Creek is being maintained in an excellent manner (see photos 2 & 4).

Photo 2: Looking upstream at levee along right bank of Dry Creek upstream of Route 38 bridge – no problems.

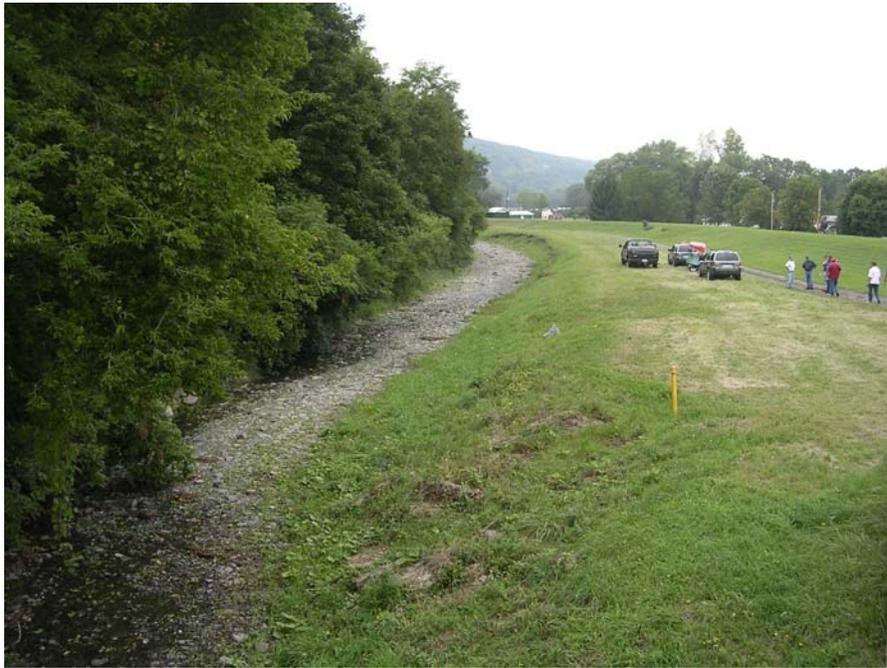
Photo 3: Dry Creek, looking downstream from Route 38 bridge – no problems.

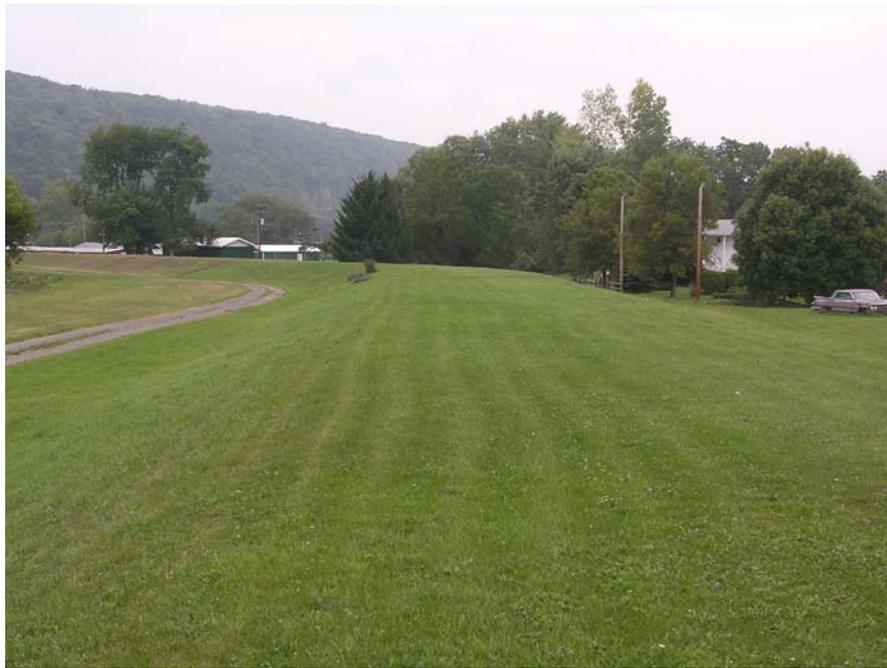
Photo 4: Looking downstream at levee along right bank of Dry Creek downstream of Route 38 bridge – no problems.

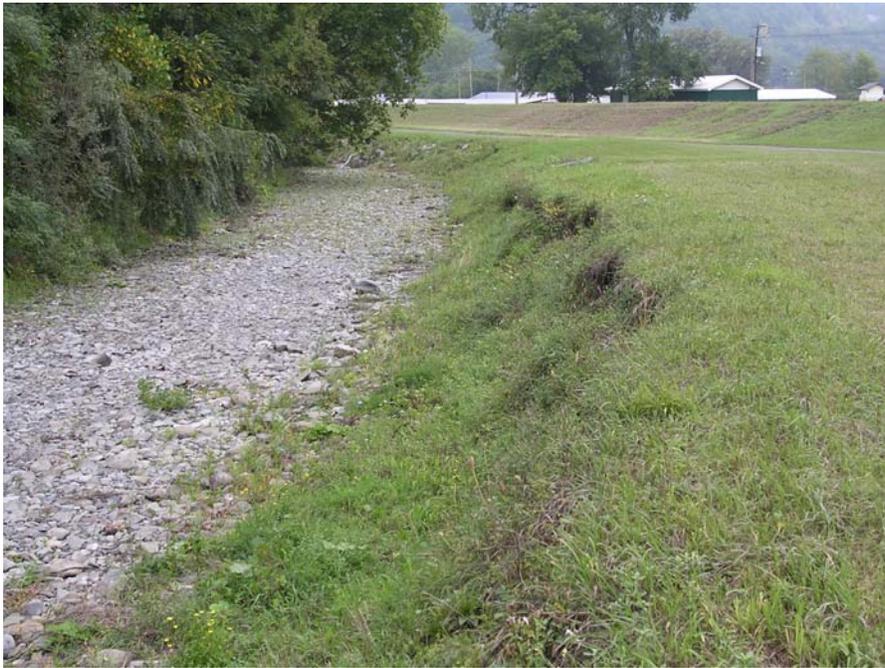
Photo 5: Erosion along right bank of Dry Creek between Route 38 and abandoned Lehigh Valley Railroad bridge.

(2) Repair erosion along right bank of Dry Creek between Route 38 and abandoned Lehigh Valley Railroad bridge before it becomes worse. Placement of riprap may resolve problem.

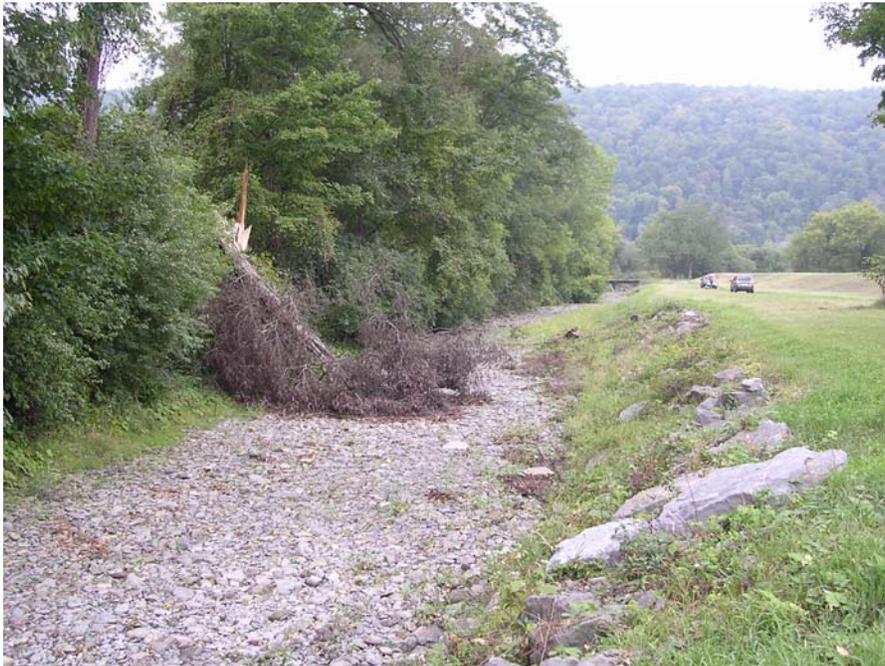
Photo 6: Downed tree in channel along left bank of Dry Creek between Route 38 and abandoned Lehigh Valley Railroad bridge.

(3) Remove all trees, branches, debris, and shoals from stream as noted in Sections 7.a. and 7.b above, as well as any new obstructions.

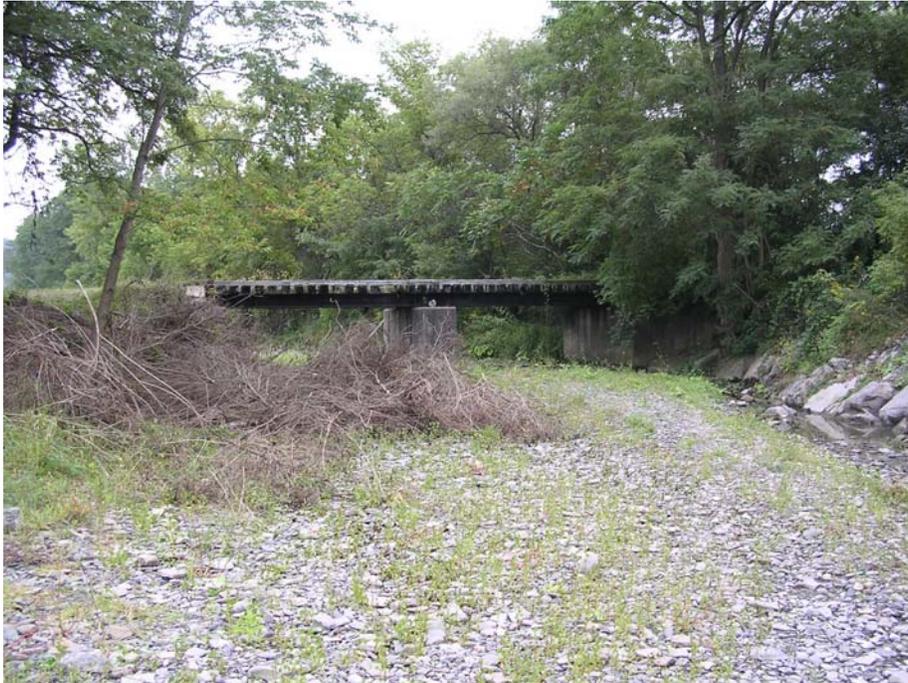
Photo 7: Branches along right bank of Dry Creek just downstream of abandoned Lehigh Valley Railroad bridge.

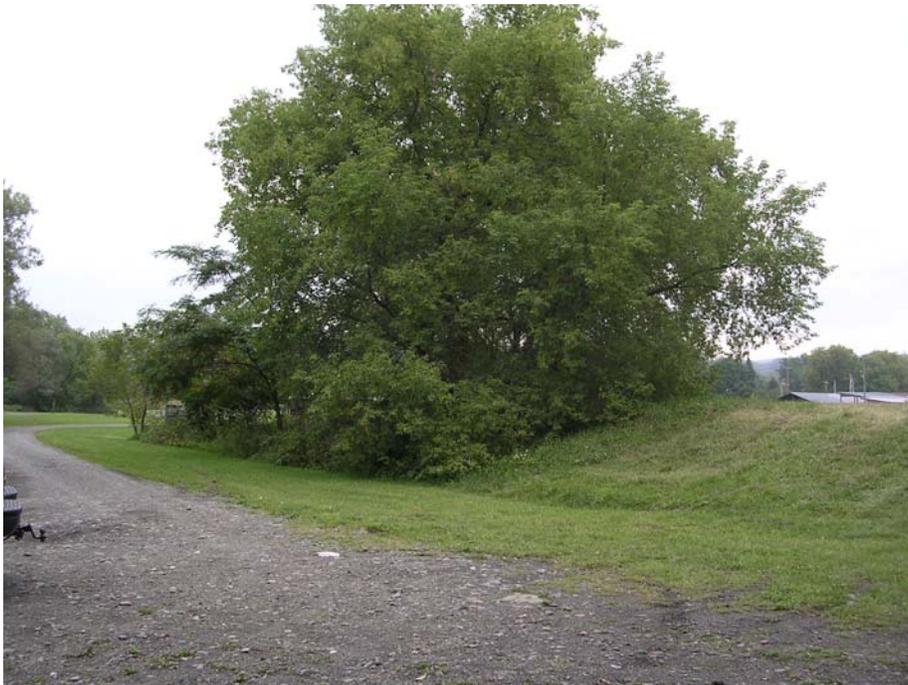
Photo 8: End of levee near abandoned Lehigh Valley Railroad bridge – levee is open ended at this point.

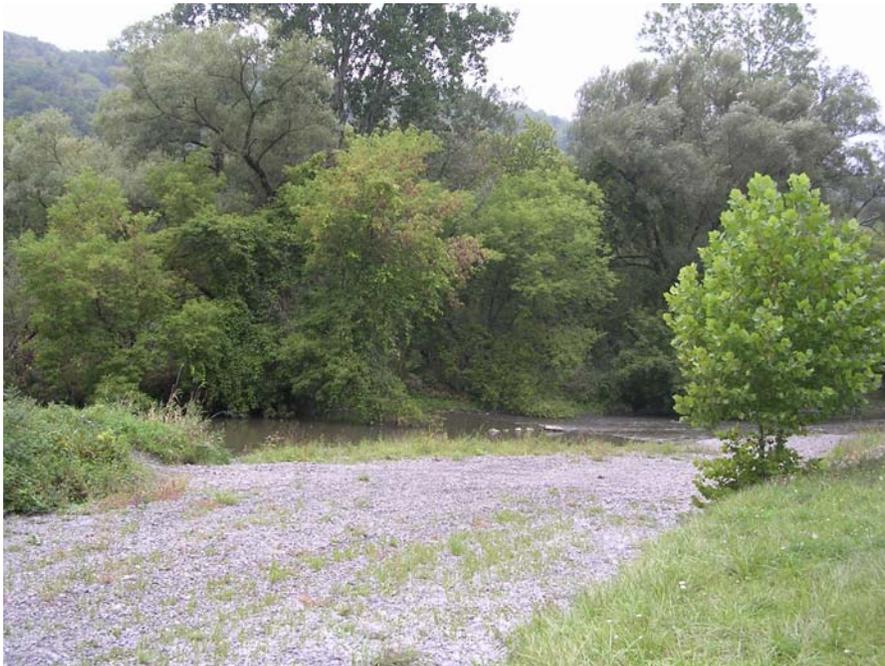
Photo 10: Downstream end of Dry Creek at its confluence with Owasco Inlet – no problems.

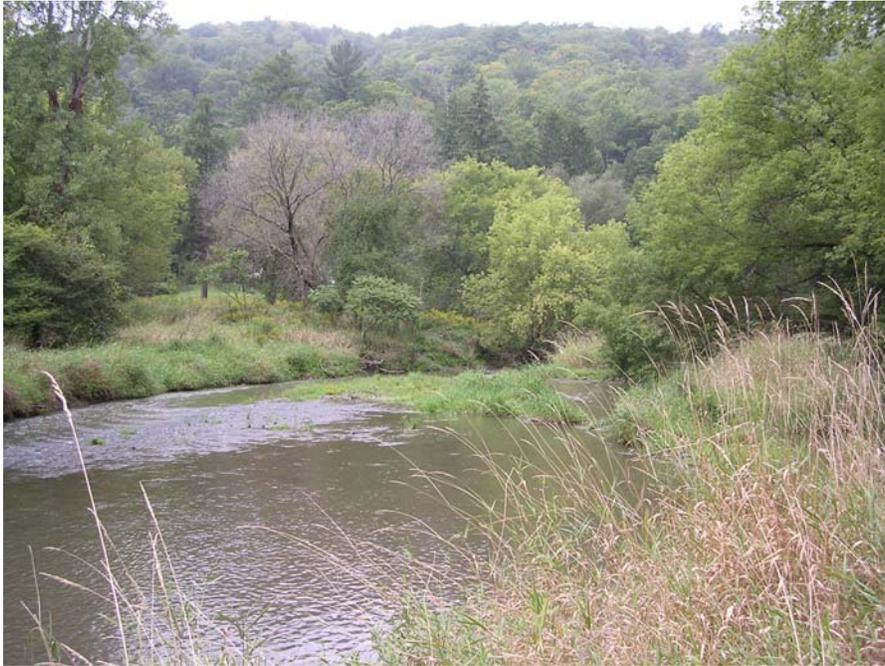
Photo 11: Owasco Inlet downstream of Dry Creek – minor shoaling forming.

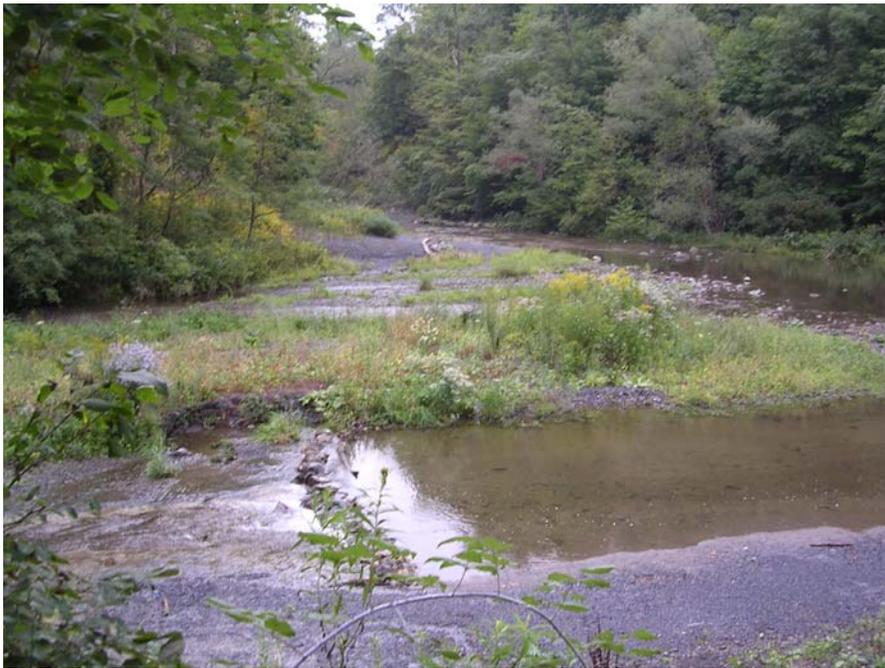
Photo 12: Mill Creek settling basin. A moderately large vegetated shoal has developed in middle of settling basin.

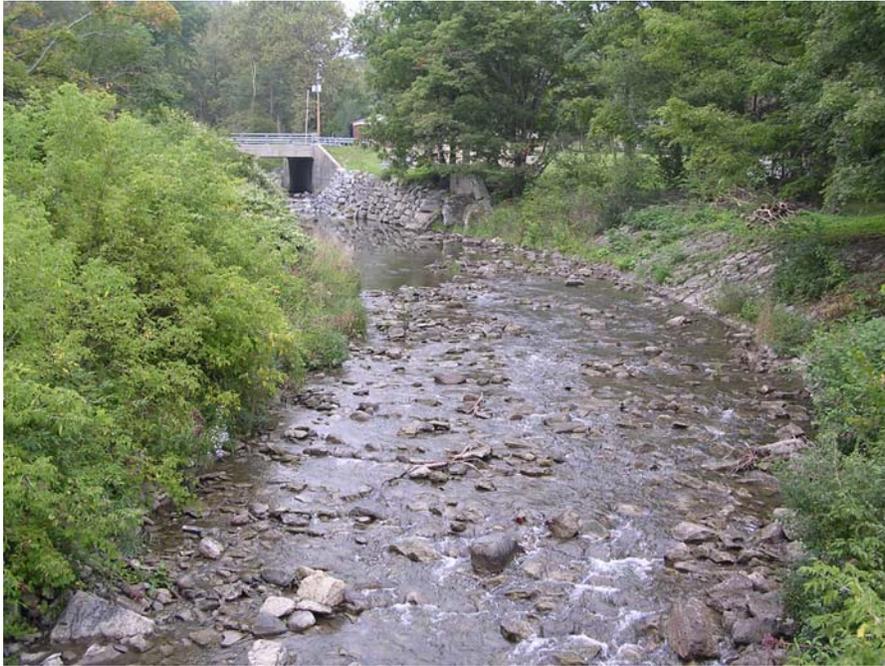
Photo 13: Looking upstream at Mill Creek from Smith Street bridge. Vegetation growing in the riprap along the left and right banks.

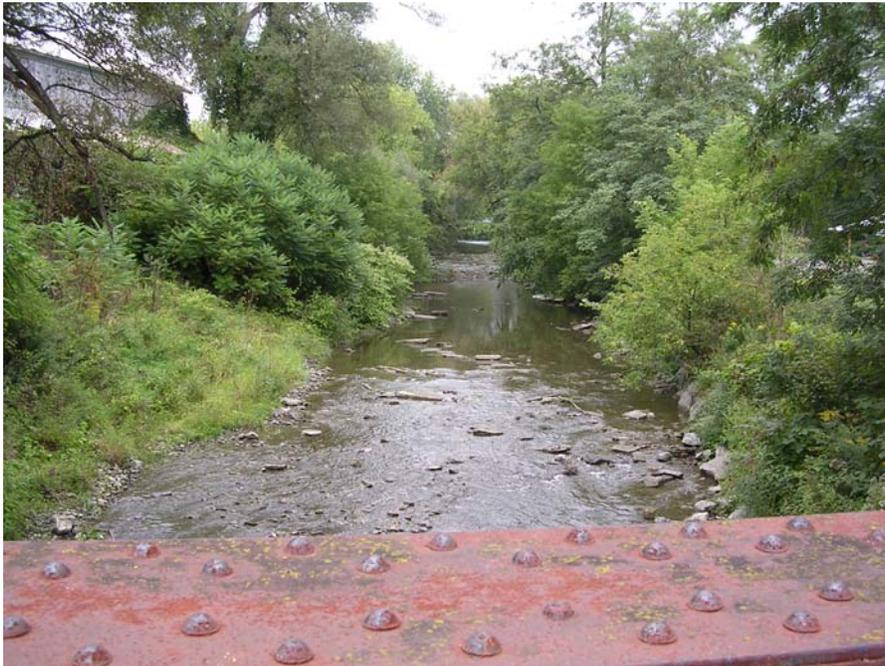
Photo 14: Looking downstream at Mill Creek from Smith Street bridge - no problems.

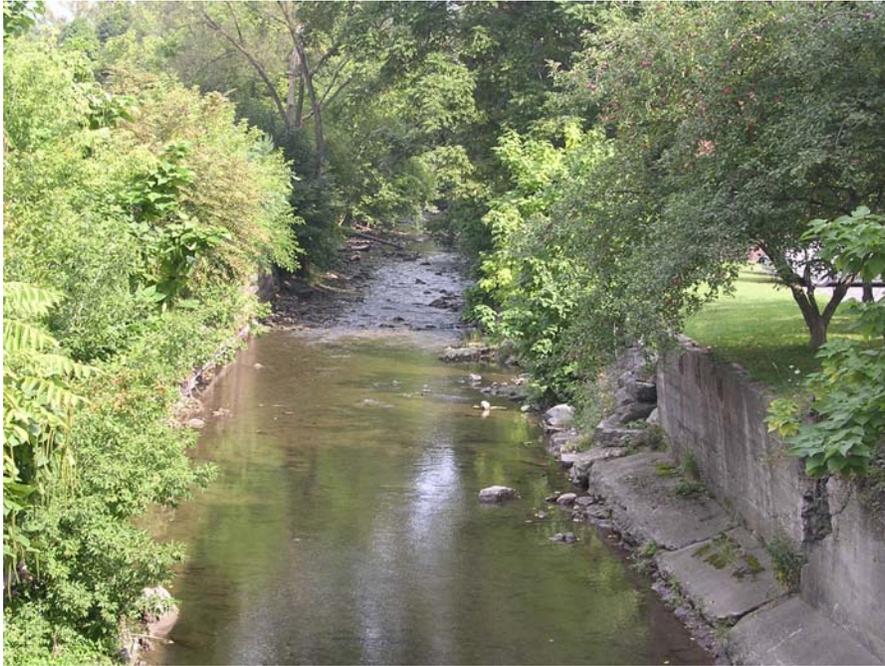
Photo 15: Looking upstream at Mill Creek from Main Street bridge – Tree in creek on right bank (in distance).

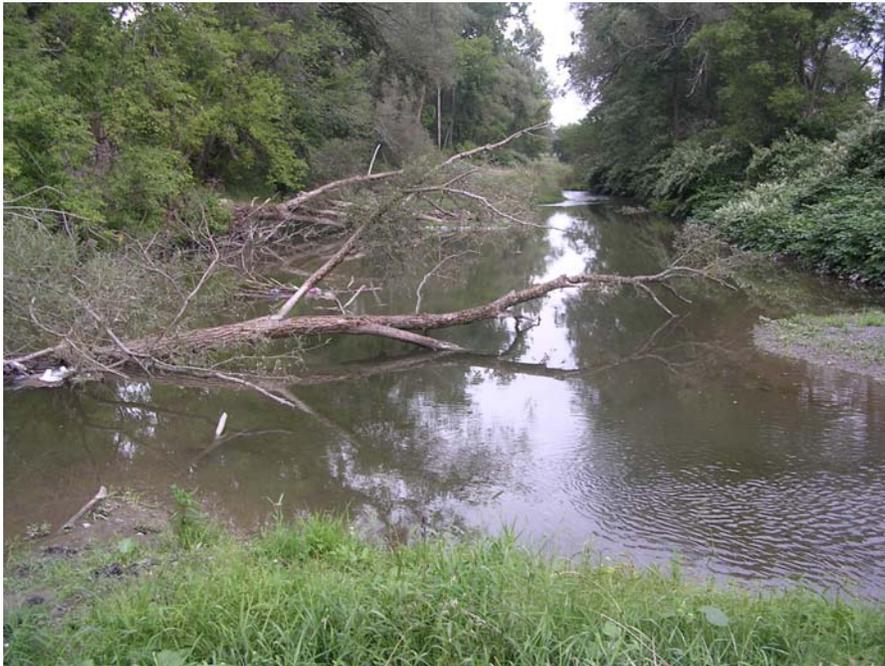
Photo 16: Two large downed trees on left bank of Owasco Inlet at confluence with Mill Creek.

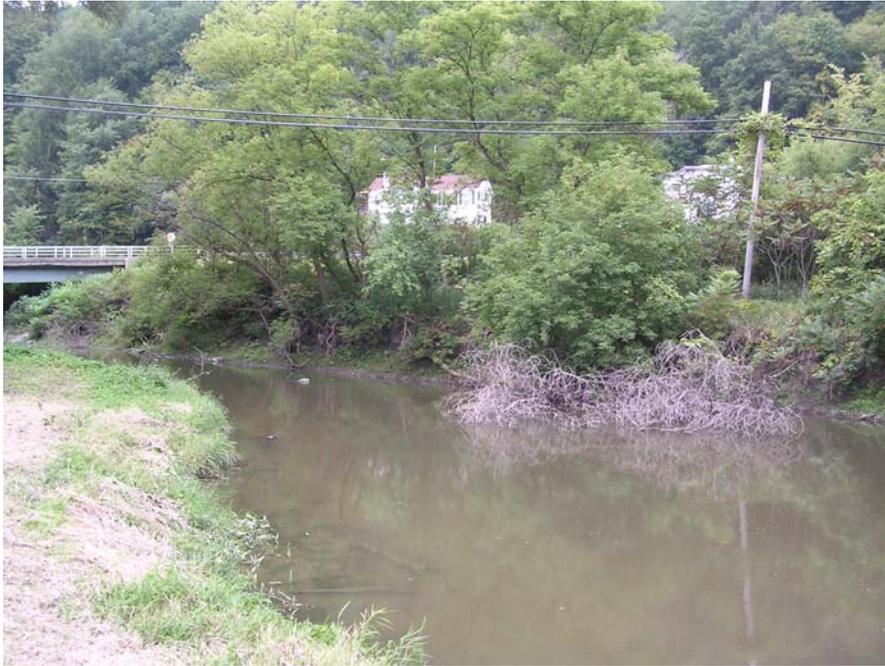
Photo 17: Minor brush snags along the left bank of Owasco Inlet just downstream of the Aurora Street bridge.

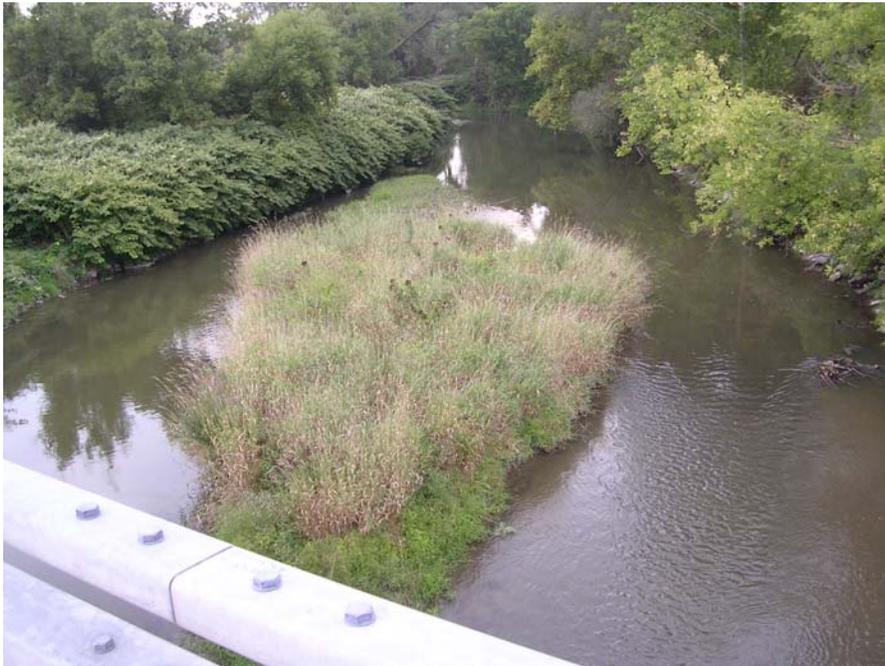
Photo 18: Large shoal in Owasco Inlet channel upstream of the West Cayuga Street bridge.

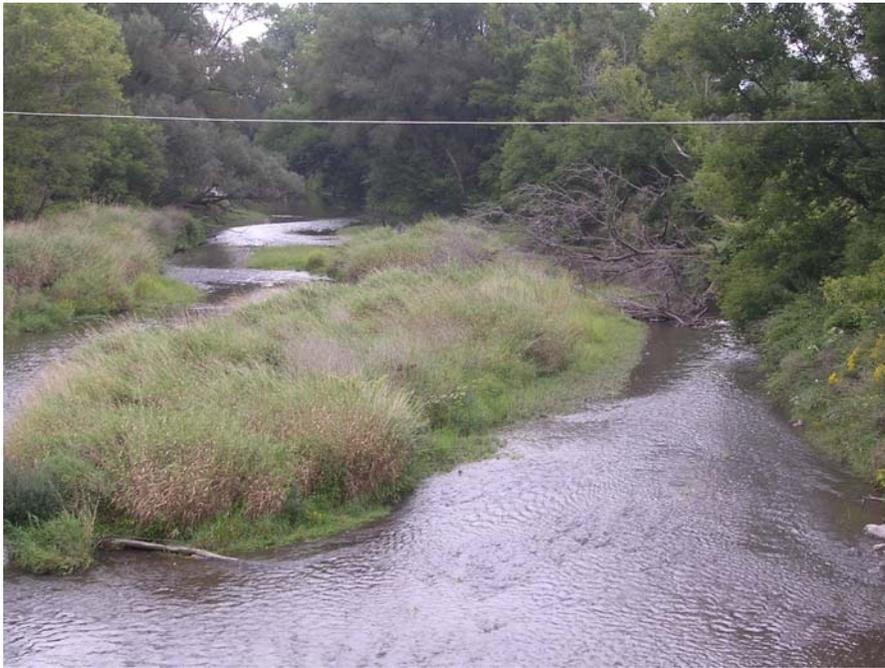
Photo 19: Large shoal in Owasco Inlet channel downstream of the West Cayuga Street bridge.

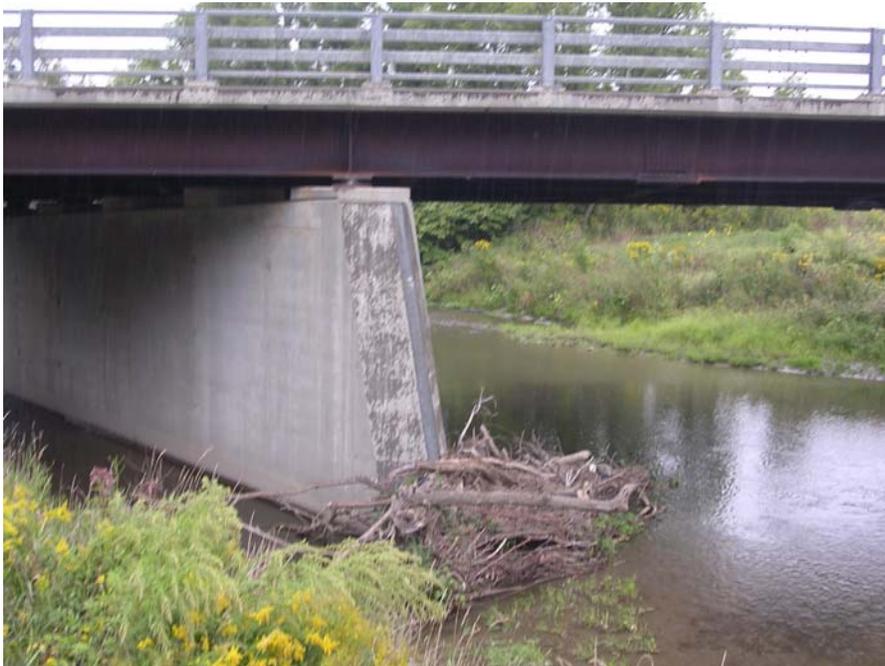
Photo 20: Debris accumulation on the upstream side of the West Cayuga Street bridge, Owasco Inlet Channel.

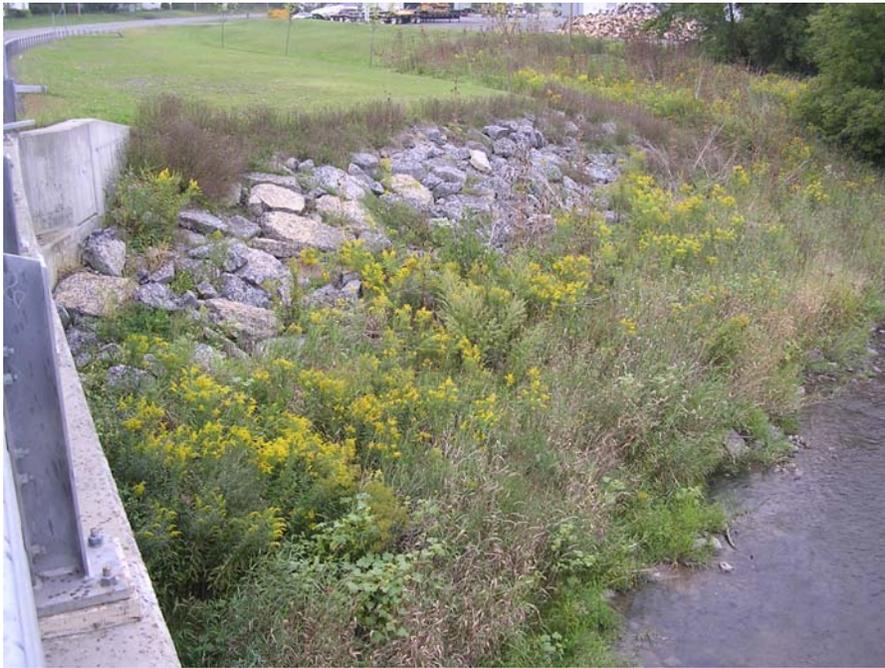
Photo 21: Vegetation in riprap at West Cayuga Street bridge, Owasco Inlet.

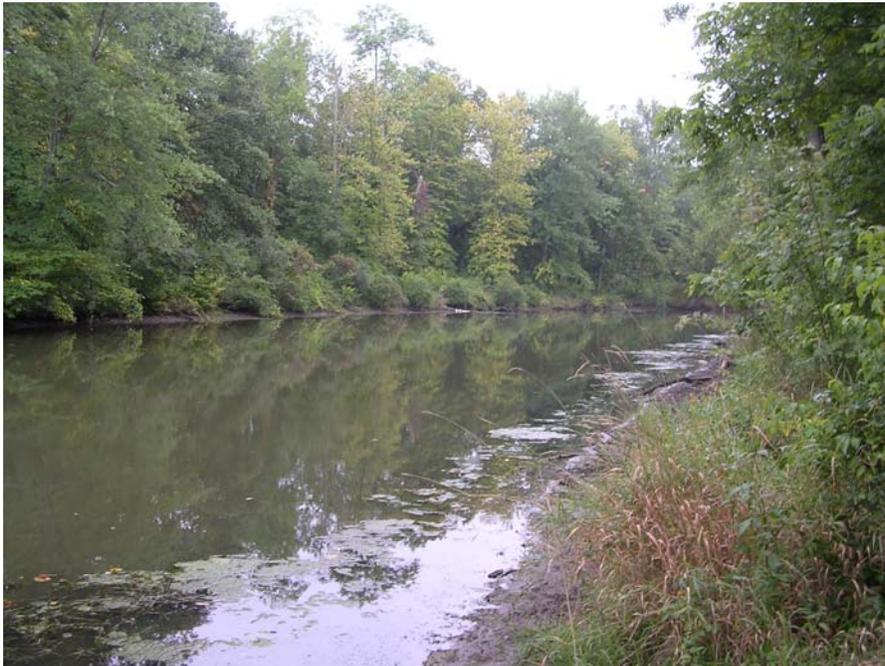
Photo 22: Looking upstream at Owasco Inlet, near south end of Owasco Lake – no problems.
