## DEPARTMENT OF THE ARMY

BUFFALO DISTRICT, CORPS OF ENGINEERS  
1776 NIAGARA STREET  
BUFFALO, NEW YORK 14207-3199

SUBJECT: FY07 Joint Routine Inspection of Completed Works, Flood Damage Reduction Project, Onondaga Creek, Nedrow, New York (9/13/07)

**Attachment “A” - Project Inspection Photographs**

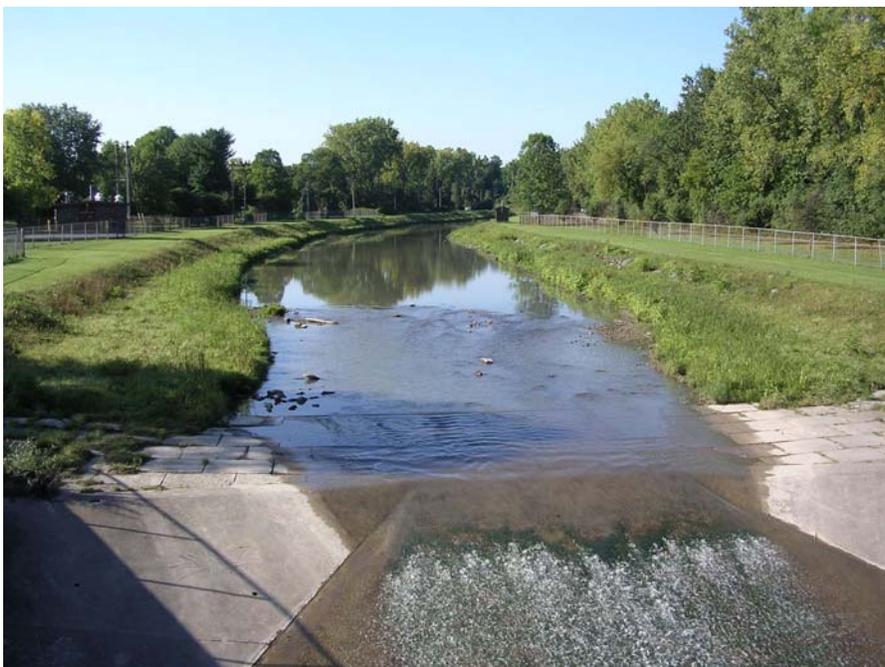
- (1) Riprap is either missing or is covered by sediment and/or vegetation at downstream limit of project, left and right banks between approx. stations 51+00 and 55+00 (see photos 2-4). Correction of deficiency required by 06/30/09.

- (2) Shoals forming along and left right banks at downstream limit of project, immediately upstream of the Dorwin Ave. drop structure, between approx. stations 51+00 and 55+00 (see photos 2-4). Correction of deficiency required by 06/30/09.

**Photo 2: Channel at downstream limit of project (looking upstream). Riprap either missing or covered by sediment and/or vegetation (both banks). Shoaling along left and right banks along length of riprap. Drop structure is upstream limit of Onondaga Creek, Syracuse flood control project.**

(2) Riprap at downstream limit of project along left and right banks between approx. stations 51+00 and 55+00 needs to be either uncovered from vegetation and sediment or replaced.

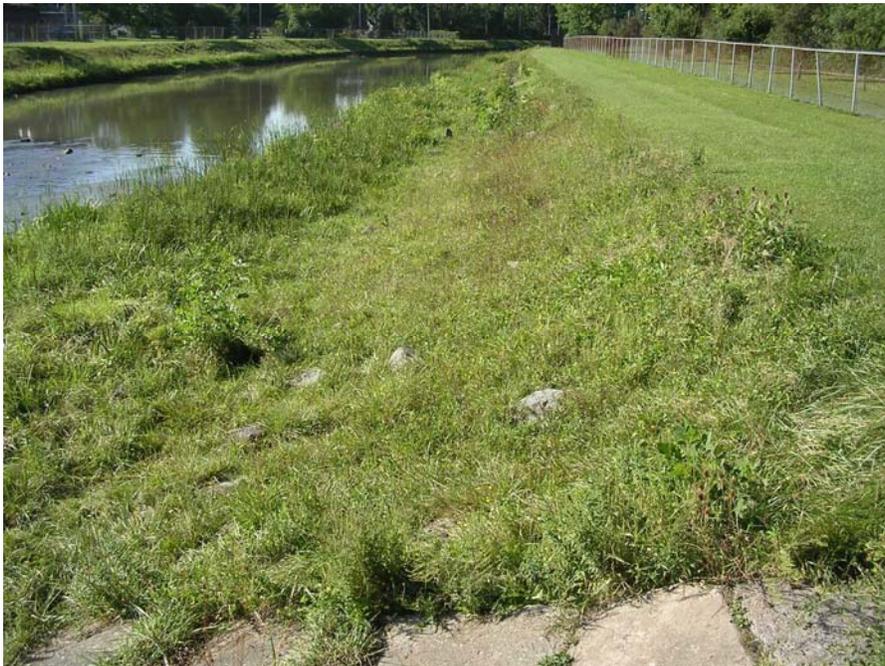
**Photo 4: Left bank of Onondaga Creek, just upstream of Dorwin Ave. bridge. Riprap either missing or covered by sediment and/or vegetation. Shoaling along bank for length of riprap.**

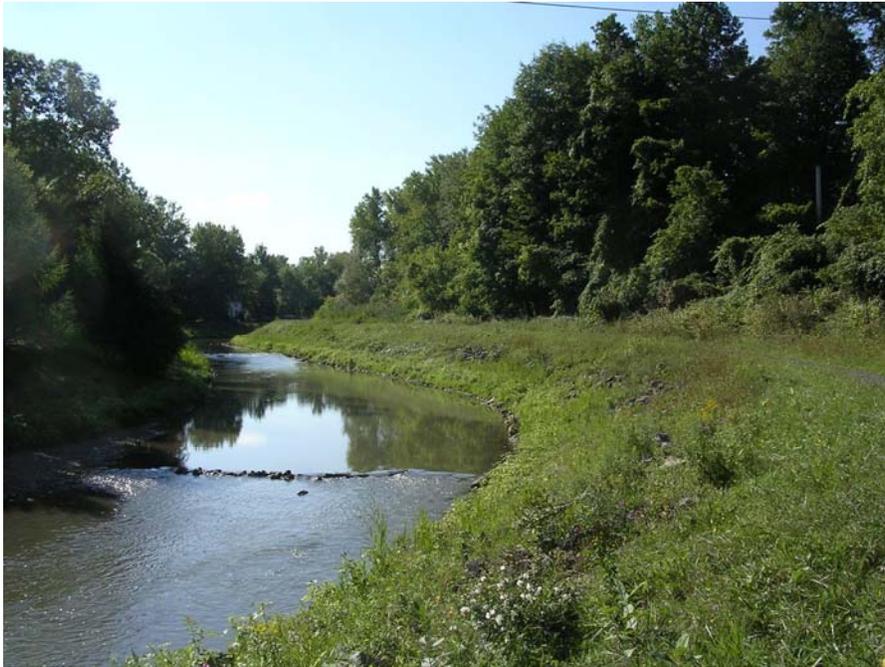
- (3) Vegetation growing in riprap along left bank between stations 29+00 and 38+00 and along right bank between stations 29+00 and 33+74 (see photos 5-7 & 9). Correction of deficiency required by 12/31/08.

**Photo 5: Left bank Onondaga Creek, from approx. Sta. 35+00 (looking upstream). Vegetation in riprap on left and right banks.**

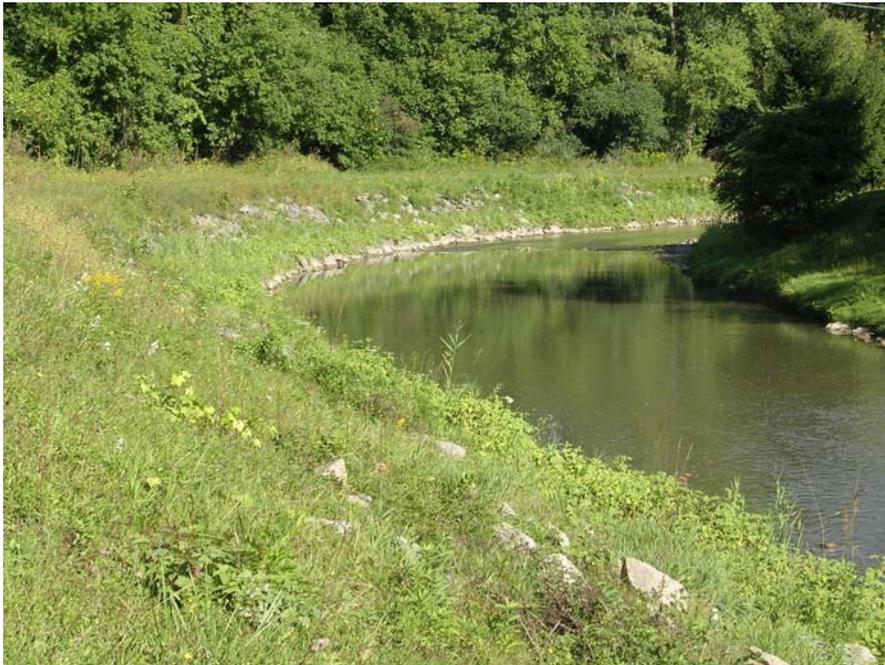
**Photo 6: Left bank Onondaga Creek, from approx Sta. 32+50 (looking downstream). Vegetation in riprap on left and right banks.**

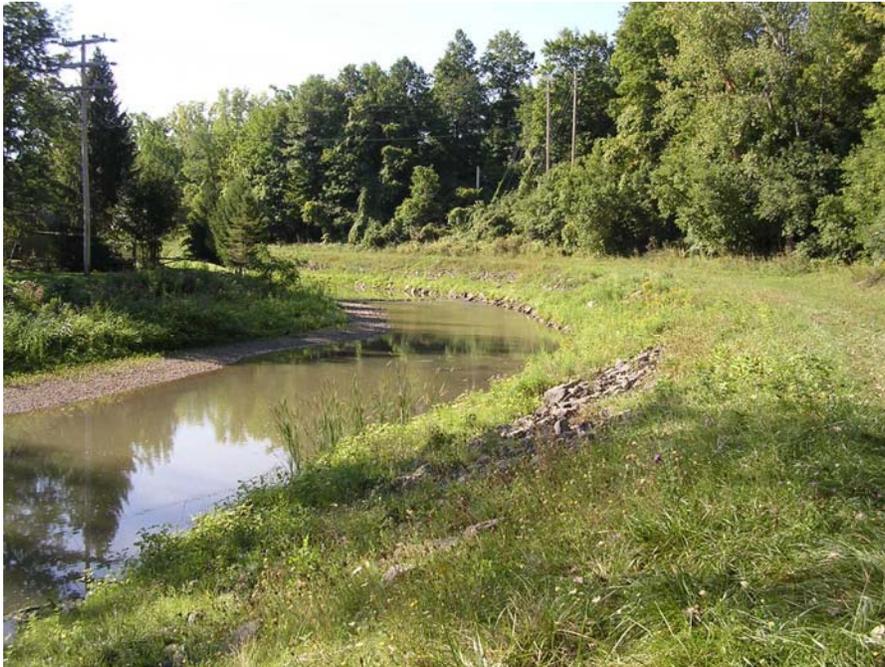
**Photo 7: Onondaga Creek, from approx. Sta. 37+50 (looking upstream).  
Vegetation in riprap on left bank.**

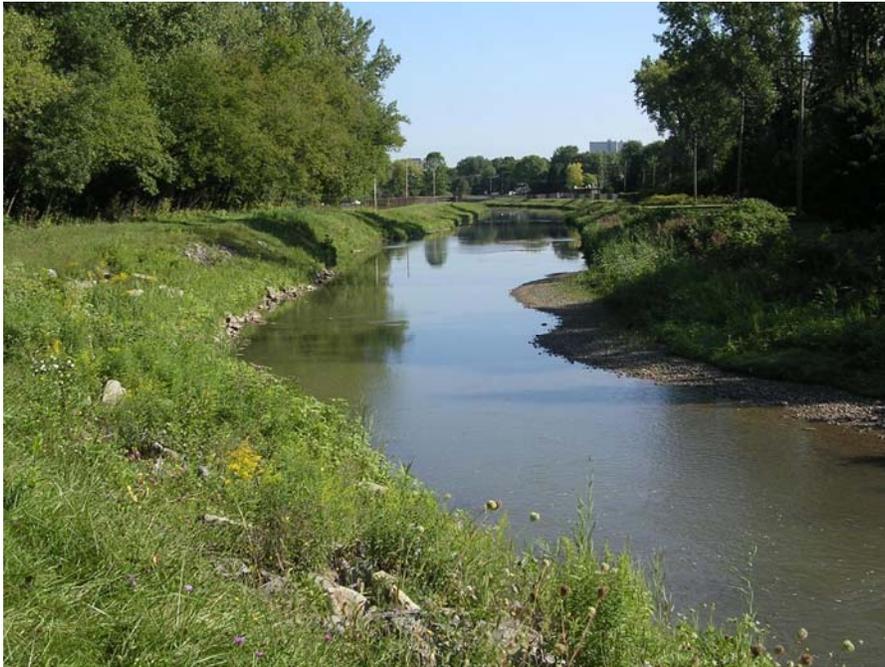
**Photo 9: Onondaga Creek, from approx. Sta. 35+00 (looking downstream). Vegetation in riprap on left bank; shoal forming on right bank.**

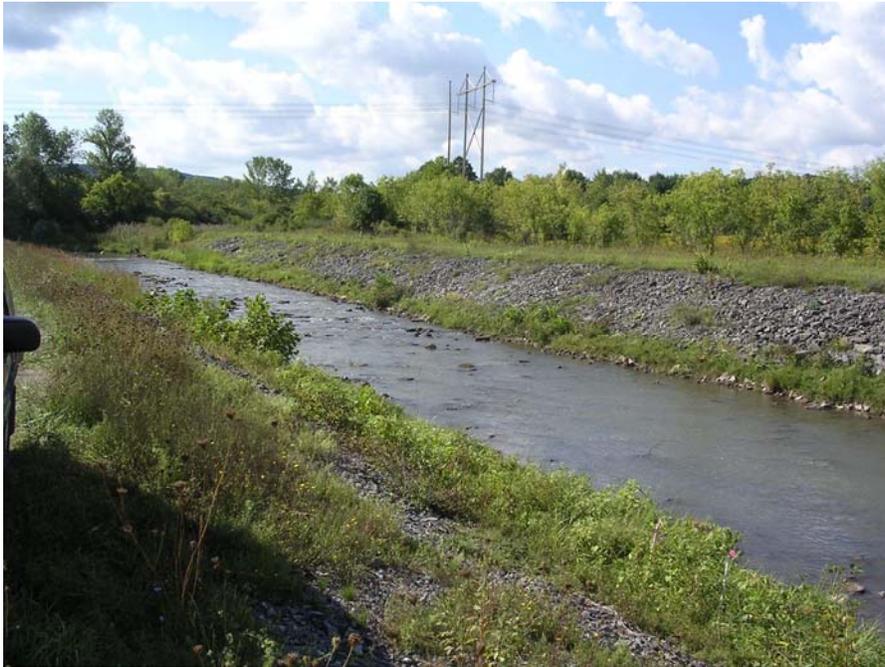
- (4) Vegetation in riprap along left and right banks between station 0+00 and approx. station 6+50 (see photos 11-14). Correction of deficiency required by 12/31/08.

**Photo 11: Onondaga Creek from approx. Sta. 5+00 (looking upstream).  
Vegetation in riprap on left and right banks.**

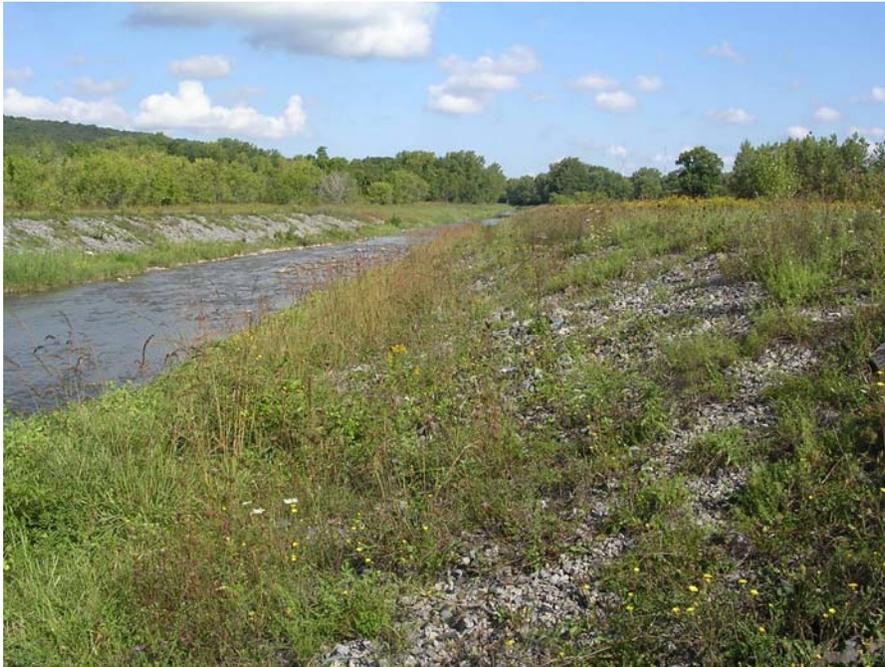
**Photo 13: Onondaga Creek from approx. Sta. 1+00 (looking downstream). Vegetation in riprap on left and right banks.**

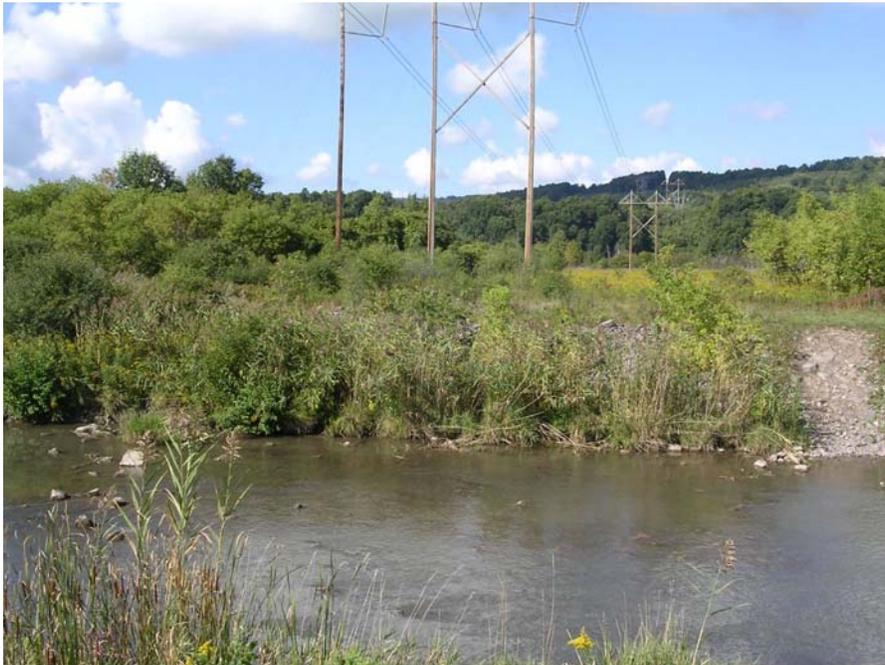
- (5) Vegetation covering riprap along left and right bank flow diversion "dikes" at upstream end of project at station 0+00 (see photos 14-16). Correction of deficiency required by 12/31/08.

**Photo 14: Onondaga Creek from approx. Sta. 1+00, looking at left bank and towards flow diversion “dike” on left bank (near power poles). Left bank riprap and flow diversion riprap embankment covered with vegetation.**

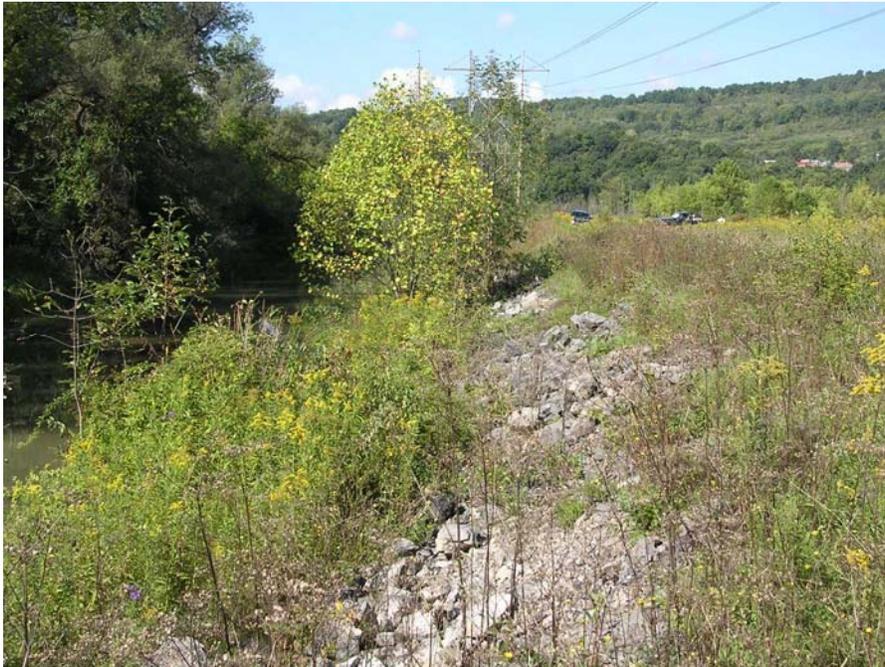
**Photo 15: Onondaga Creek, from approx. Sta. 0+00 (upstream end of project) looking downstream at right bank of flow diversion "dike". Riprap embankment covered with vegetation.**

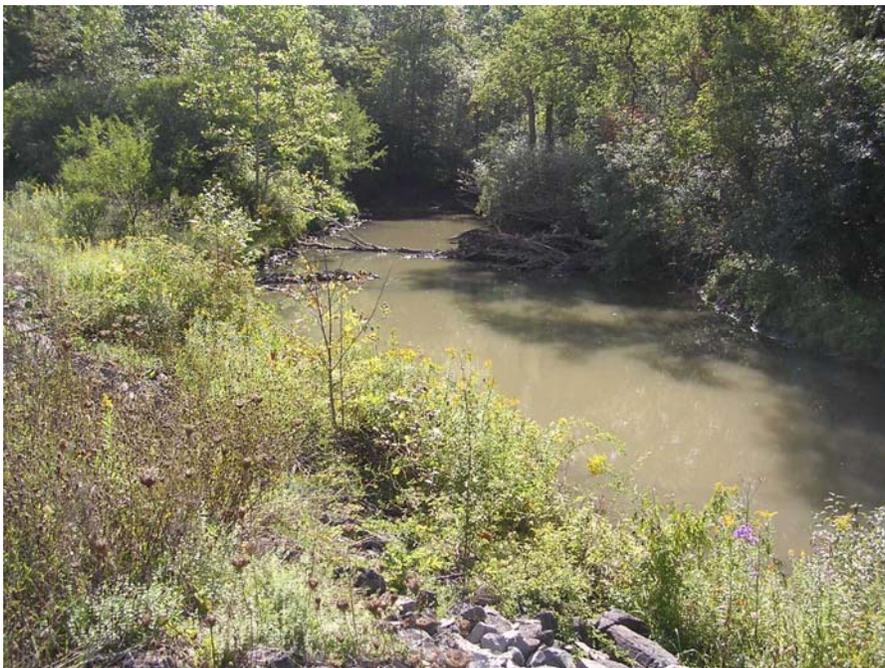
- (6) Tree and debris in creek at station 0+00, at furthest point upstream of project and adjacent to, but not on, Onondaga Nation Territory (see photo 16). Correction of deficiency required by 12/31/08.

**Photo 16: Onondaga Creek, from approx. Sta. 0+00 (upstream end of project), looking upstream at right bank flow diversion "dike". Riprap embankment covered with vegetation, tree in creek, and debris against left bank.**
