DEPARTMENT OF THE ARMY

SUBJECT: FY07 Joint Routine Inspection of Completed Works, Flood Damage Reduction Project, Onondaga Creek, Syracuse, New York (9/13/07)

Appendix “A” - Project Inspection Photographs

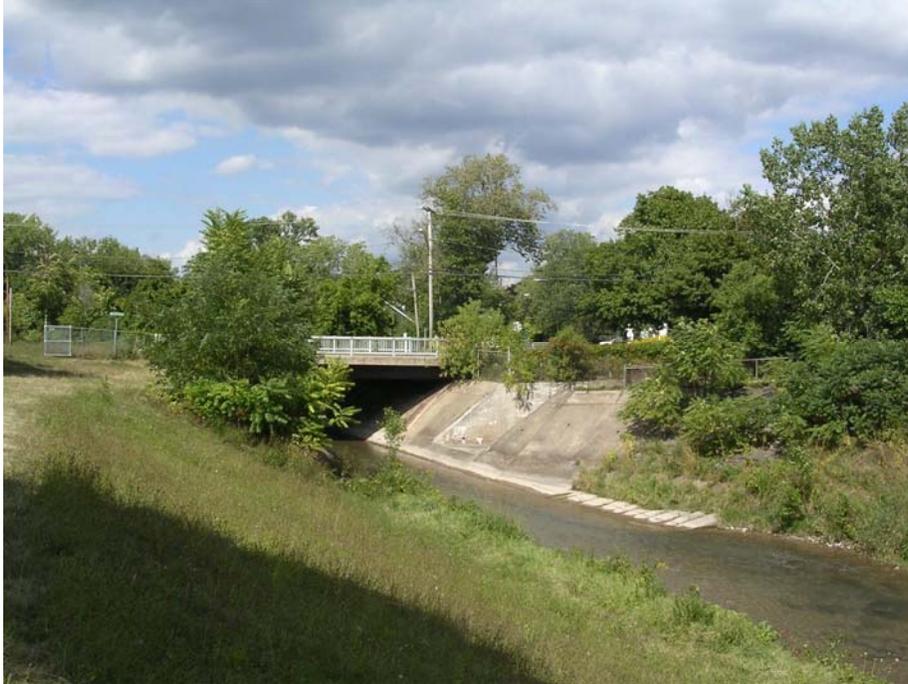
Photo 1: Downstream limit of project at Ballantyne Road bridge (looking downstream) – vegetation on sideslopes.

(4) Vegetation needs to be removed from riprapped areas, around drainage structures, from concrete flume, and around channel sideslopes at downstream end of project near Ballantyne Road bridge, as noted in Section 7.b. (#s 1, 2, 7, 11, 12, and 13). Vegetation at concrete flume needs to be removed from within flume, along sides, and to at least where the approx. 24" pipe enters the flume. Recommend removal of vegetation as noted in Section 7.a.2 & 3.

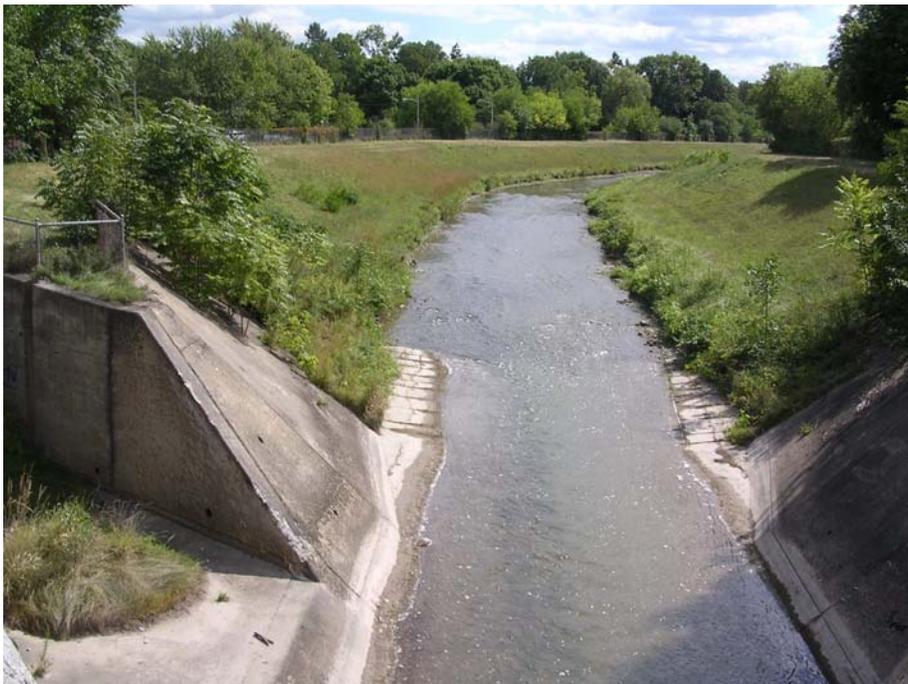
Photo 2: Onondaga Creek just upstream of Ballantyne Road bridge – vegetation on sideslopes.

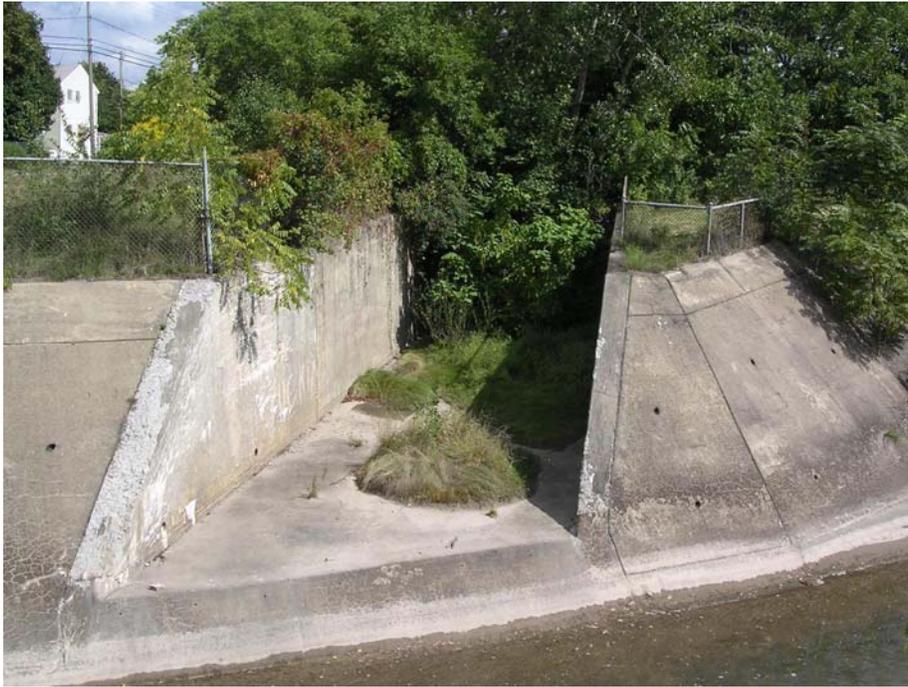
- (2) Vegetation growing in and along sides of concrete flume at Sta. 104+20 (see photo 3).
- (3) Chain link fence damaged at left bank sideslope wall, just upstream of Ballantyne Road bridge (see photo 4).

Photo 3: Concrete flume – right bank just upstream of Ballantyne Road bridge - vegetation in flume.

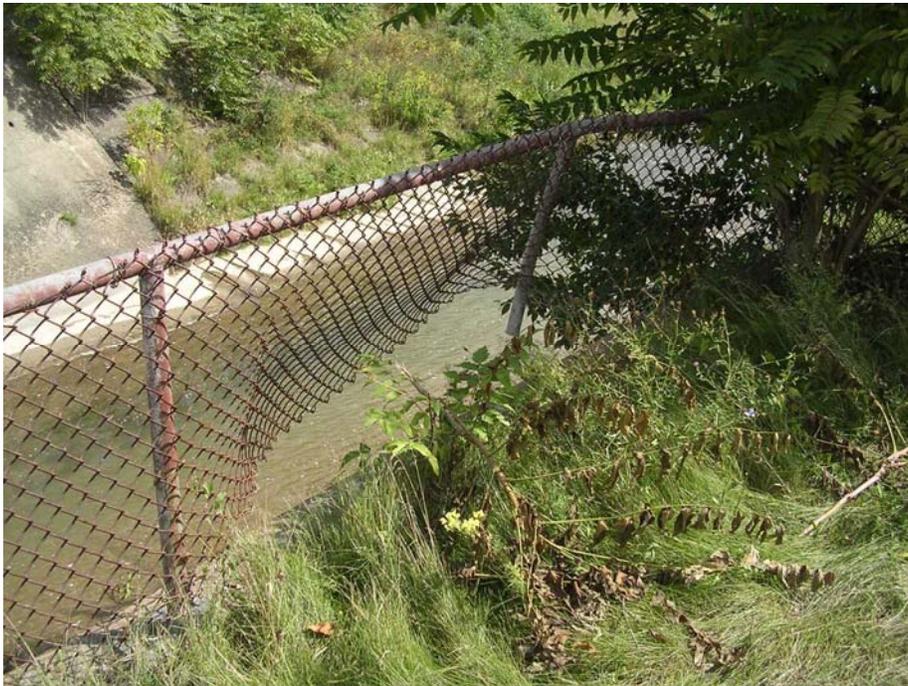
Photo 4: Damaged chain link fence at left bank sideslope wall, just upstream of Ballantyne Road bridge.

(5) Repair damaged chain link fence on left sideslope wall, just upstream of Ballantyne Road bridge (7.b.3).

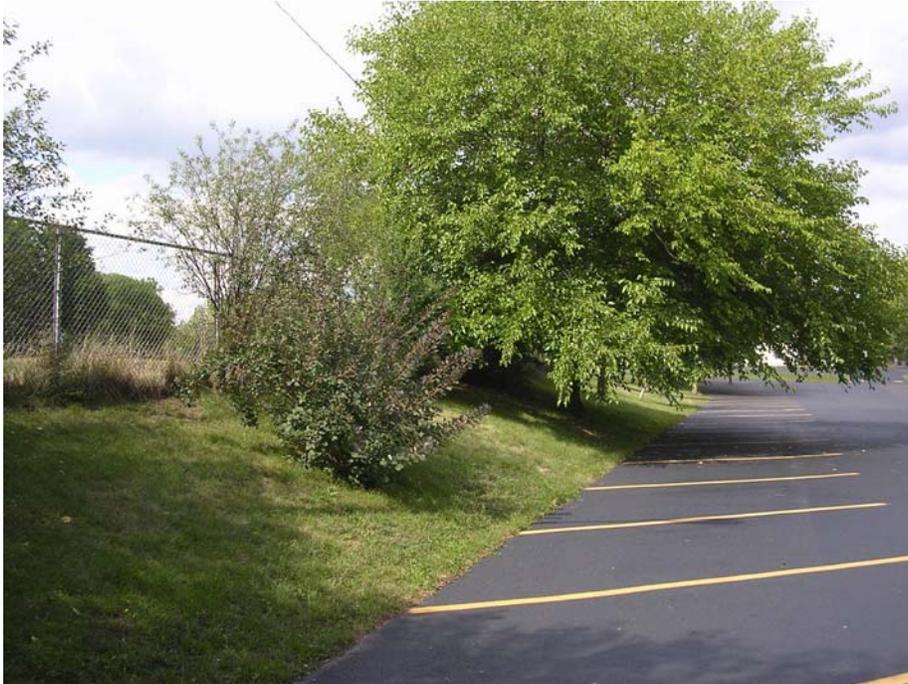
(1) A significant amount of trees, bushes, and brush is growing on levees on right bank between Sta.'s 92+00 and 102+00 and, on left bank between Sta.'s 87+00 and 101+00 (see photos 5, 6, 11, 31, & 32). Vegetation is growing into chain link fence placed along top of levees by City of Syracuse. See Section 10.(1). Correction of this deficiency is required by 12/31/09.

Photo 5: Trees and bushes on levee – right bank of Onondaga Creek, upstream of Ballantyne Road bridge.

(12) Remove trees (including stumps and major roots), bushes, and brush growing in left and right bank levees, to a distance of 15 feet outward from the toes of the levees. Repair levee embankment with compacted impervious fill and topsoil and seed. Fill in impacted areas between levee toe and 15 foot limit with compacted fill. Remove vegetation from City of Syracuse chain link fence. NYSDEC may wish to have City relocate fence off levees to facilitate future maintenance (7.c.).

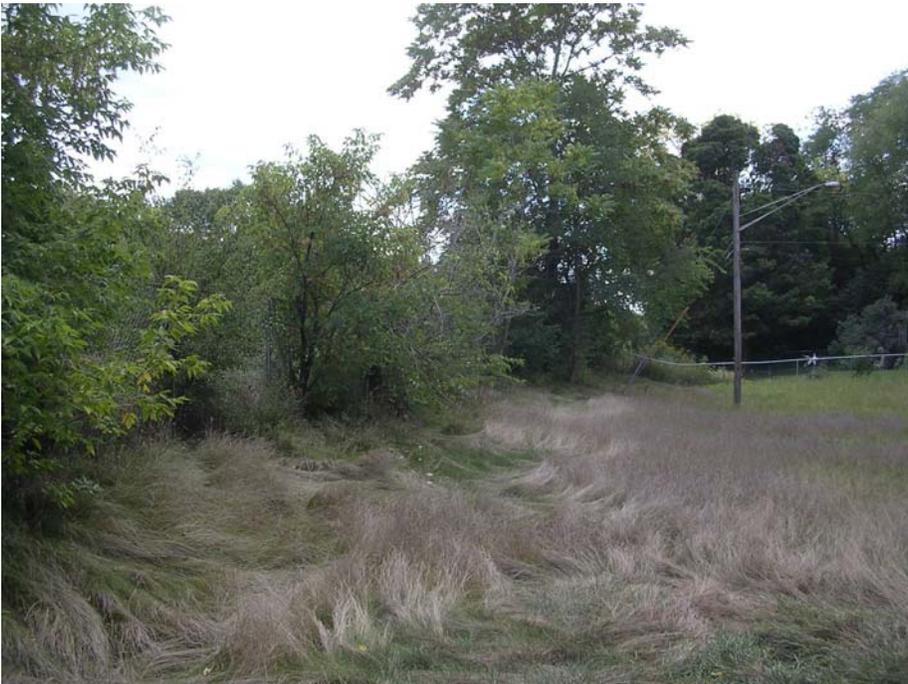
- (4) There are a number of fences constructed by private homeowners which encroach upon the right and left bank levees (see photo 6 for example).
- (5) Concrete paver block apron is damaged at outfall on right bank at approx. Sta. 85+00 (see photo 14).

Photo 6: trees and brush on levee – left bank upstream of Ballantyne Road bridge.

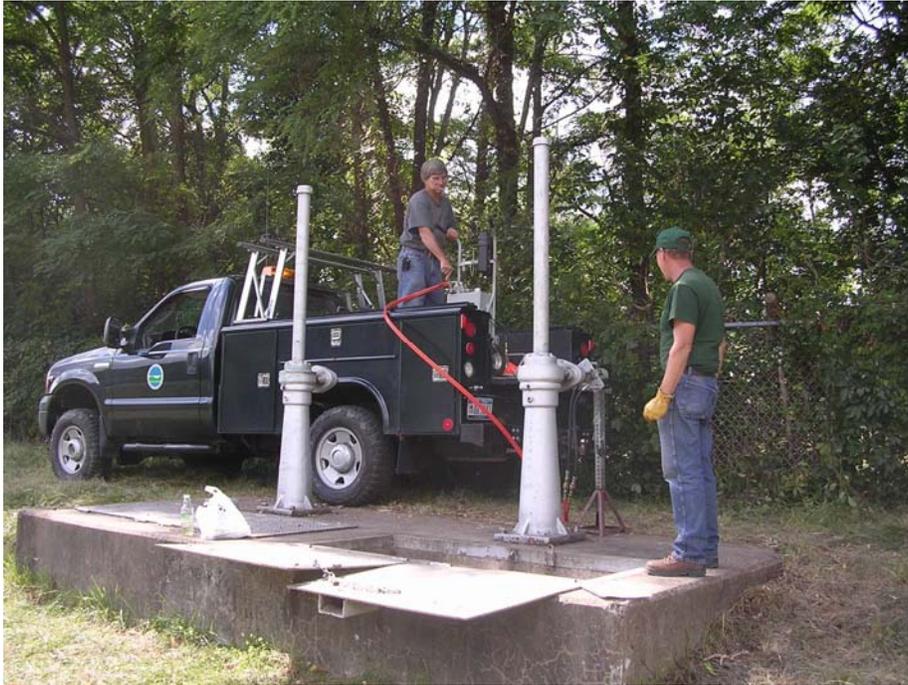
Photo 7: Testing gateway for drainage structure at approx. Sta. 96+10, left bank.

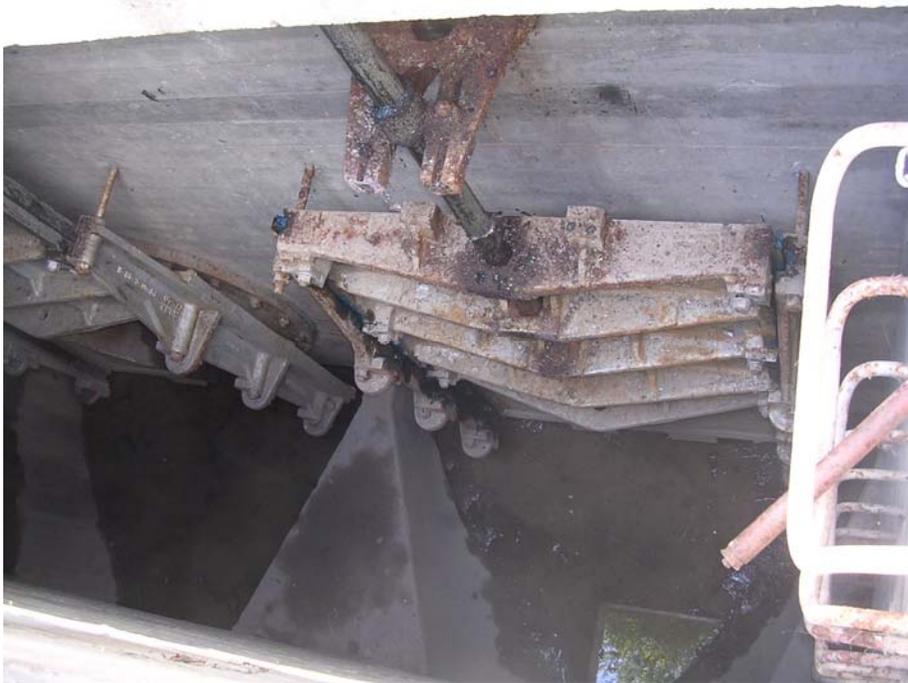
Photo 8: Sluiceways in gateway at approx. Sta. 96+10, left bank – upstream sluiceway (left side in photo) kept closed since connecting pipe no longer used.

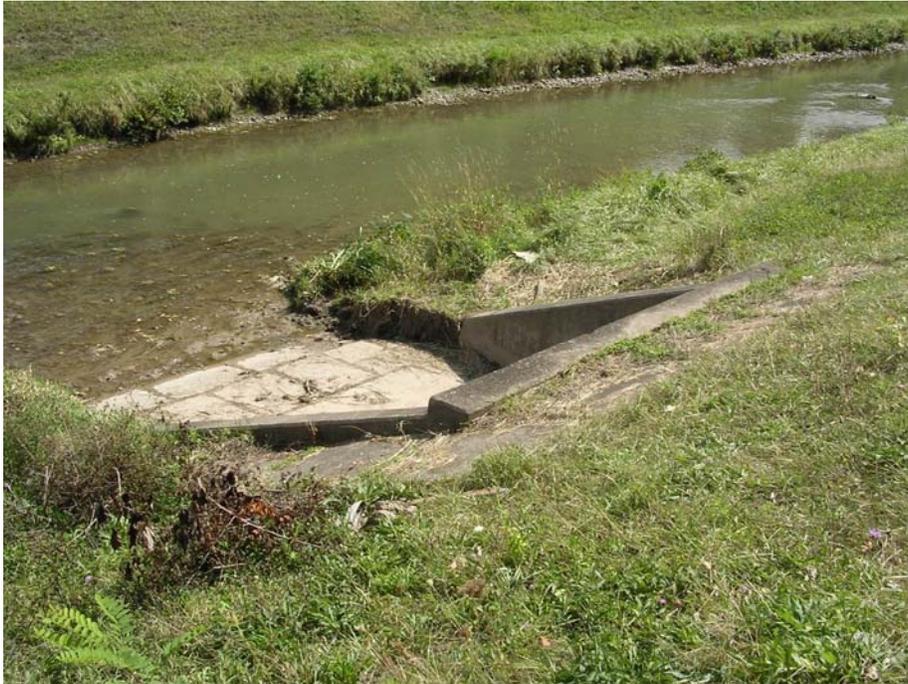
Photo 9: Outlet structure for drainage structure at approx. Sta. 96+10, left bank.

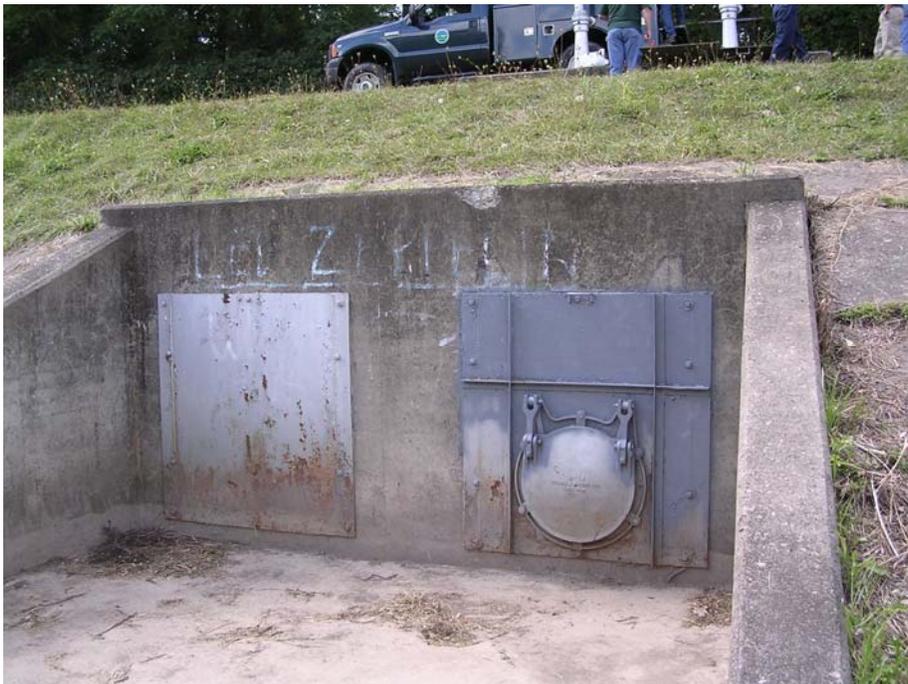
Photo 10: Outlet for drainage structure at approx. Sta. 96+10, left bank. Upstream outfall (left side in photo) permanently closed.

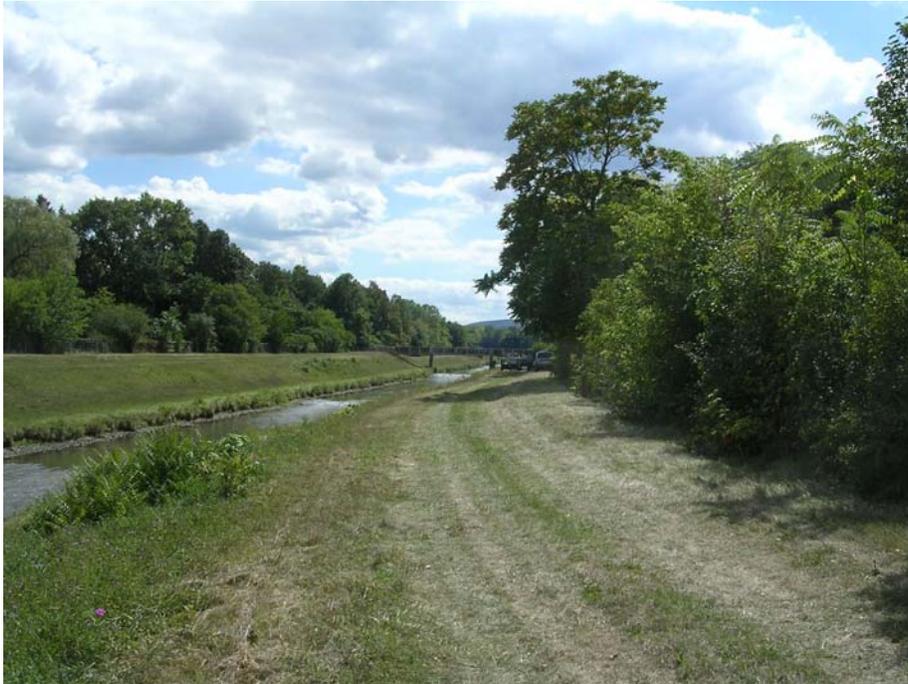
Photo11: Channel and left/right bank levees (looking upstream) between Ballantyne Road and pedestrian bridge. Trees and vegetation on levees.

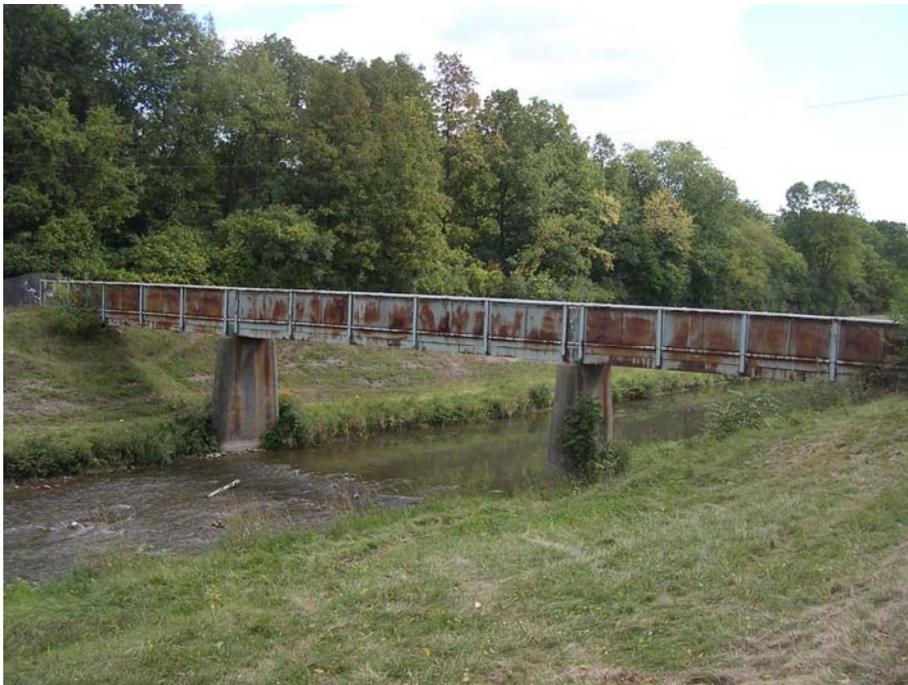
Photo 12: Pedestrian bridge over channel, approx. Sta. 91+40, looking upstream.

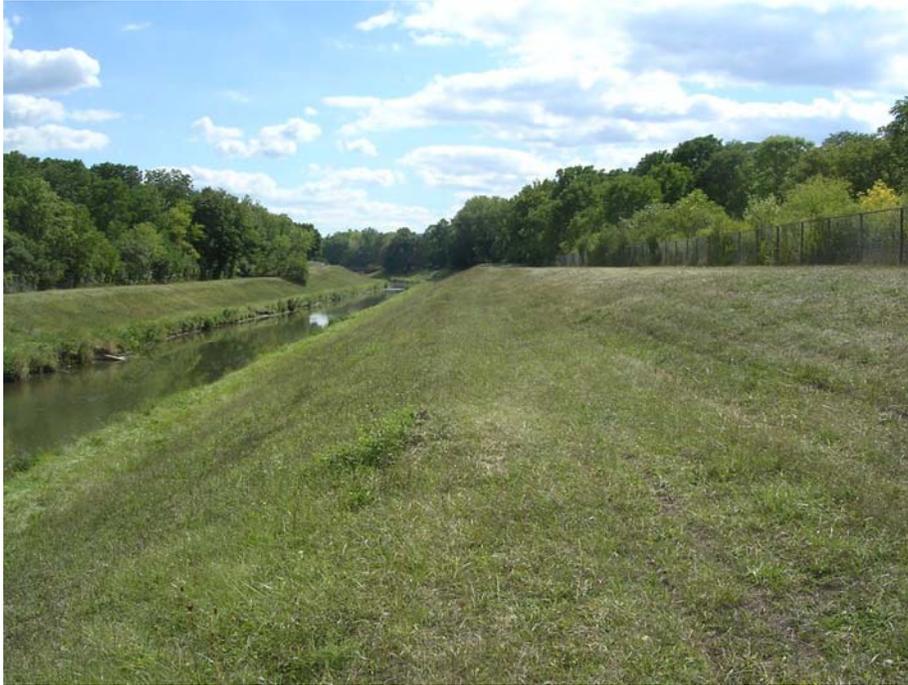
Photo 13: Channel and left bank levee (looking upstream) from pedestrian bridge at Sta. 91+40.

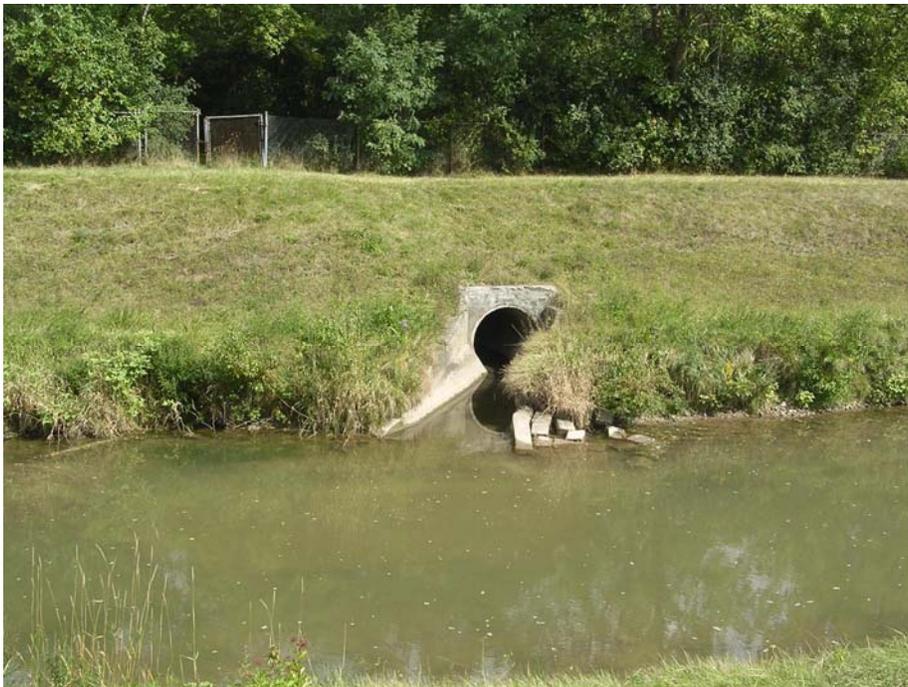
Photo 14: Damaged paver blocks at outfall on right bank at approx Sta. 85+00.

(7) Damaged concrete paver blocks at right bank outfalls at approx. Sta.'s 85+00 and 58+00 need to be repaired (7.b.5 & 8).

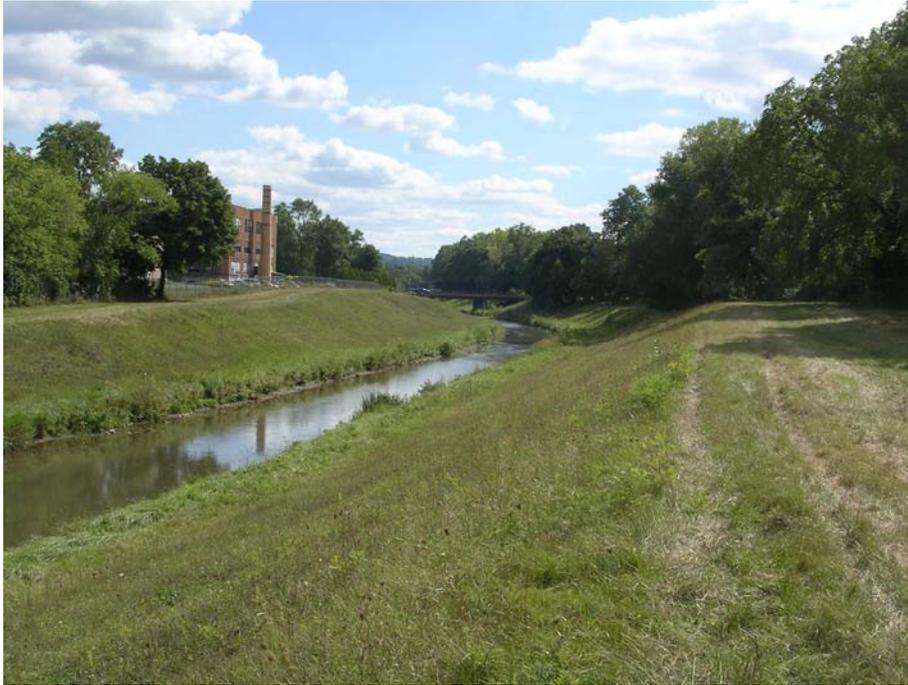
Photo 15: Channel looking upstream (from approx. Sta. 78+00) towards West Seneca Turnpike bridge.

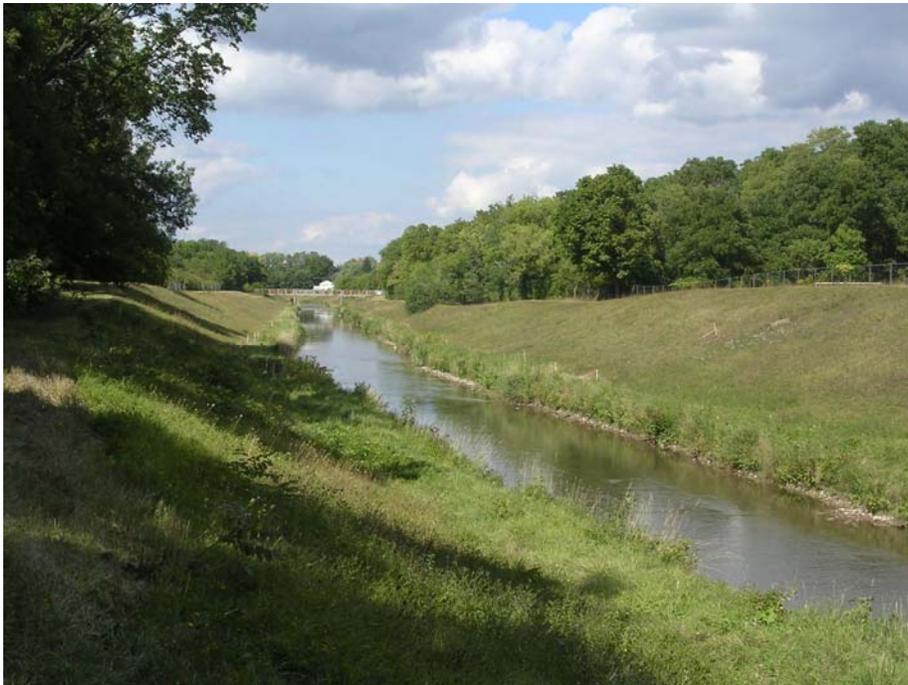
Photo 16: Channel looking downstream from approx. Sta. 74+00.

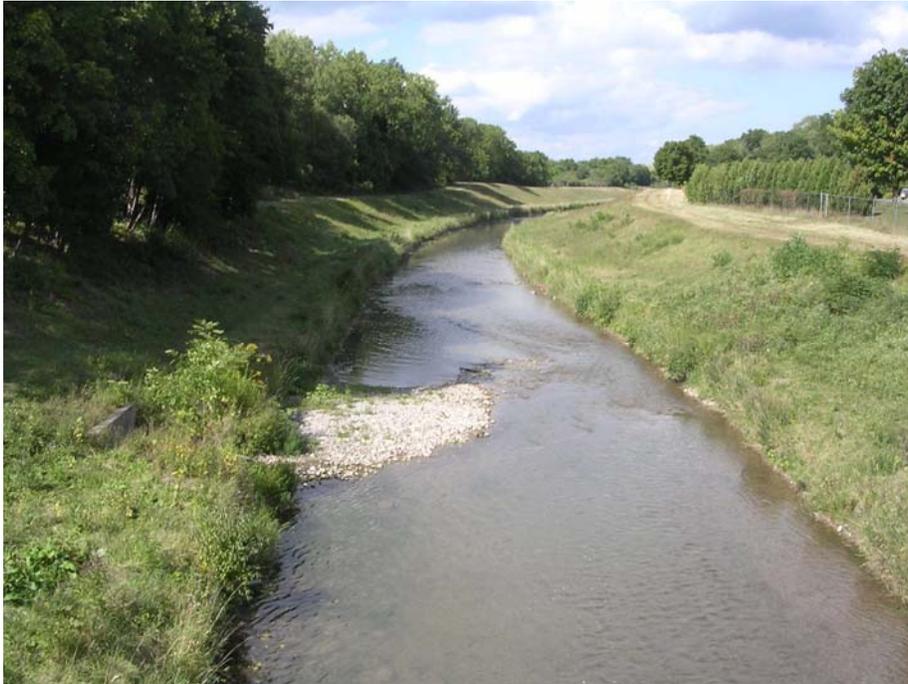
Photo 17: Shoals forming on left bank at outfall, approx. Sta. 72+00; just downstream of West Seneca Turnpike. Minor vegetation at outfall.

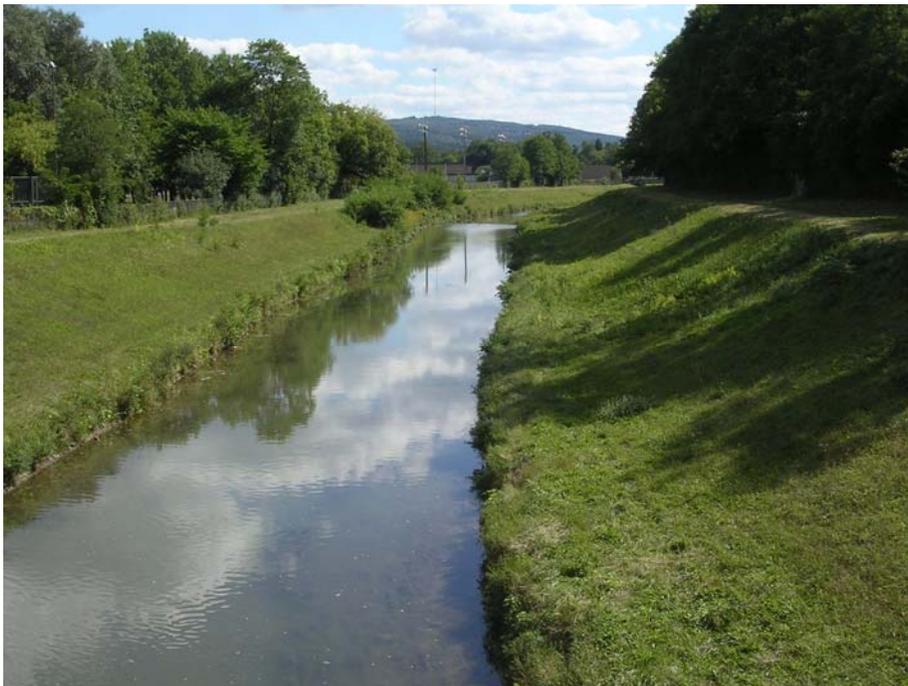
Photo 18: Channel looking upstream from West Seneca Turnpike bridge.

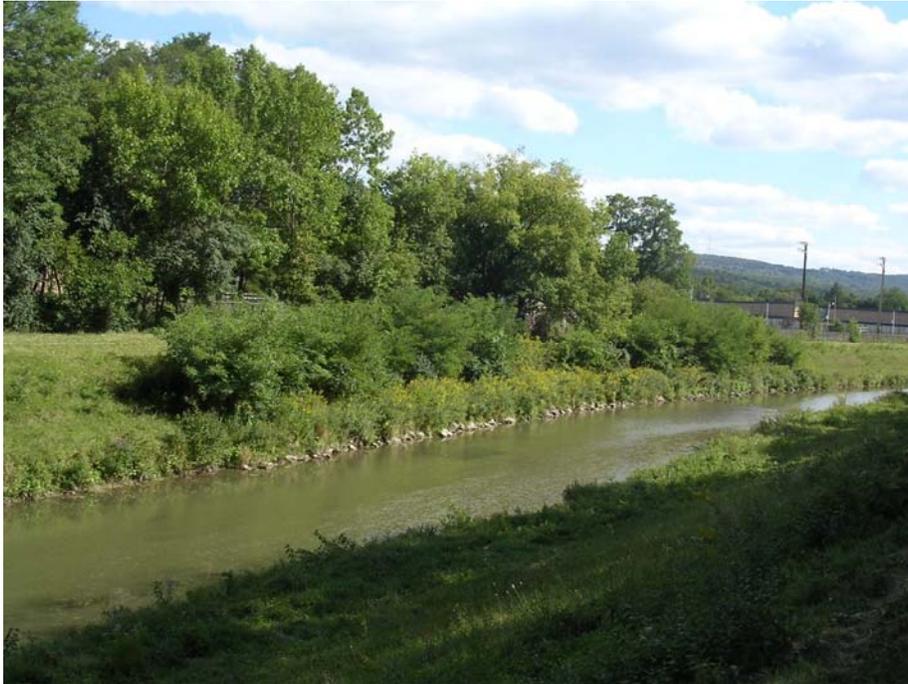
Photo 19: Heavy vegetation in riprap along right bank at approx. Sta. 67+00.

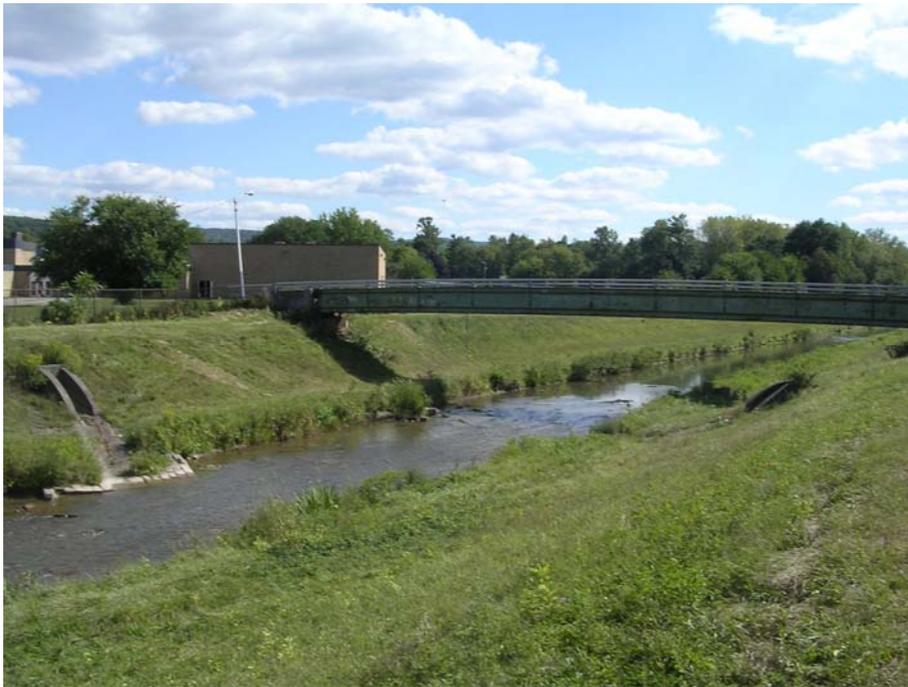
Photo 20: Pedestrian bridge for Frank G. McCarthy School, approx. Sta. 57+50.

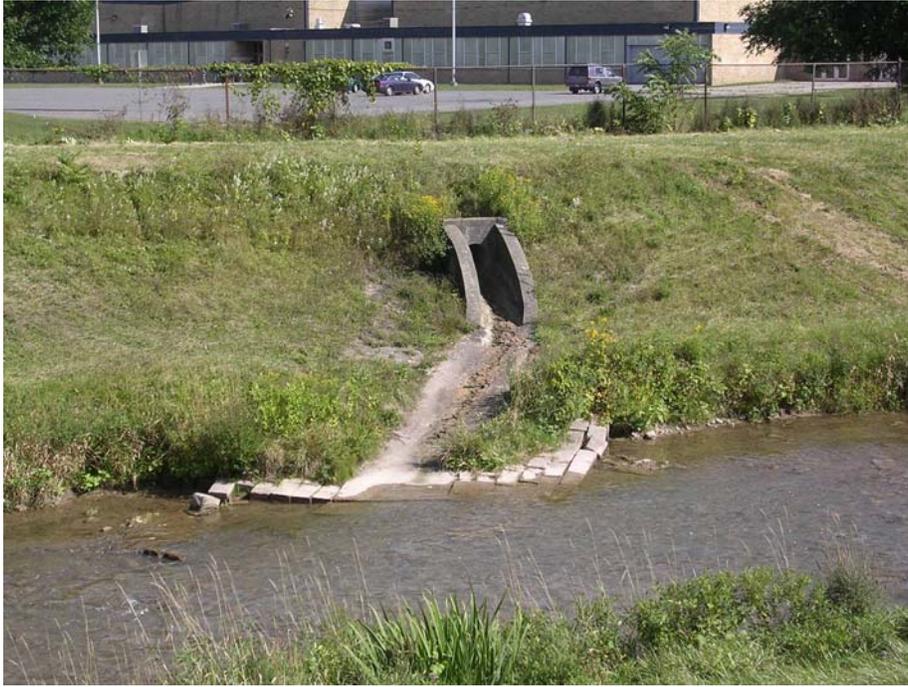
Photo 21: Outfall on right bank at approx. Sta. 58+00 – paver blocks becoming dislodged.

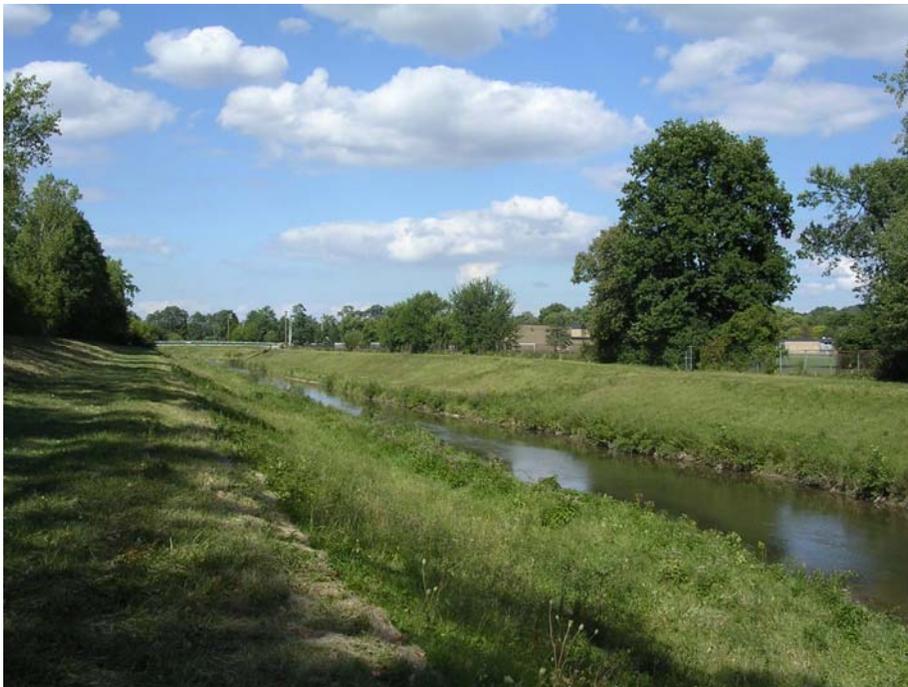
Photo 22: Channel looking downstream from approx Sta. 50+00.

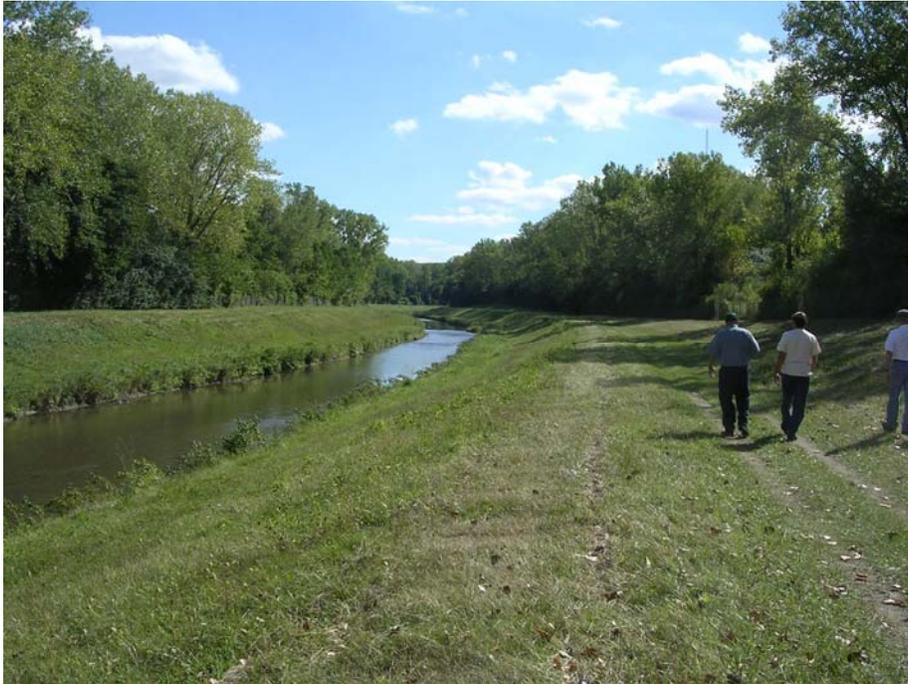
Photo 23: Channel looking upstream from approx Sta. 45+00.

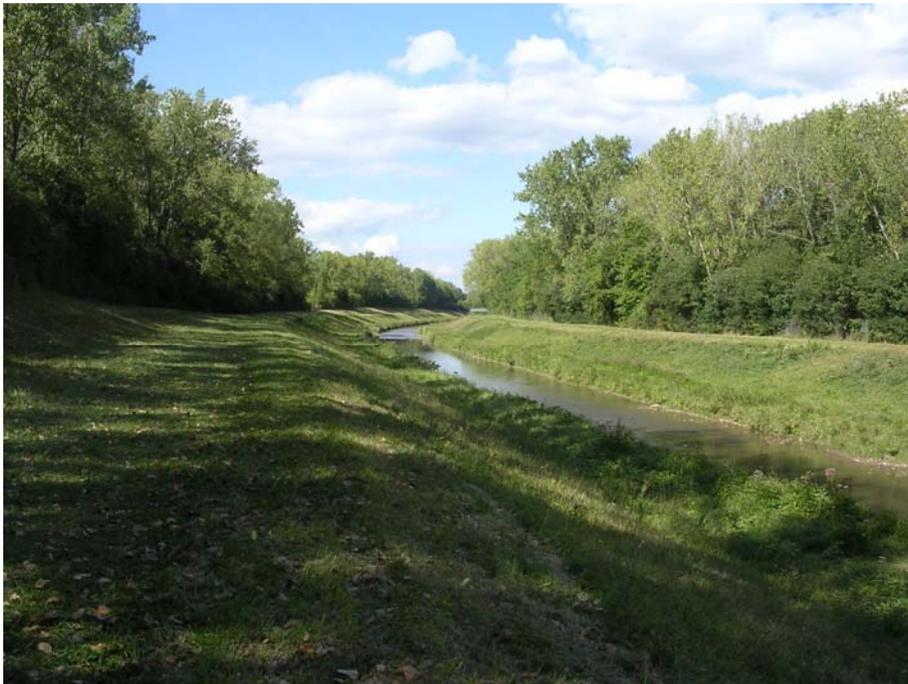
Photo 24: Channel looking downstream from approx. Sta. 30+00.

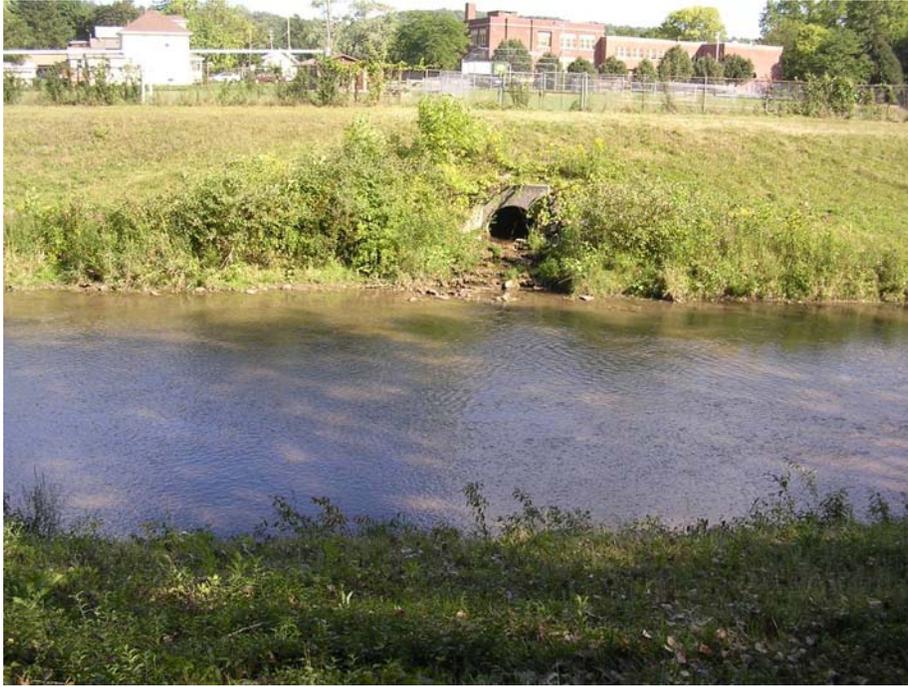
Photo 25: Vegetation around outfall on right bank, approx. Sta. 20+00.

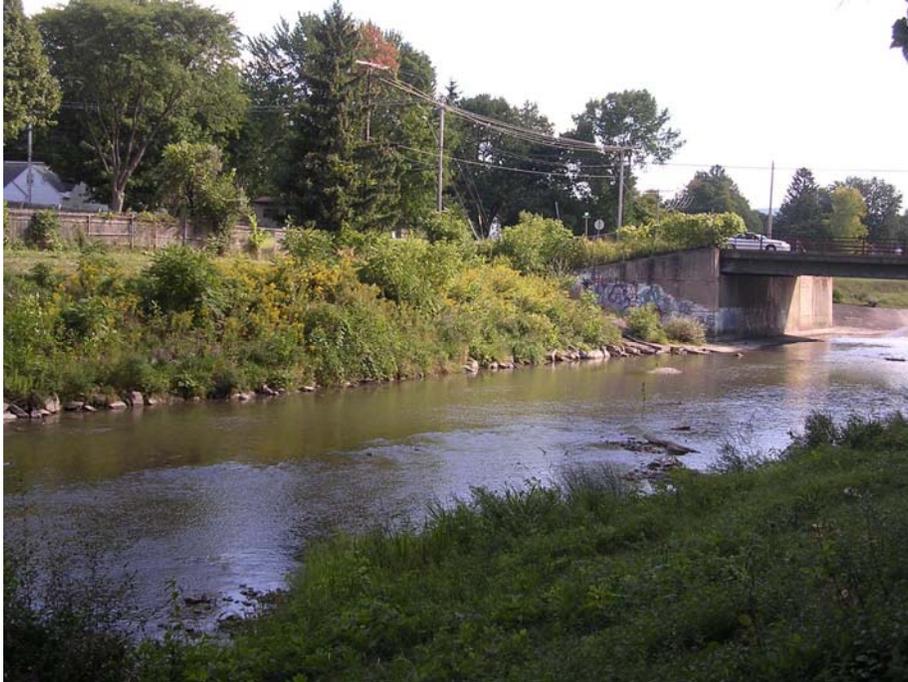
Photo 26: Heavy vegetation in riprap along right bank, just downstream of Dorwin Avenue bridge.

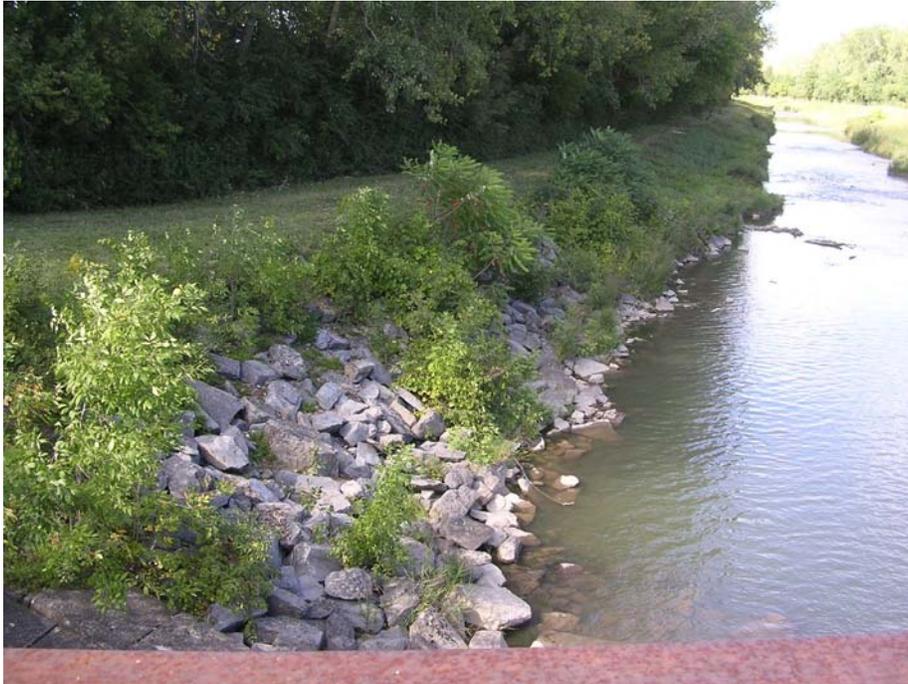
Photo 27: Heavy vegetation in riprap along left bank, just downstream of Dorwin Avenue bridge.

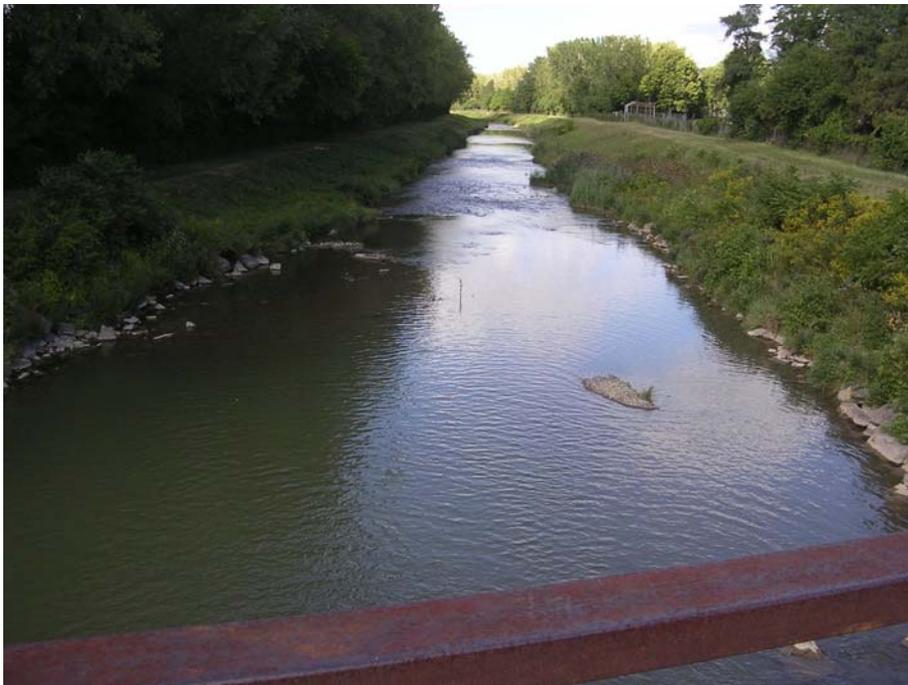
Photo 28: Channel looking downstream from Dorwin Avenue bridge - riprap on left and right banks covered with heavy vegetation.

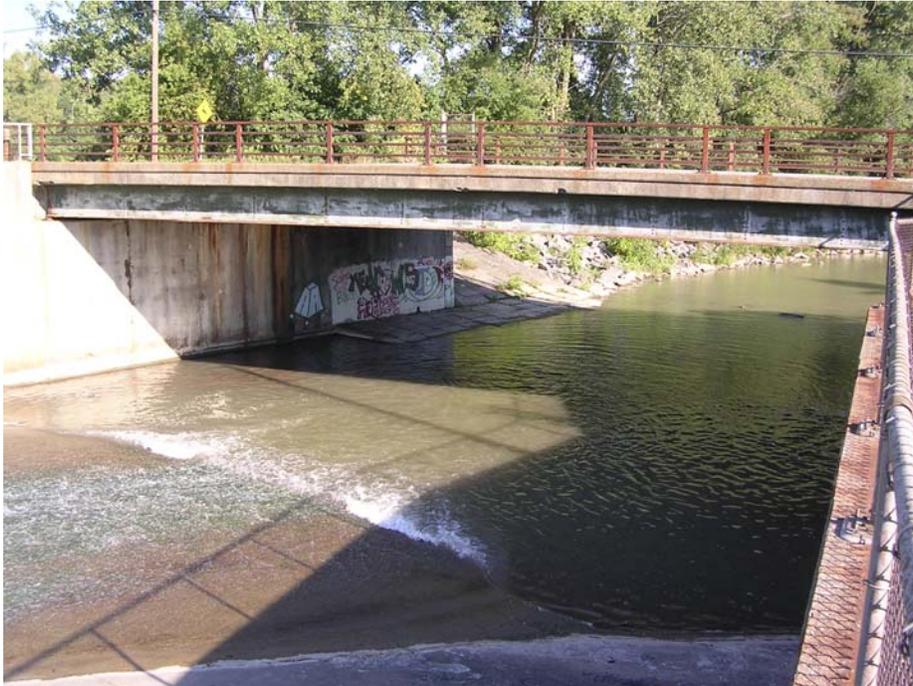
Photo 29: Upstream limit of project at Dorwin Avenue bridge (looking downstream).

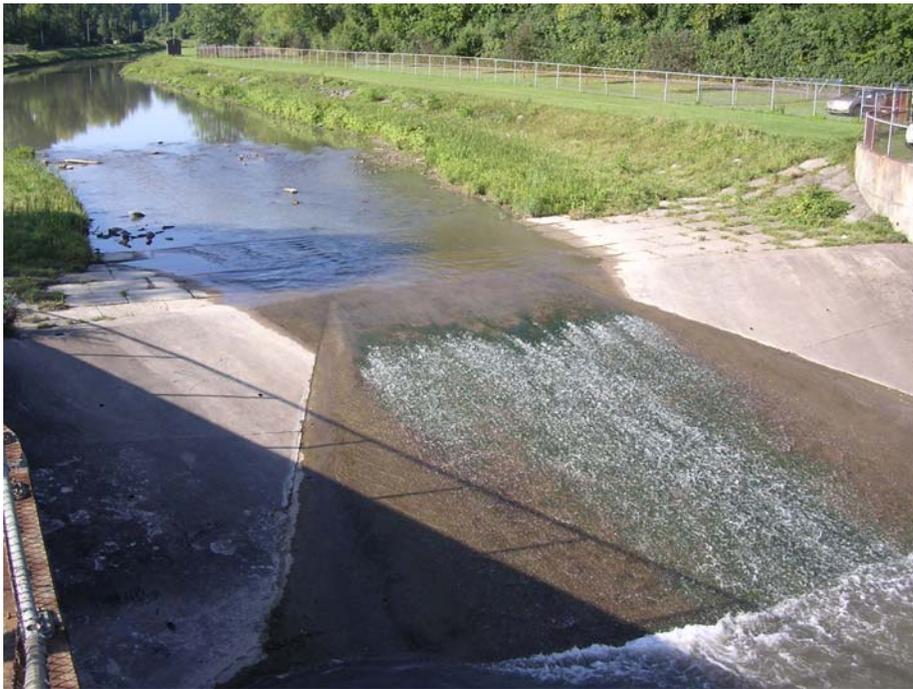
Photo 30: Drop structure at upstream limit of project (looking upstream from Dorwin Avenue bridge). Channel upstream of drop structure is part of Onondaga Creek, Nedrow flood control project.

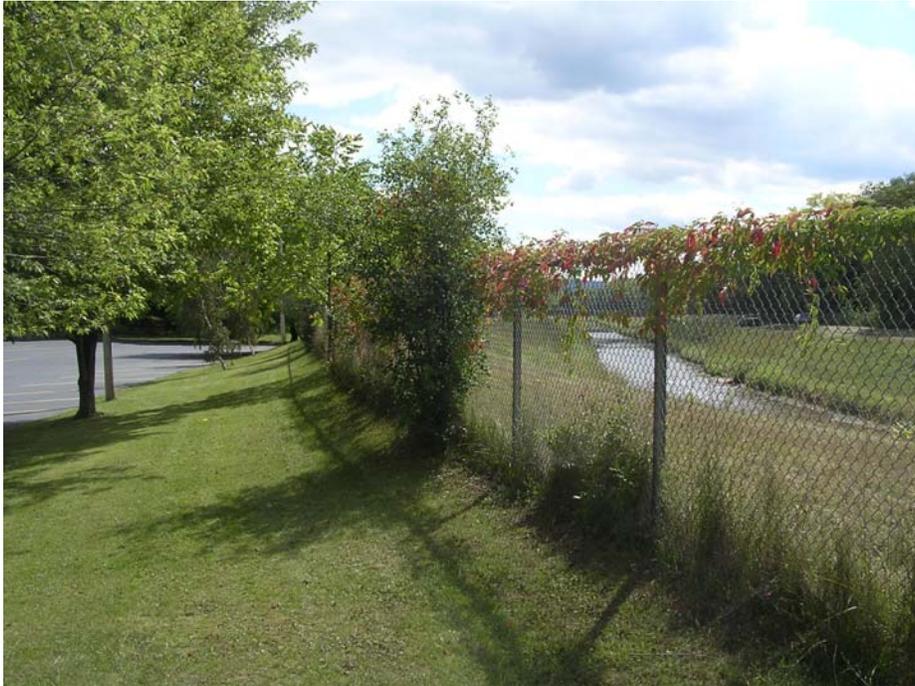
Photo 31: Chain link fence placed by local sponsor on top of levee – right bank upstream of Ballantyne Road bridge – trees on or near toe of levee; vegetation in fence.

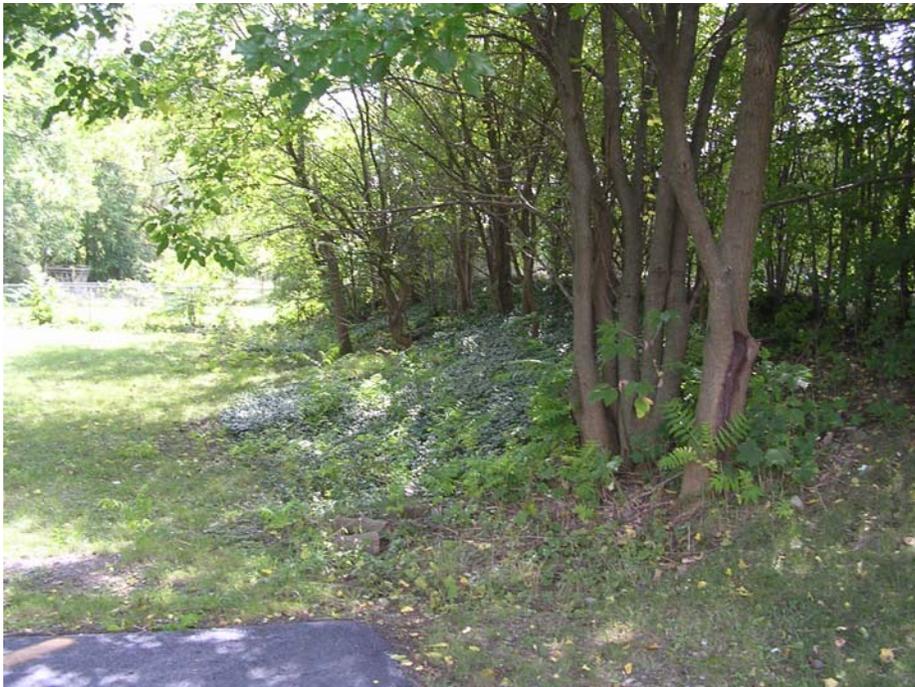
Photo 32: Trees and brush on levee – left bank upstream of Ballantyne Road bridge.
