## DEPARTMENT OF THE ARMY

SUBJECT: FY07 Joint Routine Inspection of Completed Works, Flood Damage Reduction Project, Onondaga Dam and Reservoir, Onondaga Creek, Syracuse, New York (9/13/07)

**Attachment “A” - Project Inspection Photographs**

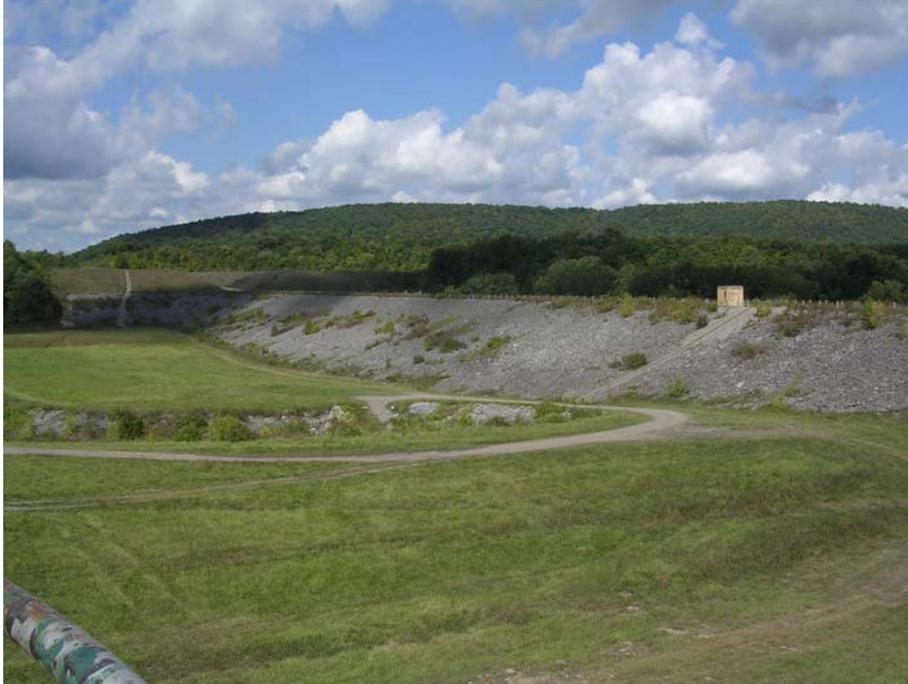
- (1) Vegetation on upstream face of dam (see photos 1-3, 7, & 28).
- (2) Broken railing fence at overlook on east side of dam - repeat deficiency from last inspection (see photo 4)
- (3) Excessive vegetation in riprap and on intake channel slopes (see photo 5).

**Photo 1: Upstream face of dam (looking west) – note vegetation.**

(7) Remove vegetation as noted in Sections 7.b.(1), (3), (4), (5), (7), and (9) above.

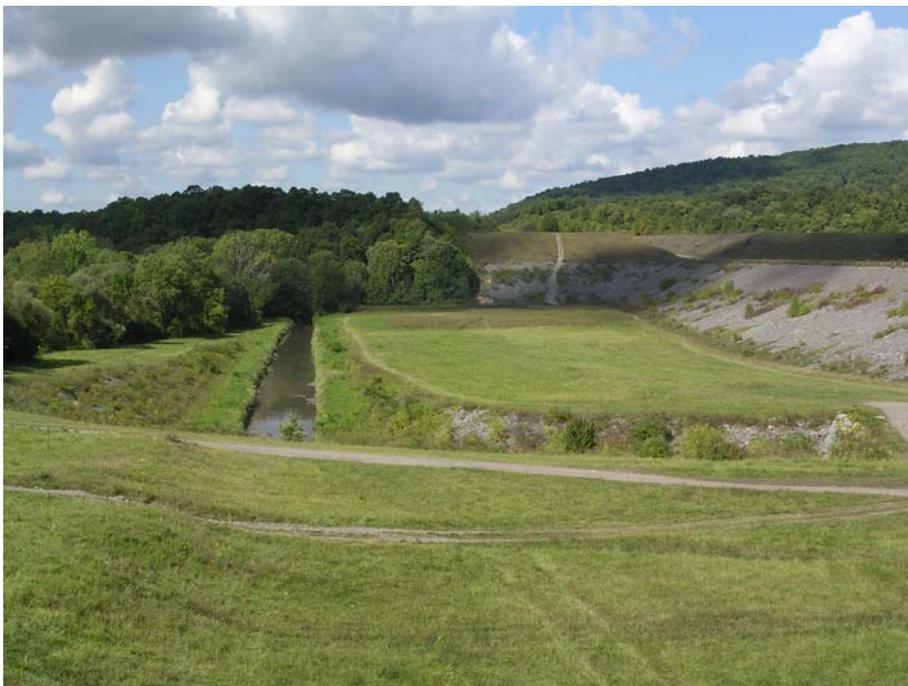
**Photo 2: Intake channel and upstream side of dam (looking west)**

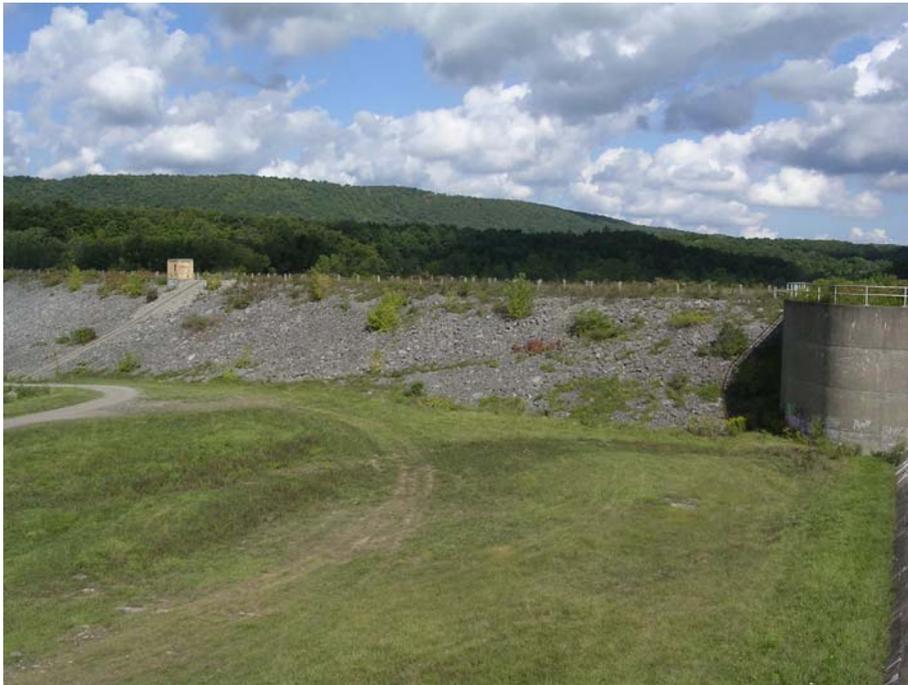
**Photo 3: East side of upstream face of dam – note vegetation.**

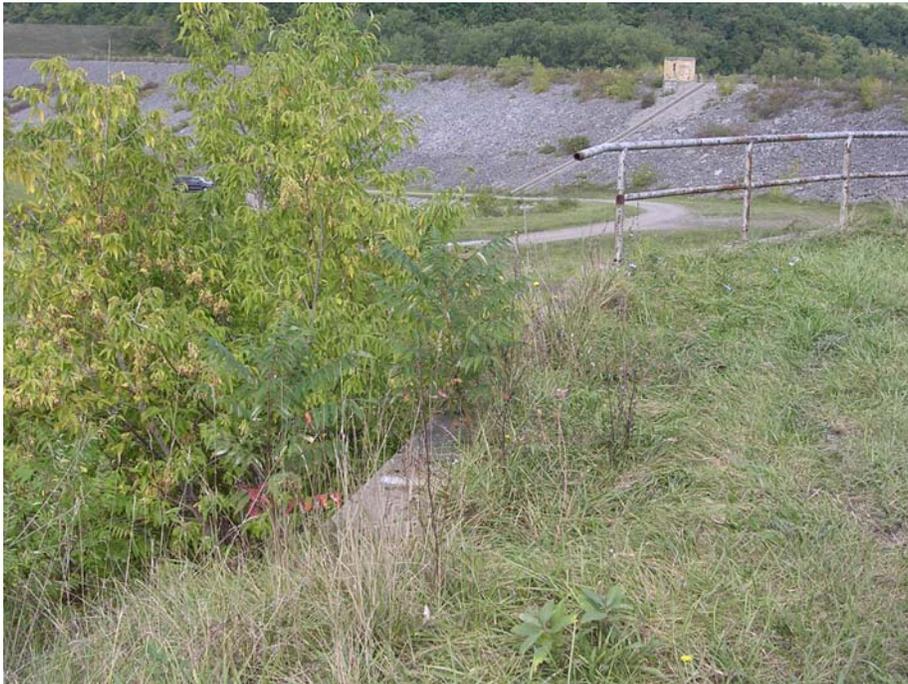
**Photo 4: Broken railing fence at overlook.**

(8) Repair broken railing fence at overlook on east side of dam.

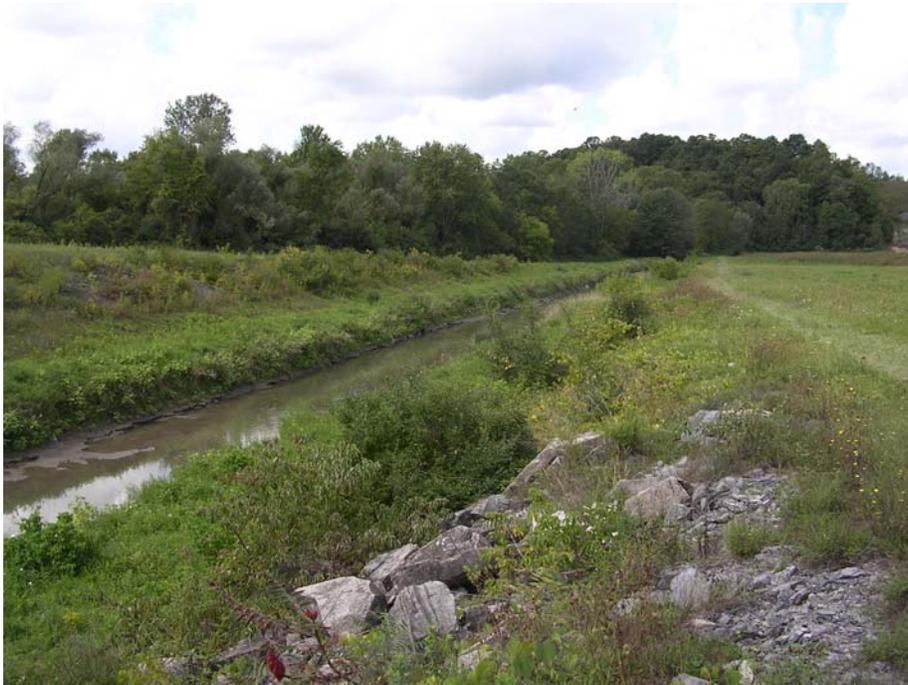
**Photo 5: Intake channel, just upstream of intake structure – note vegetation in riprap and along channel.**

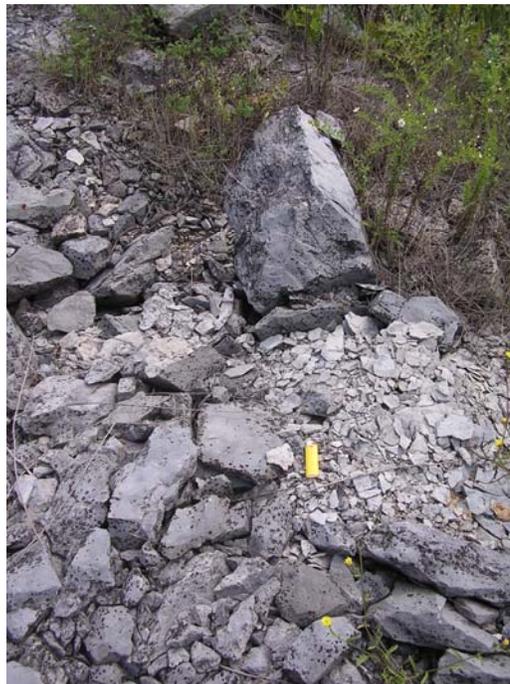
(5) Riprap around the intake structure appears to be either missing or hidden by sediments/vegetation (see photo 7). Some of the riprap around the intake structure and intake channel (near the intake structure) has deteriorated (see photo 6).

**Photo 6: Deteriorating riprap on upstream side of dam near intake structure.**

(9) Uncover and/or repair riprap in vicinity of intake structure and intake channel. Highly turbulent flows can be expected in this area when reservoir is significantly filled. Lack of proper protection around the intake could lead to intake structure failure during high reservoir stages.

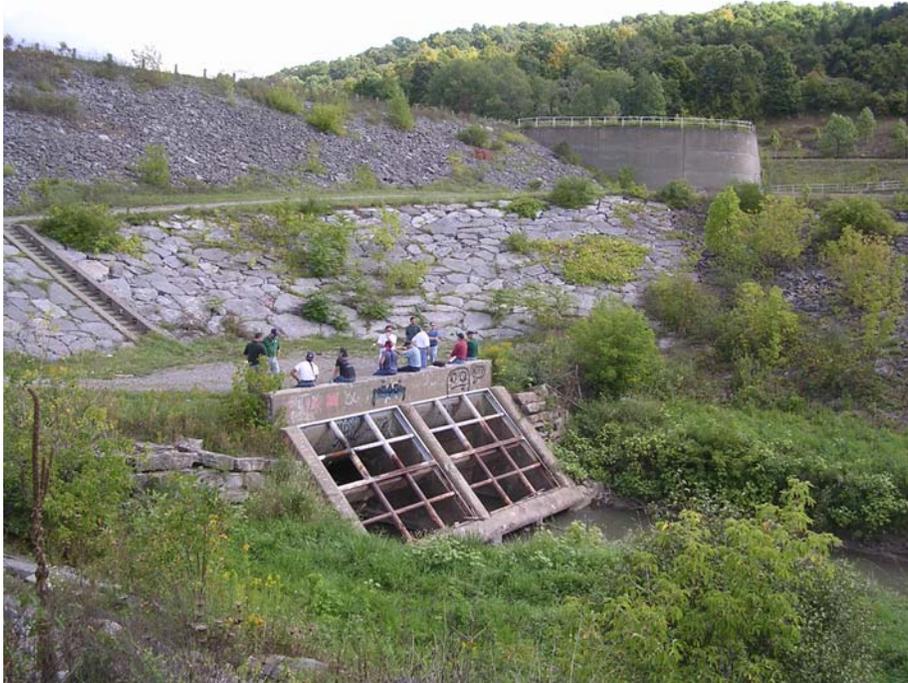
(4) Excessive vegetation around intake structure (see photo 7).

**Photo 7: Intake structure and trash rack; eastern end of dam (upstream face) - note vegetation and lack of visible riprap around intake structure.**

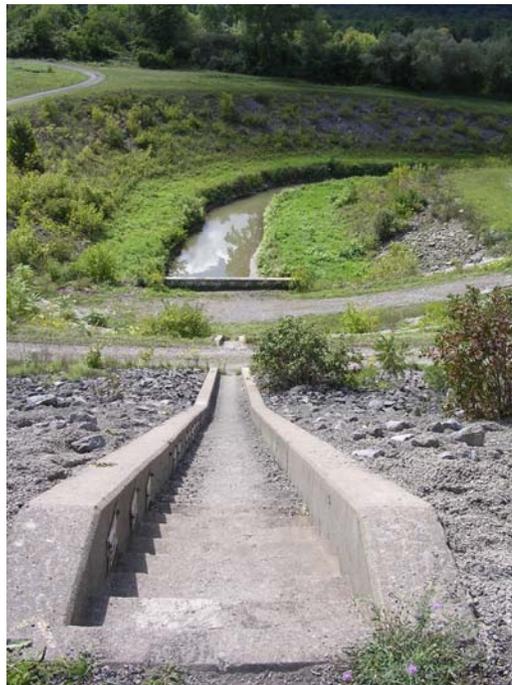
- (1) Concrete stairs on upstream face of dam is starting to spall (see photo 8).
- (2) Riprap on upstream and downstream sides of the dam is starting to show signs of deterioration.

**Photo 8: Concrete stairs and intake channel – note spalling of concrete stairs.**

(5) Monitor spalling of concrete stairs; repair if becomes necessary.

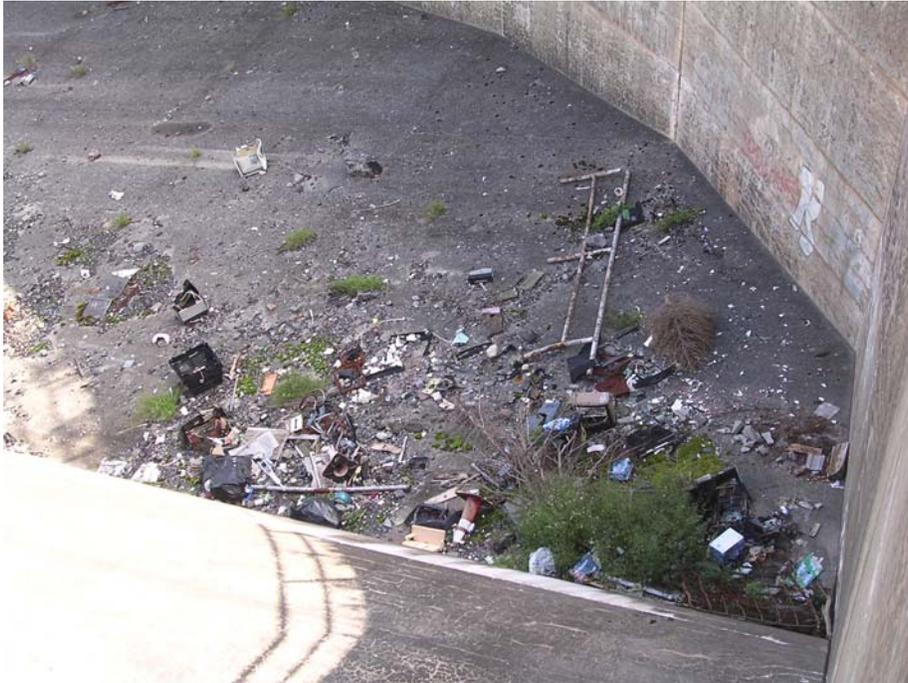
(6) Debris in spillway basin (see photo 15).

**Photo 15: Debris in spillway basin**

(10) Remove debris from spillway basin.

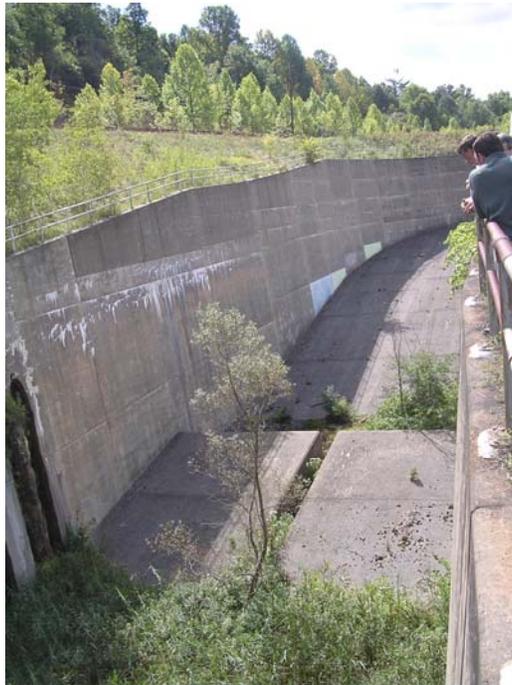
(7) Small trees and brush in spillway channel at control weir (see photo 17).

**Photo 17: Control weir in spillway basin – note growth of small trees and brush**

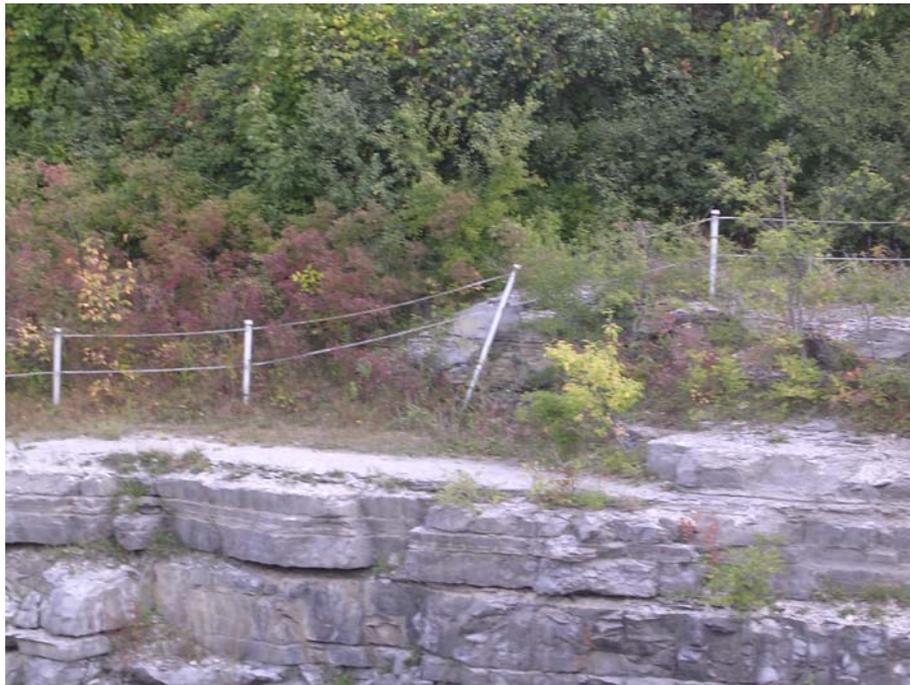
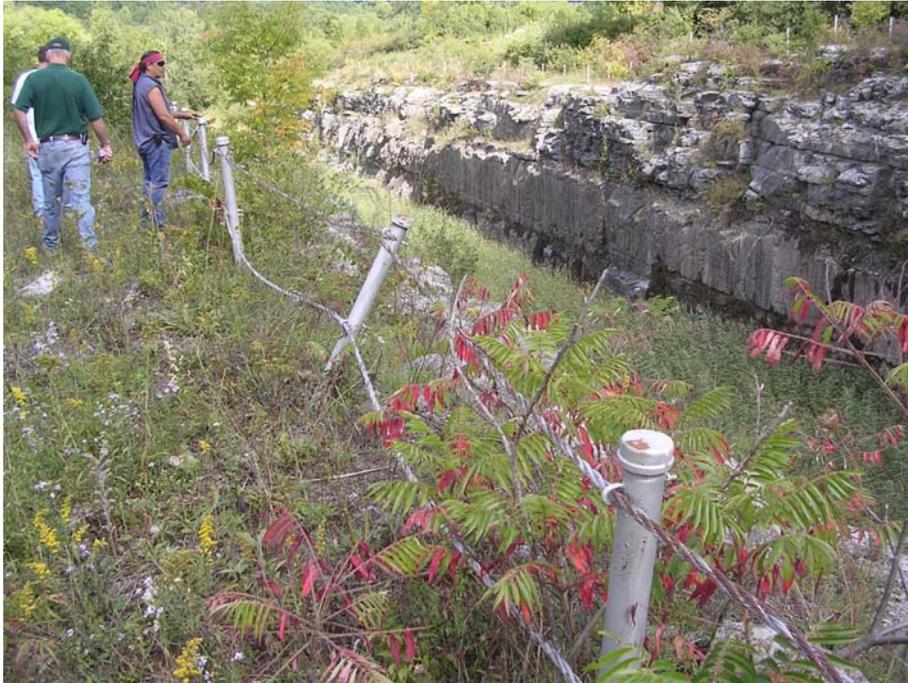
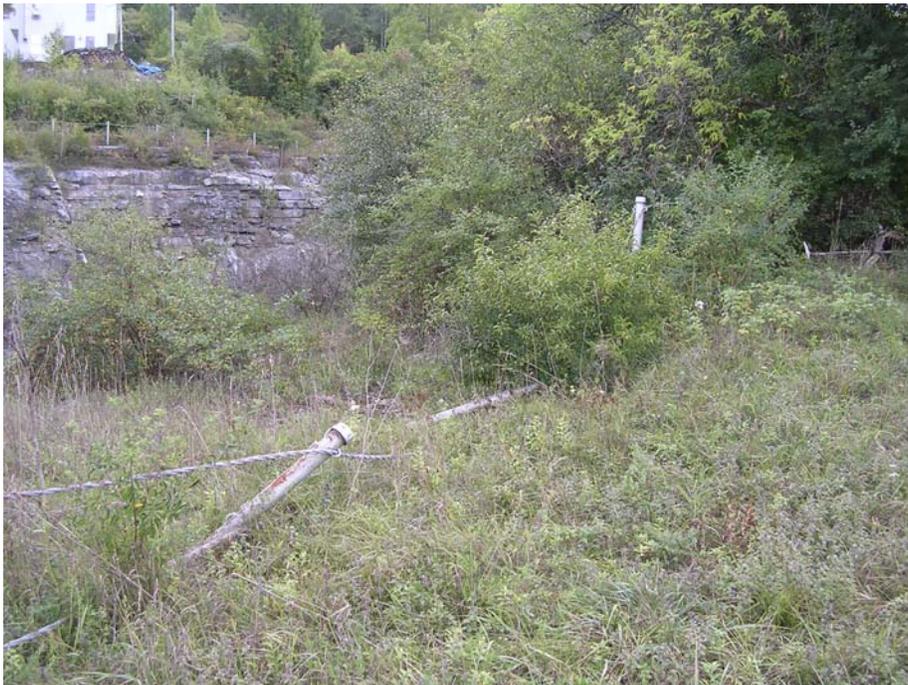
(8) Wire rope fence is damaged in a number of locations along the east and west sides of the spillway channel. Posts are loose or broken and wire rope is not securely tightened. This is a safety hazard and needs to be corrected as soon as possible. See photos 18-20.

**Photo 18: Broken post for wire rope fence – east side of spillway channel.**

**Photo 19: Broken wire rope fence along west side of spillway channel.**

**Photo 20: Broken wire rope fence – west side of spillway channel.**

(11) Repair damaged wire rope fence in various locations along the east and west sides of the spillway channel.

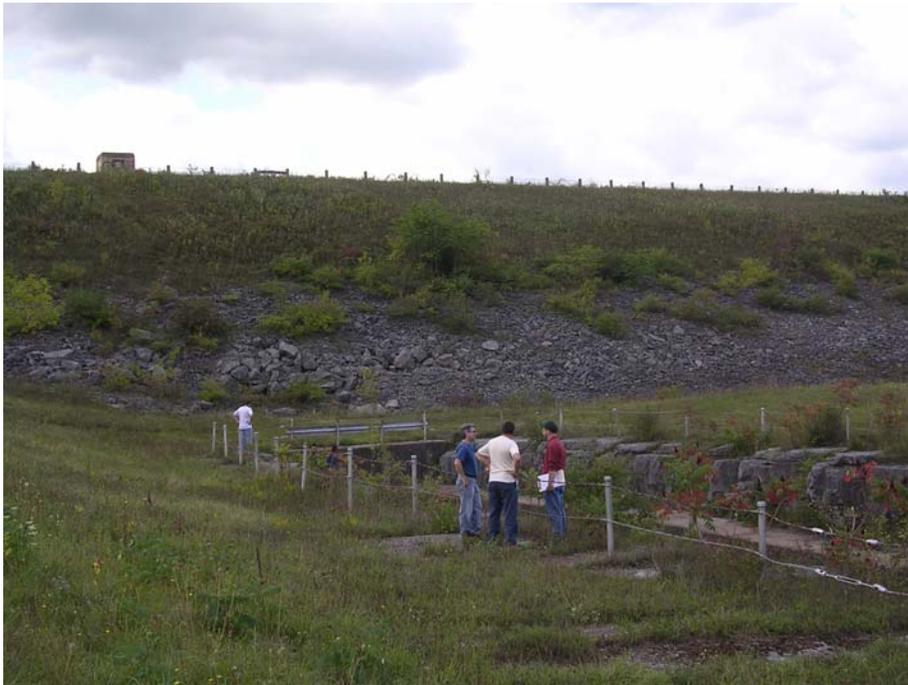
(9) Excessive vegetation on downstream face of dam (see photo 21). Note some vegetation was planted on downstream face of dam as part of the project, however, due to excessive vegetation, couldn't visibly identify the difference.

**Photo 21: Downstream face of dam (east end).**

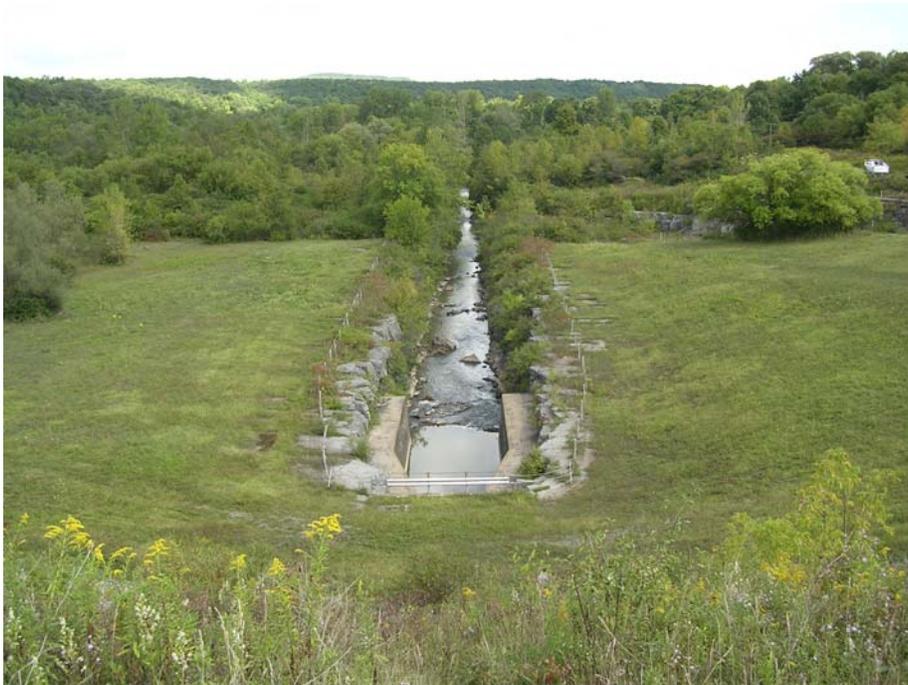
(10) Rocks in outlet channel just downstream of outlet structure (see photo 23).

**Photo 23: Outlet structure and channel.**

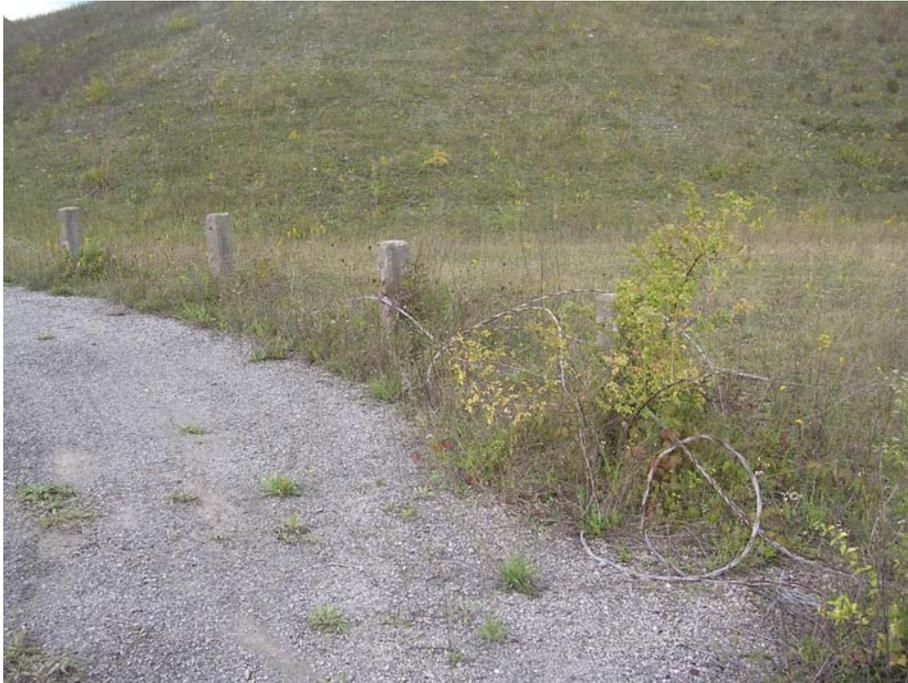
(11) Wire rope guardrail at west end of dam crest is broken (see photo 27).

**Photo 27: Broken wire rope guardrail at west end of dam crest.**

(13) Repair damaged wire rope guardrail at west end of dam crest.

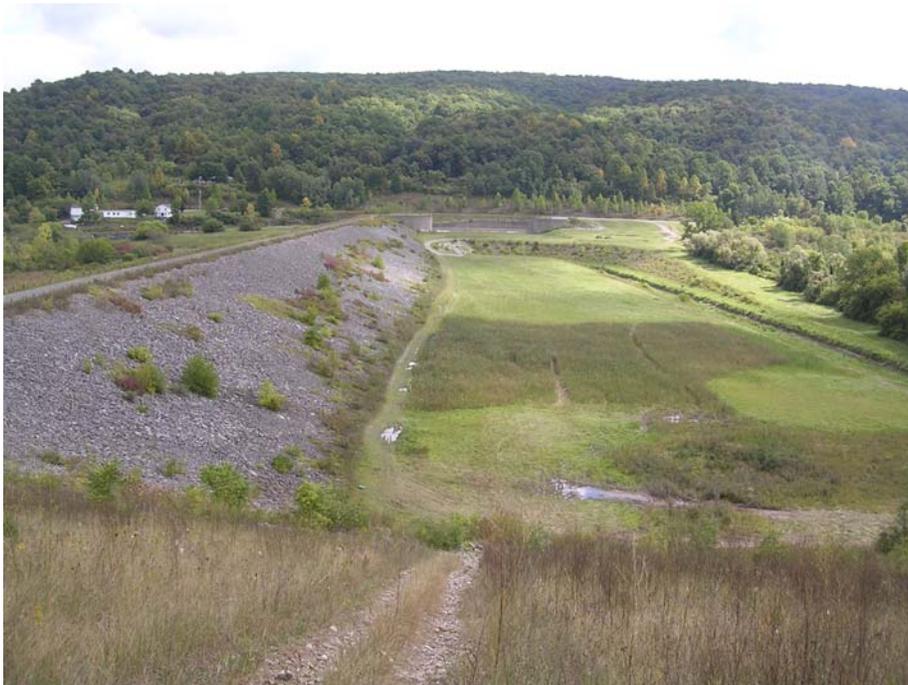
**Photo 28: Upstream side of dam (from west end looking east).**
