**EXISTING CONDITIONS SURVEY AND  
SITE REPORT**

**REMEDIAL DESIGN SITE 1**

**NAVAL WEAPONS  
INDUSTRIAL RESERVE PLANT**

**JUNE, 1995**

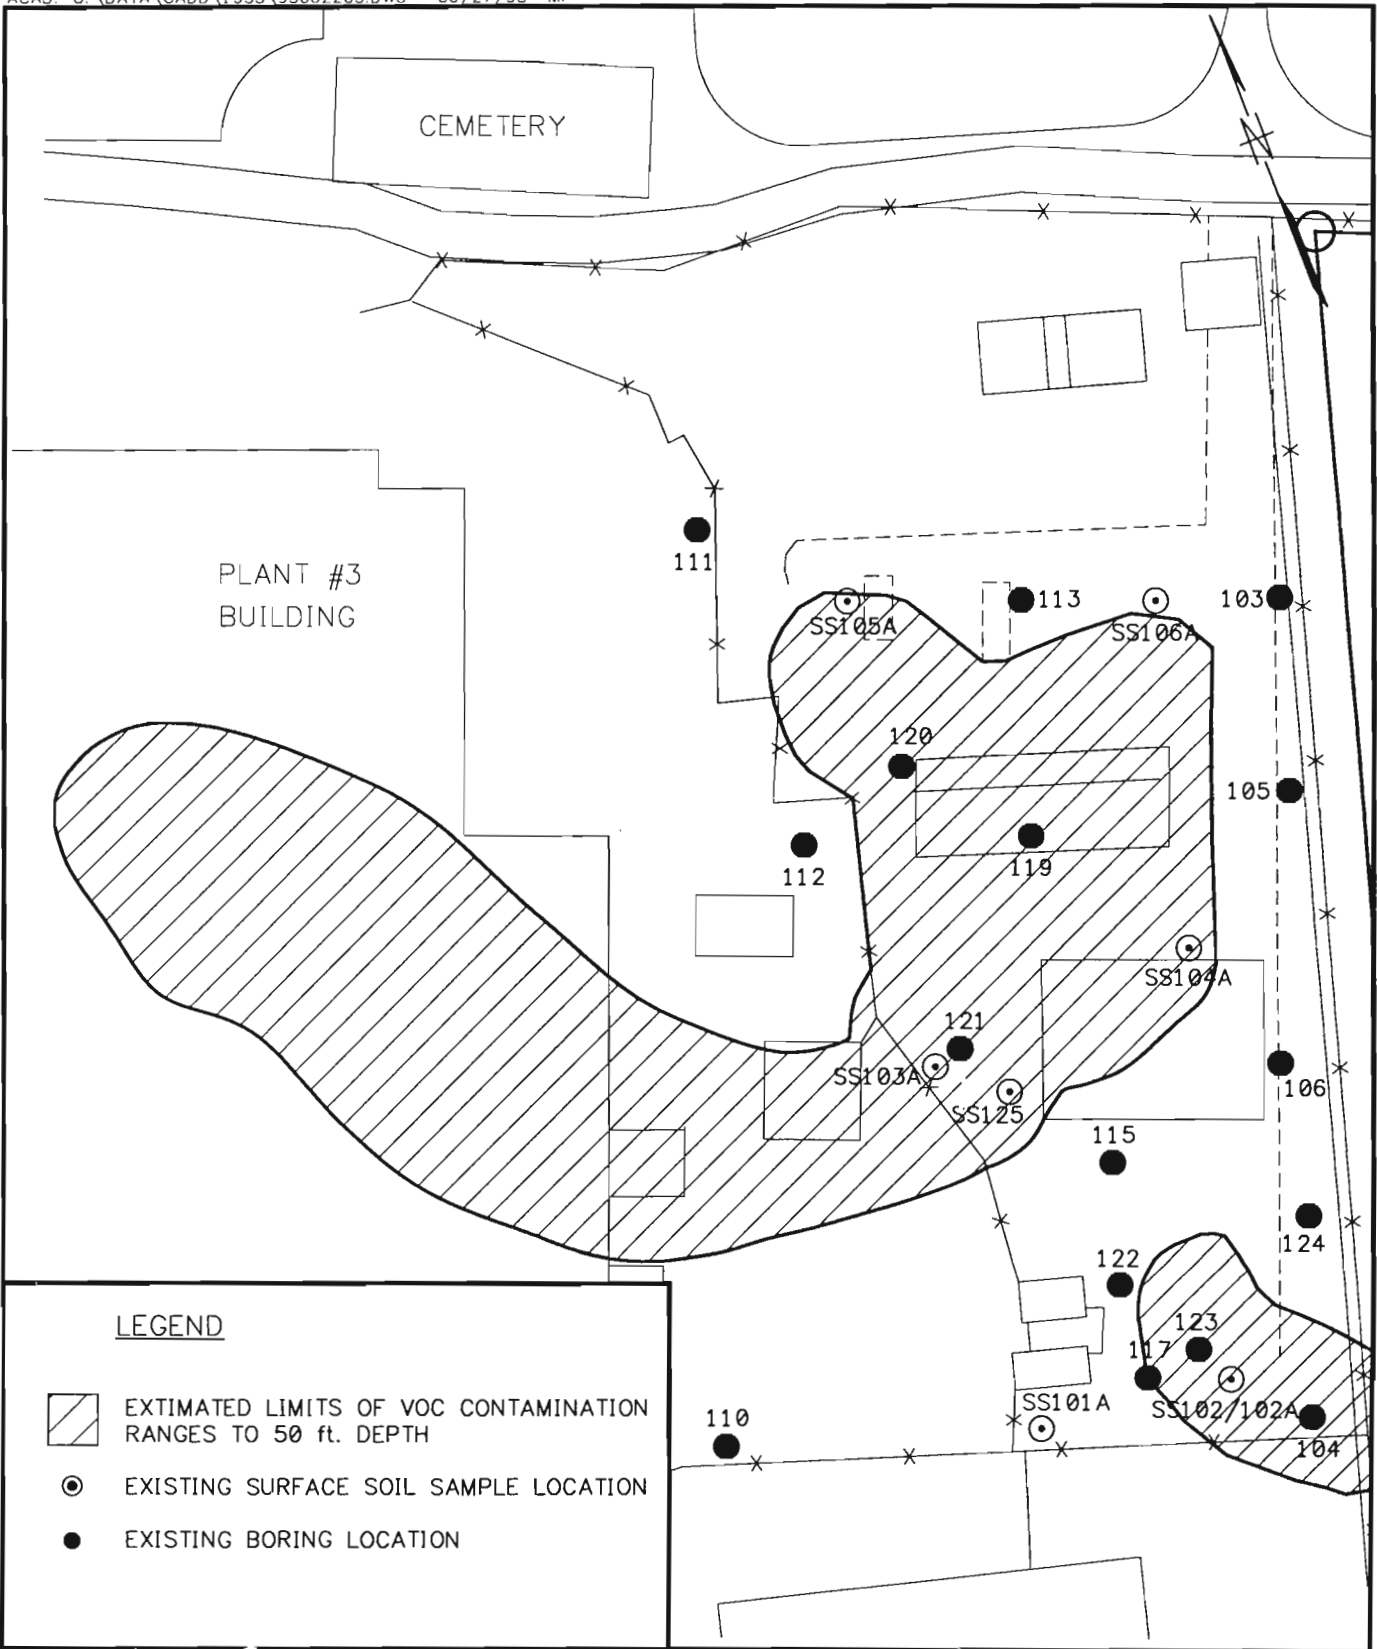
**FIGURE 1**

**SITE 1 - SAMPLING LOCATIONS AND ESTIMATED AREA**

The scope of CTO 213 is to remediate the volatile organic contamination using an air sparging/vapor extraction (ASVE) system. The approximate location of the VOC plume is provided in Figure 1.

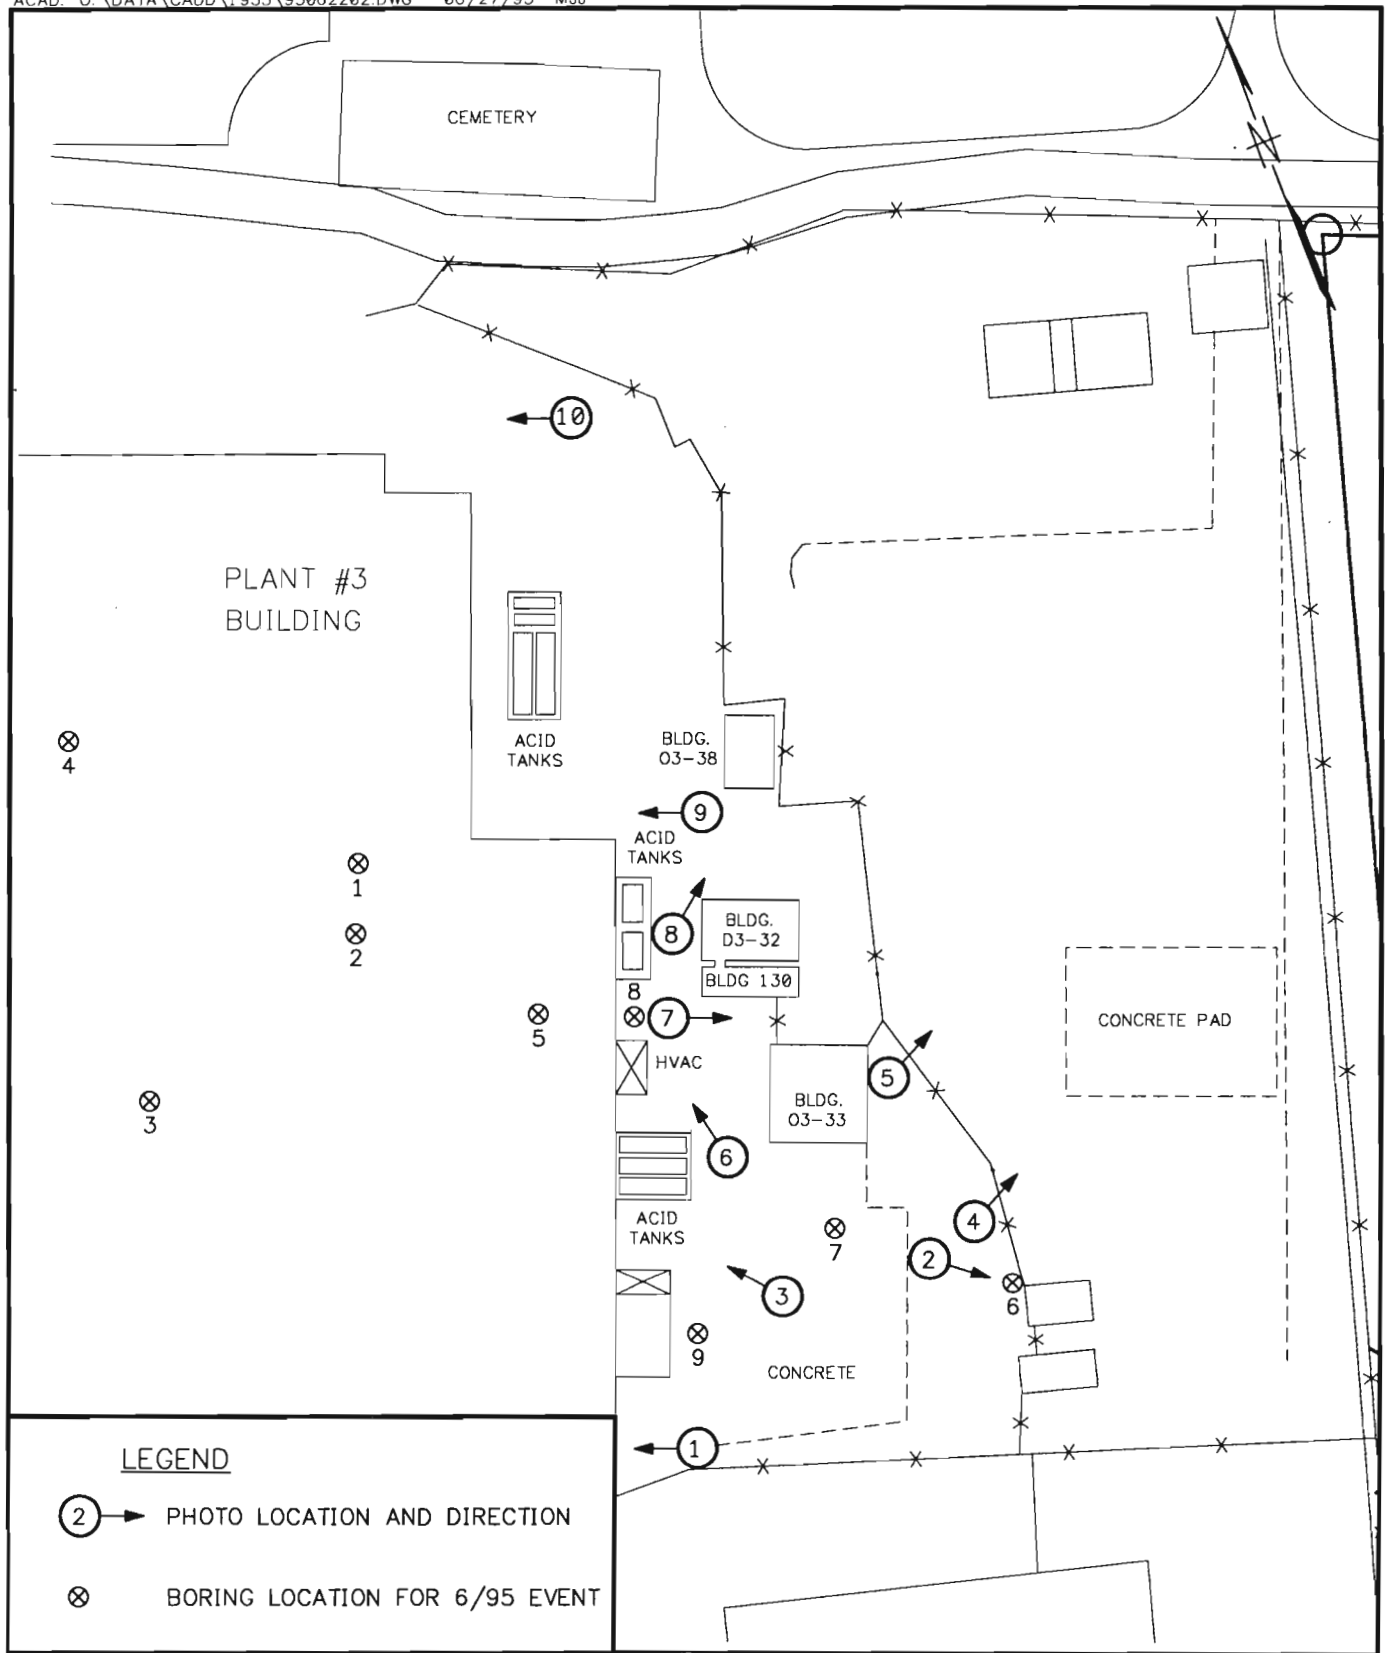
**FIGURE 3**

Photographs were taken of the area outside Plant No. 3 which included the outside of Plant No. 3. These photographs were taken to show the existing condition of the existing buildings, concrete, and bare ground areas. These photographs also show the Plant No. 3 equipment access doors. Figure 3 provides the location of and direction from which the photographs were taken.

**SKETCH OF PHOTOGRAPH LOCATIONS  
NAVAL WEAPONS INDUSTRIAL RESERVE PLANT**

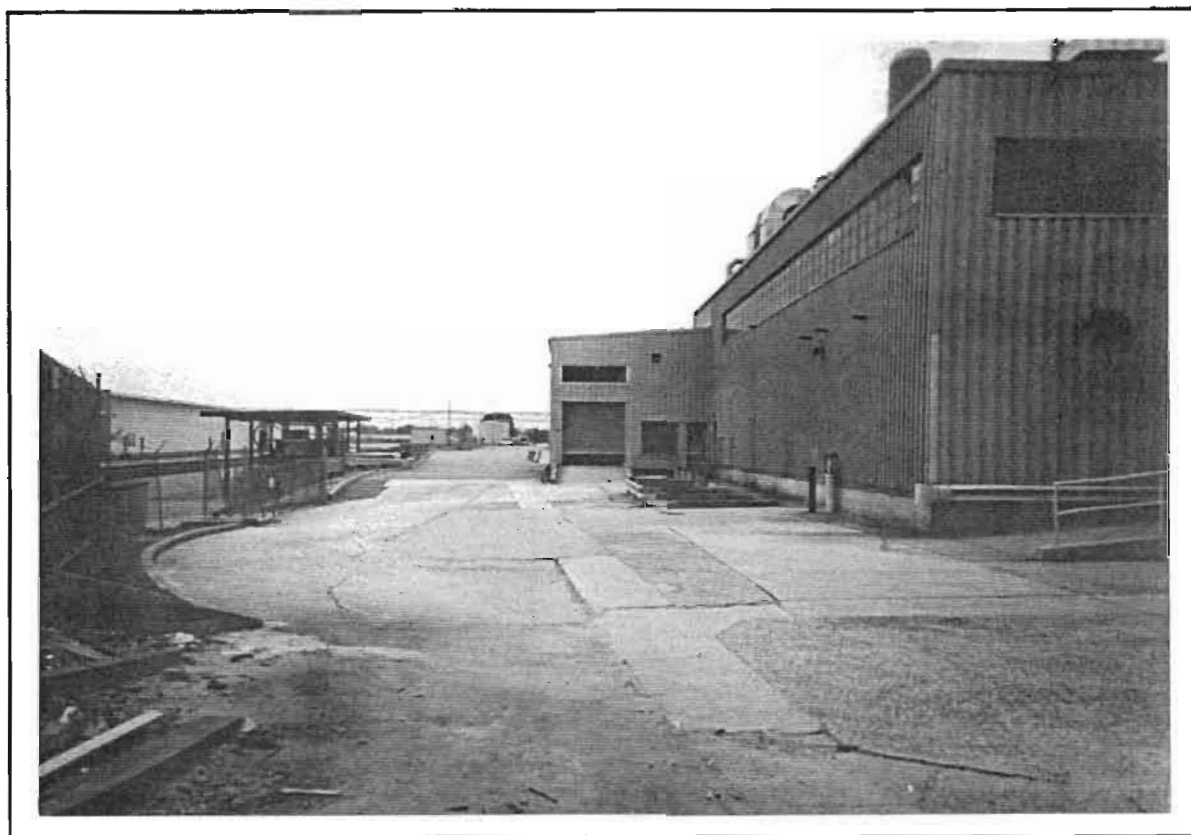
Photo #1: South side of plant #3 looking west.

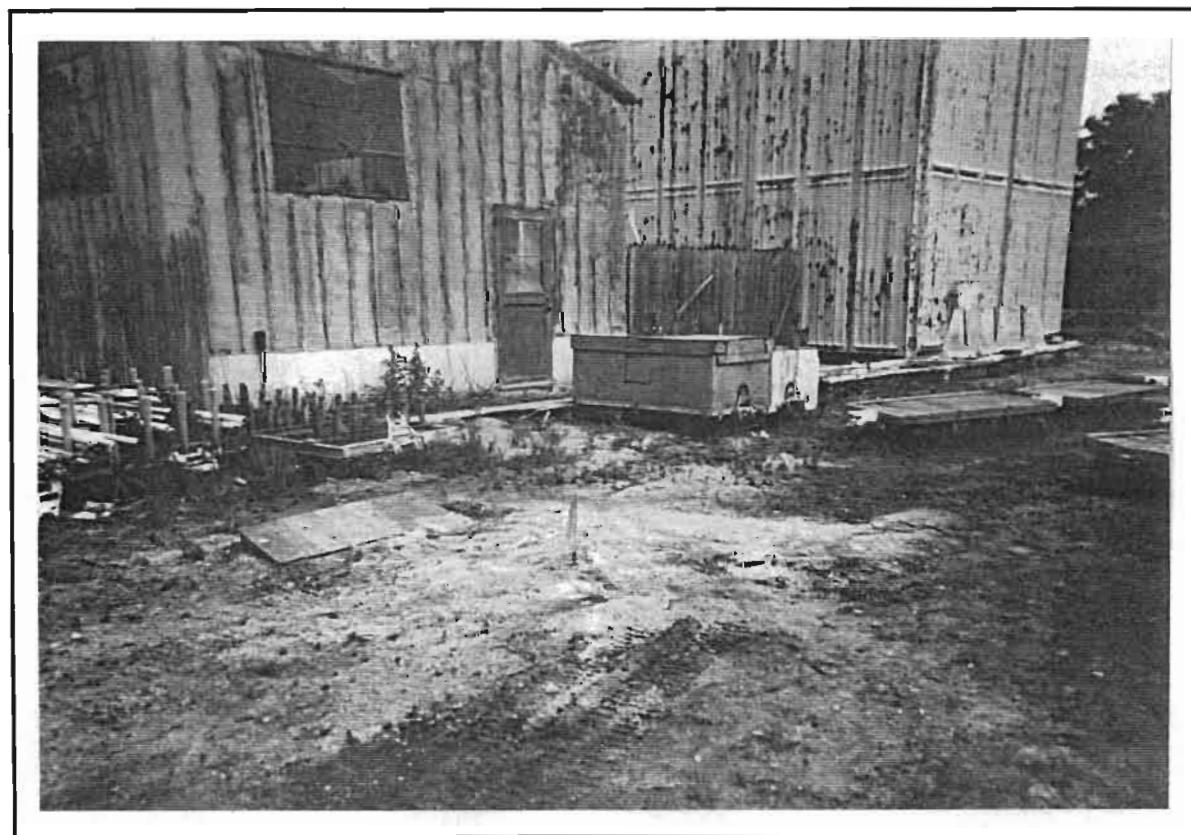
Photo #2: Boring #6 behind old maintenance shed looking east.

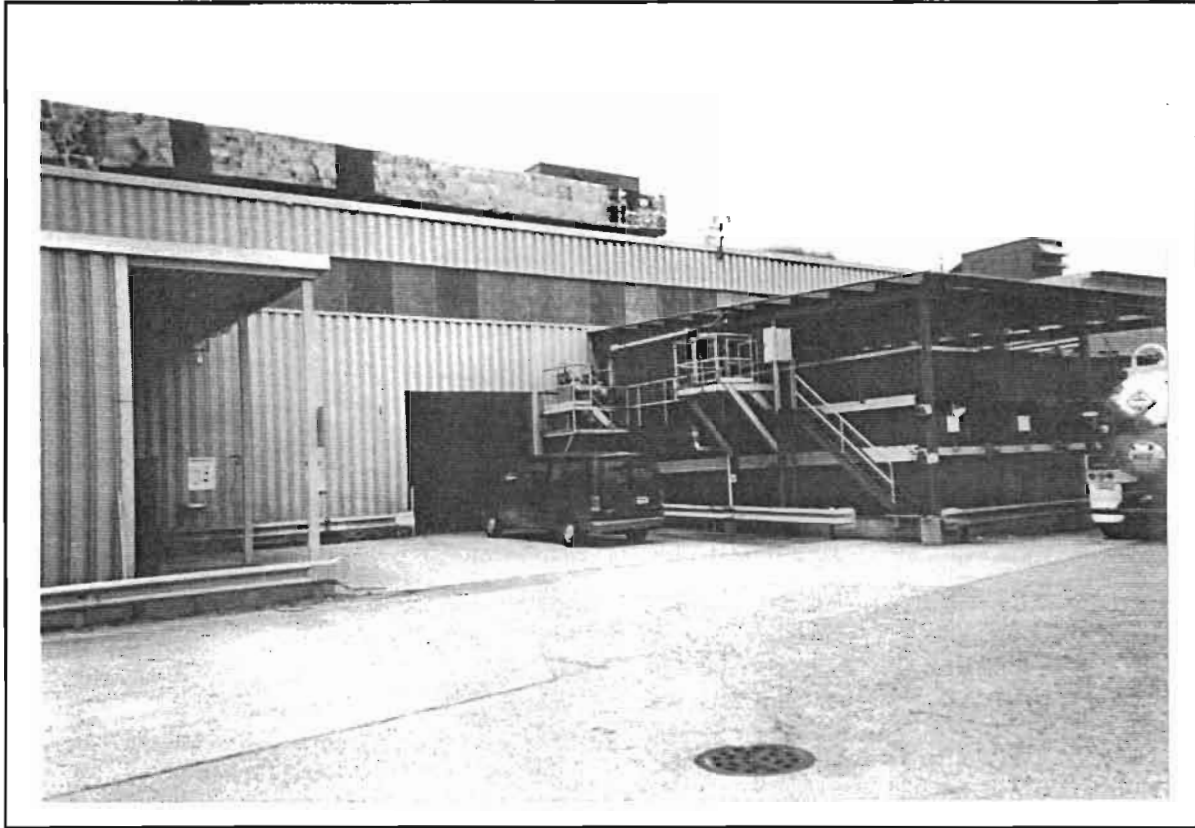
Photo #3: East side of Plant #3 looking northwest.

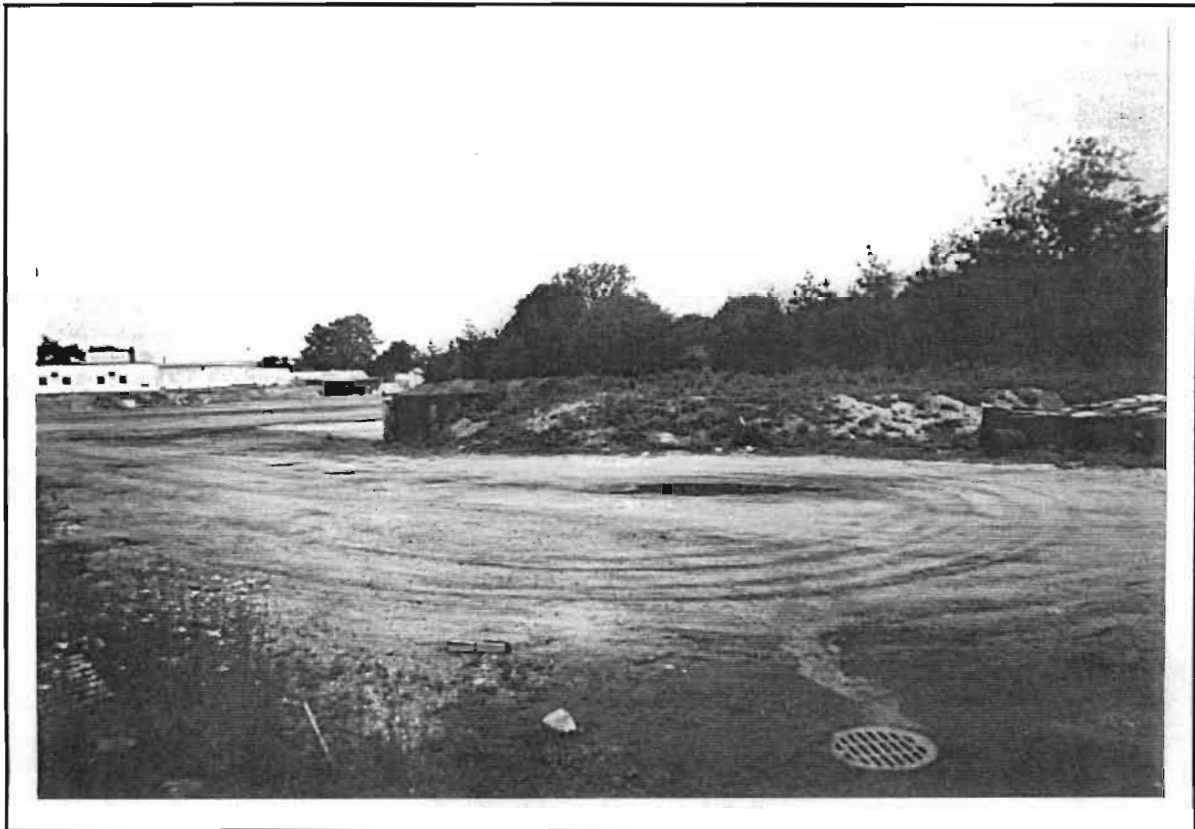
Photo #4: Area east of fence looking toward eastern extent of VOC contamination.

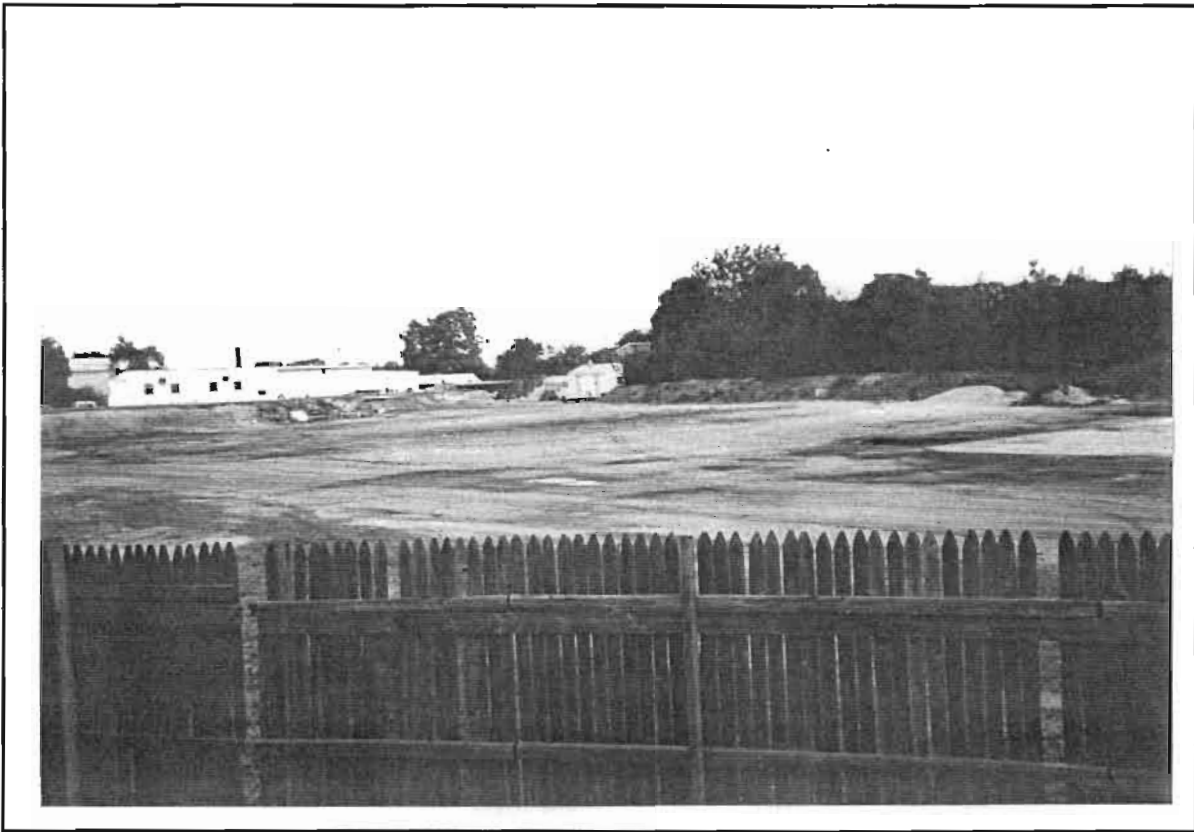
Photo #5: Area east of fence looking toward eastern extent of VOC contamination.

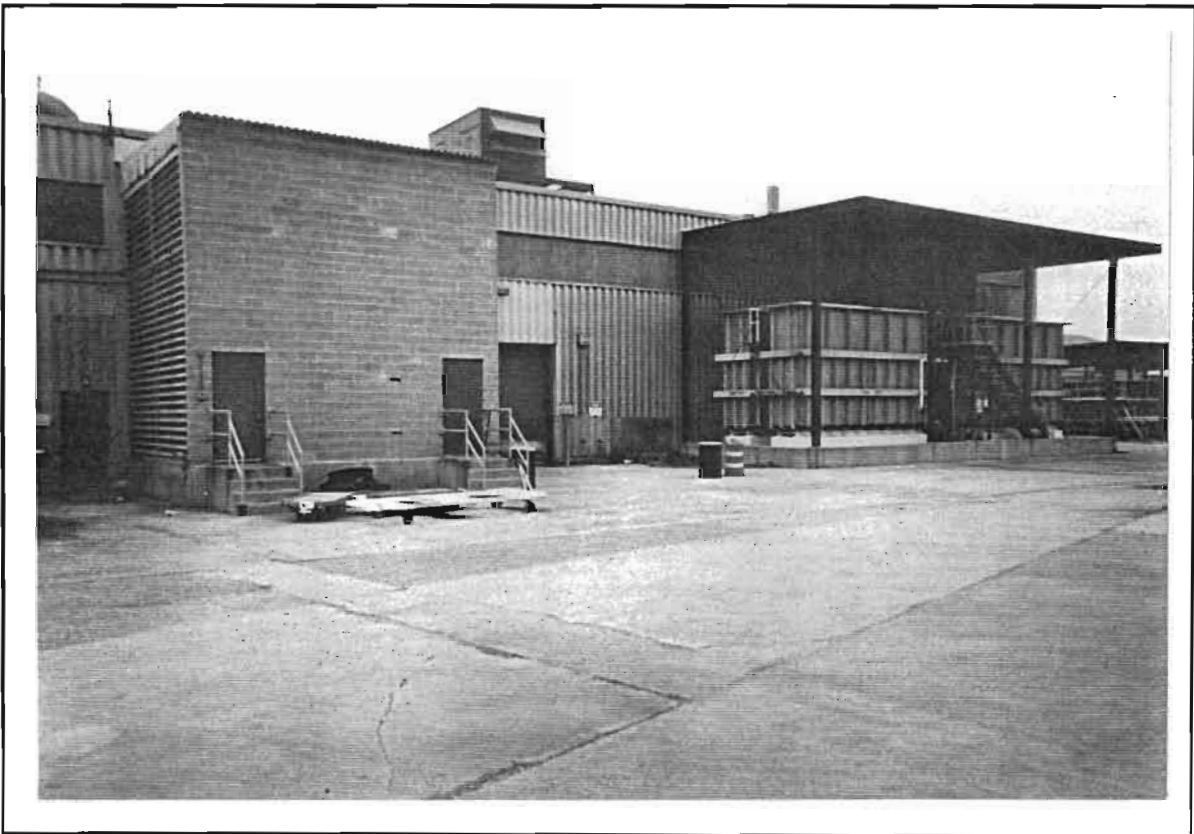
Photo #6: East side of plant #3 looking northwest.

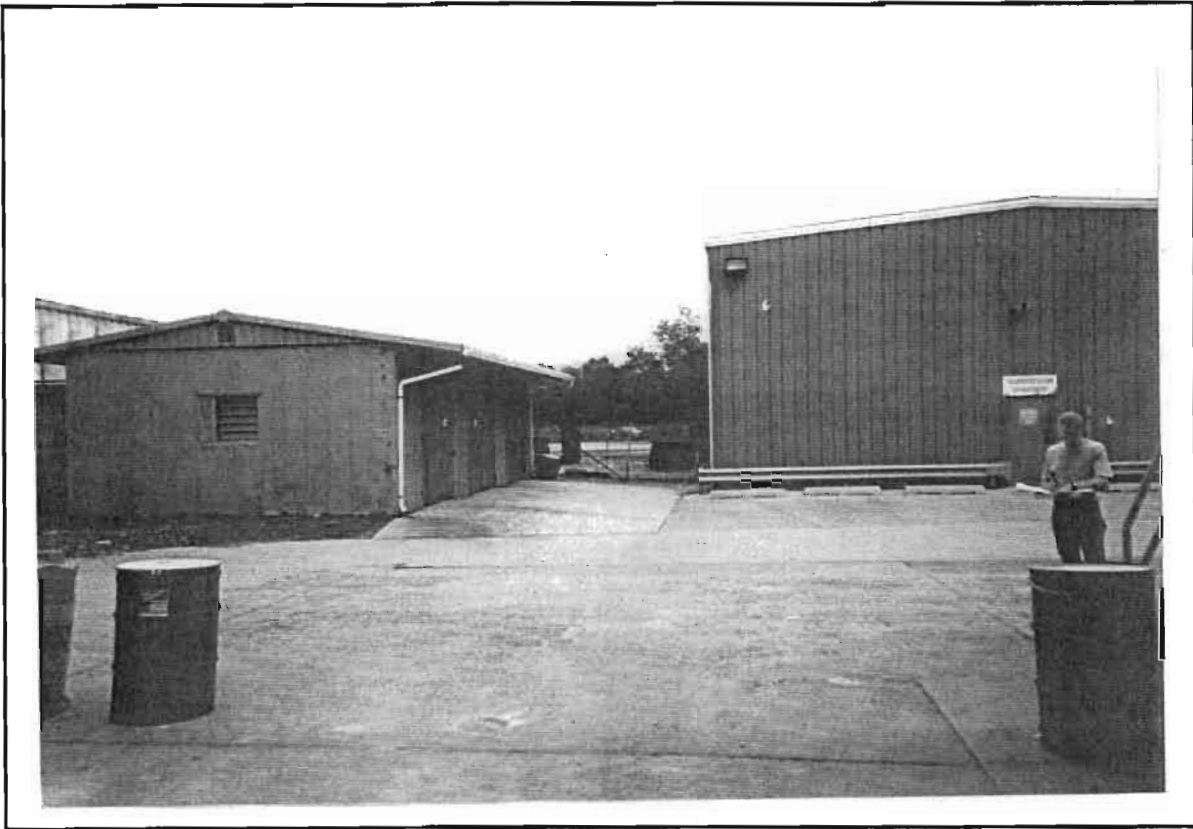
Photo #7: Looking east between building 130 & 03-33 toward eastern extent of VOC contamination.

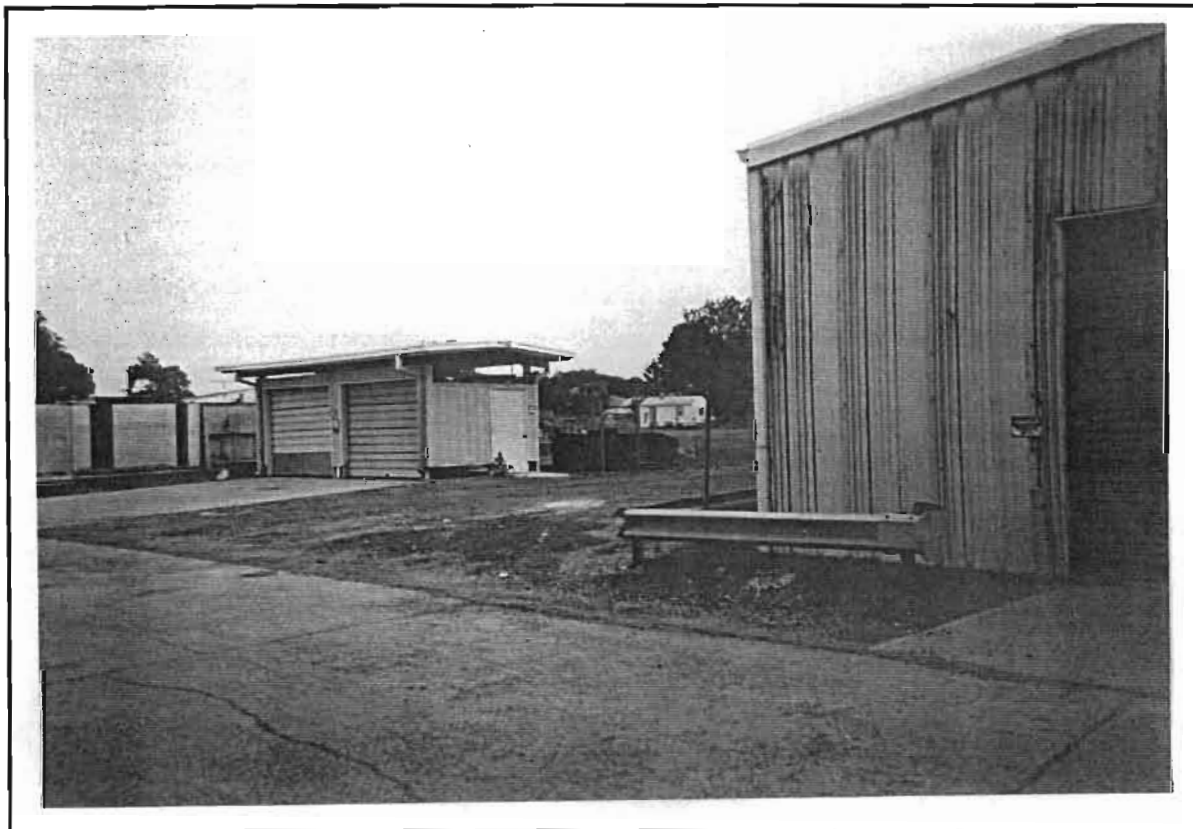
Photo #8: Looking northeast in the direction of building 03-38 toward northern extent of VOC contamination.

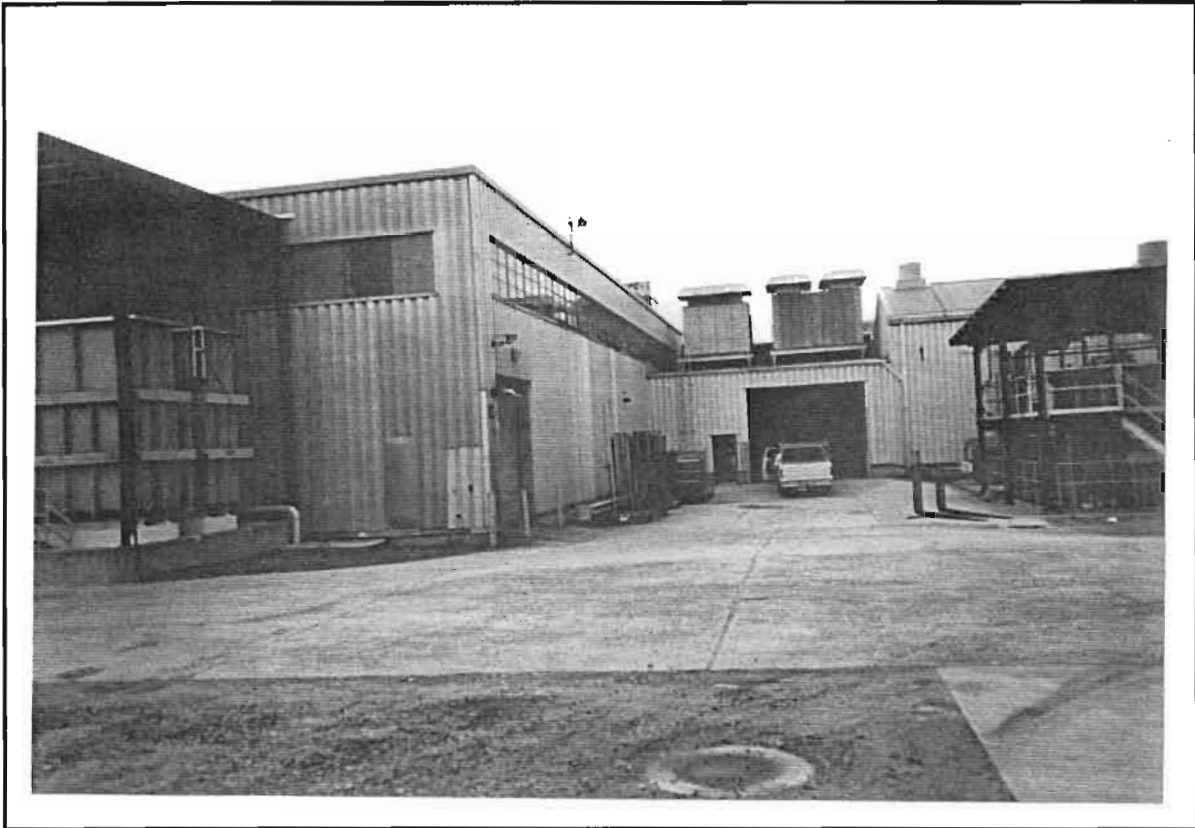
Photo #9: East side of plant #3 looking west.

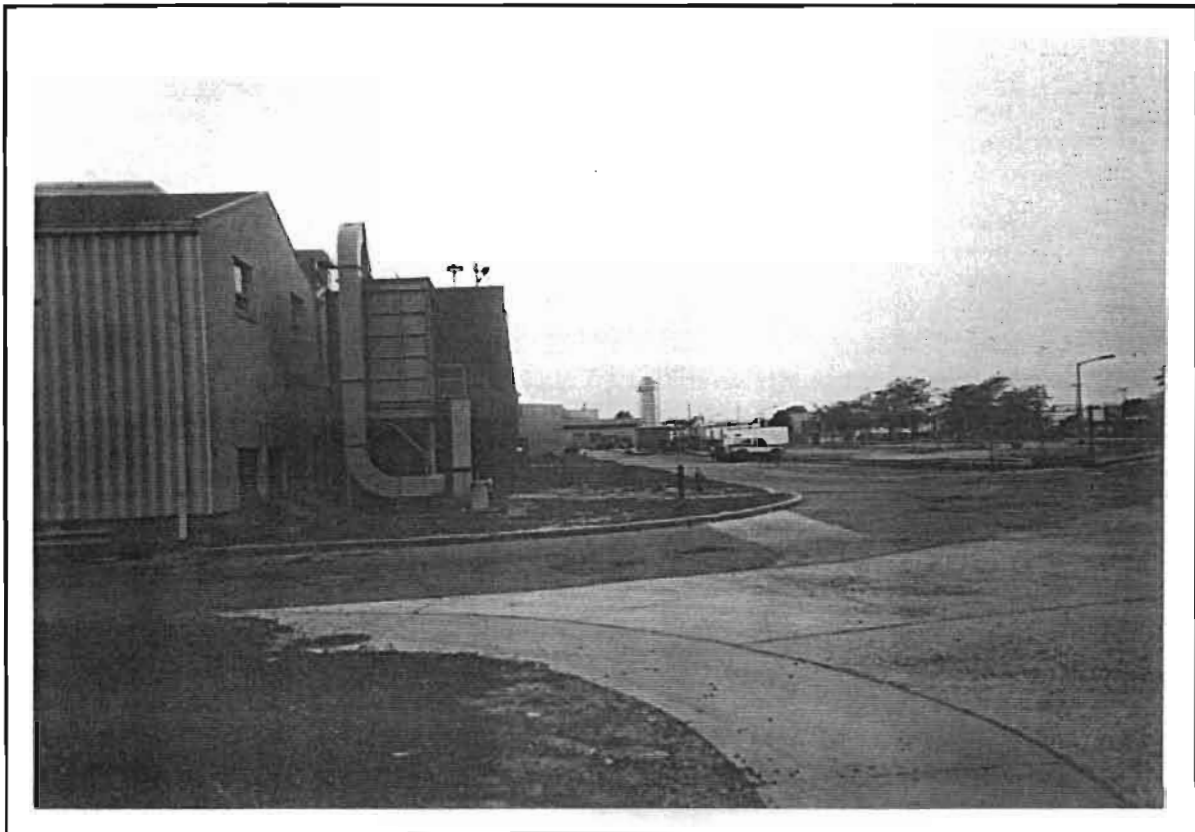
Photo #10: Northeast corner of plant #3 looking west.
