Subj: 2007 FIVE-YEAR REVIEW FOR SITE 1 – FORMER DRUM MARSHALLING  
AREA; SITE 2 – RECHARGE BASINS; SITE 3 – SALVAGE STORAGE AREA;  
NAVAL WEAPON INDUSTRIAL RESERVE PLANT (NWIRP) BETHPAGE, NEW  
YORK; EPA ID # NYD002047967

**2007 FIVE-YEAR REVIEW**

**FOR SITES 1, 2, AND 3**

**April 2008**

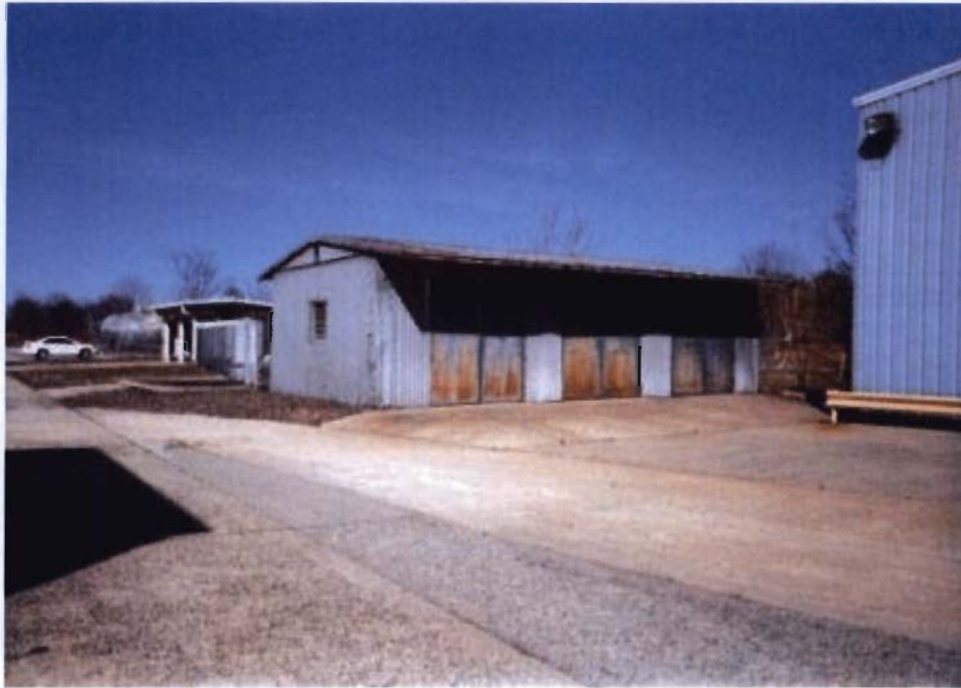
**Photo 1 – Site 1, metal buildings, southwest concrete pad situated in the southwestern portion of the Site, looking northeast.**

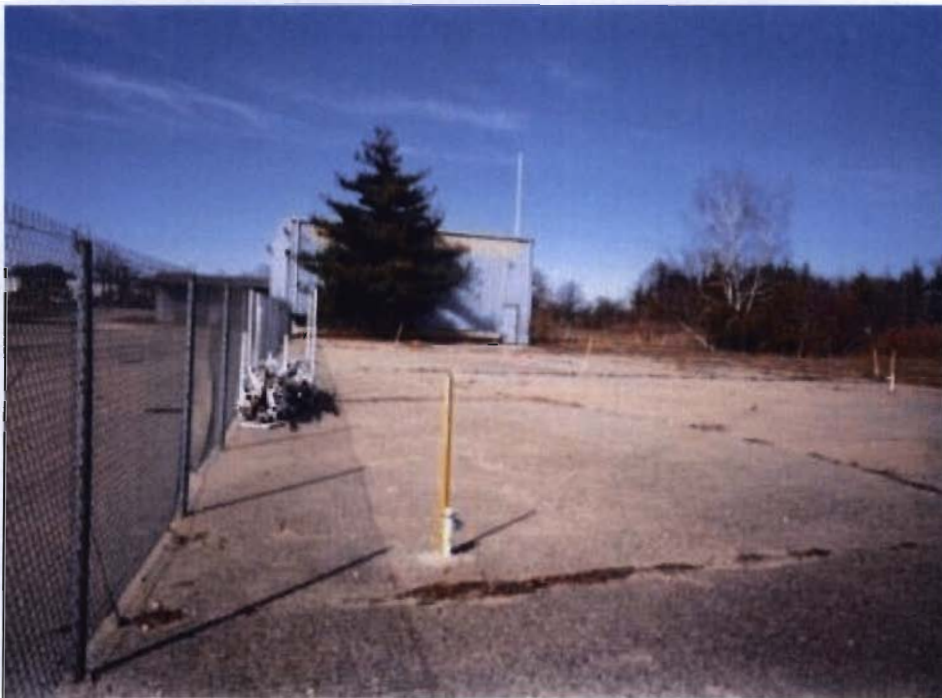
**Photo 2 – Site 1, southwest concrete pad situated in the southwestern portion of the site, looking north**

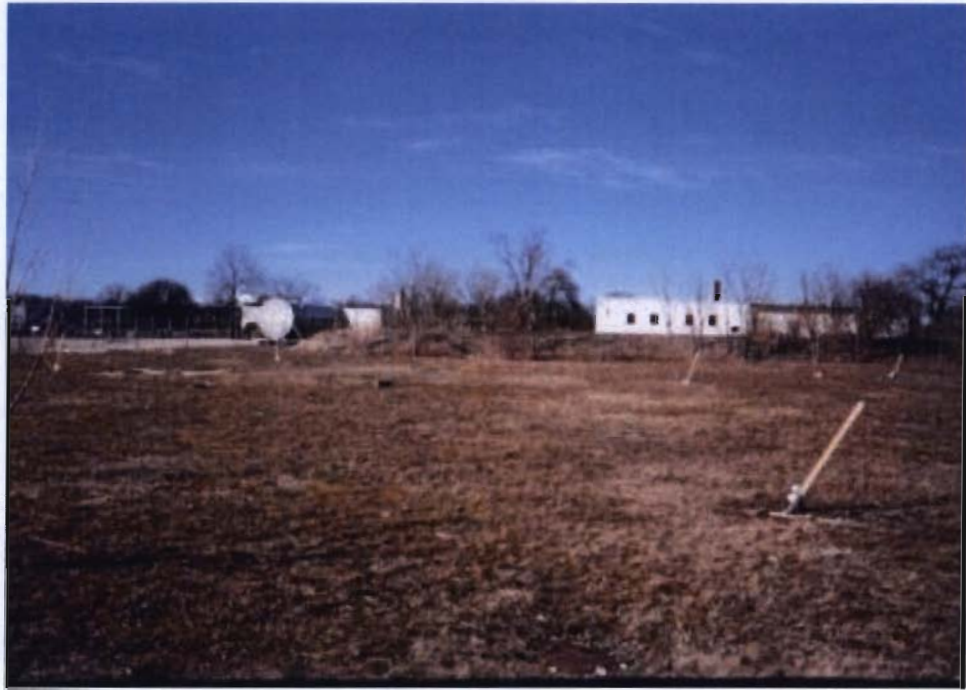
**Photo 3 – Site 1, northern portion of the Site, looking north.**

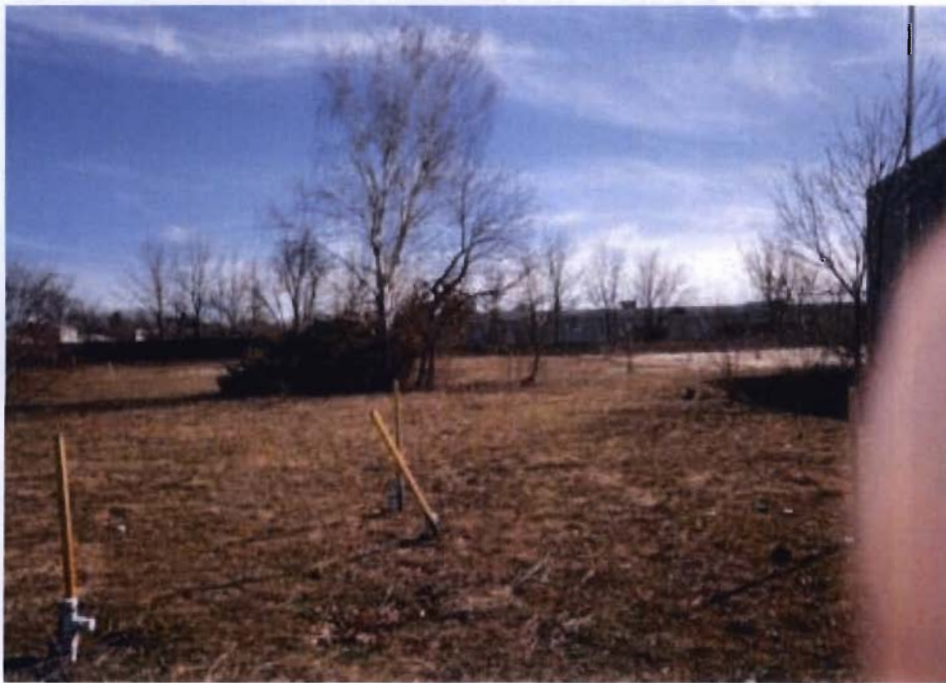
**Photo 4 – Site 1, central portion of the Site, looking south.**

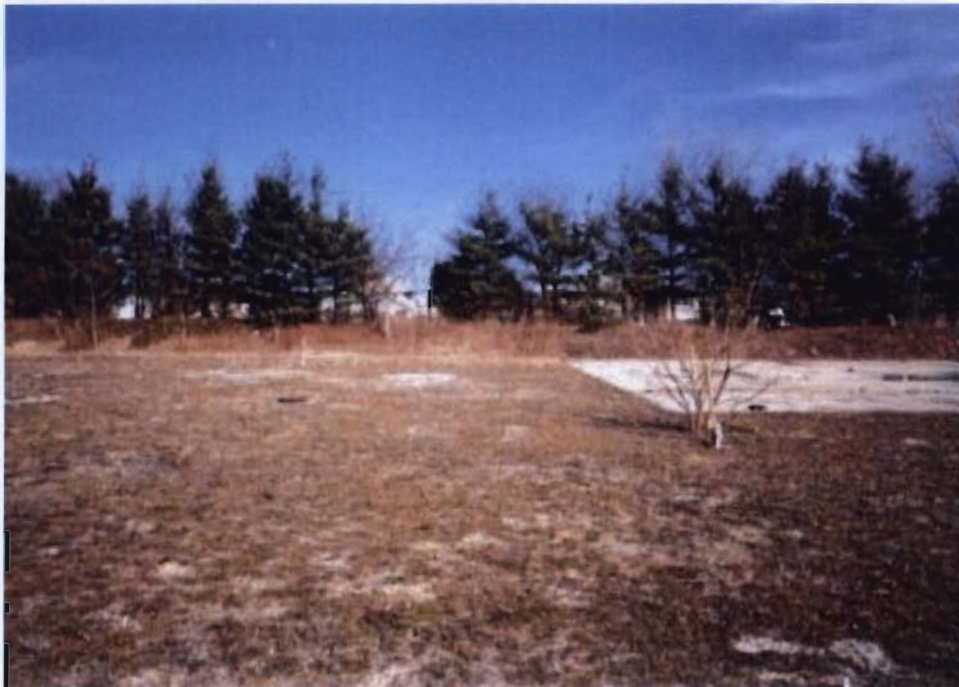
**Photo 5 – Site 1, central portion of the Site, looking east.**

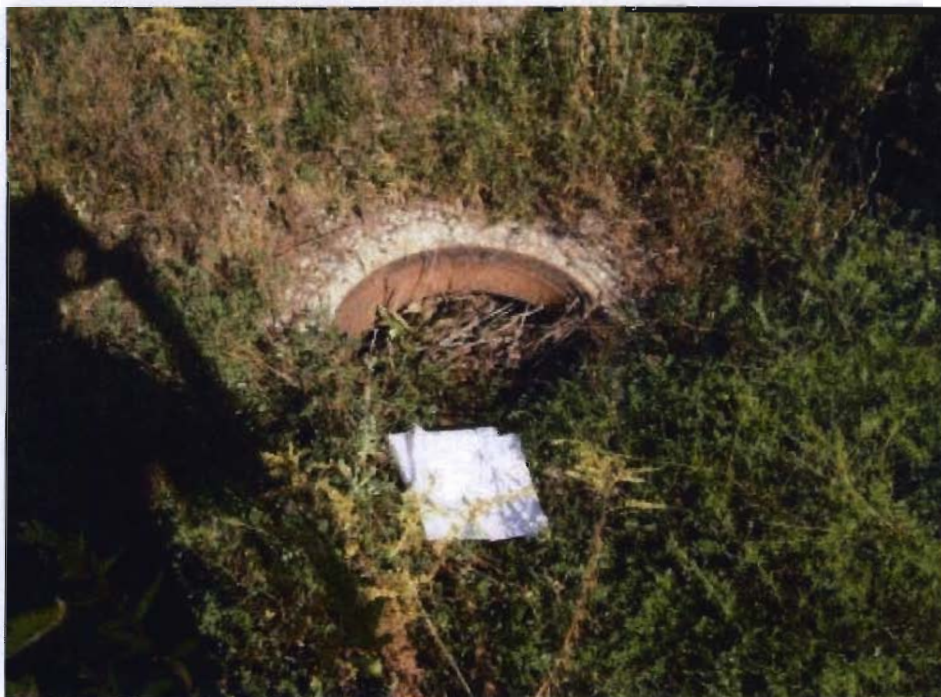
**Photo 6 –Site 1, former cesspool.**

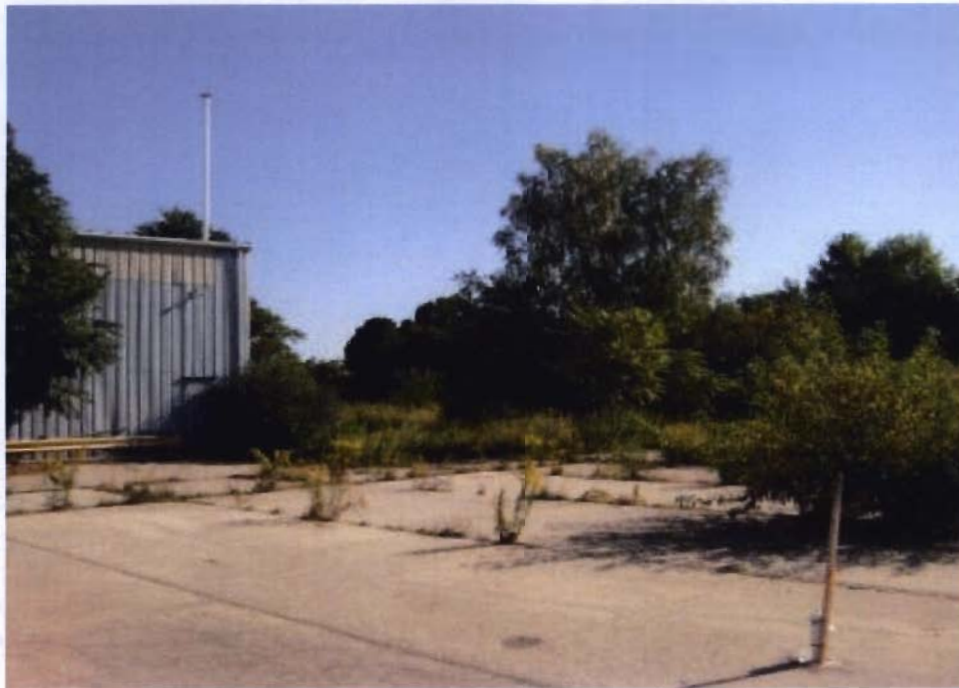
**Photo 7 – Site 1, southwestern portion of the Site, looking northeast.**

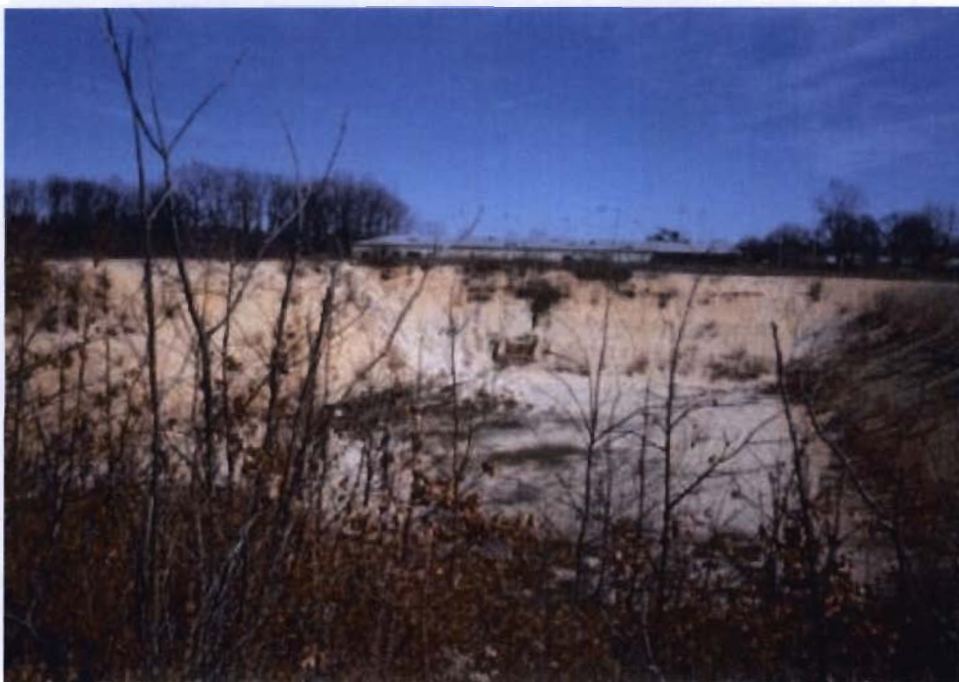
Some erosion was noted within the recharge basins. At this time, the erosion has not extended to soil cover at the top of the basins. Continued monitoring, and if required repair, of the erosion needs to be conducted to ensure that contaminated soils do not become exposed.

**Photo 8 –Site 2, Southeast Recharge Basin, western portion of the basin looking east**

1. Continue to monitor the recharge basins for erosion. If the erosion reaches a point that a wall collapse is a concern or erosion of the soil cover occurs, repairs would be needed.

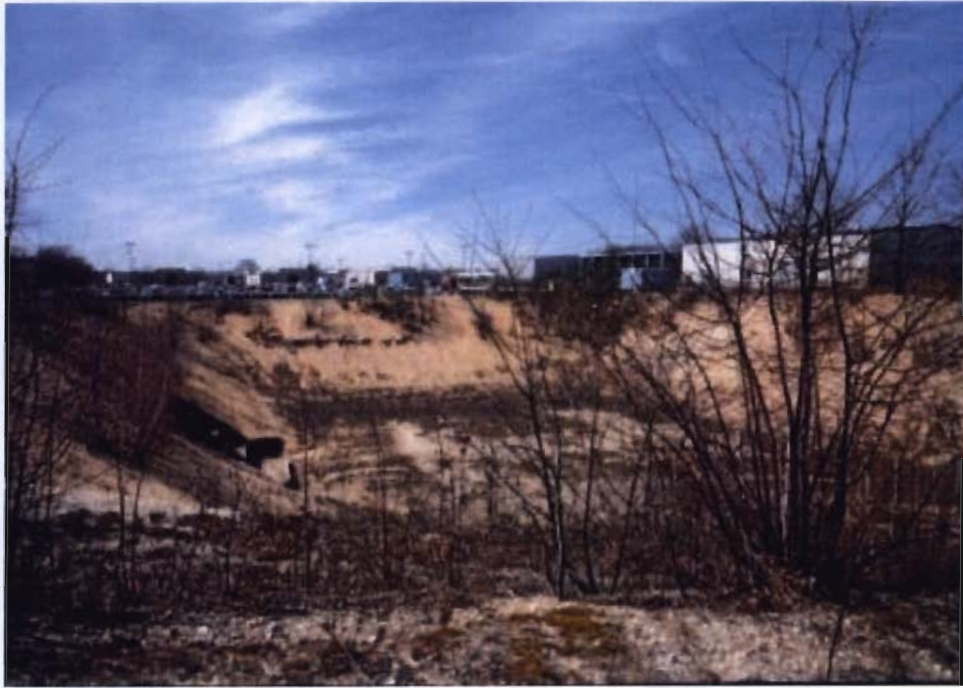
**Photo 9 – Site 2, Southwest Recharge Basin, eastern portion of the basin looking west.**

2.	<b>Cracks</b> <u>N/A</u>	Location shown on site map	Cracking not evident
	Lengths _____	Widths _____	Depths _____
	Remarks _____		
3.	<b>Erosion</b>	Location shown on site map	Erosion not evident
	Areal extent <u>20x40 feet</u>	Depth <u>2 feet</u>	
	Remarks <u>Erosion noted on eastern wall of Southwestern basin. Erosion being monitored.</u>

9.	<b>Slope Instability</b>	Slides	Location shown on site map
	Areal extent	20x40 feet	No evidence of slope instability
	Remarks	Side walls of recharge basins exhibit some erosion due to broken inlet pipe.	
<b>B. Benches</b>	Applicable	<b>N/A</b>	
(Horizontally constructed mounds of earth placed across a steep landfill side slope to interrupt the slope in order to slow down the velocity of surface runoff and intercept and convey the runoff to a lined channel.)

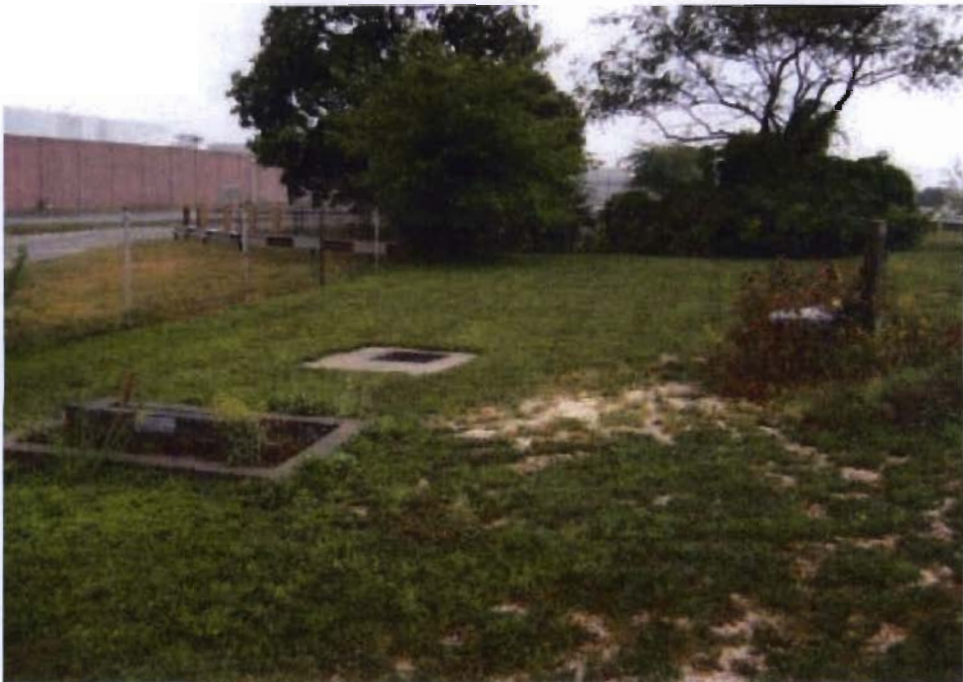
**Photo 10 –Site 2, storm water diverter situated in the southeast portion of the Site.**

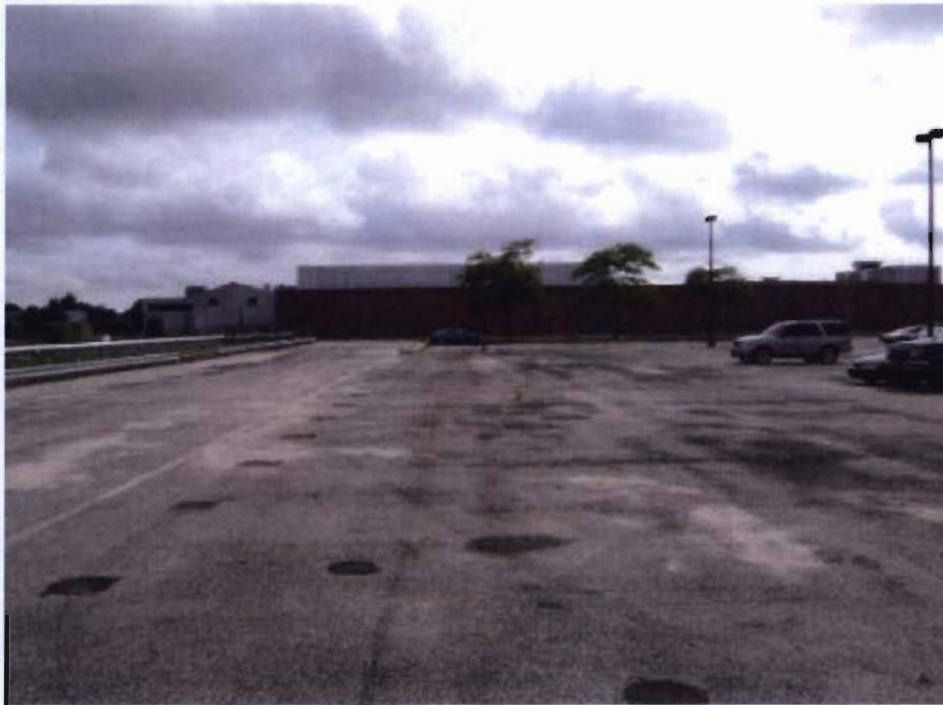
**Photo 11 – Site 3, western portion of Impound Lot 1, looking south.**

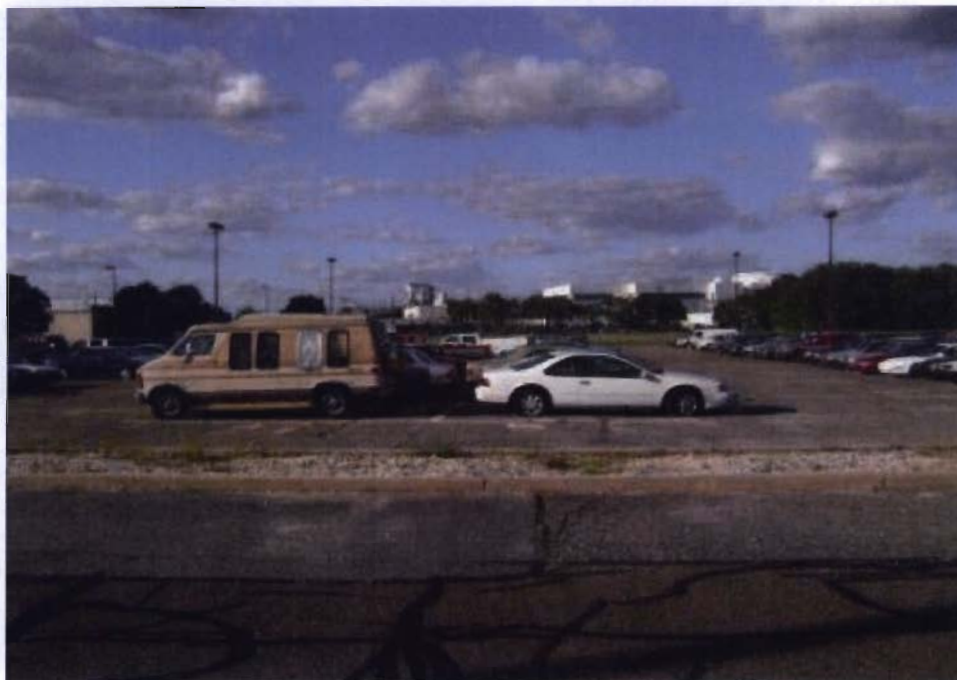
**Photo 12 –Site 3, central portion of Impound Lot 1, looking north.**

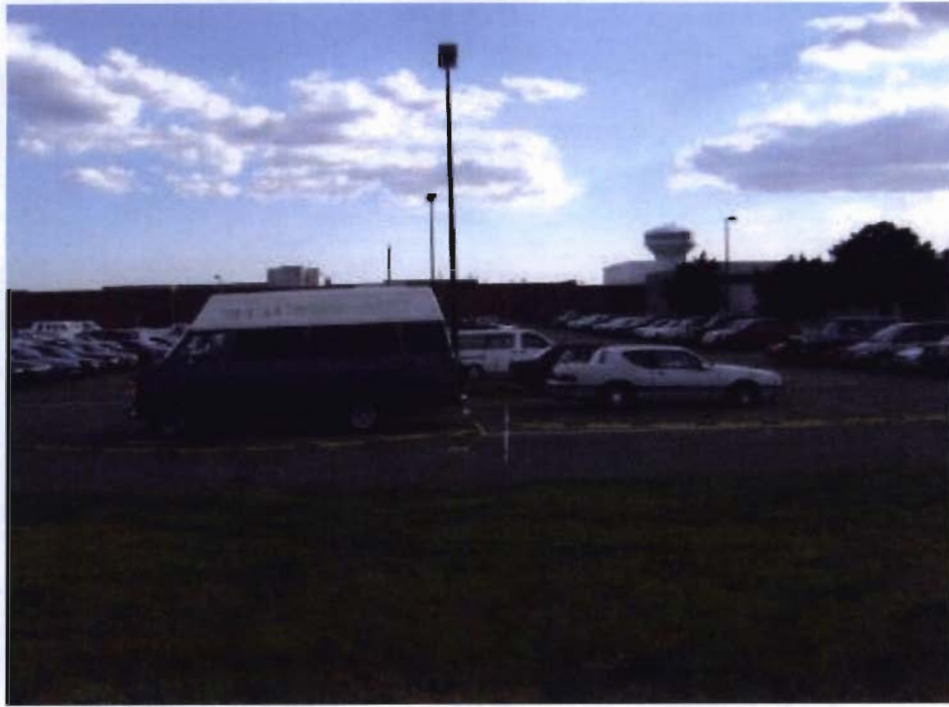
**Photo 13 – Site 3, eastern portion of Impound Lot 1, looking south.**
