SYOSSET LANDFILL

2018 ANNUAL POST-CLOSURE SUMMARY REPORT

TOWN OF OYSTER BAY

DEPARTMENT OF PUBLIC WORKS
SYOSSET, NEW YORK 11791

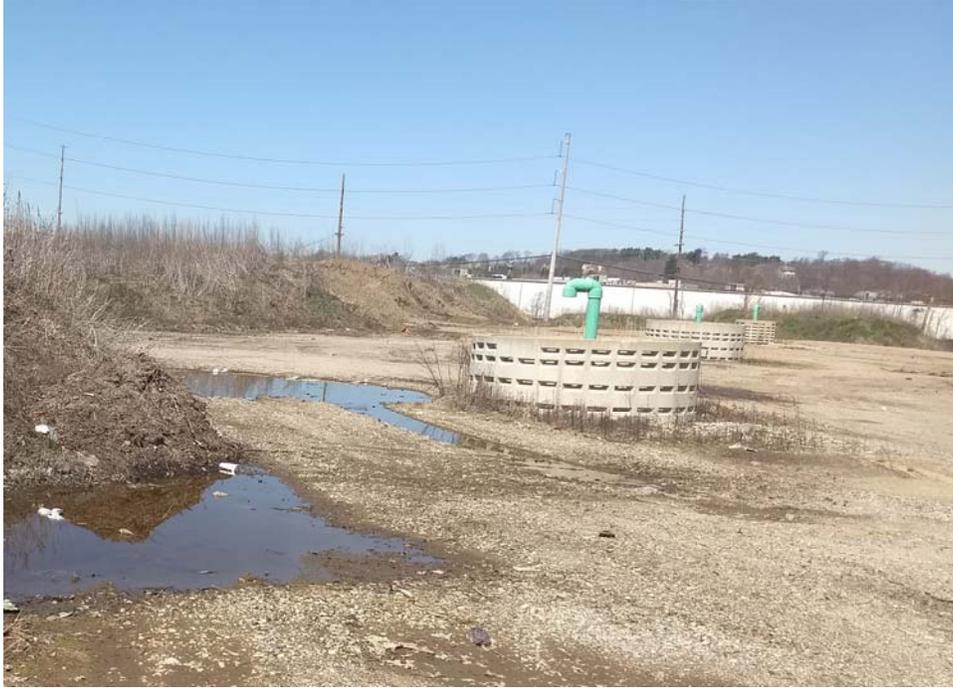
Minor ponding areas were observed in Area A during the first round of inspections during this reporting period due to uneven grading. During the second round of inspections minor ponding areas were also observed in the E due to uneven pavement and potholes.

Minor Ponding in Area A

It is recommended that surface grading within the RCA material in Area A should be routinely adjusted to remove low points that occur. The asphalt section in Areas E experiencing ponding should be restored in accordance with the original Capping Contract specifications as discussed in Section 1.5 when routine pavement repairs are performed in the future in these areas.

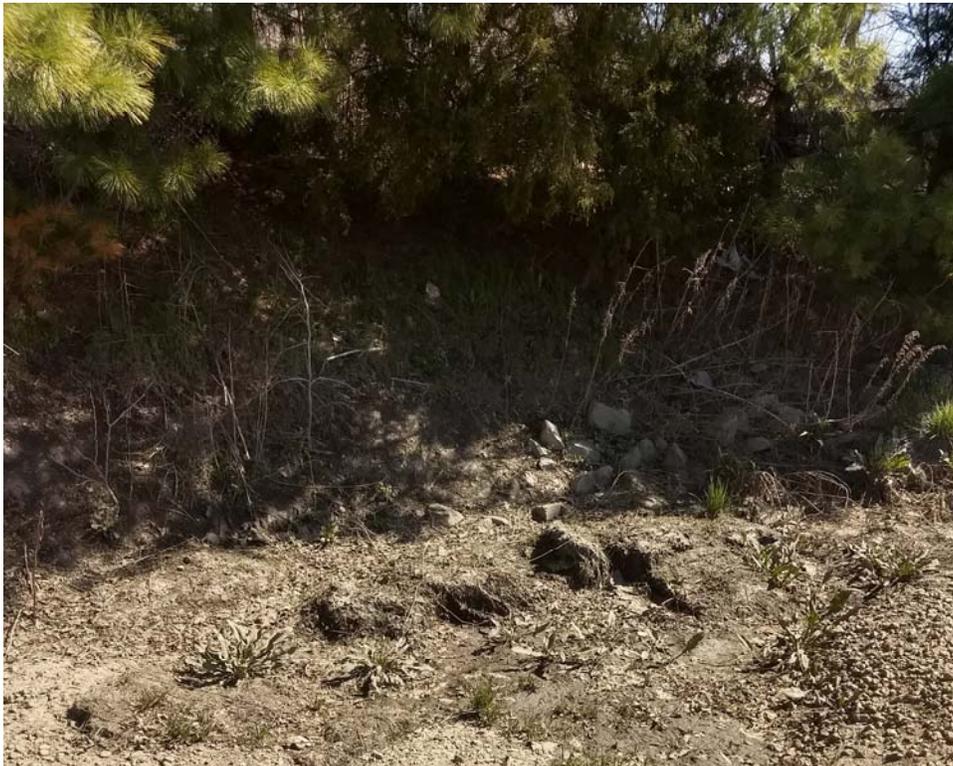
Areas of surface material erosion (i.e., ruts) were found in the vegetative cover buffer area of the Miscellaneous Equipment Storage Facility (Area B) and the Salt Storage Facility (Area C) during both rounds of inspections. These Areas are sloped toward the perimeter drainage ditches. The vegetative cover buffer area therefore receives runoff from both RCA and paved areas. Ruts form as a result of continued erosion of the surface material from stormwater runoff.

Surface erosion at perimeter in Area B

It is recommended that ruts in the surface material be repaired by removing silt, filling/regrading the surface area to remove the ruts, replacing topsoil that may have eroded away and reseeding this area during the planting season to prevent further erosion problems.

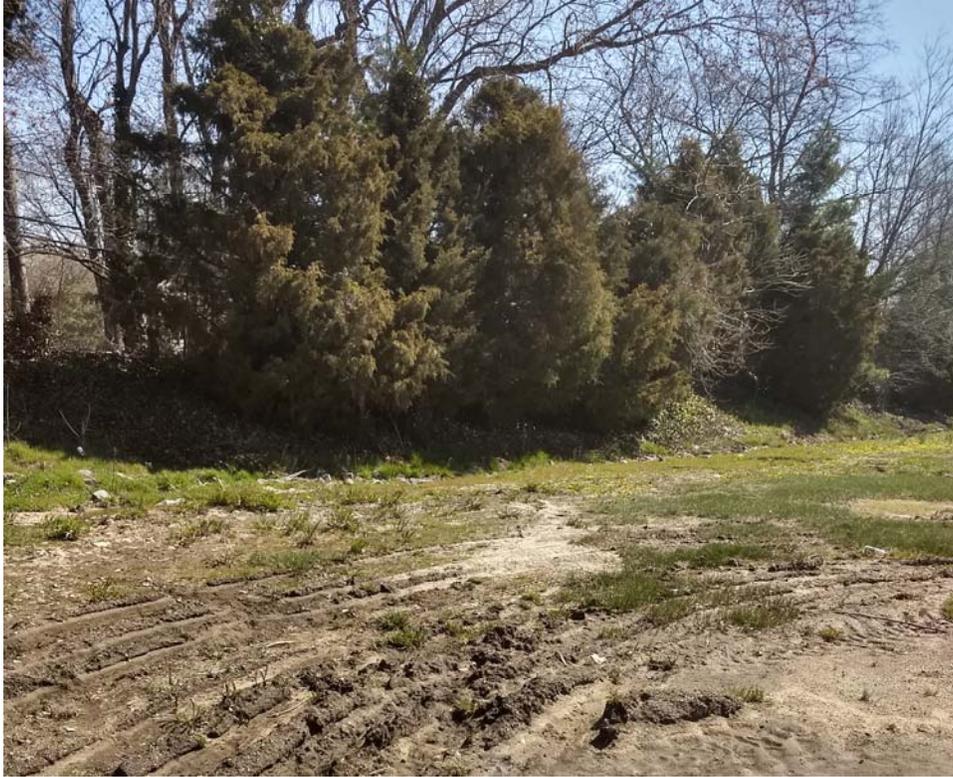
Vegetative surface erosion in Area C

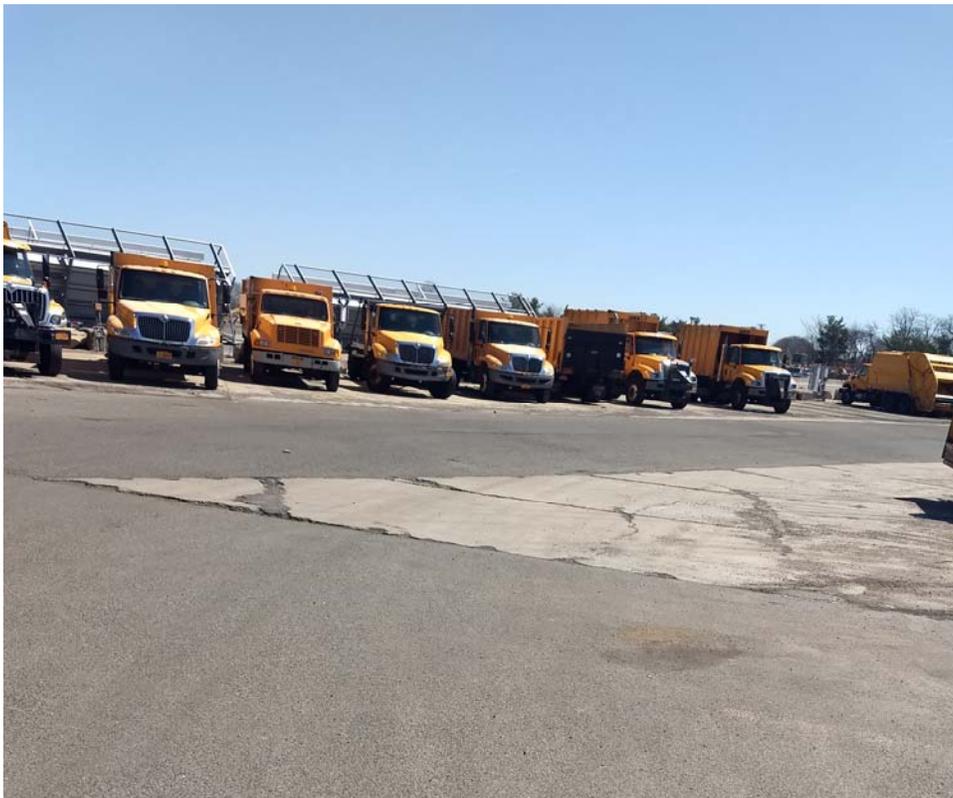
The condition of the concrete and asphalt pavement located in the Highway Department's Salt Storage Facility and Vehicle Parking Facility (Areas C & D) as well as the TOBDPW Sanitation Division's Vehicle Parking Facility (Area E), in general, continues to be good. Routine fracturing of pavement cracks occurs at construction joint locations and is likely occurring due to weathering. Minor cracks are inherent in these types of pavement materials. Some irregularly shaped pavement cracks also exist in Area E and are likely occurring due to a minor amount of settlement in the subsurface material in those areas. Their locations have been monitored/maintained throughout the post-closure period, the minor amount of settlement has not increased and is not necessarily attributable to the Landfill.

Minor surface cracks in Area E

It is recommended that these areas continue to be repaired on a regular basis as part of routine yard maintenance. The joints should be cleaned and sealed to prevent further weathering damage in accordance with the New York State Department of Transportation (NYSDOT) Standard Specifications, Construction and Materials, Section 633-3.02, "Cleaning, Sealing and Filling Joints and Cracks". It is recommended that the cracks in the asphalt pavement be cleaned and sealed as per the NYSDOT Pay Item for Cleaning and Sealing Cracks in Hot Mix Asphalt Pavement using Hot Applied Sealant, ITEM 402.7602 08. Cracks in the concrete pavement should be cleaned and sealed as per the NYSDOT Pay Item for Crack Repair by Epoxy Injection (Restoration), ITEM 01555.8002 M.

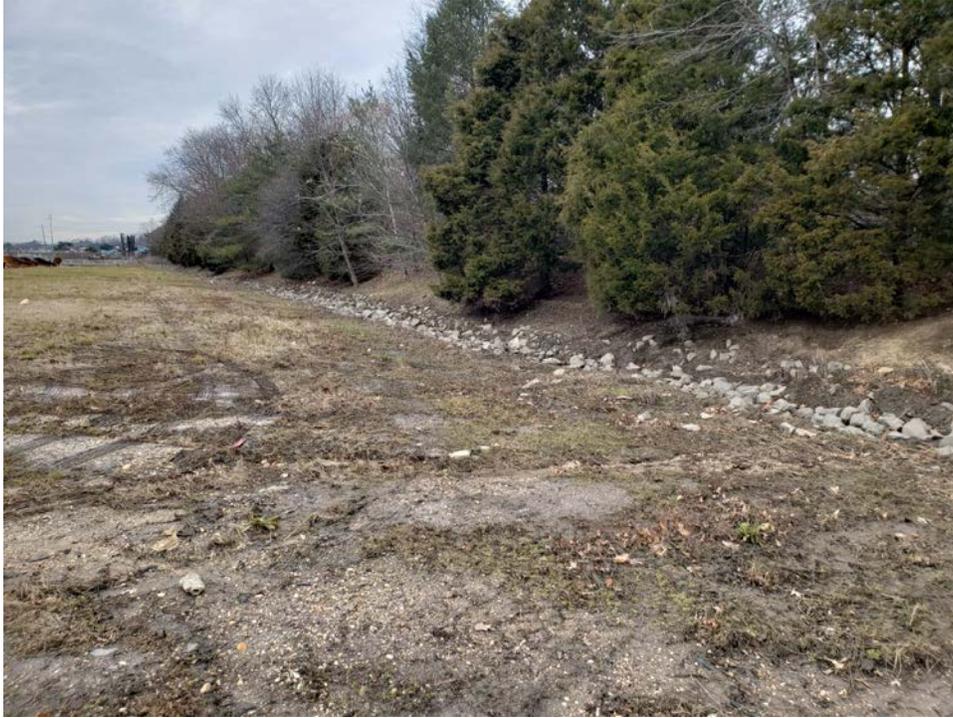
Lack of vegetation at perimeter in Area B

It is recommended that the topsoil be replaced in eroded areas and reseeding be performed during the planting season to prevent further erosion problems. It is also recommended that perimeter vegetation located around the property line gas vent wells and along the property line in general should be trimmed and maintained to a manageable level.

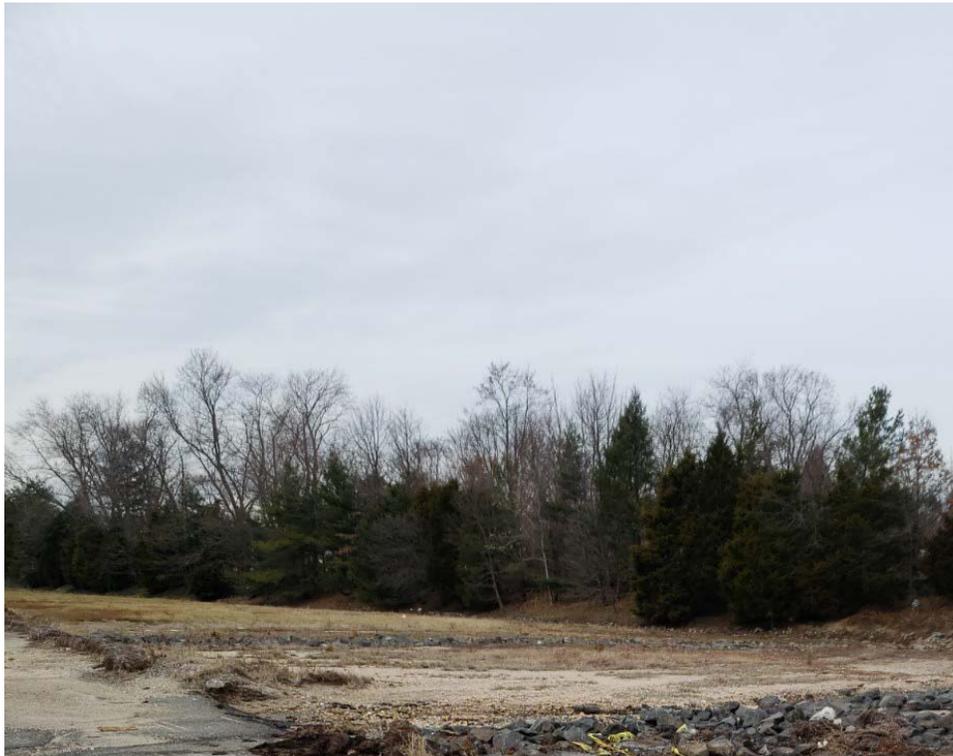
Lack of vegetation at perimeter in Area C

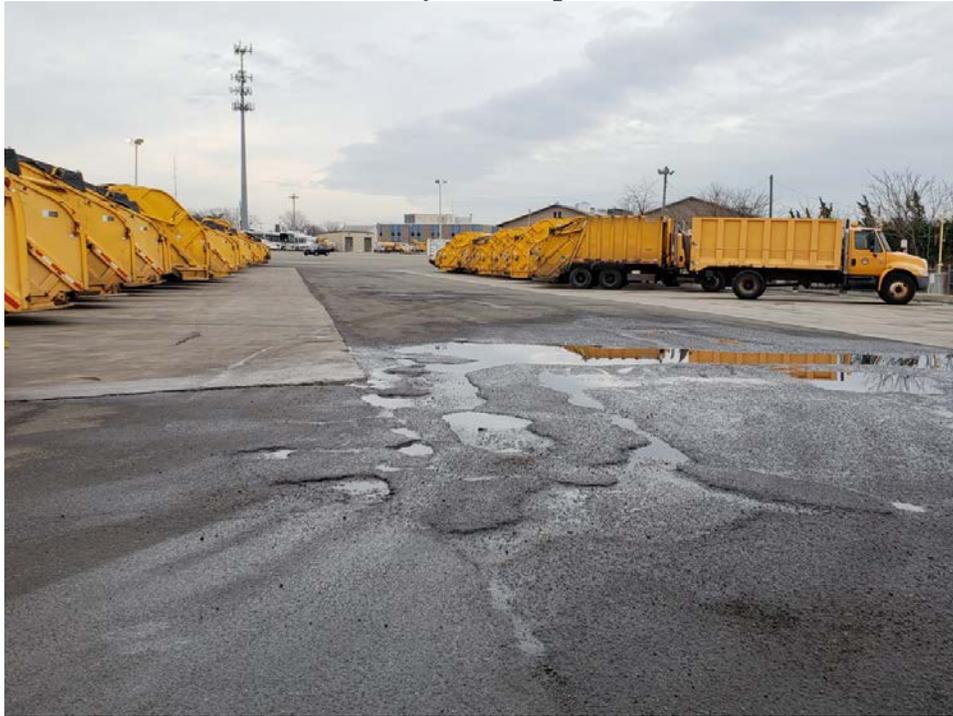
Minor Ponding in Area E

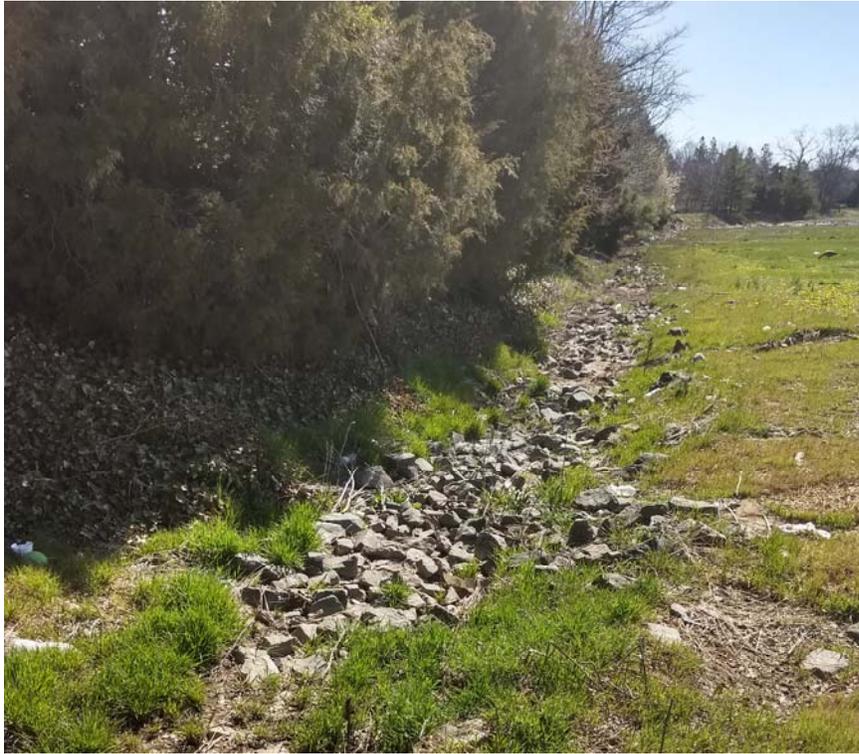
Some siltation, vegetation growth and debris – DS#3

The drainage ditches should receive routine maintenance to prevent future sediment accumulation and vegetation growth conditions. The apparent cause of most of the ditch siltation appears to be from the erosion of materials stored in stockpiles onsite. Erosion control techniques should be implemented around the material stockpiles to prevent the transport of silt and sediment from the piles to the drainage ditches. However, only erosion control devices that can be installed on the ground surface or anchored above the cap elevation should be utilized.

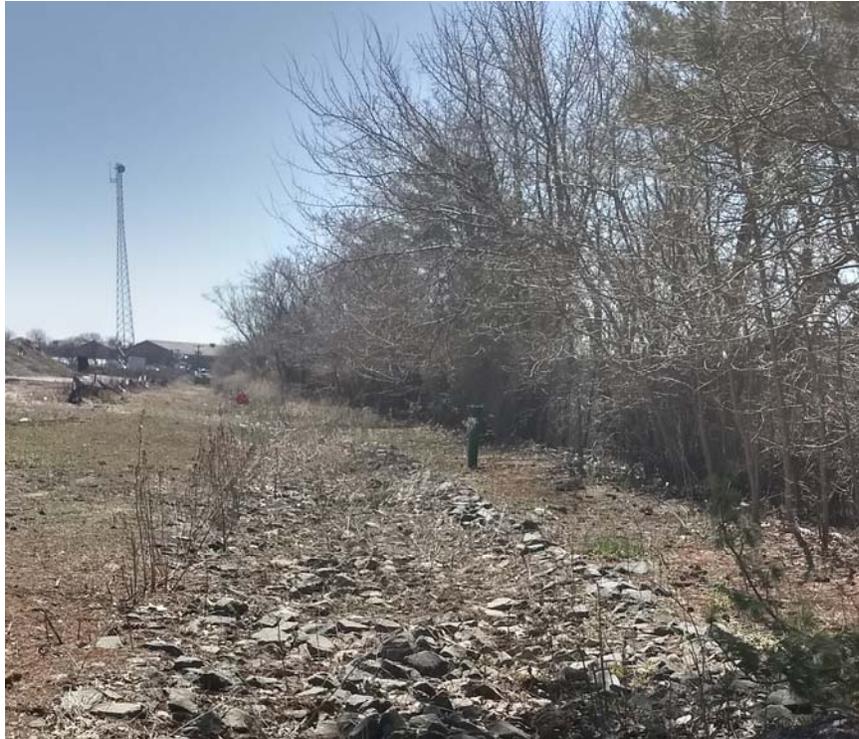
Siltation, vegetation growth and debris – DS#6

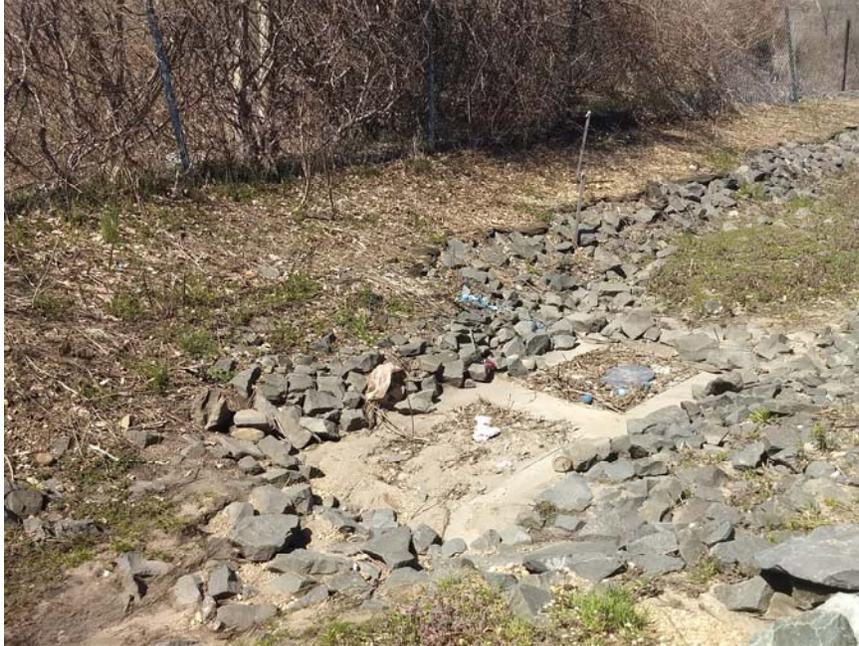
Siltation and debris – Catch Basin #2

It is recommended that the silt and sediment be removed on a regular basis from catch basins and the area in the vicinity of the catch basin inlets and drainage ditches. It is also recommended to have silt protection around all of the catch basin inlets. The hay bales previously installed at the catch basin inlets should be replaced. The erosion control measures recommended in Section 2.1 should be implemented onsite to minimize the silt and sediment transport to the catch basin locations.

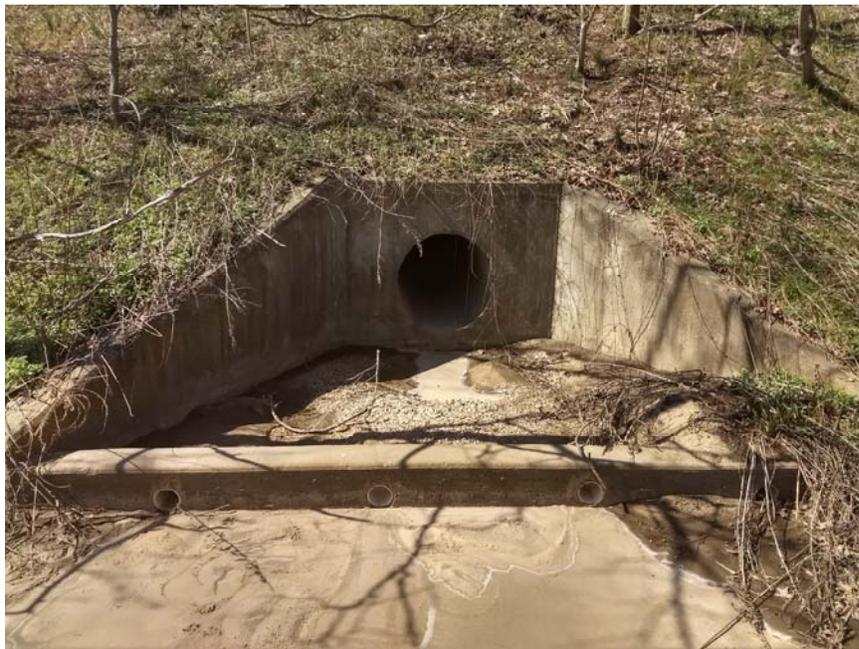
Minor Siltation – RB#284

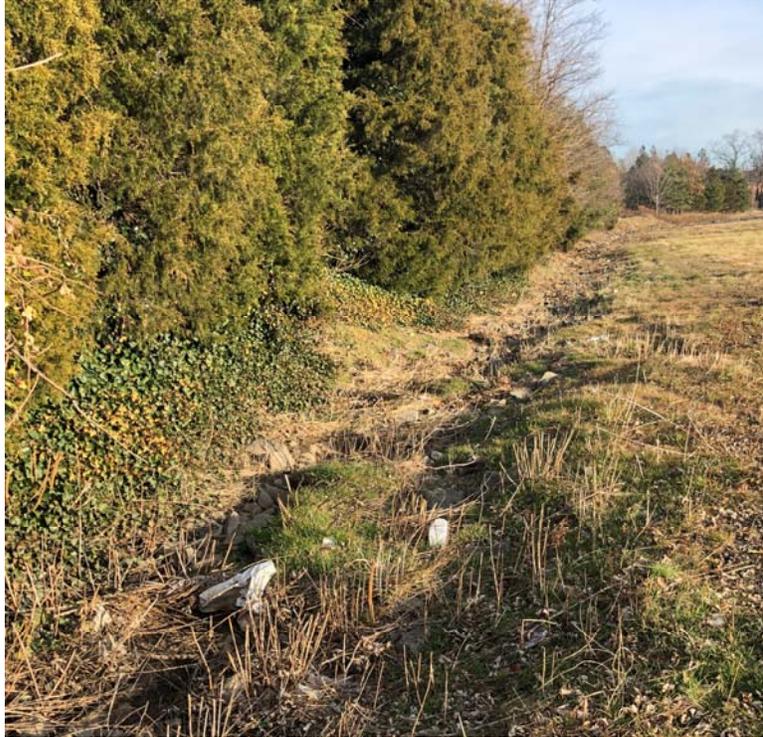
Siltation, vegetative growth and debris- DS#3

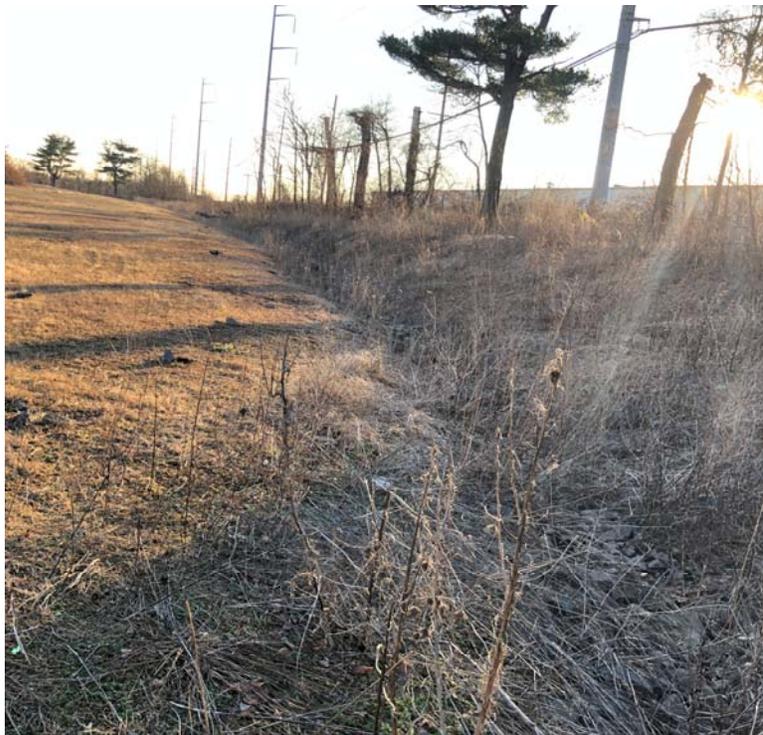
Siltation, vegetative growth and debris- DS#5

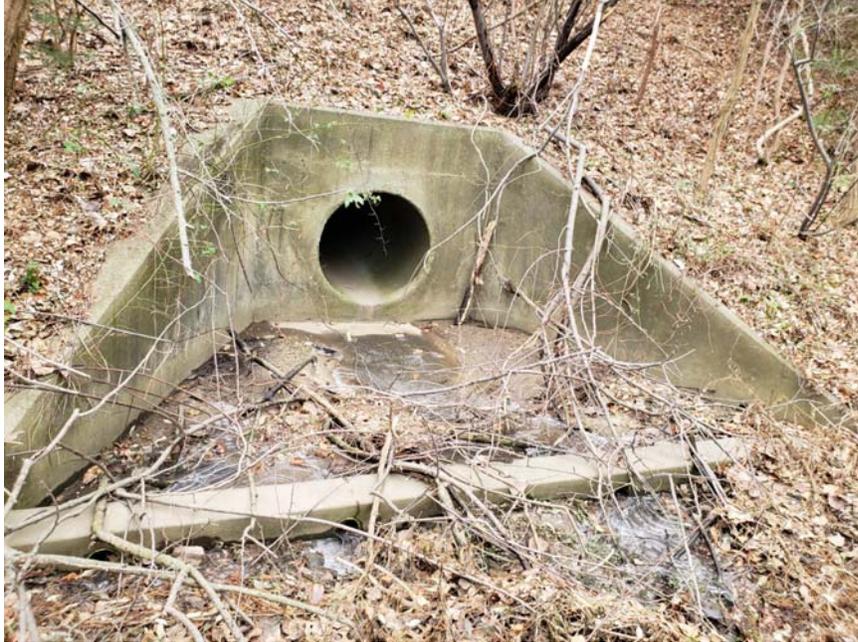
Some siltation and debris- RB#284

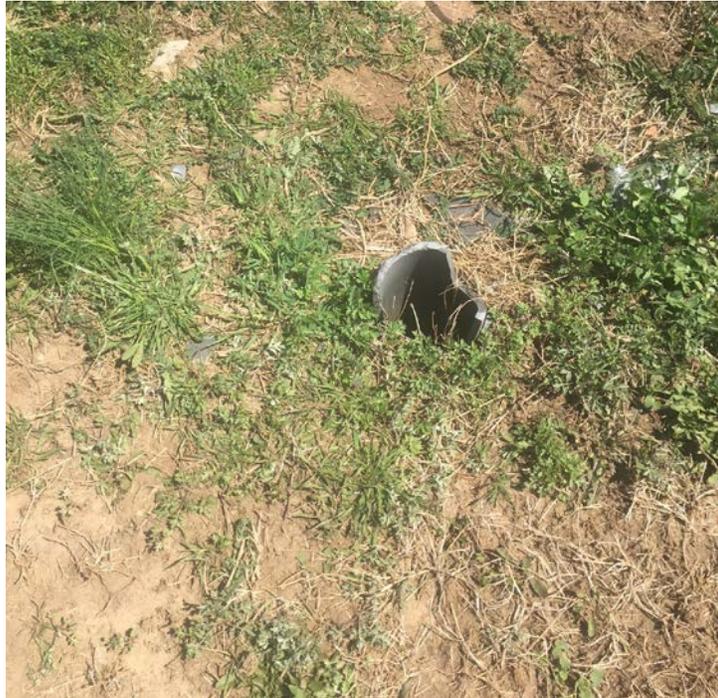
Inspection of each gas vent well was performed prior to each round of gas monitoring. Of the 54 property line and perimeter gas vent wells inspected in the first round of inspections, wells NE-16, NW-3, and SW-6 were noted to be damaged (the upper sections of the gas vent wells were detached from the well casing pipes at grade). The three wells are secured with a temporary protective cover to prevent debris from entering the wells. Machinery used in this area combined with overgrown vegetation may have been the cause of the damage. While Well NE-16, NW-3, and SW-6 are still capable of venting and being monitored in their current condition, when necessary, it is recommended that the upper section of the casing pipe be reattached and the wells restored to their original configuration during the next well repair service order. It is recommended that vegetation near the gas vent wells be carefully maintained on a regular basis to improve visibility and help prevent damage to vent wells in the future.

Well Broken at Grade – NE-16

In December 2018, the Town solicited quotes from contractors to repair Wells NE-16, NW-3, SW-6 and R-18 and to decommission Well SE-2. Subsequently, the Town issued a service order and the repair work was performed during the next post-closure reporting period.

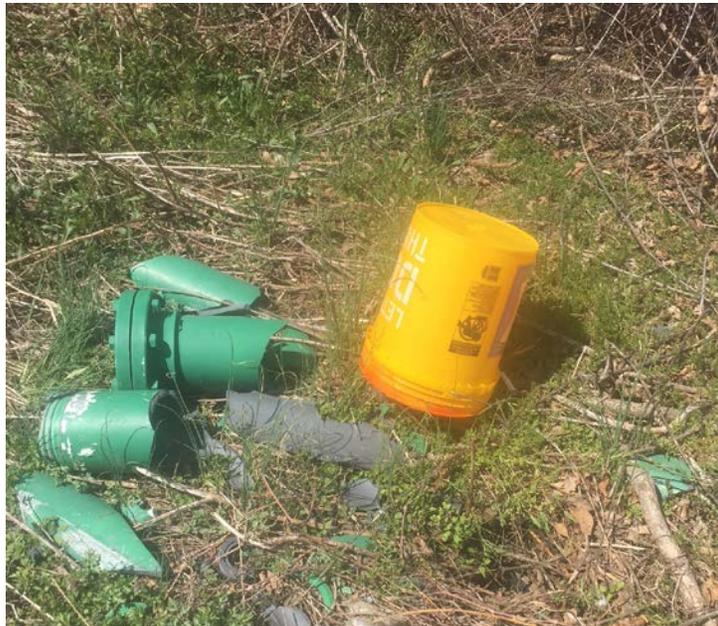
Well Broken at Grade – NW-3

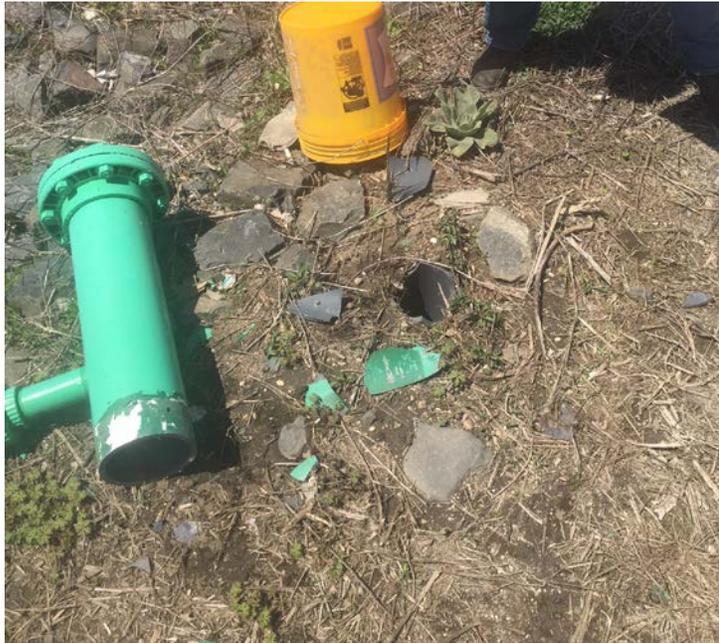
Well Broken at Grade – SW-6

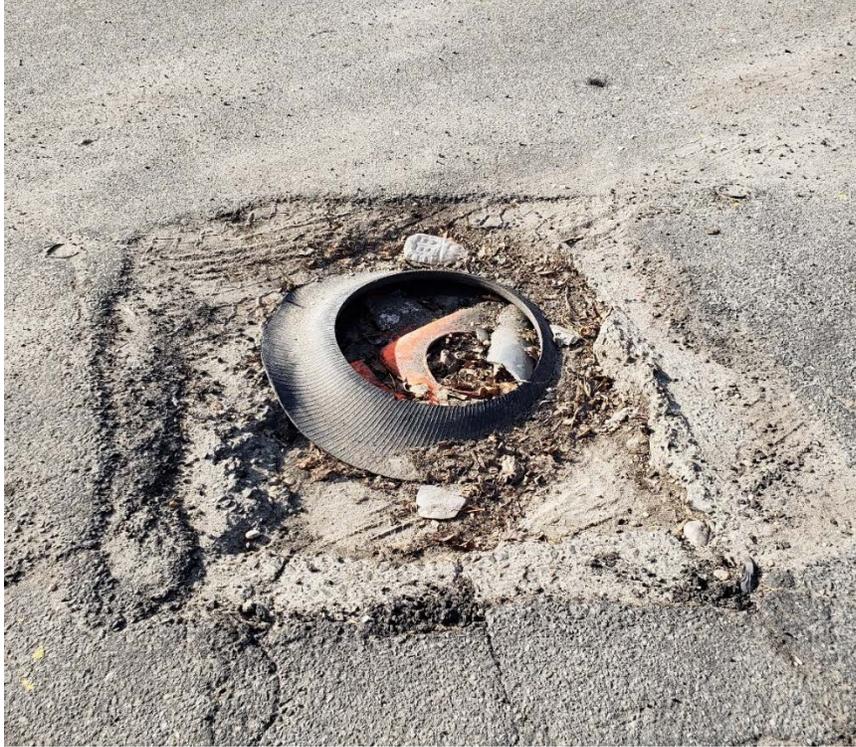
During the second inspection round, the same wells remained damaged and it was noted that Well SE-2 was also damaged below grade. Based on the extent of damage, Well SE-2 could no longer be monitored in its current condition. However, the USEPA granted the Town's petition to remove this well from the post-closure gas monitoring well network based on the following facts:

Well Broken at Grade – SE-2

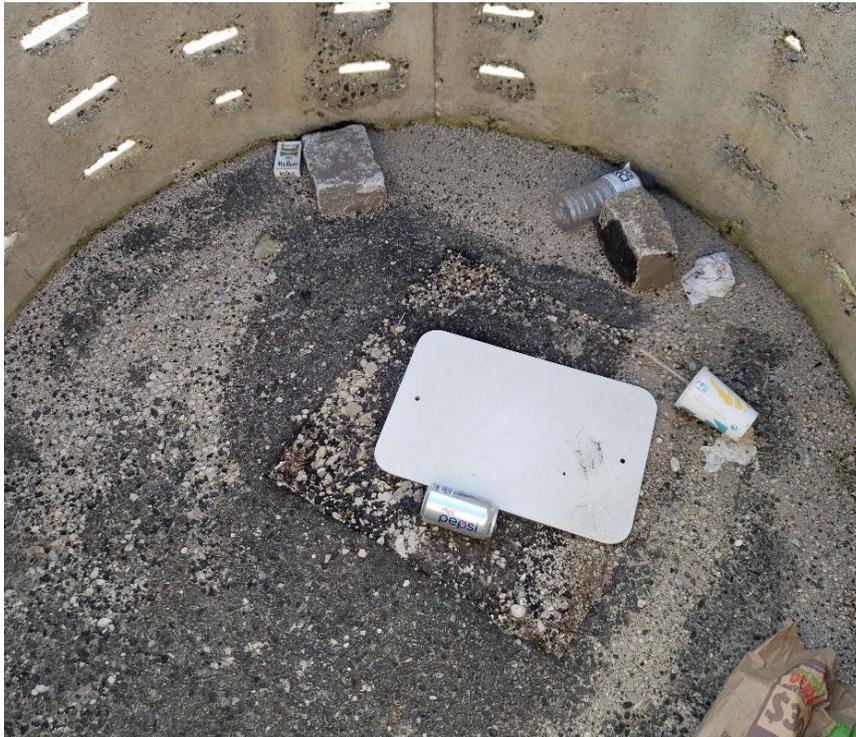
The first round of 2018 ridge vent well inspections showed no damage to the vent wells. However, during the second round of inspections it was noted that the wellhead for Ridge Vent Well R-18 was broken at grade. It is recommended that the damaged well casing be replaced with a 6-inch diameter PVC wellhead and connected to the undamaged well section of at a point at or slightly below grade. Historically, the leading cause of damage to the ridge vent well casings and protective concrete rings has been attributed to impact with trucks or other vehicles used onsite.

Well Broken at Grade – R-18
