### **DAILY INSPECTION REPORT - No. 20230823**

Alsy Manufacturing, Inc., Site No. 130027

Department of Environmental Conservation Contract No. D009812

#### Site Location: 270-280 Duffy Avenue, Hicksville, NY

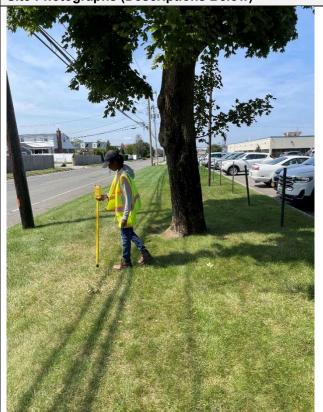
TRC attempted to locate monitoring well MW-3 using a metal detector and hand tools. Monitoring well MW-3 could not be located. Monitoring well AMS-1 could not be located and has likely been destroyed or paved over. Monitoring well MW-1 could not be sampled due to a bladder pump and associated tubing stuck in the well from the previous groundwater sampling event (2022). TRC recommends retaining a drilling contractor for the removal of the pump and tubing.

TRC employee attempting to locate monitoring well MW-3 with metal detector.

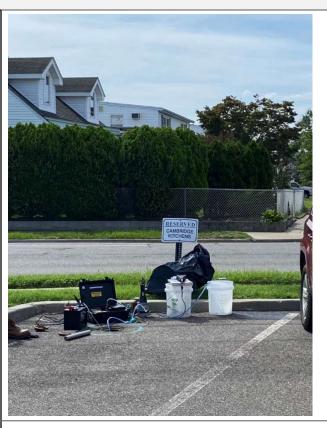
Purging of groundwater from monitoring well AMS-2.

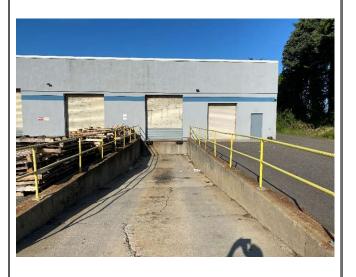
Cracks observed on loading dock located at the northern portion of the 270 Duffy Avenue Site.
