Re: Sonia Road Landfill Remediation Program
Site Registry No. 152013
Post Closure Program

**SONIA ROAD LANDFILL
WEST BRENTWOOD, NEW YORK
SITE REGISTRY NO. 152013**

**POST CLOSURE
MONITORING AND MAINTENANCE REPORT**

DECEMBER 2006

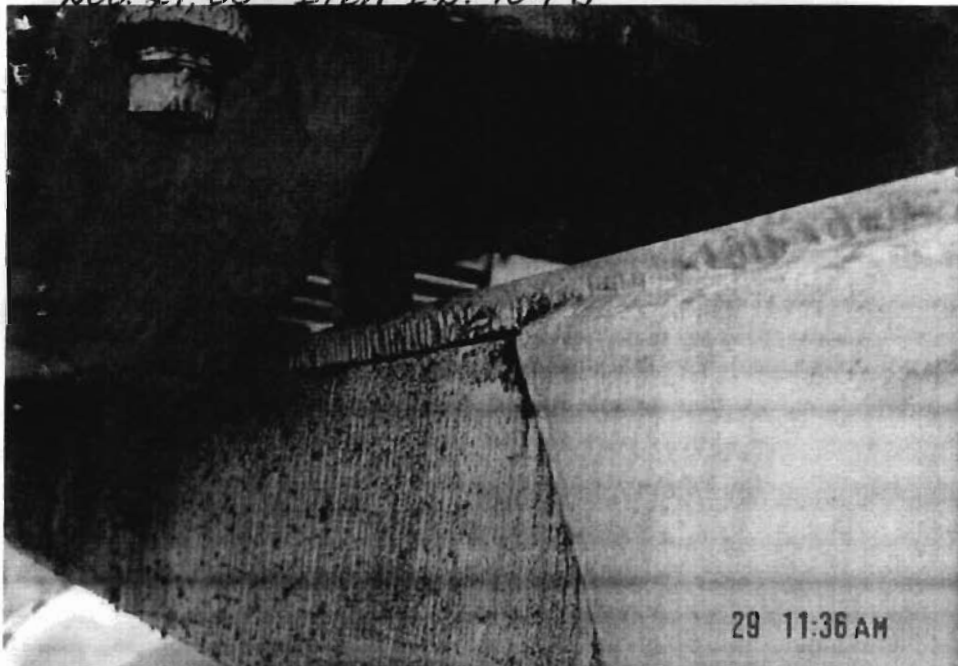
NOV. 29, 06 - ITEM I.D. - 104 B

ITEM I.D.	PROBLEM CODE	PRIORITY CODE	PHOTO TAKEN	COMMENTS
Blower Pad / Blower Nos. 104A and 104B				
104B	K	4	YIN # 2	OIL LEAKING FROM FRONT OF BLOWER,
---	---	---	YIN #	APPROX AFTER THIRTY MINUTES OF RUN TIME.
			YIN #	
Flare				
				SYSTEM USED FOR VENTING
			YIN #	
			YIN #	
Condensate Storage				
				Liquid Volume = <u>1.174</u> gallons Alarms: Y <input checked="" type="checkbox"/> N Test System: OK / Not Successful
			YIN #	STICK MEASURE EIGHTEEN INCHES (SYSTEM NOT TESTED)
			YIN #
