TOWN OF ISLIP DEPARTMENT OF ENVIRONMENTAL CONTROL

**SONIA ROAD LANDFILL
WEST BRENTWOOD, NEW YORK
SITE REGISTRY NO. 152013**

**POST CLOSURE
MONITORING AND MAINTENANCE REPORT**

JUNE 2007

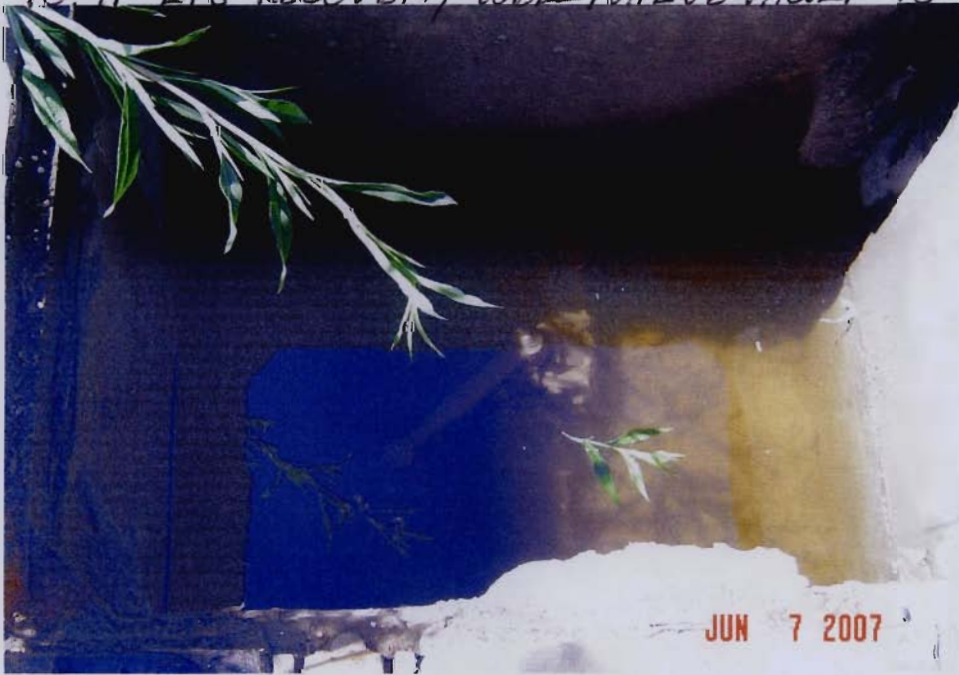
PG 11 LFG RECOVERY WELL / VALVE VAULT 13

4. **Condition:** The well head on Gas Collection Well GC-13 is set under the concrete slab of the access chamber, unlike on the other wells where it is located under the access chamber cover.

Problem: If the access chamber settles it will damage the well head.

Perceived Cause: Closer inspection reveals that the well was most likely installed the way it is now and that there is no immediate evidence of movement or settlement of the access chamber.

Recommendations: Although there may not be settlement occurring, the access chamber on GC-13 should be monitored for settlement as a precaution.
