**TOWN OF ISLIP
SUFFOLK COUNTY, NEW YORK**

**SONIA ROAD LANDFILL
WEST BRENTWOOD, NEW YORK
SITE REGISTRY NO. 152013**

**POST CLOSURE
MONITORING AND MAINTENANCE REPORT**

MARCH 2007

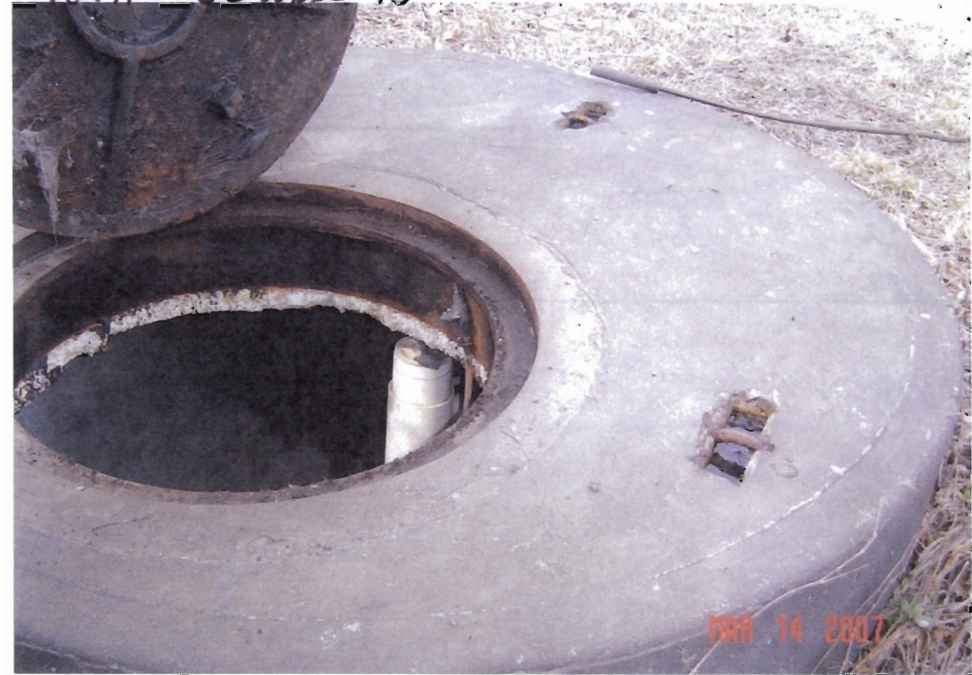
⑩ PG.11 GCWELL 13

4. **Condition:** The well head on Gas Collection Well GC-13 is set under the concrete slab of the access chamber, unlike on the other wells where it is located under the access chamber cover.

Problem: If the access chamber settles it will damage the well head.

Perceived Cause: Closer inspection reveals that the well was most likely installed the way it is now and that there is no immediate evidence of movement or settlement of the access chamber.

Recommendations: Although there may not be settlement occurring, the access chamber on GC-13 should be monitored for settlement as a precaution.
