Re: Sonia Road Landfill Remediation Program  
Site Registry No. 152013  
Post Closure Program

**POST-CLOSURE MONITORING AND MAINTENANCE REPORT  
SONIA ROAD LANDFILL  
BRENTWOOD, NEW YORK**

TOWN OF ISLIP  
SONIA ROAD LANDFILL  
POST CLOSURE MONITORING AND MAINTENANCE PLAN  
SITE INSPECTION CHECKLIST

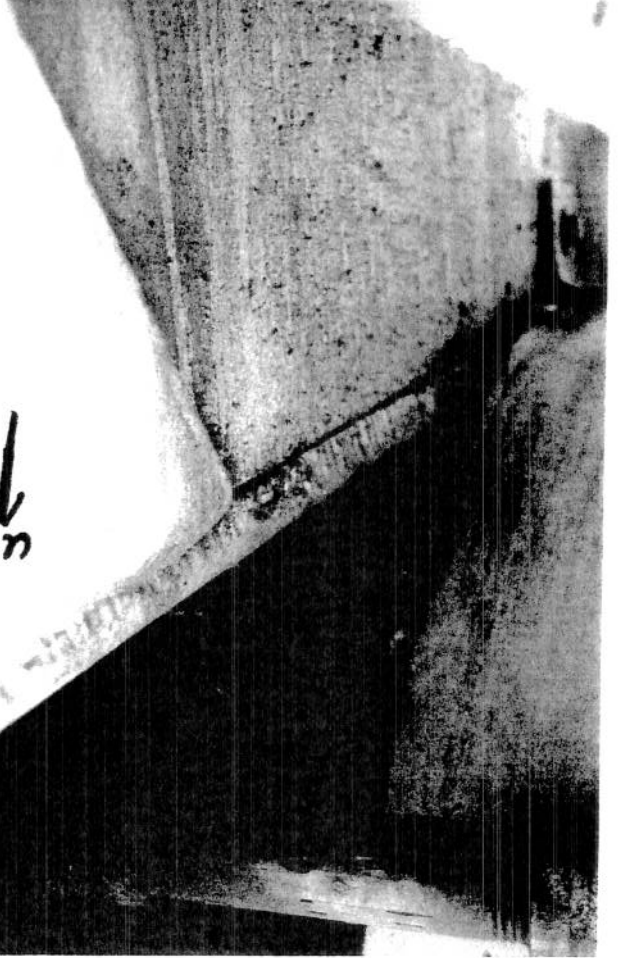
12/19/08, BLOWER 104 B.

ITEM I.D.	PROBLEM CODE	PRIORITY CODE	PHOTO TAKEN	COMMENTS
Blower Pad / Blower Nos. 104A and 104B				
104A			Y/N #	DE-ENERGIZED. SCHED. NEED TO BE INJECTED W/ST AIR.
104B	JAK	4	Y/N # 1	TEMP. A OUTLET GAUGES, ALSO OIL LEAK BETWEEN RAILS/HOUSING.
Flare			Y/N #	USED FOR VENTING ONLY.
Condensate Storage			Y/N #	
ACCESS COVER	K	4	Y(N) #	Liquid Volume = 0.3 @ 3 gallons Alarms: Y(N) Test System: OK/ Not Successful REPLACE BROKEN BOLTS ON WITH DEGREE L APE ACCESS COVER.

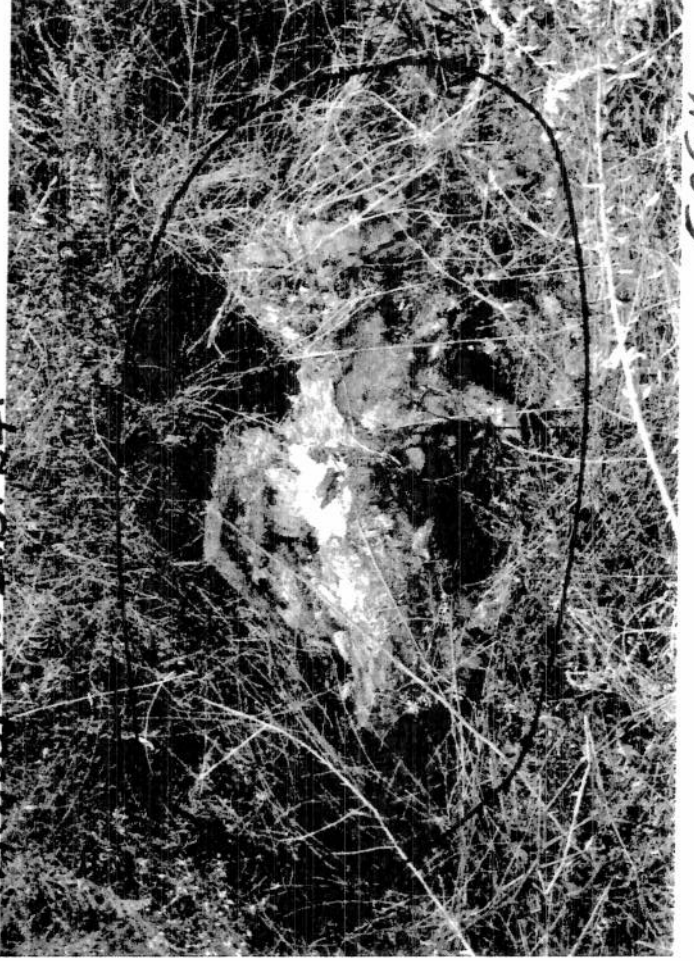
12/17/08, GR10 I.O.-B4

GRID I.D.	PROBLEM CODE	PRIORITY CODE	PHOTO TAKEN	COMMENTS
<b>Inlet Structures</b>				
			Y/N #	
			Y/N #	
			Y/N #	
			Y/N #	
<b>Rip Rap Drainway</b>				
<u>B4</u>	<u>L</u>	<u>4</u>	<u>Y/N</u> #	<u>Culvert Outlets REMOVE</u>
			Y/N #	
			Y/N #	
			Y/N #

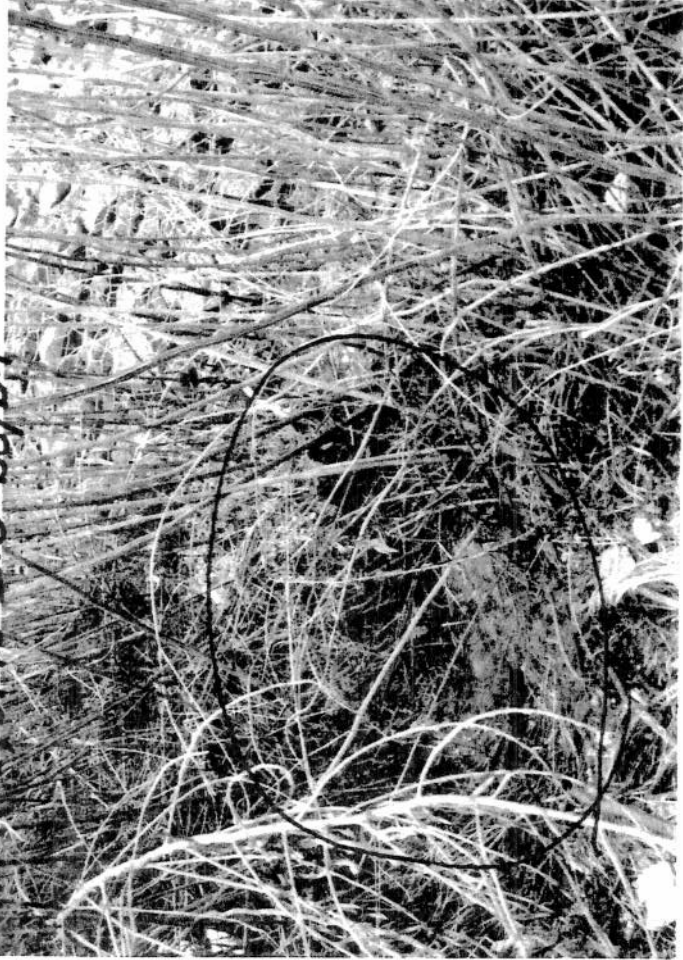
12/17/08 GR10 I.O.-B3/B4

GRID I.D.	PROBLEM CODE	PRIORITY CODE	PHOTO TAKEN	COMMENTS
<b>Side Slopes</b>				
			Y/N #	
			Y/N #	
			Y/N #	
			Y/N #	
<b>Gabion Curb</b>				
<u>B3/B4</u>	<u>L</u>	<u>4</u>	<u>Y/N # 1</u>	
			Y/N #	
			Y/N #	
			Y/N #

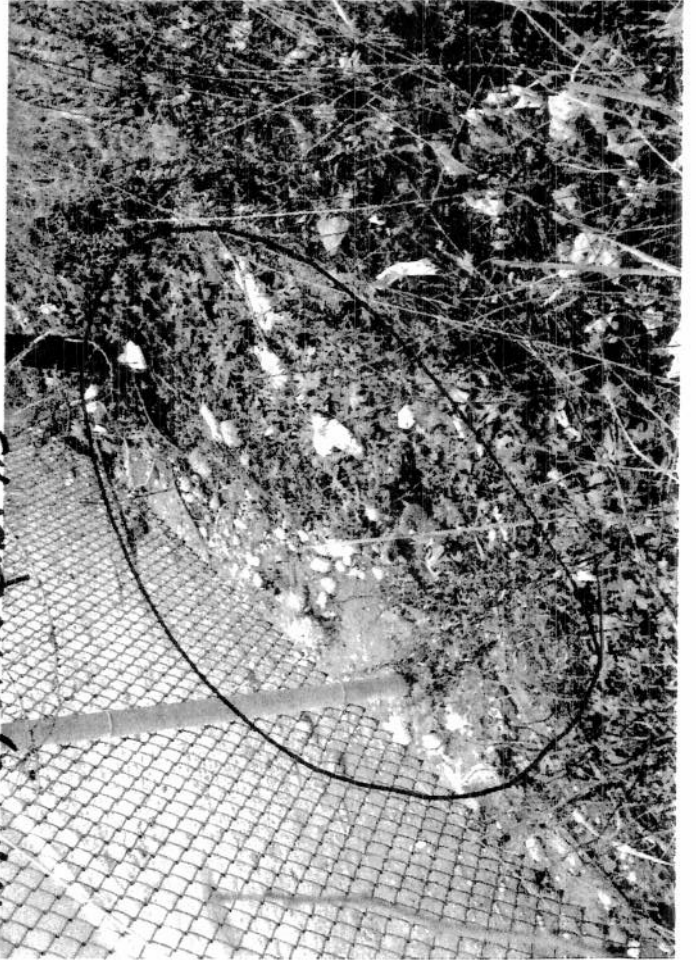
12/17/08, GR10 I.O.-A3

GRID I.D.	PROBLEM CODE	PRIORITY CODE	PHOTO TAKEN	COMMENTS
<b>Recharge Basin No. 1</b>				
A3	A	4	Y/N #	ACCESS ROAD.
			Y/N #	
			Y/N #	
			Y/N #	
<b>Recharge Basin No. 2</b>				
A5	A	4	Y/N #	ACCESS ROAD.
			Y/N #	
			Y/N #	
			Y/N #

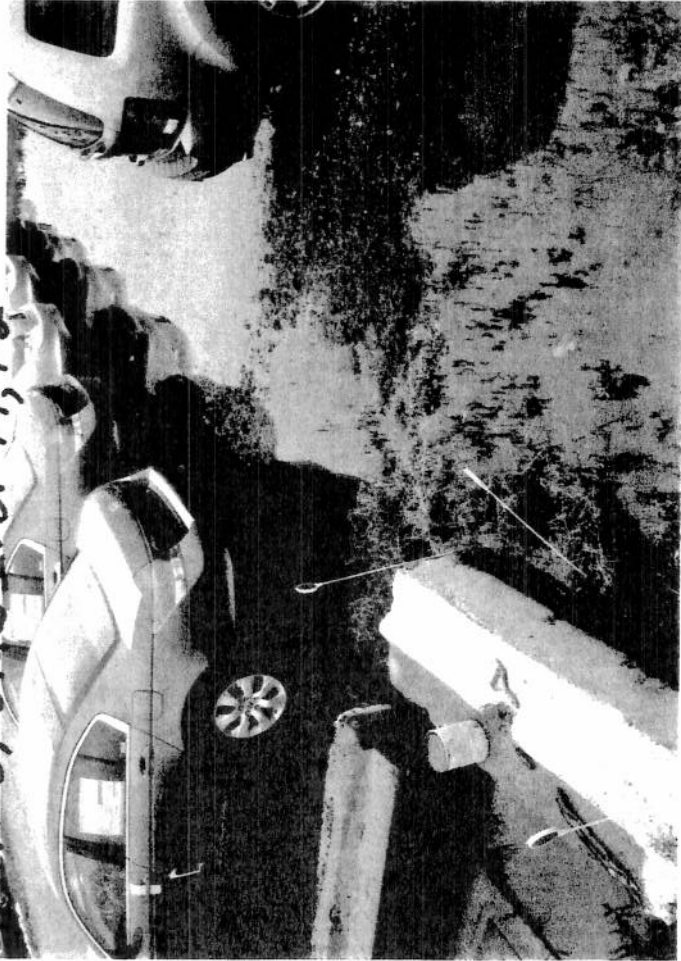
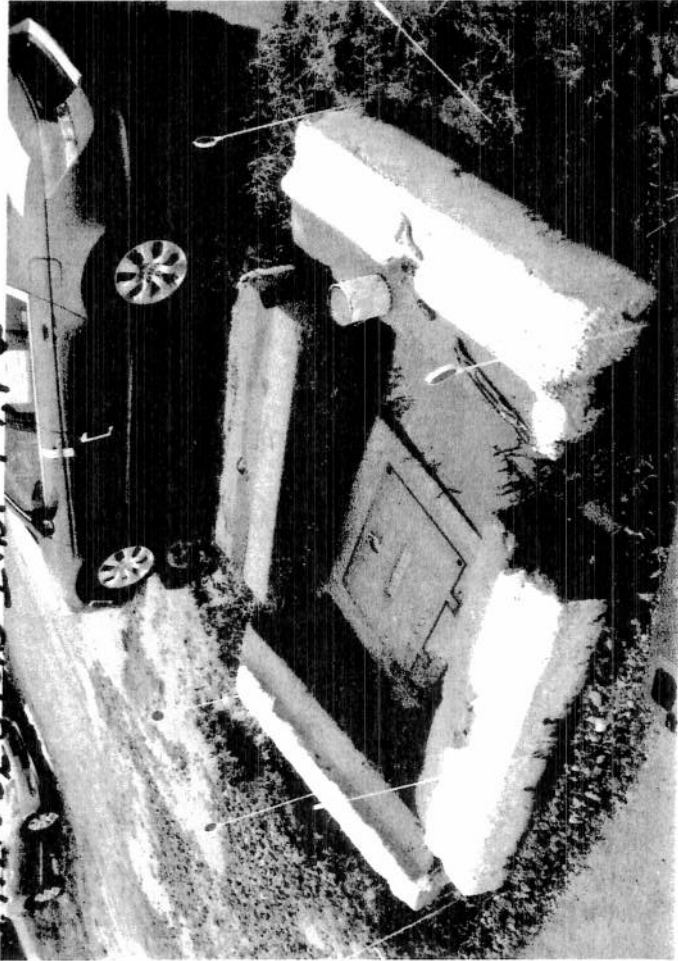
12/17/08, GRID I.O. - F1, F2

GRID I.D.	PROBLEM CODE	PRIORITY CODE	PHOTO TAKEN	COMMENTS
F1, F2	C	7	(Y)N # 2	AROUND LFG RECOVER WELL/VALE VACUUM #13
			Y/N #	
			Y/N #	
			Y/N #	
			Y/N #	
			Y/N #	
			Y/N #	
			Y/N #	
			Y/N #	
			Y/N #

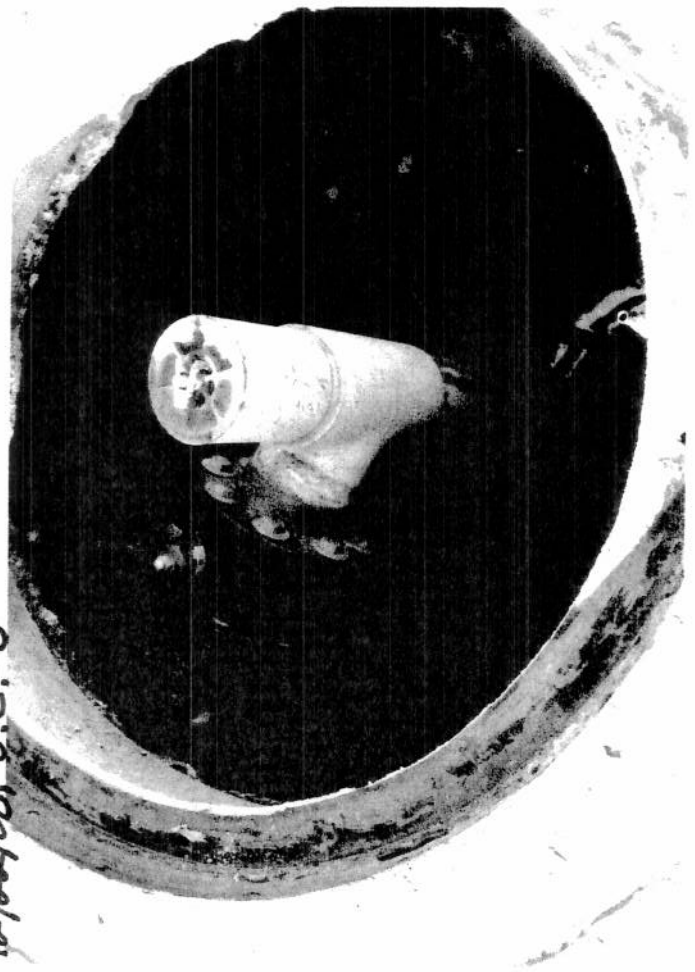
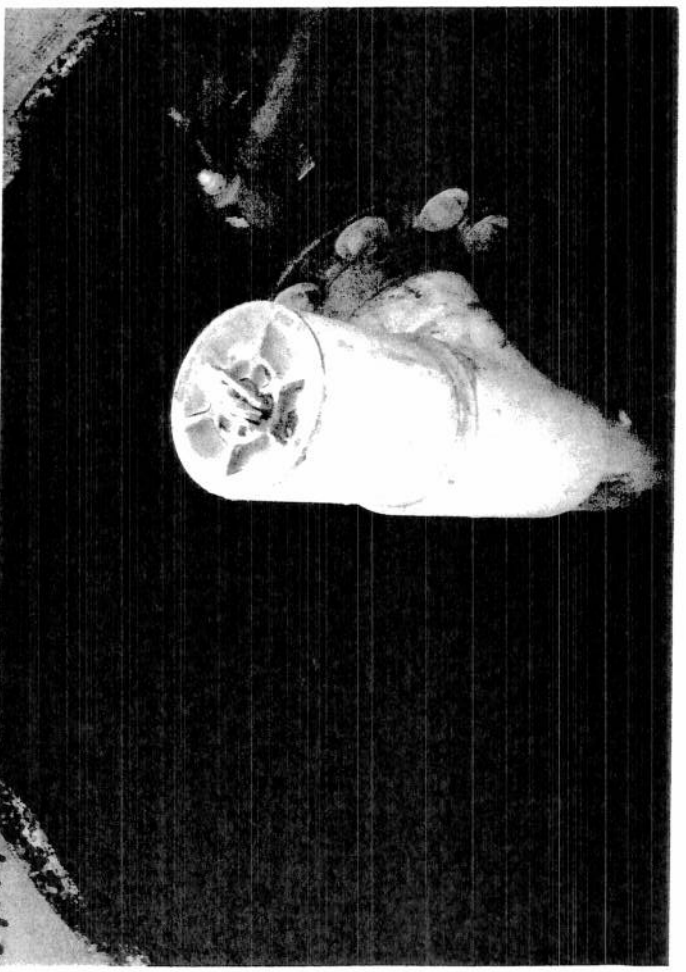
12/22/08, G.C. -3

**Recommendations:** Although there may not be settlement occurring, the access chamber on GC-13 should be monitored for settlement as a precaution.
5. **Condition:** The access chamber on Gas Collection Well GC-3 has settled and is collecting water (2 separate problems, which may be related). The well head was recently shortened by sawing off part of the top.

**Problem:** Settlement of the access chamber can damage the well head. Additionally, the storm water collecting in the access chamber may be being drawn into the gas collection system (which is under vacuum) and could be a source of excess condensate.

**Perceived Cause:** Settlement of the waste mass in the area of the wells. This type of settlement is typical of landfills and was expected  
**Recommendations:** Engage the services of a contractor to reset the access chambers.

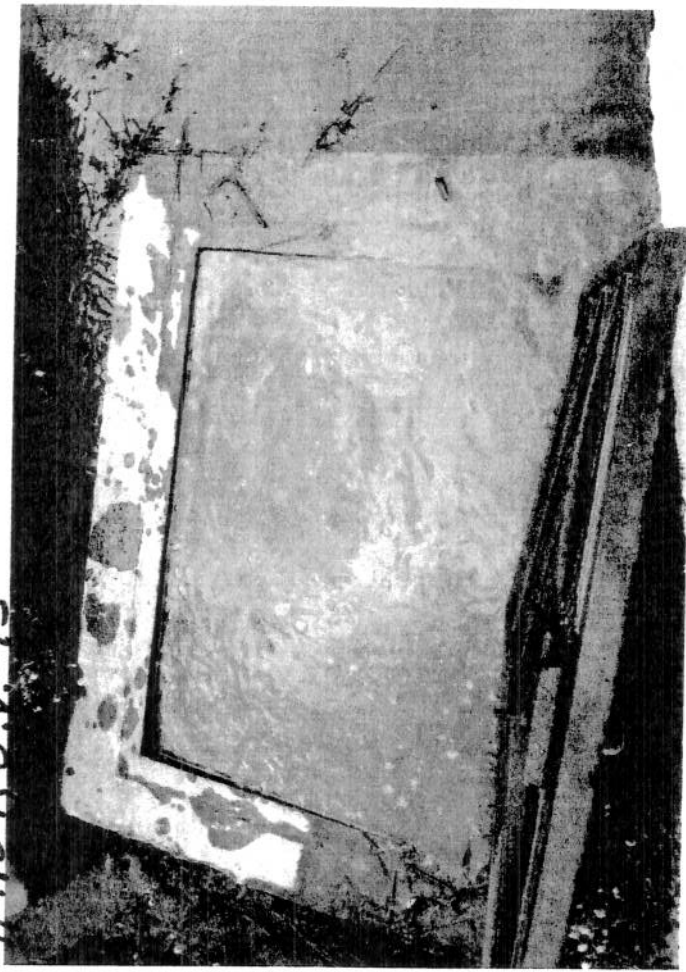
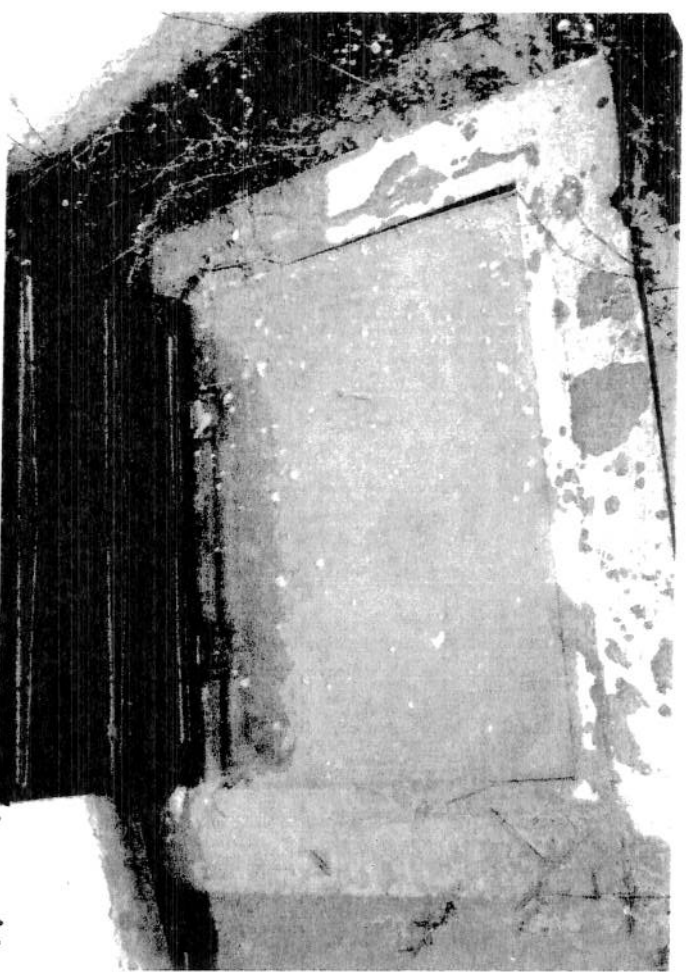
1/9/09, G.V.-13

ITEM I.D.	PROBLEM CODE	PRIORITY CODE	PHOTO TAKEN	COMMENTS
<b>LFG Recovery Wells / Valve Vaults</b>				
12	M	1	YIN # 1	RE: TO PG. 14 FOR ADDITIONAL INFORMATION.
13	M	1	YIN # 2	APPROXIMATELY FOUR INCHES.
14	M	7	YIN # 1	FILLED TO THE TOP.
15	M	1	YIN # 1	APPROXIMATELY TWO INCHES.
<b>LFG Collection Wells (GC1 - GC16)</b>				
13, 4, 8	M	1	YIN # 7	RE: TO PG. 14 FOR ADDITIONAL INFORMATION.
2, 7	D	7	YIN # 1	#1=2" H2O, #3=2.6" H2O, #4=3" H2O, #8=3" H2O.
5	D	7	YIN # 1	HEADER PIPE OFF CENTER IN RELATION TO ACCESS COVER & CLOSED PRE-CAST.
6	D	1	YIN # 2	SAND PERCOLATING, THROUGH A SUMP OPENING.
MINIMAL CLEARANCE BETWEEN VALVING STRUCTURE & PRE-CAST.
