**TOWN OF ISLIP
SUFFOLK COUNTY, NEW YORK**

**SONIA ROAD LANDFILL
WEST BRENTWOOD, NEW YORK
SITE REGISTRY NO. 152013**

**POST CLOSURE
MONITORING AND MAINTENANCE REPORT**

**JULY THROUGH SEPTEMBER
2009**

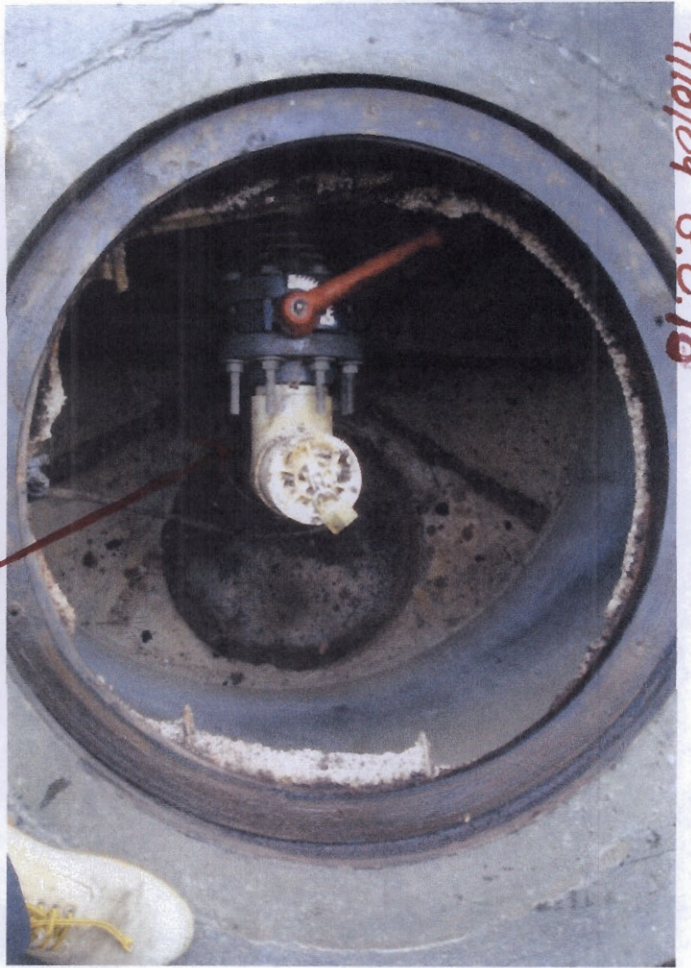
9/10/09 G.C. 10

ITEM #	PROBLEM CODE	PRIORITY CODE	PHOTO	COMMENTS	DATE	INSPECTED BY:
GC10	D	7	1		09/10/2009	Fazil Rahaman
GC11	D	7	2		09/10/2009	Fazil Rahaman
GC12	D	7	2		09/10/2009	Fazil Rahaman
GC13	D	7	2	Previous adjustments having been made.	09/10/2009	Fazil Rahaman
GC14	D	7	1		09/10/2009	Fazil Rahaman
GC 15	D	1	1	Access cover could not be closed.	09/10/2009	Fazil Rahaman
GC 16	D	1	1	Same as above. Cover can't dose due to contact w/ well cap.	09/10/2009	Fazil Rahaman
Vault 18	D	1	2		09/10/2009	Fazil Rahaman

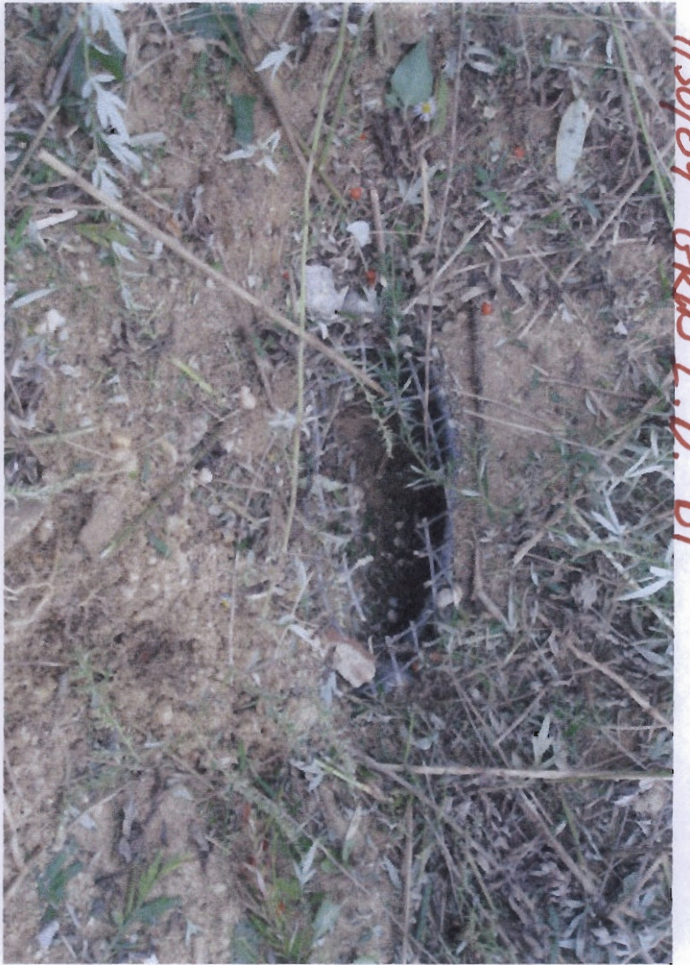
9/30/09 GRID T.D. 01

GRID NO	PROBLEM CODE	PRIOTITY CODE	PHOTO	COMMENTS	DATE	INSPECTED BY:
D1 E1	C C	4 4	1		09/30/2009 09/30/2009	F. Rahaman Fazil Rahaman
