Re: Sonia Road Landfill Remediation Program  
Site Registry No. 152013  
Post Closure Program

**SONIA ROAD LANDFILL  
WEST BRENTWOOD, NEW YORK  
SITE REGISTRY NO. 152013**

**POST CLOSURE  
MONITORING AND MAINTENANCE REPORT**

**JANUARY THROUGH MARCH  
2010**

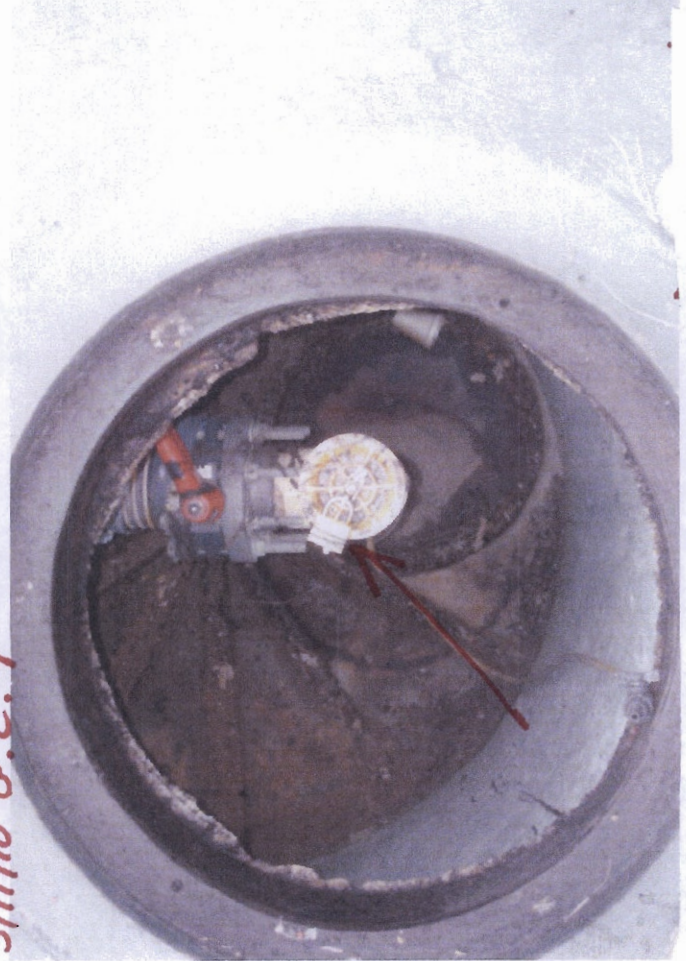
3/11/10 G.C. 9

ITEM ID	PROBLEM CODE	PRIORITY CODE	PHOTO	COMMENTS	DATE	INSPECTED BY:
GC 9.GC16	D	7	9	Corrective actions undertaken beginning 4/5/2010.	03/11/2010	Fazil Rahaman
Vault 13	L	4	1	Same as above.	03/11/2010	Fazil Rahaman
Vault 18	D	7	2	Same as above.	03/11/2010	Fazil Rahaman

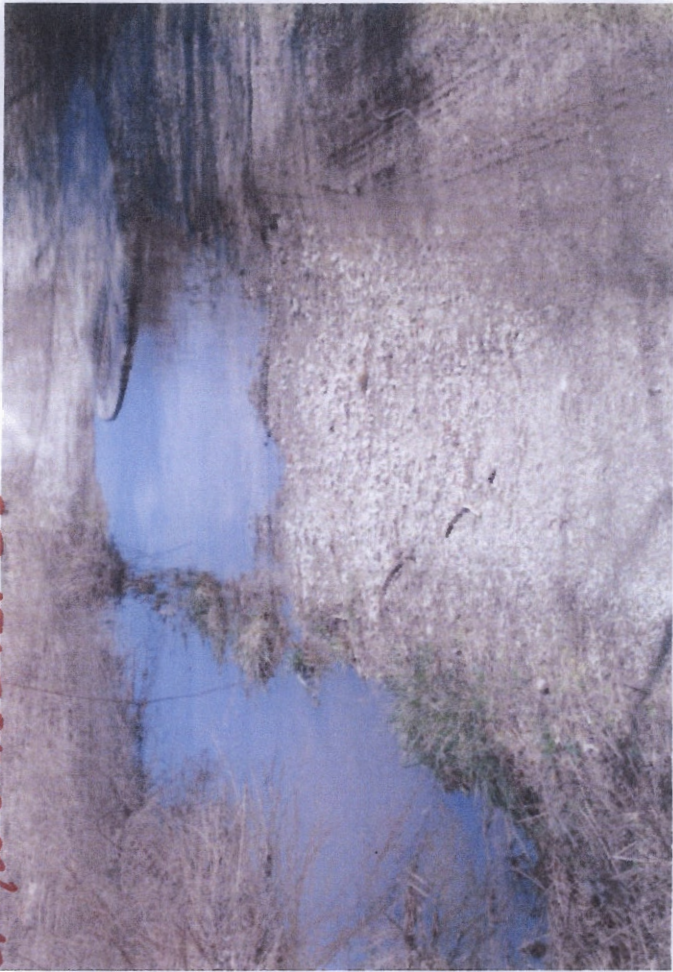
3/16/10 CRIO I.O. C5

GRID NO	PROBLEM CODE	PRIORITY CODE	PHOTO	COMMENTS	DATE	INSPECTED BY:
A3	C	4	0	Between perimeter fence & road.	03/16/2010	Fazil Rahaman
C5	D&H	7	1		03/16/2010	Fazil Rahaman
C5	D&H	7	1	Storm Inspection.	03/31/2010	Fazil Rahaman
E1	G	7	0	Affecting fence contour.	03/16/2010	Fazil Rahaman
F1	G	7	0	Same as above.	03/16/2010	Fazil Rahaman
F5	H	7	3		03/16/2010	Fazil Rahaman
G1	C	1	1		03/16/2010	Fazil Rahaman
G5	H	7	1	Needs attention.	03/16/2010	Fazil Rahaman

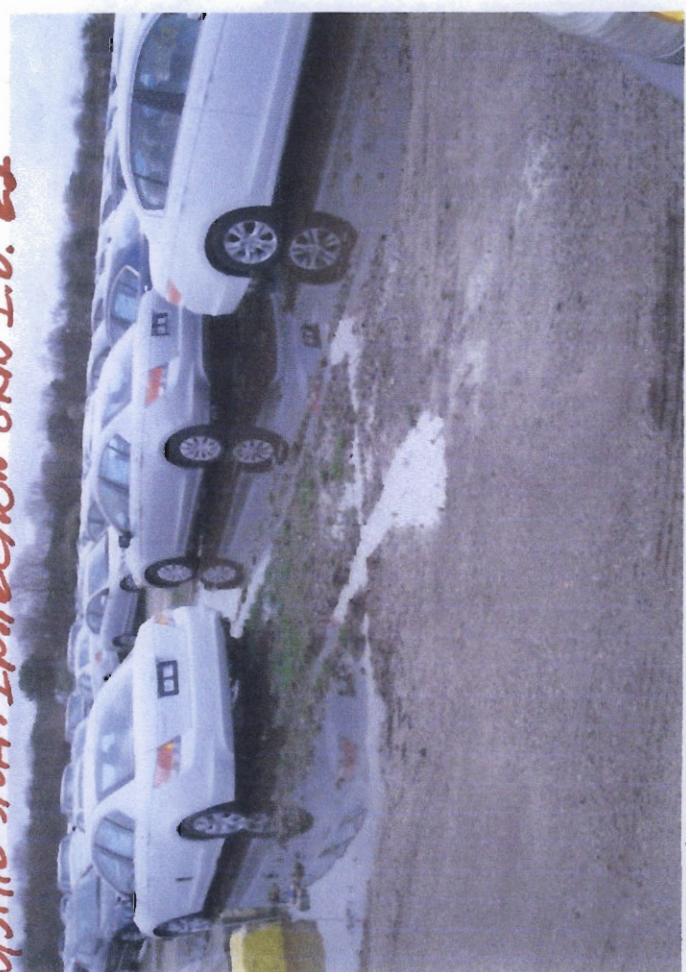
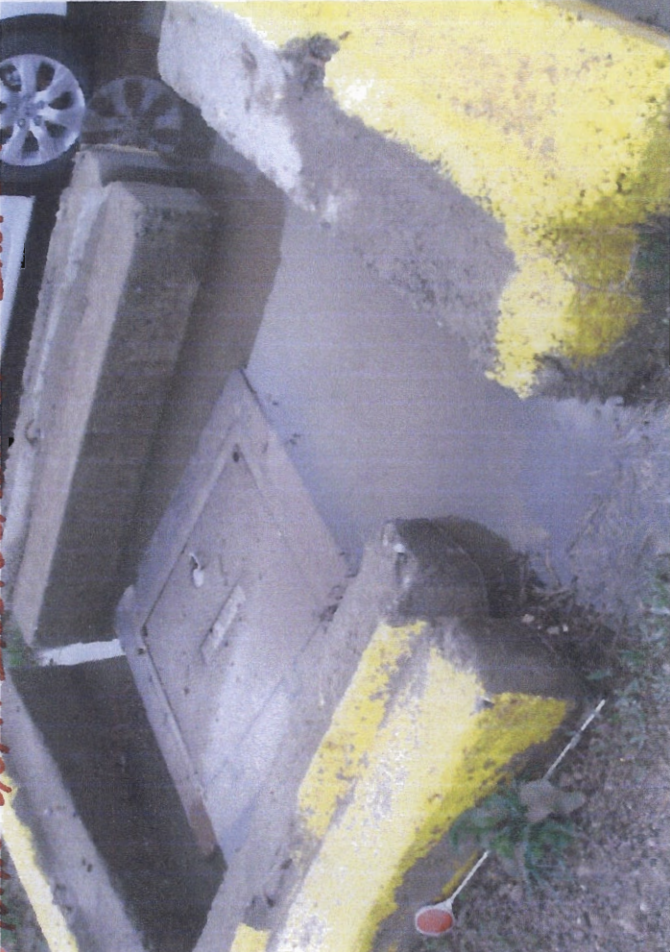
3/31/10 STORM INSPECTION GR10 I.O. E1

GRID NO	PROBLEM CODE	PRIORITY CODE	PHOTO	COMMENTS	DATE	INSPECTED BY:
D1&E1	C&D	7	2	Culverts / Outlets.	03/16/2010	Fazil Rahaman
D1&E1	C&D	7		Same as above. Storm Inspection.	03/31/2010	Fazil Rahaman
C5	H	7	1	Located in access roadway.	03/16/2010	Fazil Rahaman
