Re: Sonia Road Landfill Remediation Program
Site Registry No. 152013
Post Closure Program

**SONIA ROAD LANDFILL
WEST BRENTWOOD, NEW YORK
SITE REGISTRY NO. 152013**

**POST CLOSURE
MONITORING AND MAINTENANCE REPORT**

OCTOBER THROUGH DECEMBER
2010

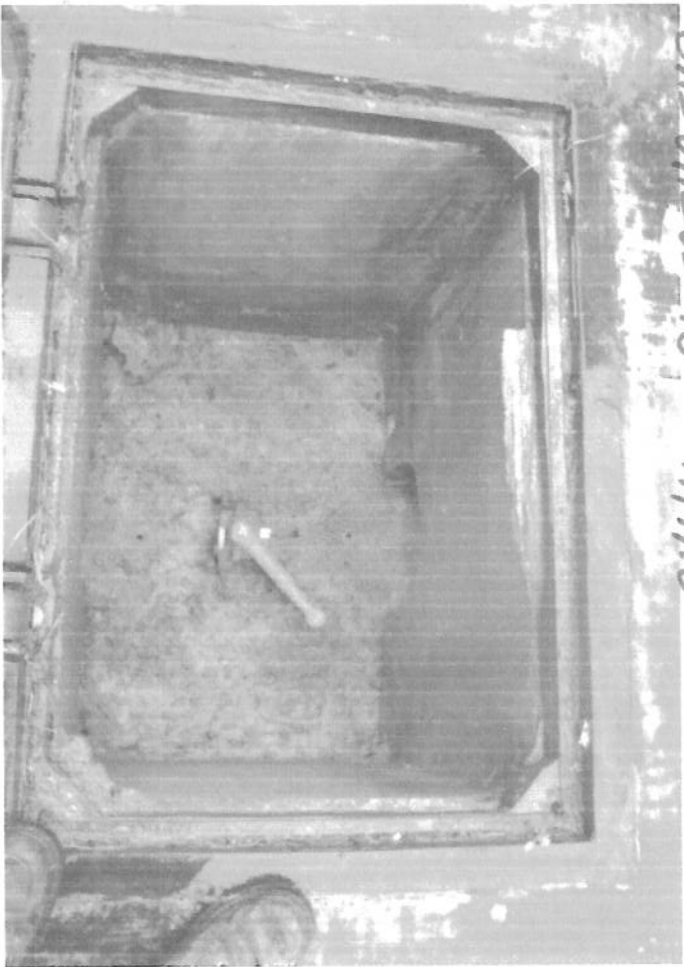
GAS VALVE 18

ITEM ID	PROBLEM CODE	PRIORITY CODE	PHOTO	COMMENTS	DATE	INSPECTED BY:
Vault 18	N	8	1	See comments on page 14.	11/04/2010	Fazil Rahaman
	D	7			11/04/2010	Fazil Rahaman
