Project: Spectrum Finishing - Remedial Action
 Contractor: EnviroTrac Environmental Services
 CDM Job No: D-006956 Site No. 1-52-029
 CDM Project Manager: John Blaum

DAILY REPORT

Date: 1-Apr-09
 REPORT No. 112
 PAGE No. 1

PHOTOGRAPHIC LOG
1-Apr-09
CDM Job No. D-006956
Spectrum Finishing Remedial Action
SITE No. 1-52-029

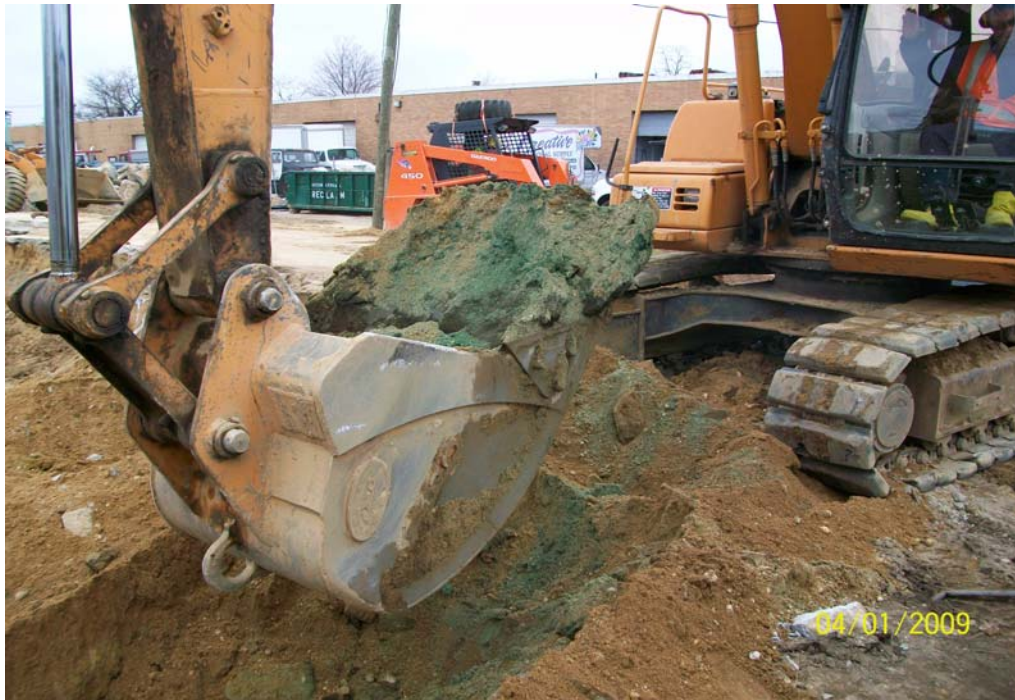
100_00302.jpg - Contaminated green chunk from NE corner in excavator bucket.

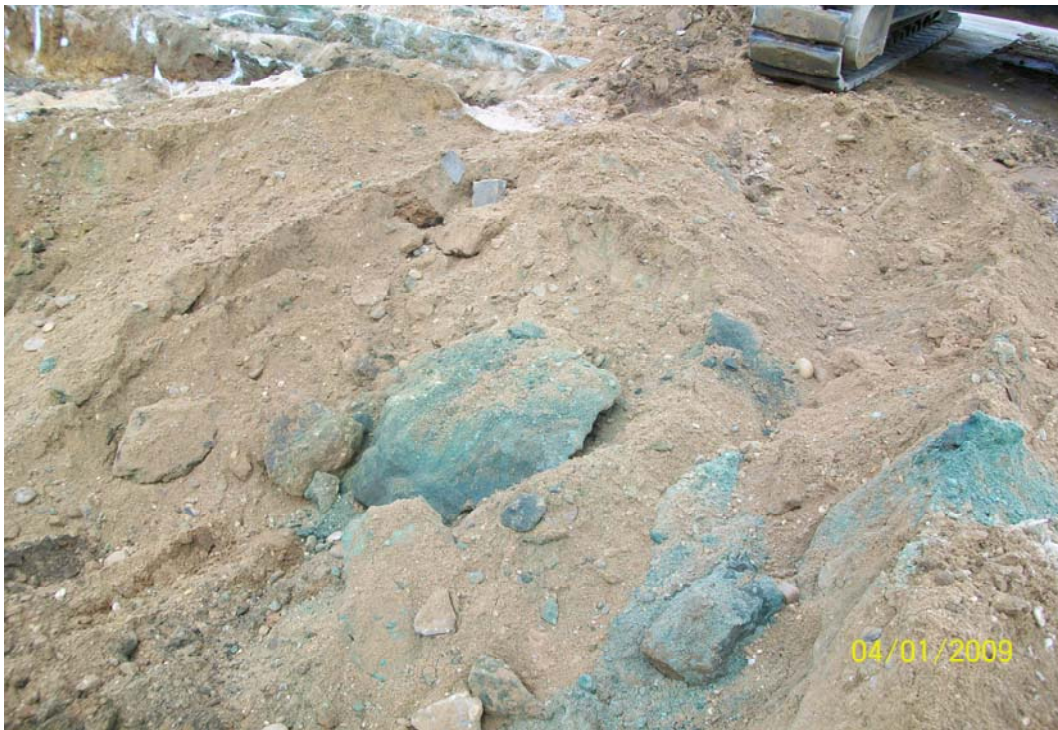
100_00306.jpg - Contaminated green soil/chunks from NE corner.

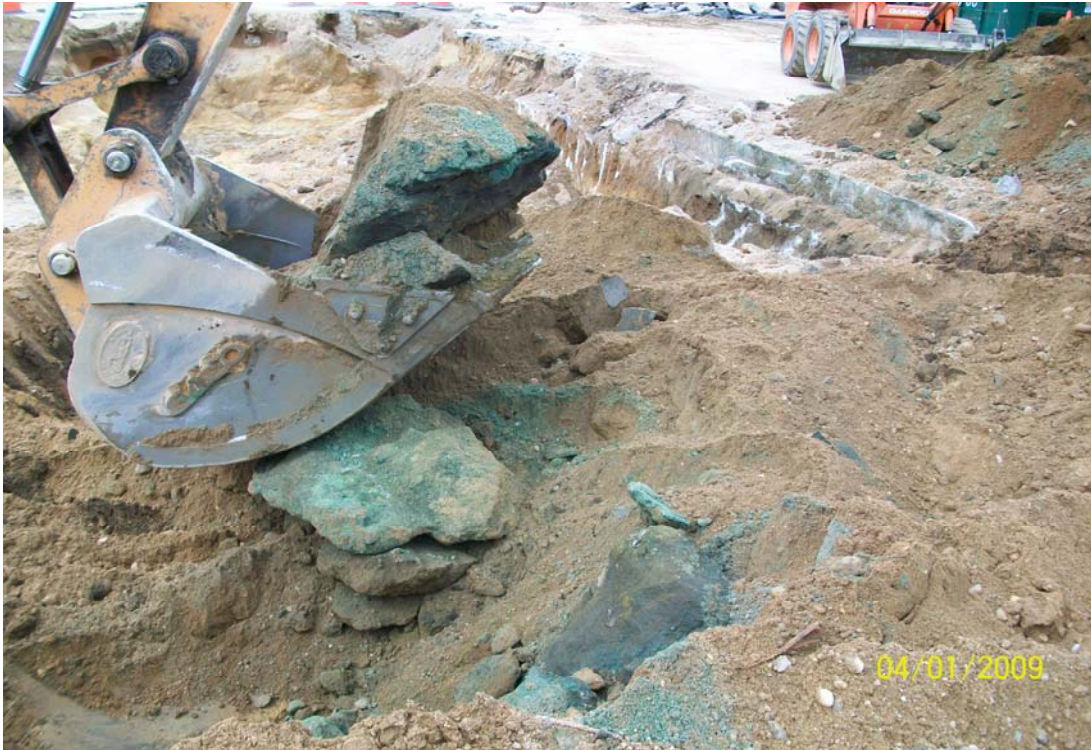
100_00307.jpg - Contaminated green soil/chunks in NE corner being removed by the excavator.

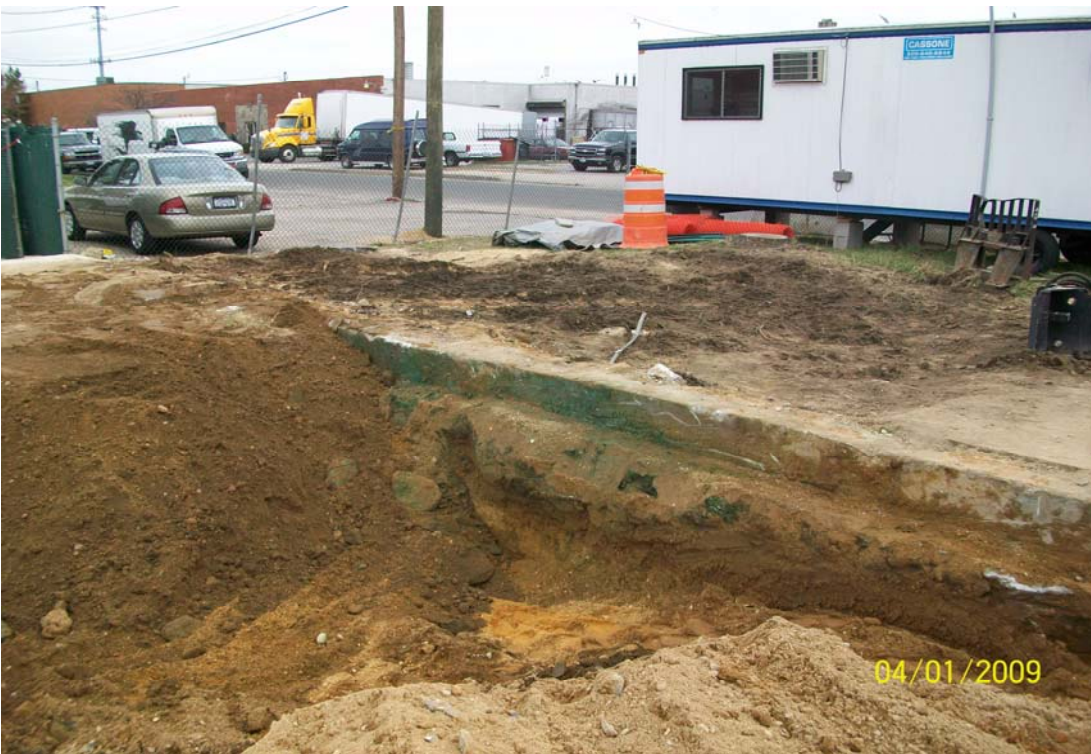
100_00310.jpg - Excavation at the end of the day looking NE.

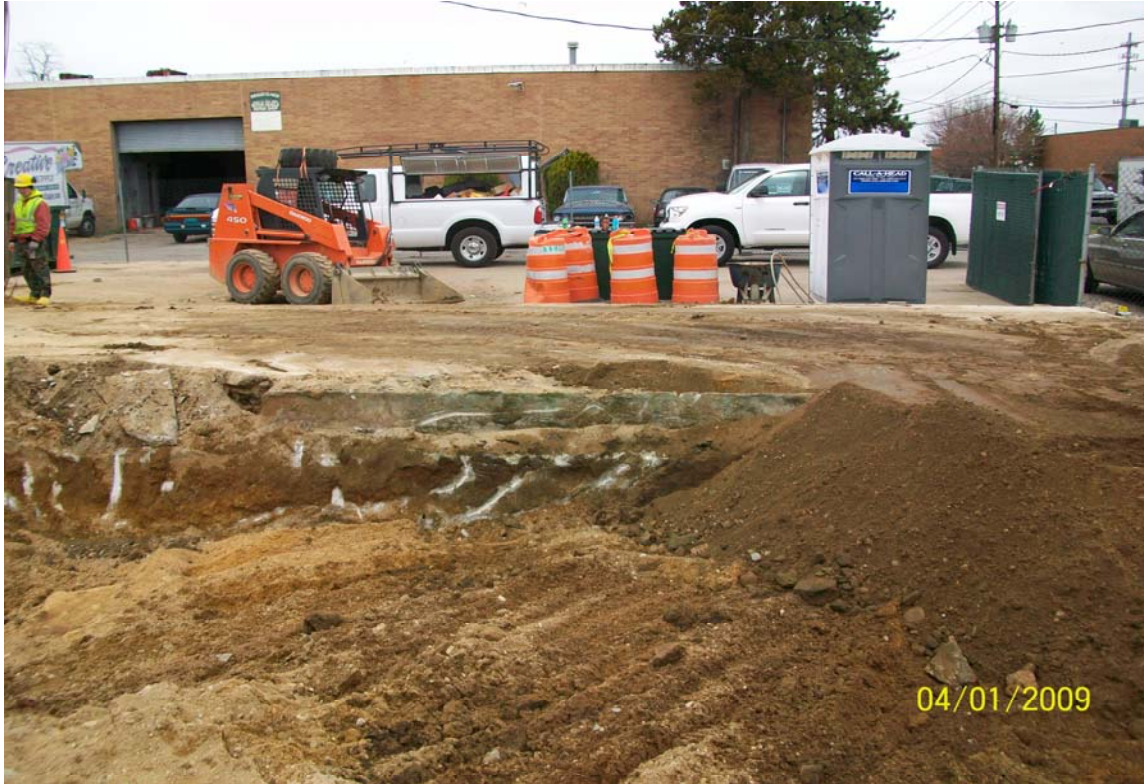
100_00311.jpg - Excavation at the end of the day looking North

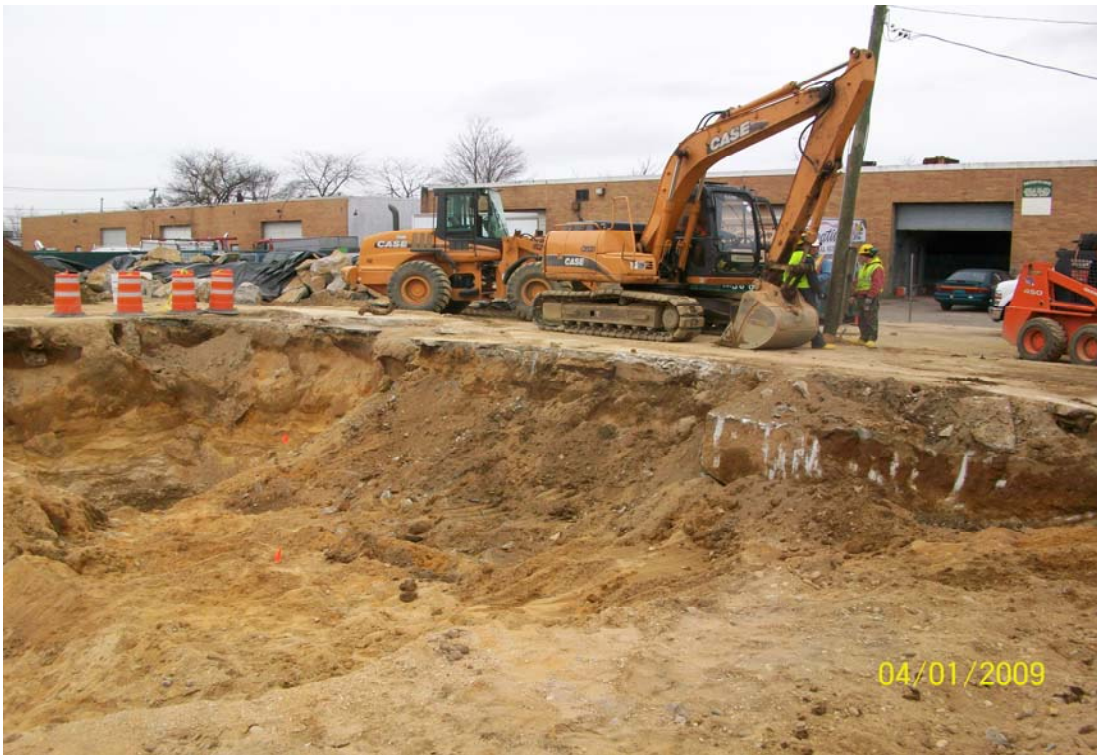
100_00312.jpg - Excavation at the end of the day looking NW

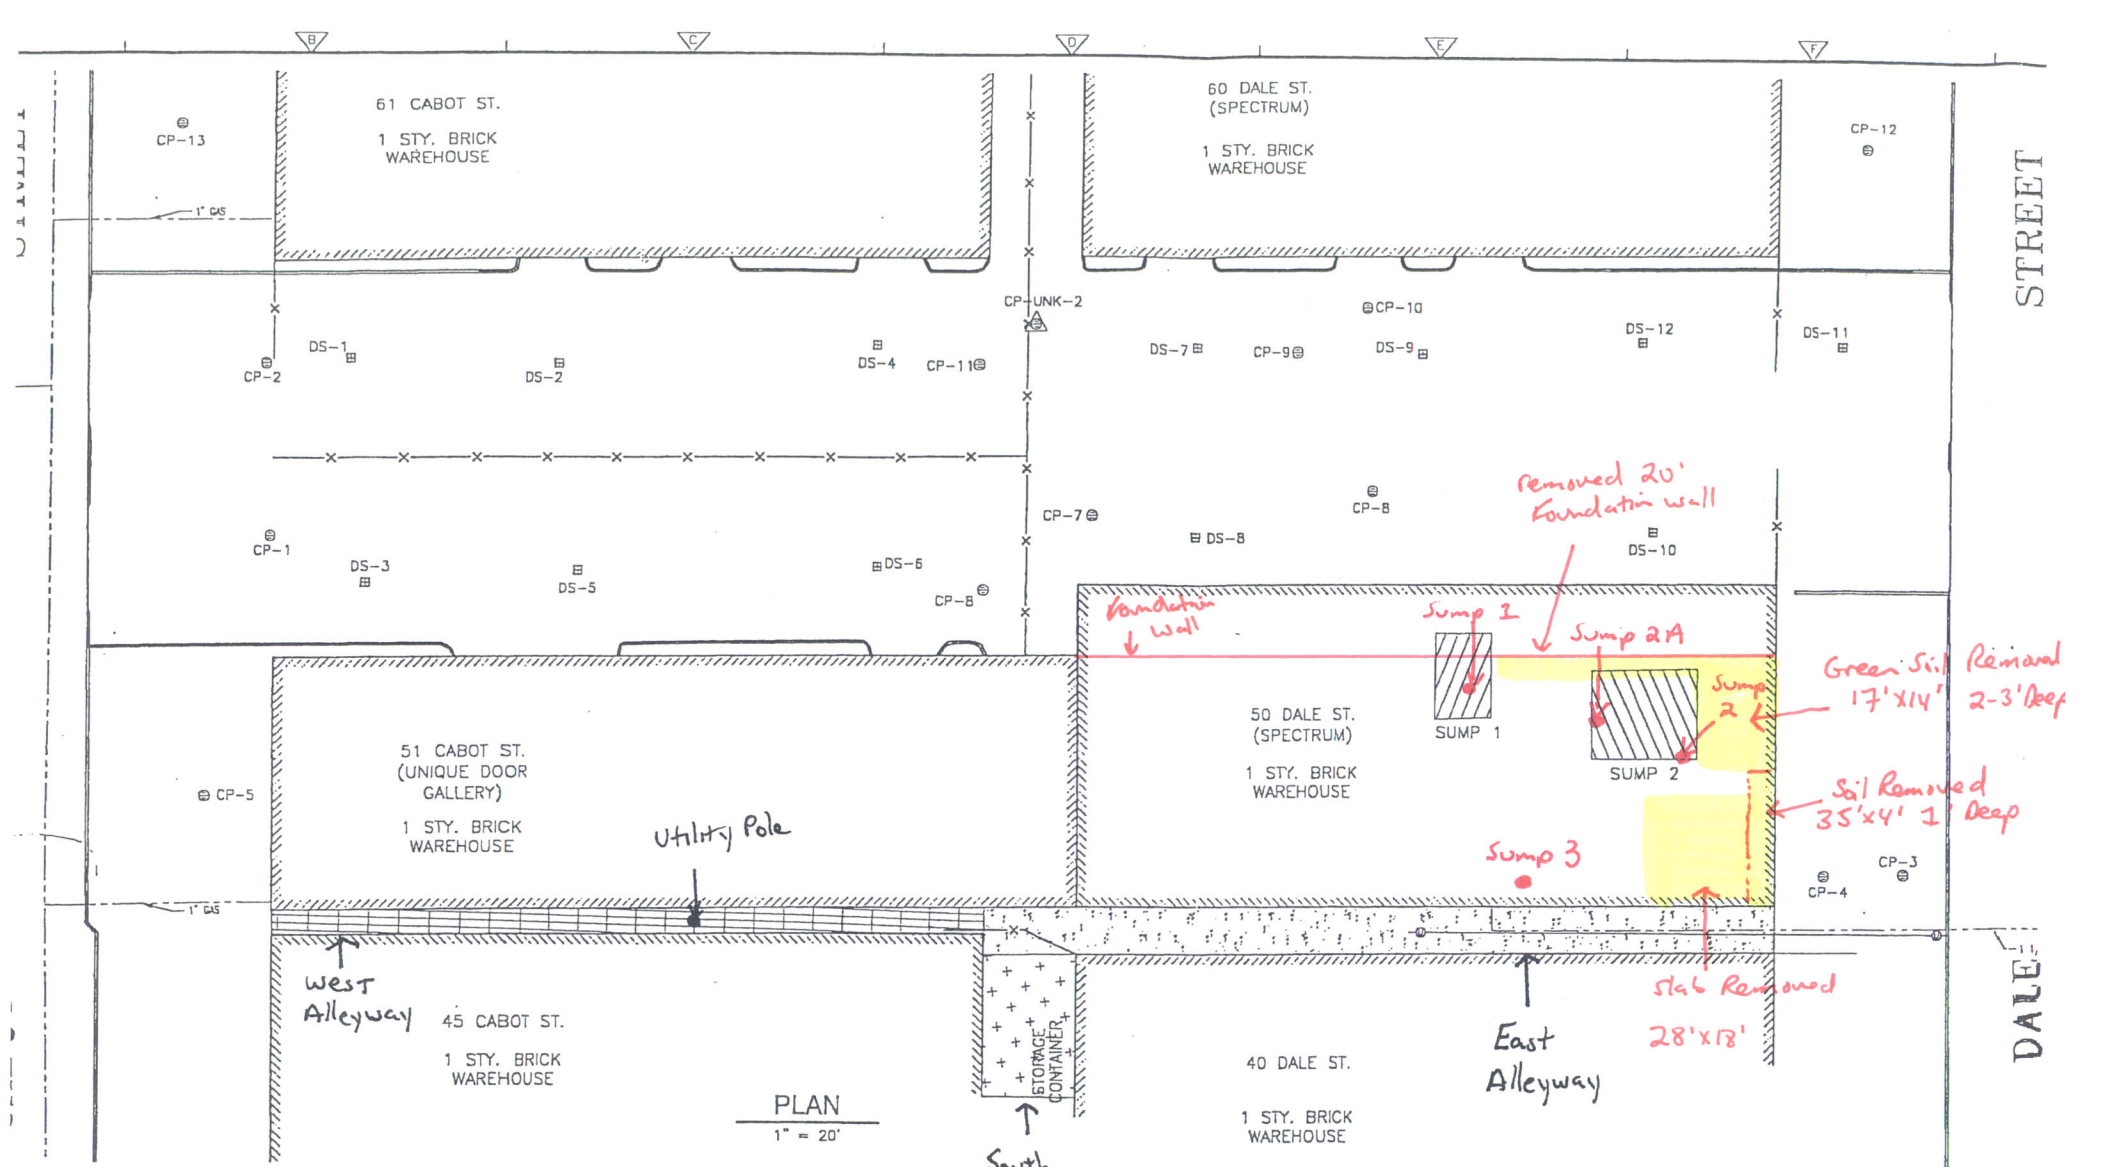
Work Areas

Removed 20' Foundation wall

Green Soil Remnant 17'x14' 2-3' deep

Soil Removed 35'x4' 1' deep

Slab Removed 28'x18'
