## PHOTOGRAPHIC LOG

## **CDM Job No. D-006956**

## **Spectrum Finishing Remedial Action**

## SITE No. 1-52-029

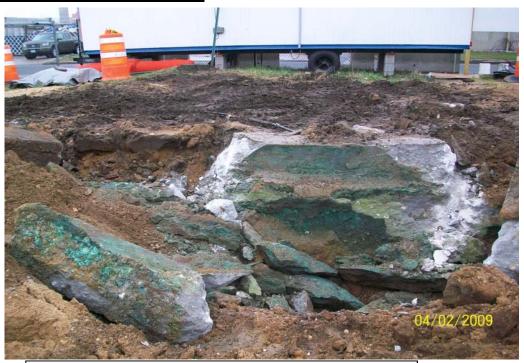
100\_00314.jpg - Green contaminated concrete on east foundation wall, looking east

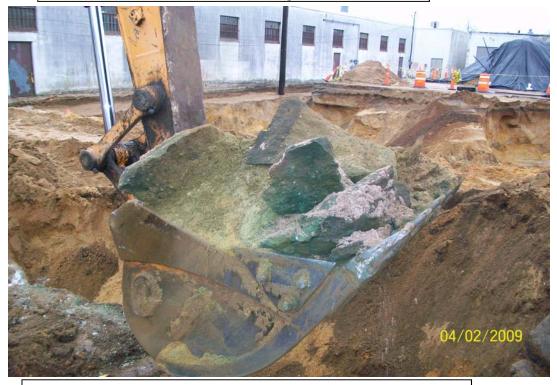
100\_00315.jpg - Green contaminated soil/chunks taken from the NE corner

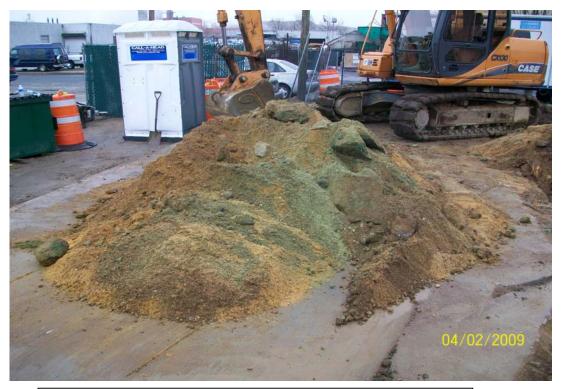
100\_00316.jpg - Pile of green contaminated soil/chunks taken from the NE corner

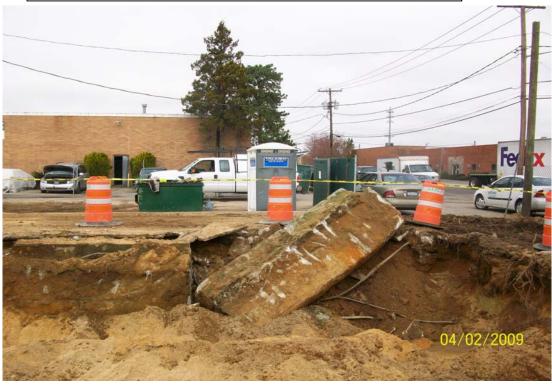
100\_00318.jpg - Excavation at the end of the day, looking north

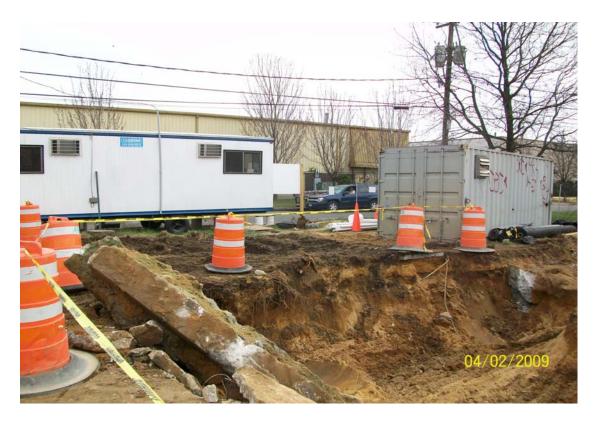
100\_00320.jpg - Excavation at the end of the day looking SE

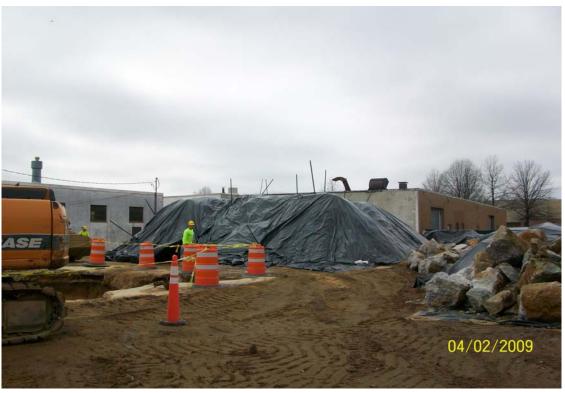
100\_00321.jpg - Mt. Spectrum at the end of the day.
