Project: Spectrum Finishing - Remedial Action
 Contractor: EnviroTrac Environmental Services
 CDM Job No: D-006956 Site No. 1-52-029
 CDM Project Manager: John Blaum

DAILY REPORT

Date: 6-Apr-09
 REPORT No. 115
 PAGE No. 1

PHOTOGRAPHIC LOG
6-Apr-09
CDM Job No. D-006956
Spectrum Finishing Remedial Action
SITE No. 1-52-029

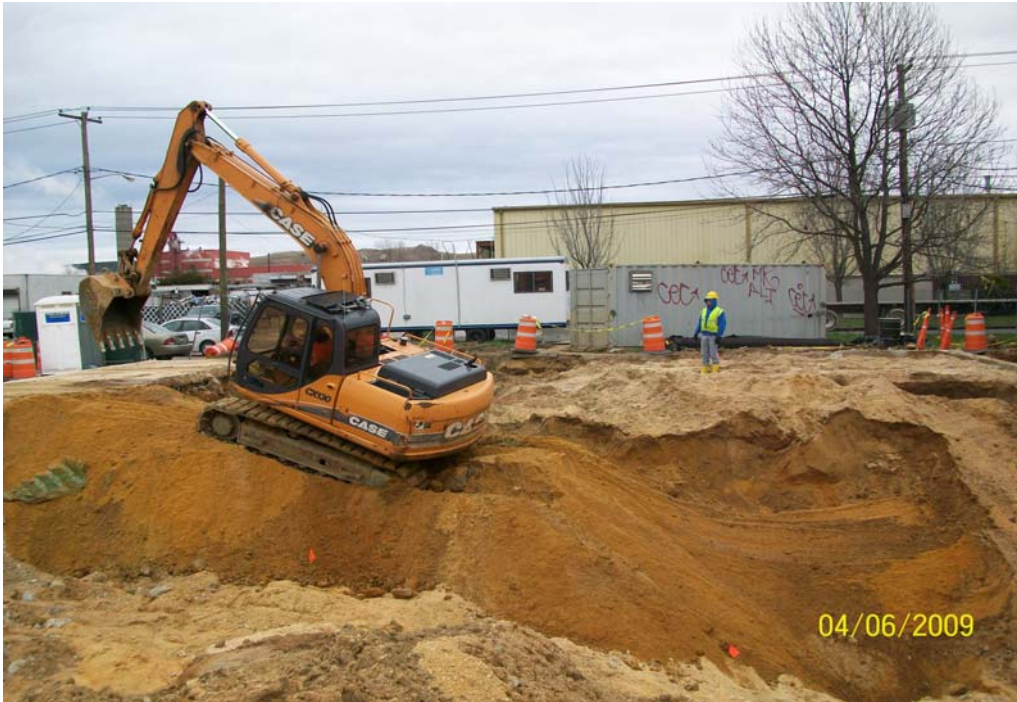
100_00330.jpg - Excavator excavating SEB-3/SES-5 area.
Green chunk from NE corner.

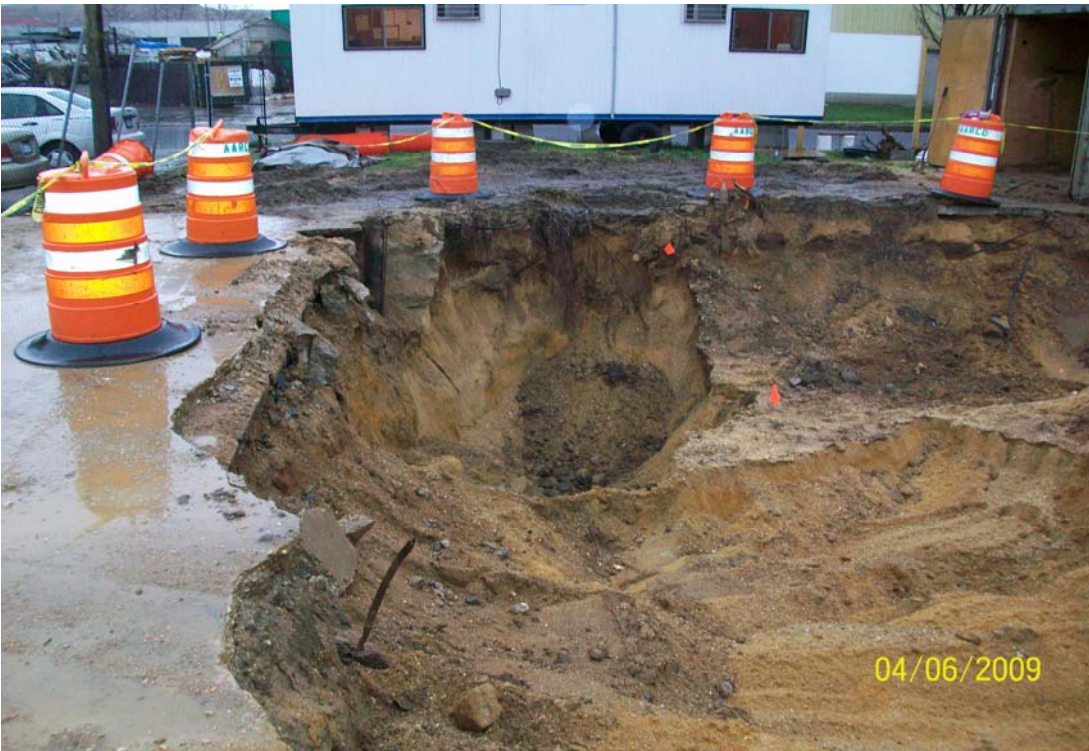
100_00331.jpg - NE corner excavated, found more green soil/chunks.

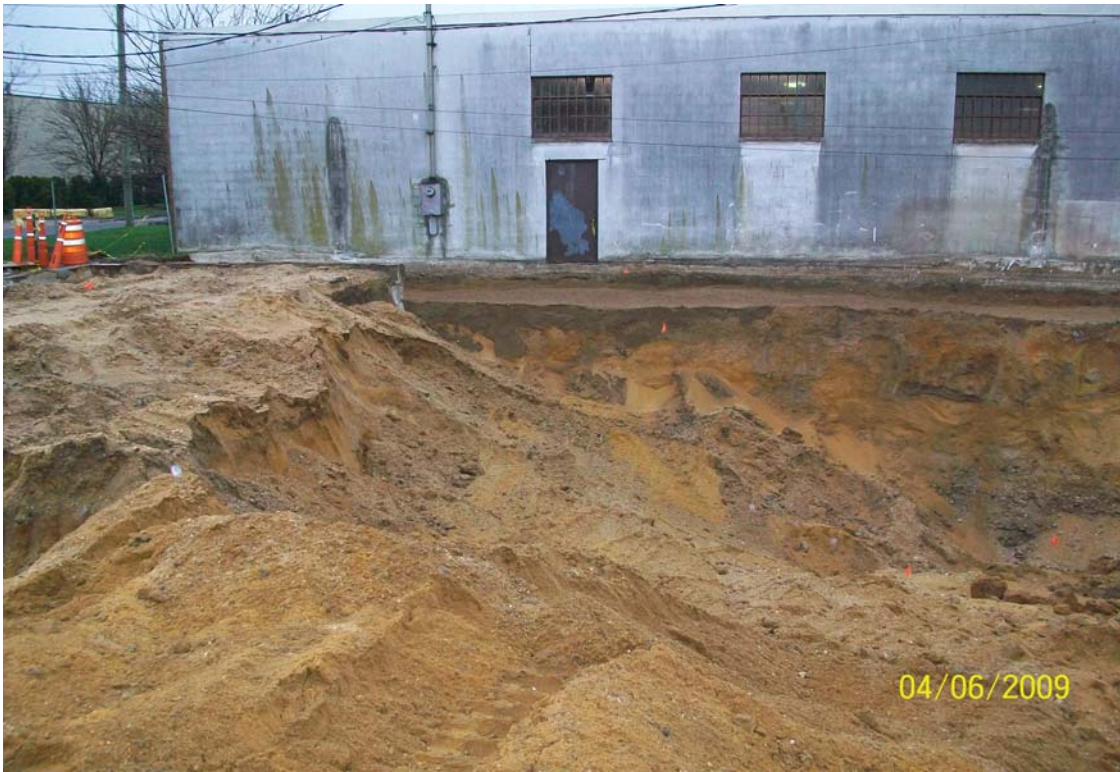
100_00332.jpg - End of day, excavated area around SEB-3/SES-5.
