Project: Spectrum Finishing - Remedial Action  
 Contractor: EnviroTrac Environmental Services  
 CDM Job No: D-006956 Site No. 1-52-029  
 CDM Project Manager: John Blaum

### DAILY REPORT

Date: 13-Apr-09  
 REPORT No. 120  
 PAGE No. 1

**PHOTOGRAPHIC LOG**  
**13-Apr-09**  
**CDM Job No. D-006956**  
**Spectrum Finishing Remedial Action**  
**SITE No. 1-52-029**

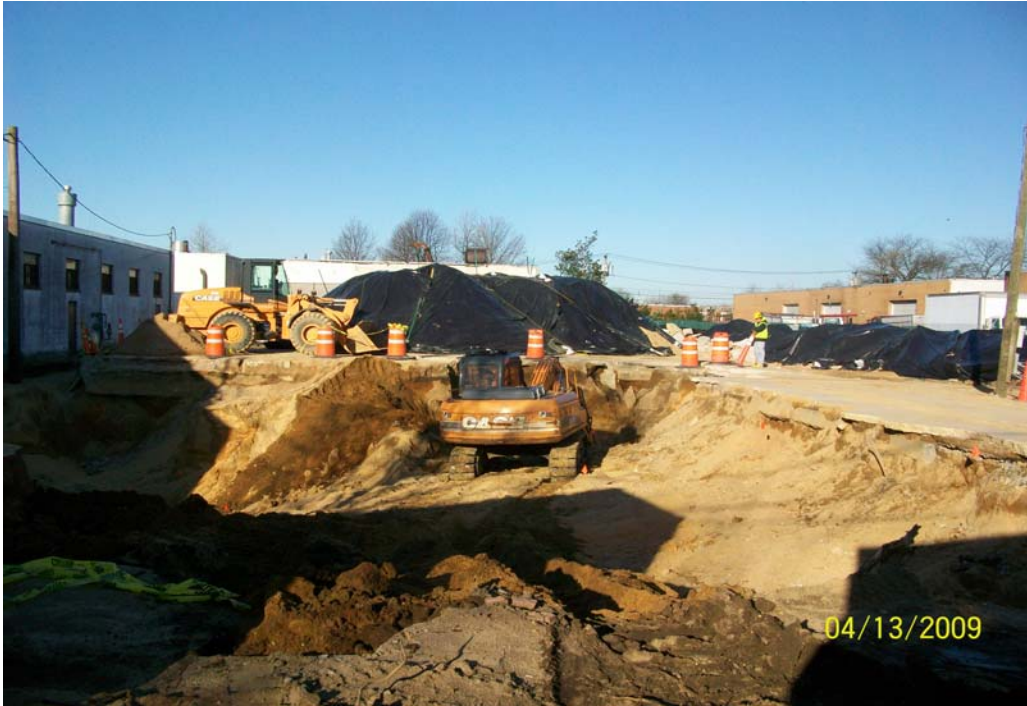
100\_00348.jpg - Filling in sump-1 using material from squaring up excavation

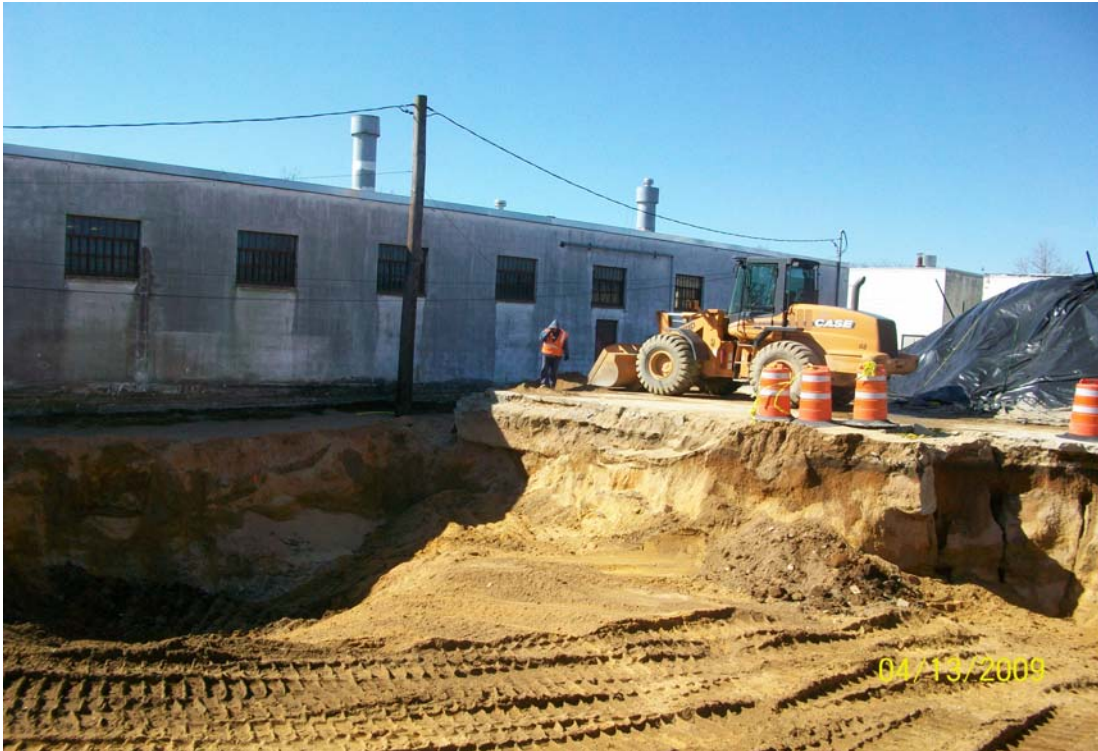
100\_00350.jpg - Finished filling up sump-3.

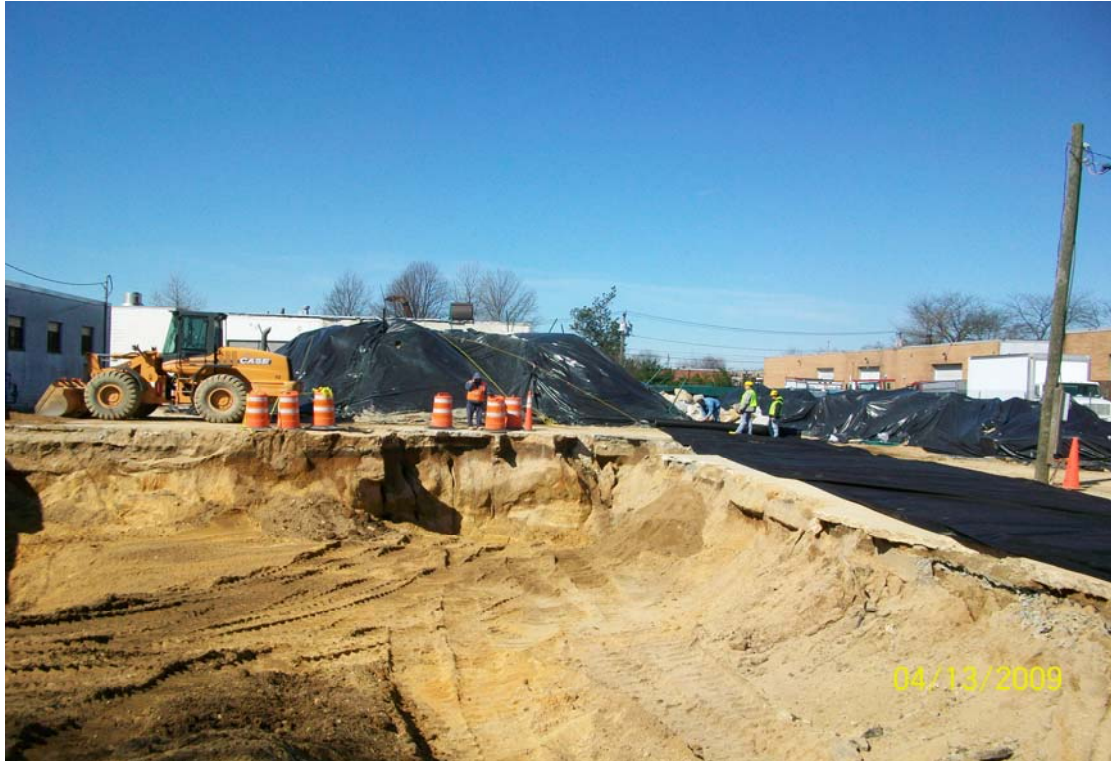
100\_00351.jpg - Finished filling up sump-1.

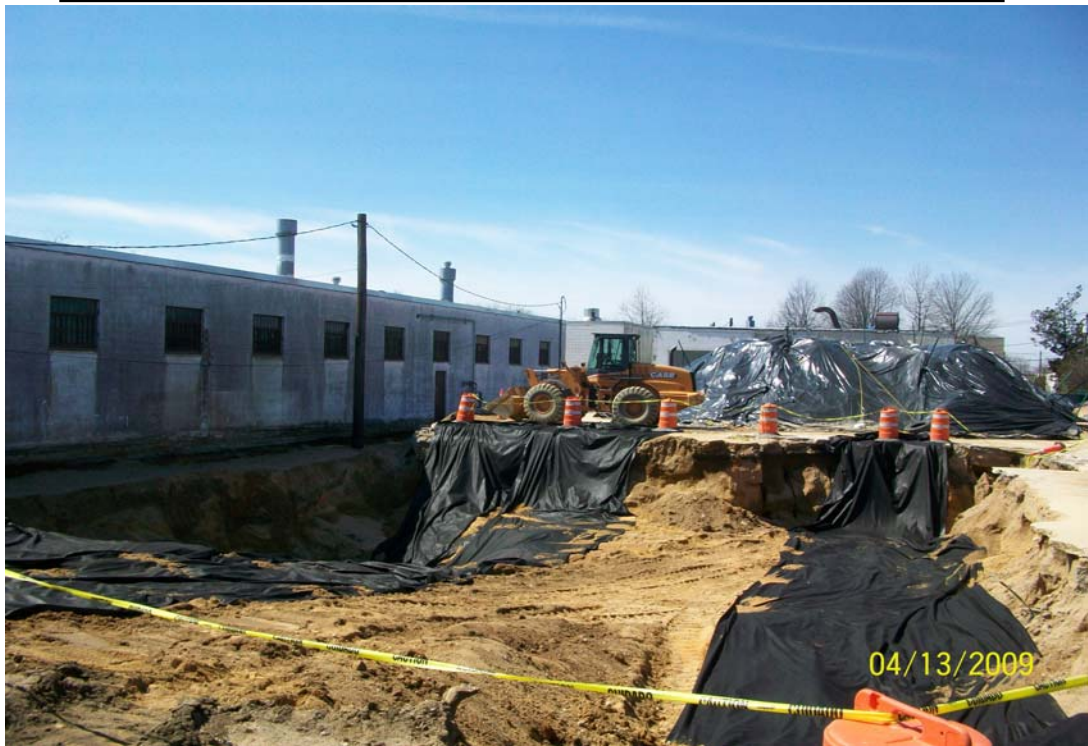
100\_00353.jpg - Excavation at the end of the day with the geotextile fabric installed.
