PHOTOGRAPHIC LOG

CDM Job No. D-006956

Spectrum Finishing Remedial Action

SITE No. 1-52-029

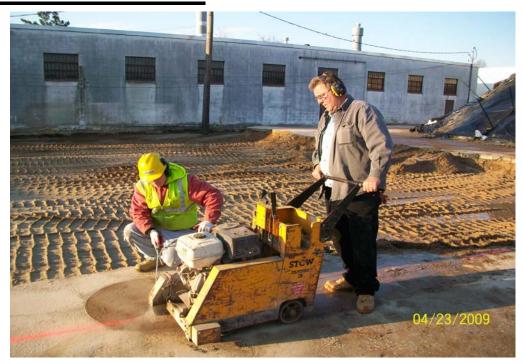
100_00455.jpg - Saw cutting concrete slab

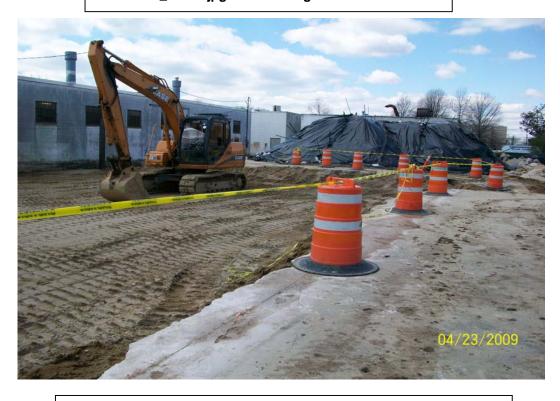
100_00456.jpg - Finished saw cutting north side of concrete slab

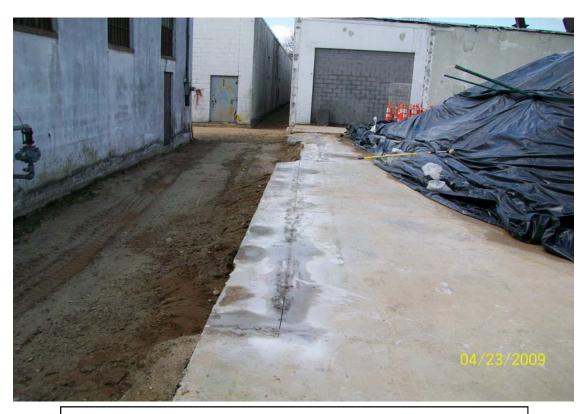
100_00457.jpg - Finished saw cutting south side of concrete slab

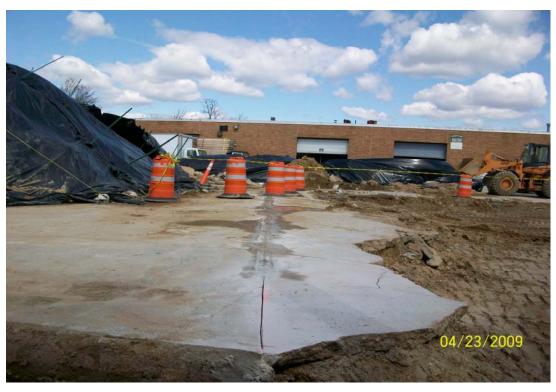
100_00458.jpg - Finished saw cutting west side of concrete slab

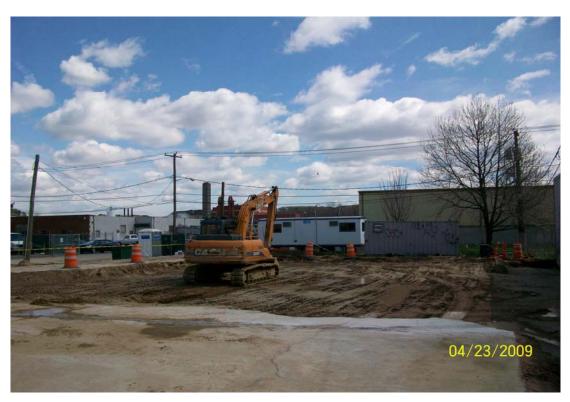
100_00459.jpg - Excavation at the end of the day, looking east

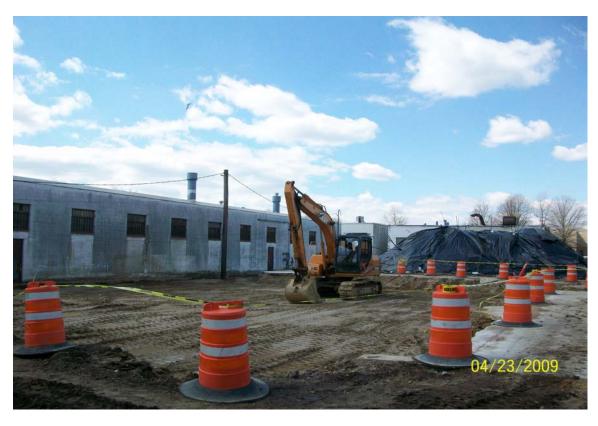
100_00460.jpg - Excavation at the end of the day, looking west
