Project: Spectrum Finishing - Remedial Action  
 Contractor: EnviroTrac Environmental Services  
 CDM Job No: D-006956 Site No. 1-52-029  
 CDM Project Manager: John Blaum

### DAILY REPORT

Date: 27-May-09  
 REPORT No. 151  
 PAGE No. 1

**PHOTOGRAPHIC LOG**  
**27-May-09**  
**CDM Job No. D-006956**  
**Spectrum Finishing Remedial Action**  
**SITE No. 1-52-029**

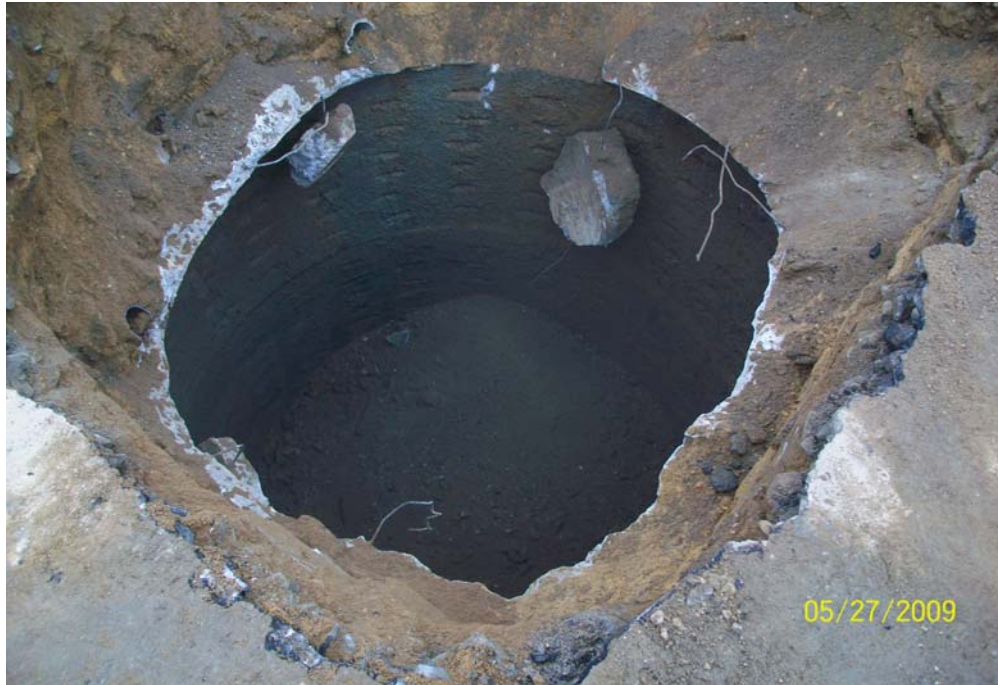
100\_0696.jpg - Dome of CP-7 broken into structure, 51 Dale St.

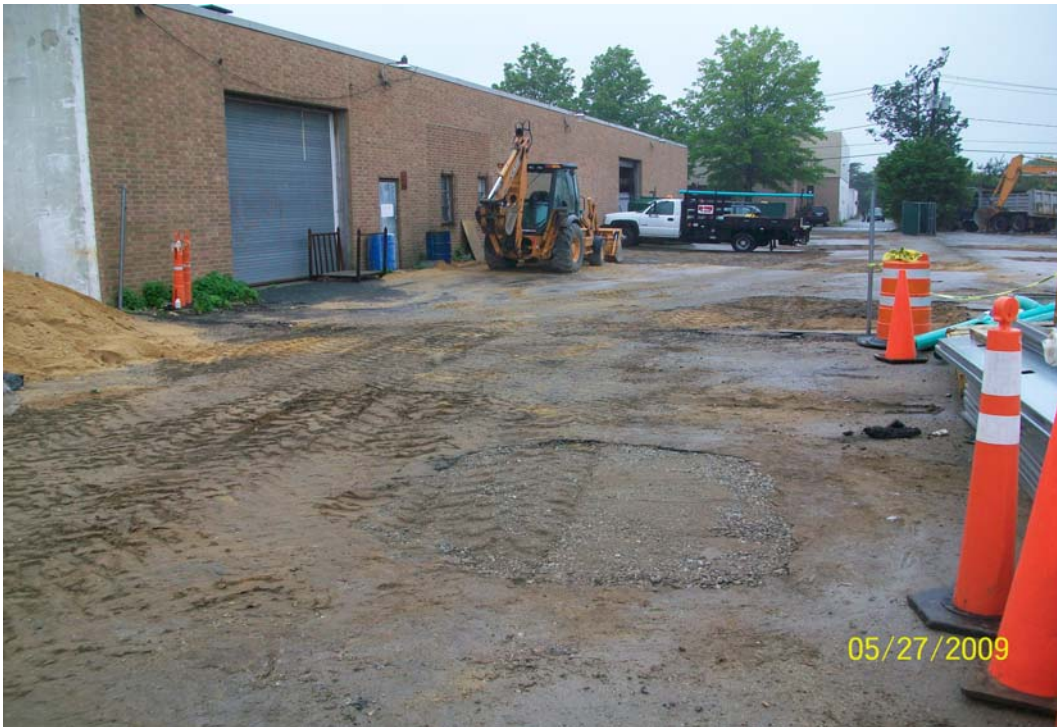
100\_0699.jpg - CP-7 completely abandoned, 51 Dale St.

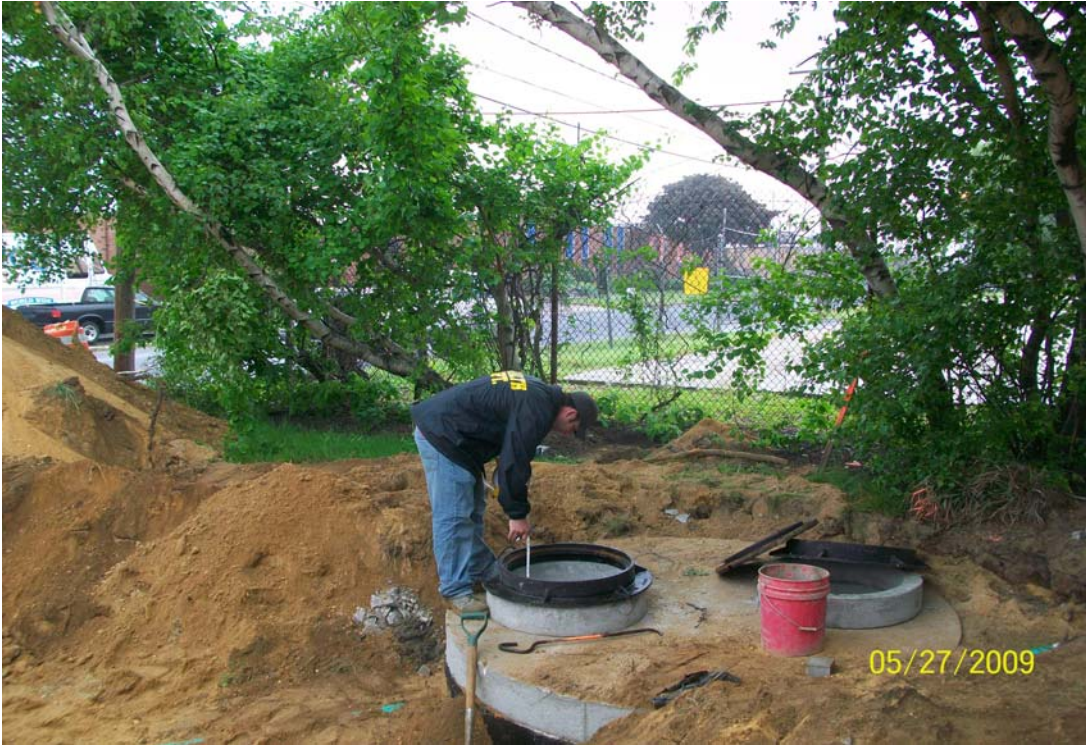
5-Jimmy Trent (SCDHS) was on site to inspect septic system #2 in the front of 61 Cabot St. The system passed the inspection.

**100\_0701pg - Jimmy Trent (SCDHS) inspecting septic system #2, 61 Cabot St.**

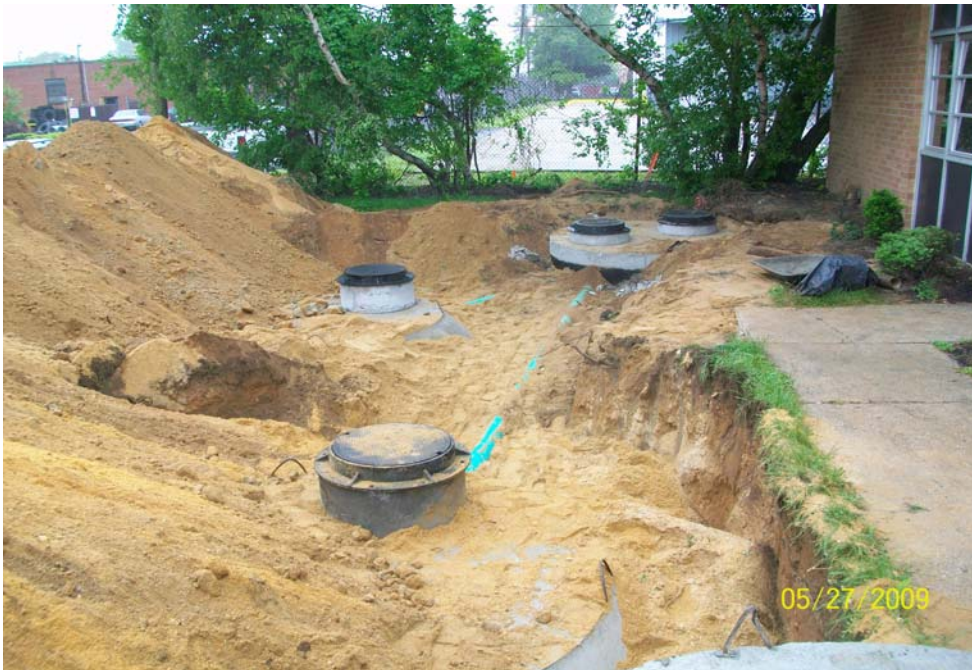
**100\_0703.jpg - Septic system #2 prior to backfilling, 61 Cabot St.**

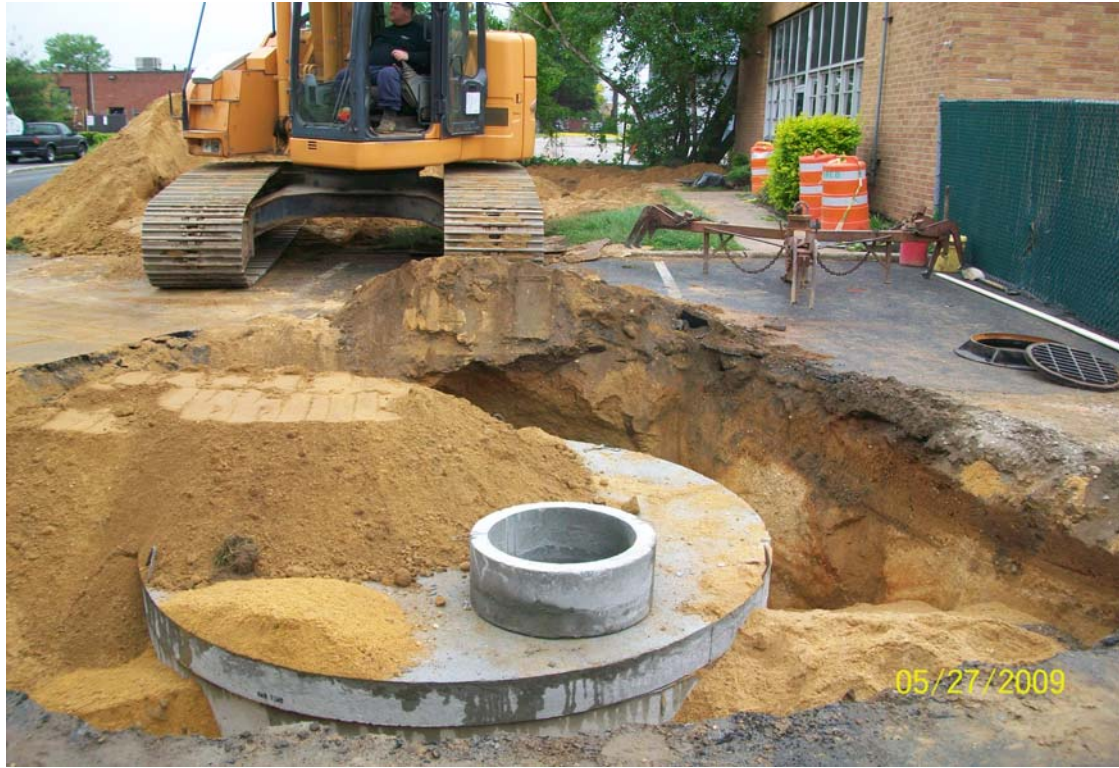
**100\_0685.jpg - PDS-1 partially backfilled, 61 Cabot St.**

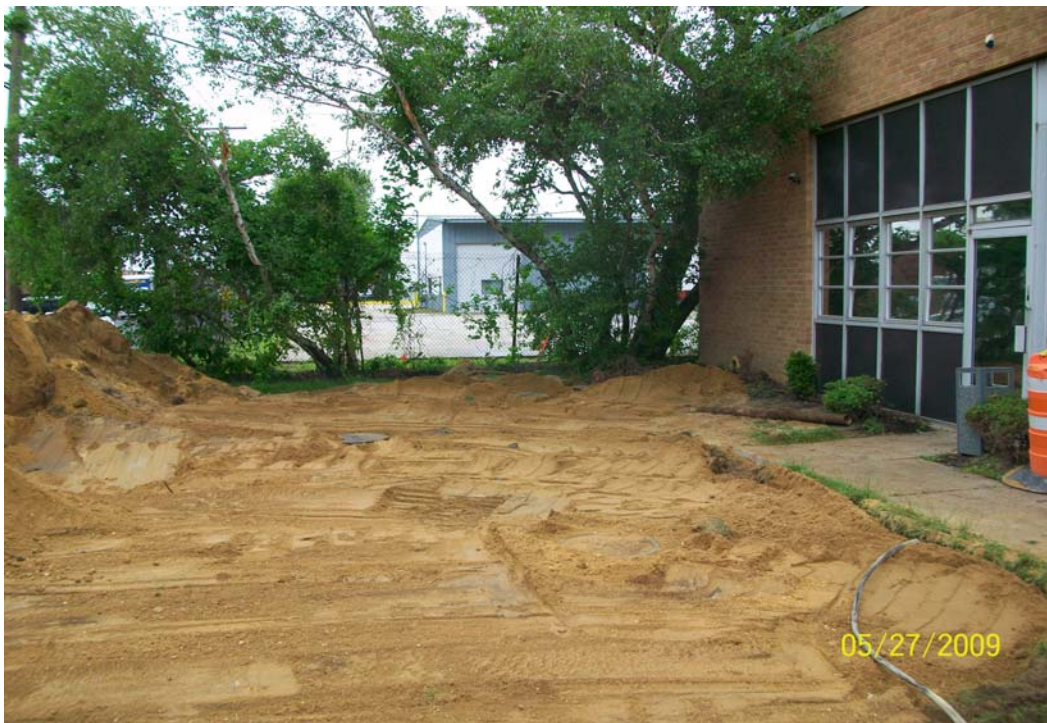
**100\_0705.jpg - Septic system #2 backfilled, 61 Cabot St.**

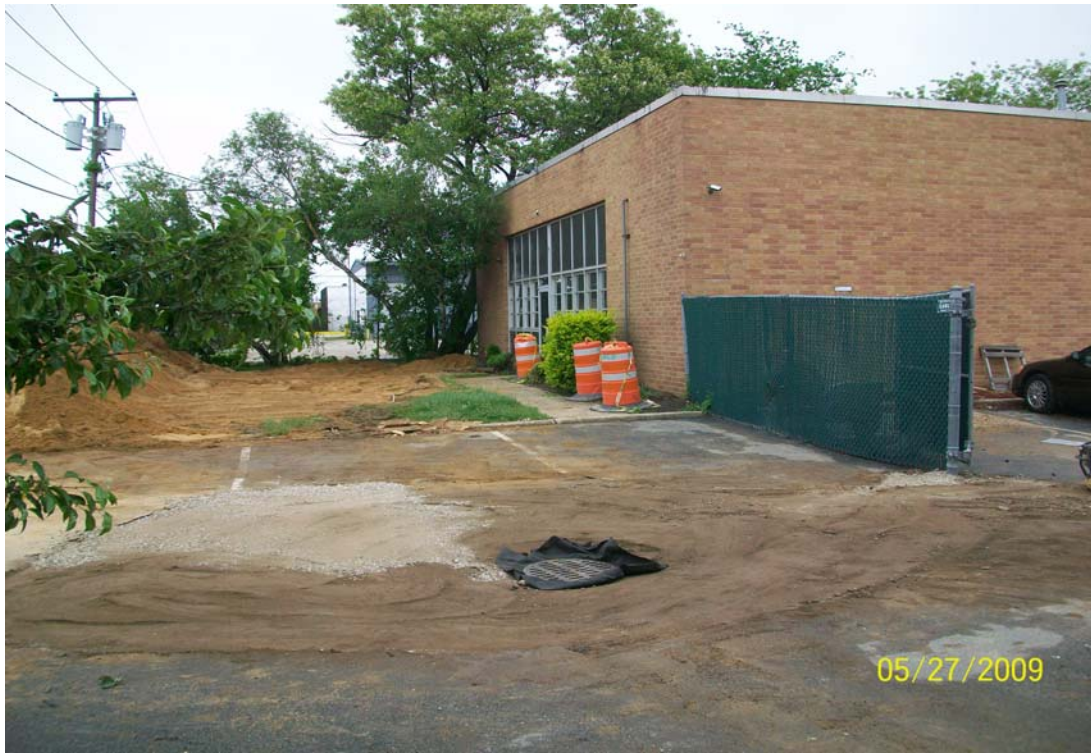
100\_0707.jpg - PDS-1 backfilled, 61 Cabot St.
