ALCO-Maxon Site C447042 - Parcel A
Spill #1604483 Monthly Report
August 2017

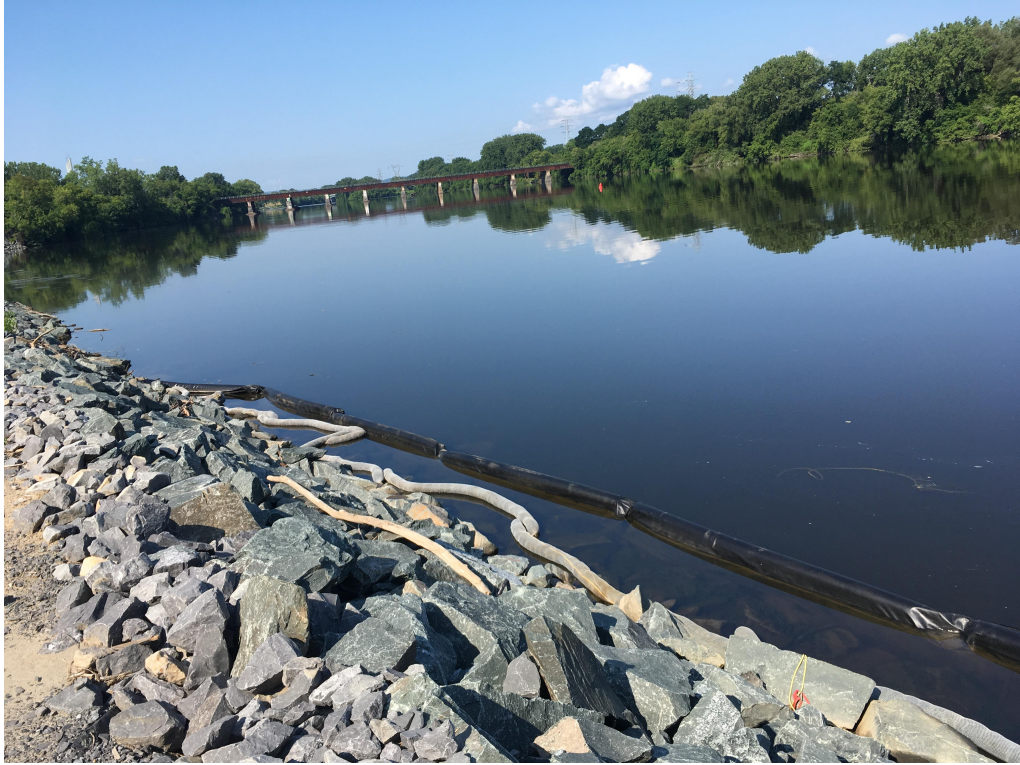
August 2017.

Water level fluctuations necessitate boom readjustment. Once boom was secured, sheen remained contained behind the boom. New areas of riverbank seepage were not observed along the riverbank in the vicinity of the booms.

Installation of the grout injection wall was started at the end of the month. During injections, sheen was noted to increase in the area of riverbank corresponding to the injection area. As this occurred, bags of charcoal were placed in these areas to help dissipate sheen and odor.

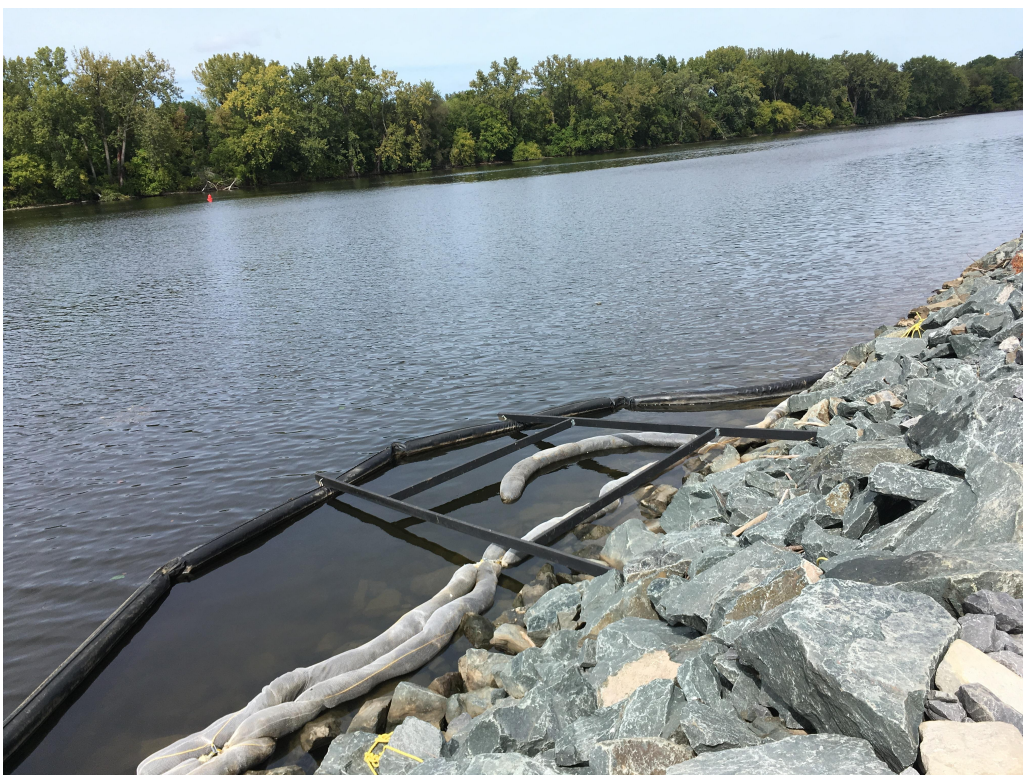
September 2017. Bracing placed to hold containment boom.

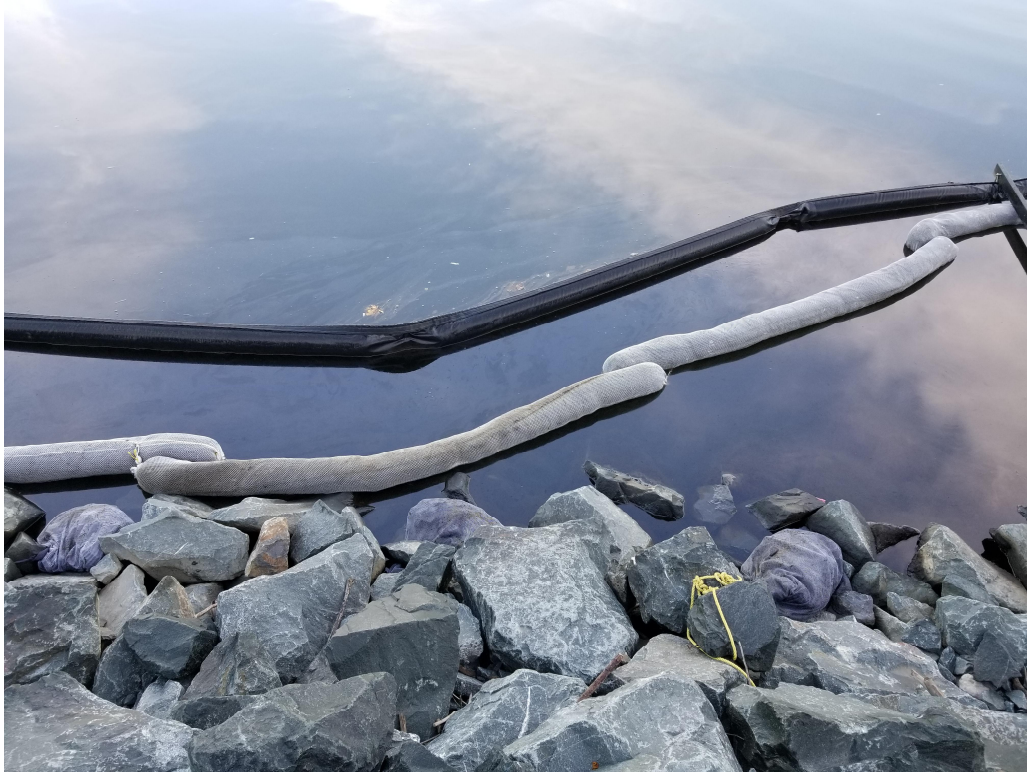
October 2017.

Water level fluctuations necessitate boom readjustment. Once boom was secured, sheen remained contained behind the boom. New areas of riverbank seepage were not observed along the riverbank in the vicinity of the booms.

Recovery well drilling of 9 wells occurred between the 18th and the 26th. Original placement of wells was adjusted to avoid interference with grout injection wall. Wells were drilled to 20' depth with 10' of screen unless otherwise noted in recovery well report.

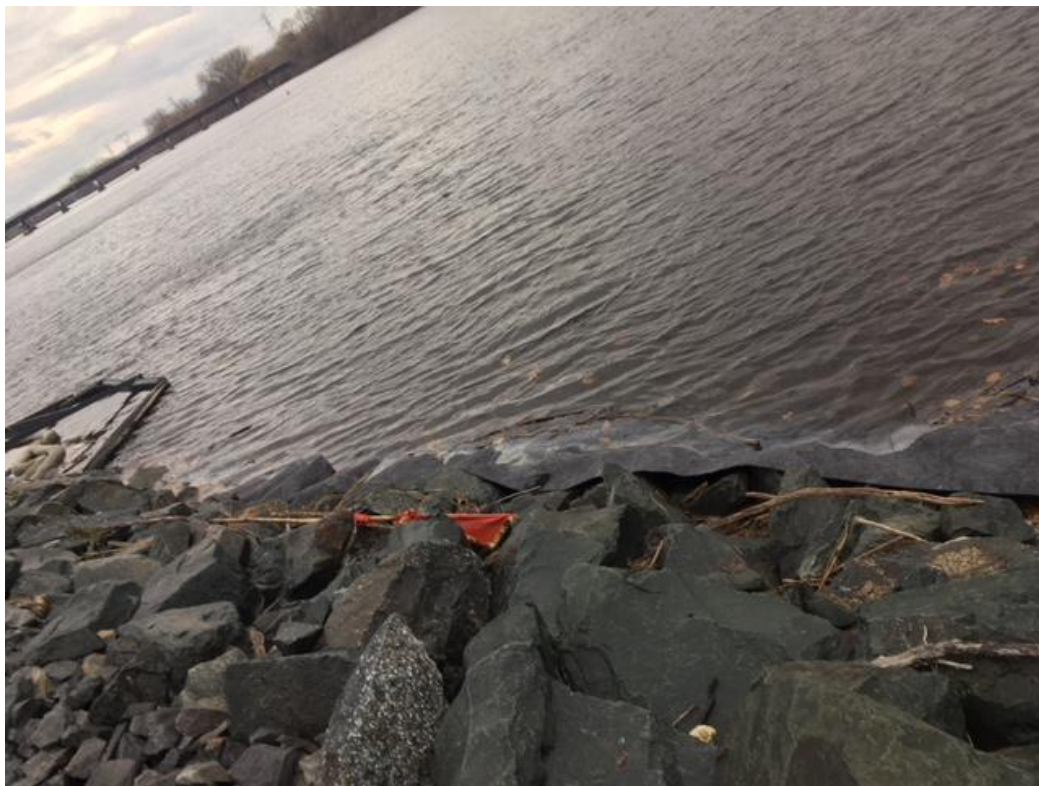
November 2017.

Water level fluctuations necessitate boom readjustment. Once boom was secured, sheen remained contained behind the boom. New areas of riverbank seepage were not observed along the riverbank in the vicinity of the booms.

It was noted the color of product in the absorbent sock in MW-73 has become a light tan color rather than the black degraded oil previously noted. The sock is also absorbing oil at a slower rate.

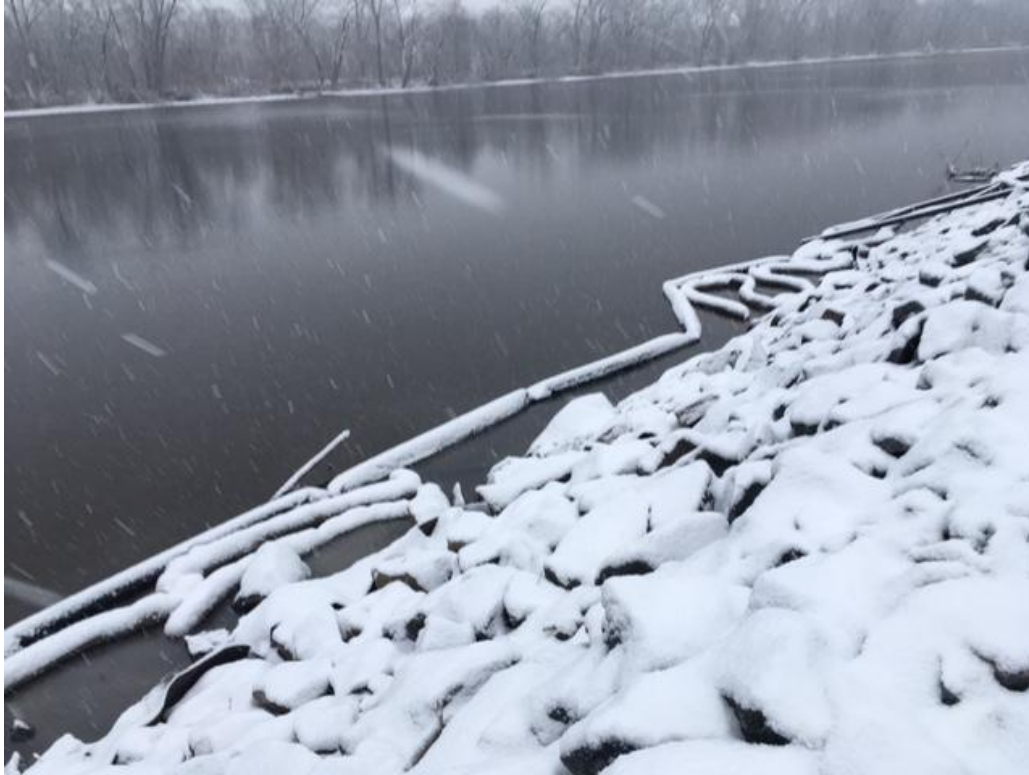
December 2017.

River levels dropped to a low of 209.5 on November 30, 2017 and stayed consistently around 210 feet above mean sea level (amsl) due to the removal of flash boards at the Vischer Ferry Dam. In early December, the request was made to remove the boom from the river for the winter due to impending ice. Therefore, the boom was left in place as the river levels dropped.

On December 9, 2017, a spill was called in to NYSDEC. The sheen along the bank was visible and continued to College Creek. As a result, the boom was re-adjusted.

The river froze by 12/20/17, locking the boom into place.

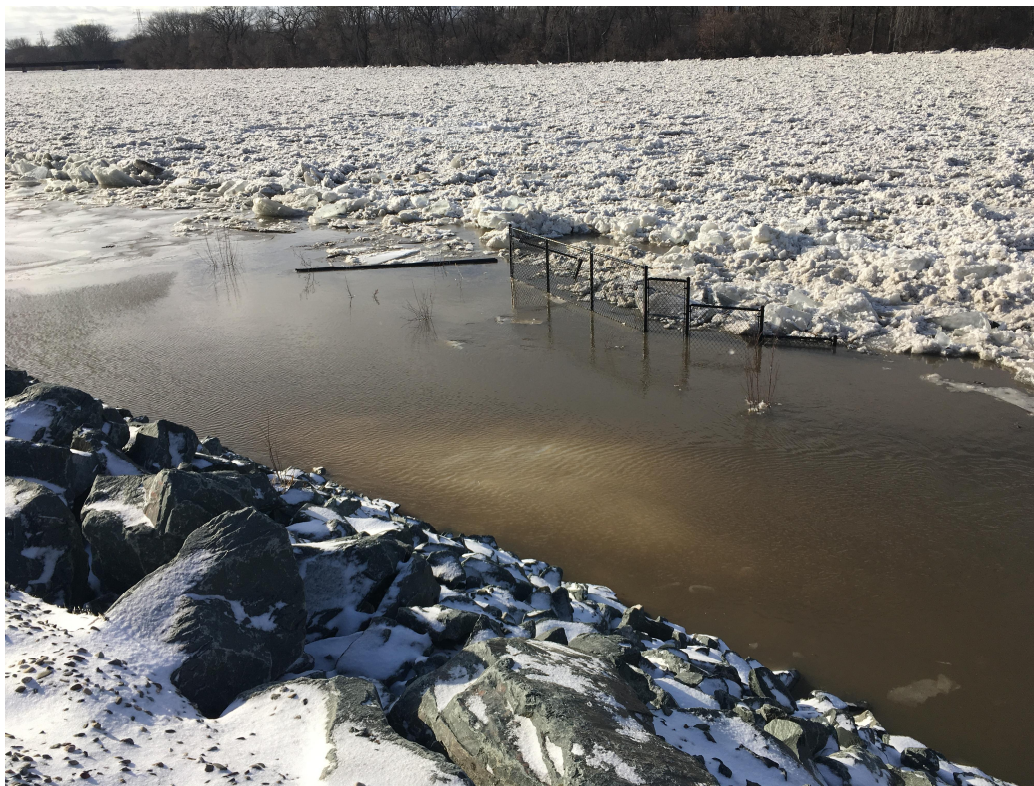
On January 13th, the Mohawk River flooded and created an ice jam. The riverbank became unsafe to access from below, so visual inspections occur at the top of bank. The wells are unsafe to access at this time. No changes have been noted.

January 2018. Mohawk River flood event at College Creek outfall.

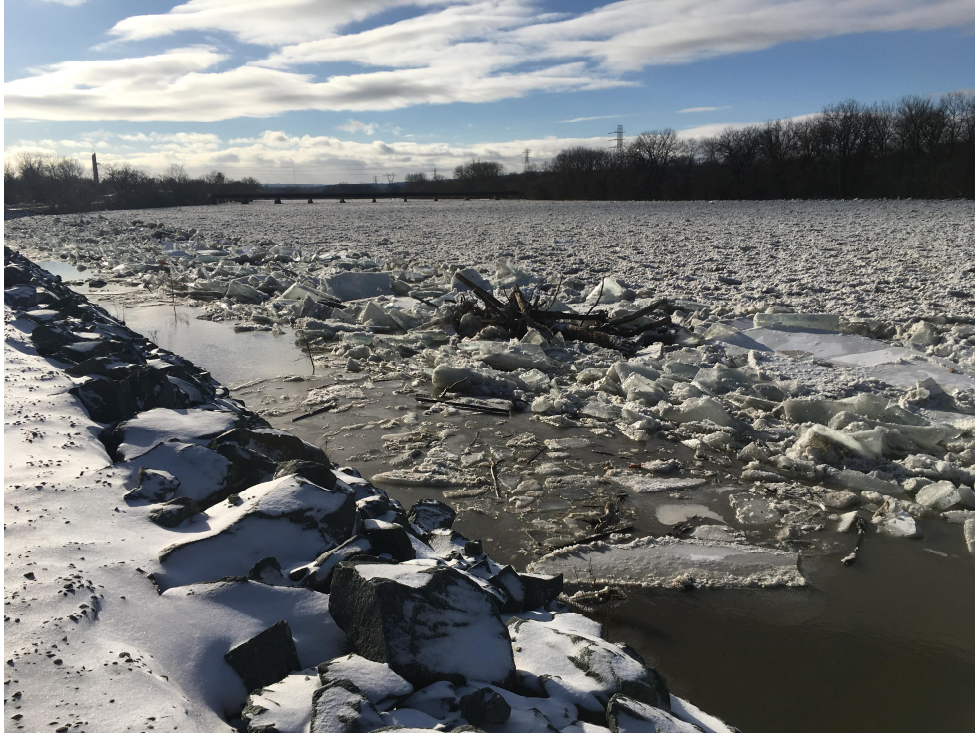
January 2018. Mohawk River flood event.
