**OPERATIONS & MAINTENANCE STATUS REPORT  
PERIOD: JULY 12, 2006 THROUGH MARCH 22, 2007**

**OPERABLE UNIT I  
FORMER WASTEWATER TREATMENT AREA  
METRO NORTH RAILROAD HARMON YARD  
CROTON-ON-HUDSON, NEW YORK**

**Prepared by:** Day Engineering, P.C.  
40 Commercial Street  
Rochester, New York 14614

**Date:** March 2007

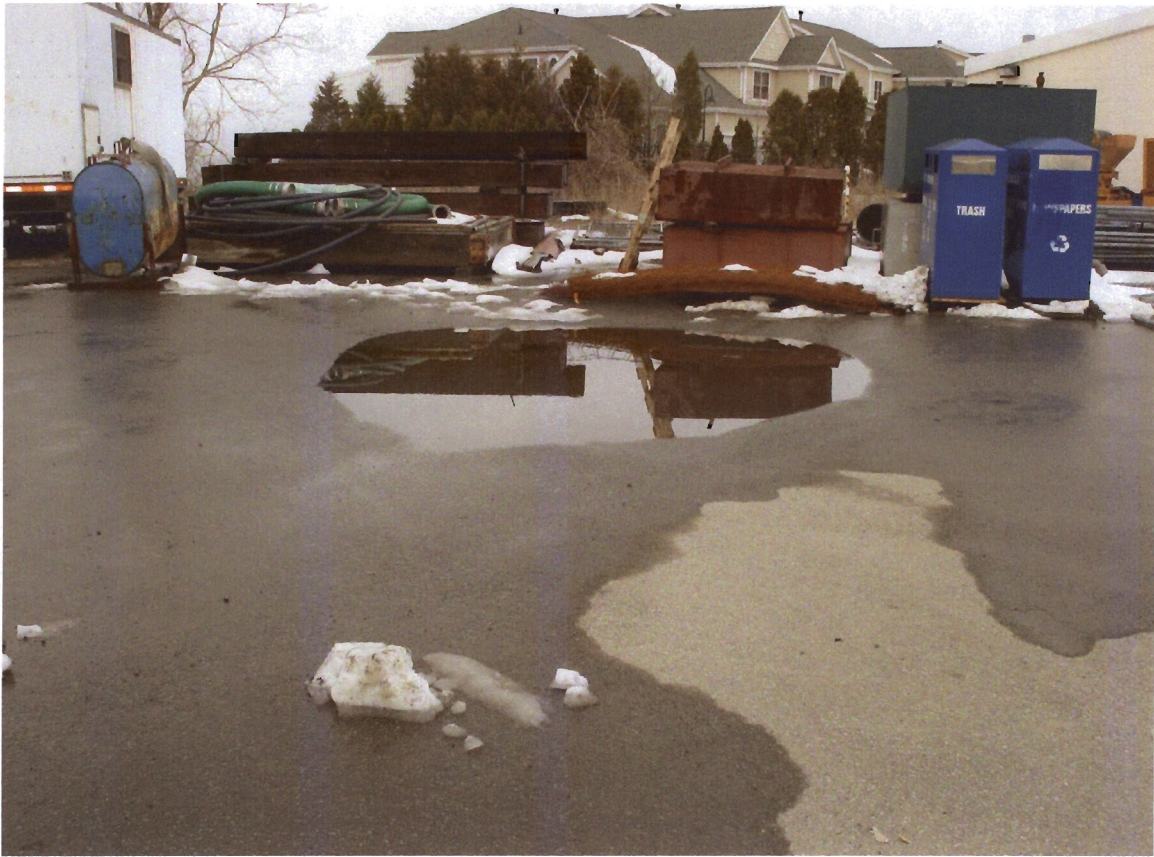
Location 1

Based upon observations made through March 31, 2007, the asphalt cover is generally in good condition and appears similar to that observed during previous inspections described in the status report dated August 2006. The area of settling observed during previous inspections appeared similar during the March 22, 2007 inspection. During the March 22, 2007 inspection, surface water ponding approximately two inches deep covered an area approximately eight feet in diameter around this low spot in the asphalt cover. Since this depression does not appear to affect the overall drainage of the asphalt cover and has not continued to settle it is not being identified as a concern at this time. However, if continued settlement of the depression occurs in the future that appears to affect the drainage of the OU-I remedy a corrective action may be recommended.

Radial cracks throughout. Minor area of settlement north of new drainage sump. Tentative plans to seal cracks during summer '07.

View of depression located approximately 25 feet north of the sump box that drains the asphalt cover.

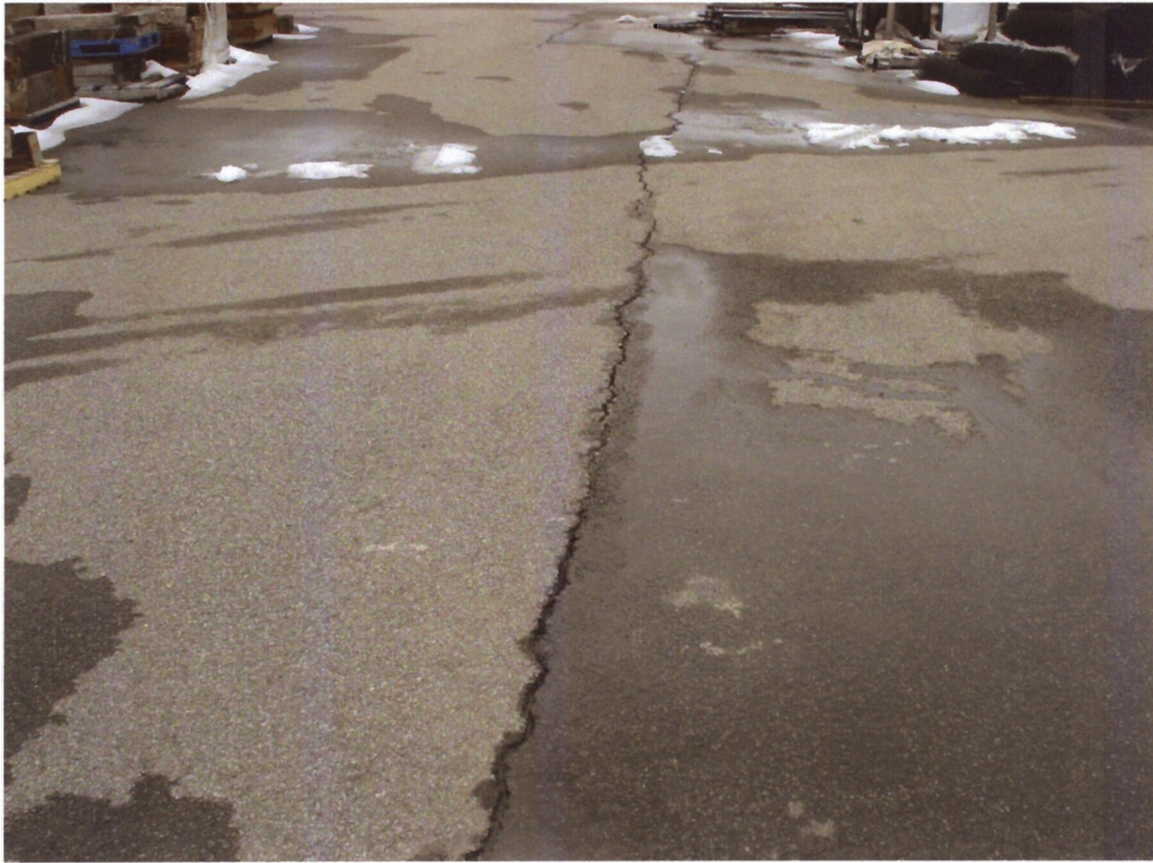
Location 2

Shallow surficial cracking radiating concentrically from the low spot in the center of the asphalt cover (i.e., in the area of the sump box, refer to Site Sketch, Location 2) to various locations throughout the asphalt cap was noted during this monitoring period. There are plans to seal this cracking in the asphalt cover during the summer of 2007.

View of minor surficial cracking on asphalt cap surface.
