**Subject: Metro-North Railroad, Harmon Yard,
Operable Unit I – Operations & Maintenance Status Report,
Report Period June 15, 2007 through December 31, 2007.**

**OPERATIONS & MAINTENANCE STATUS REPORT
PERIOD: JANUARY 1, 2008 THROUGH JULY 31, 2008**

**OPERABLE UNIT I
FORMER WASTEWATER TREATMENT AREA
METRO NORTH RAILROAD HARMON YARD
CROTON-ON-HUDSON, NEW YORK**

Date: August 2008

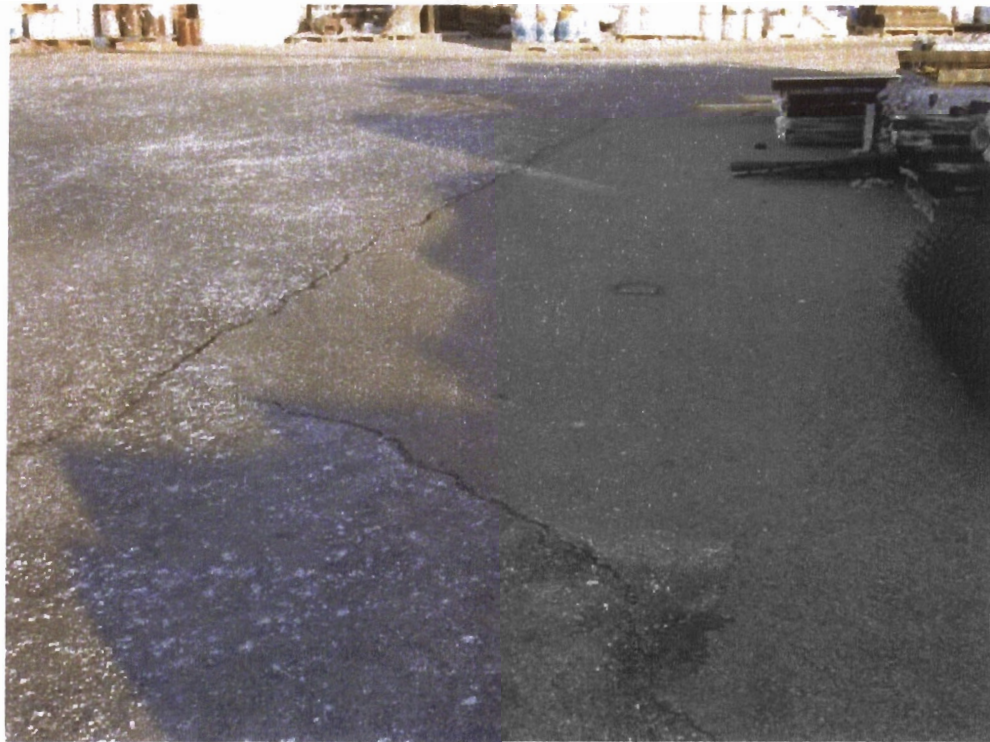
Based upon observations made on June 26, 2008, there is minor cracking in the asphalt cover and a corrective action (i.e., future filling and asphalt sealing of the cracks) should be considered. The area of settling observed on the June 26, 2008 inspection appeared similar to that observed during previous inspections. During the June 26, 2006 inspection, there was no surface water ponding observed on the asphalt cover (i.e., the drainage modification system was functioning as designed) and there were no differences in elevation observed around the grouted manhole covers within the asphalt cover during this time period.

- Based upon observations made through July 31, 2008, there is evident cracking in the asphalt cover and visual monitoring of these cracks should continue throughout the next monitoring period. As weather permits, the cracks should be filled with joint sealer and spot sealing should be conducted along the cracks with an asphalt sealant.
- The area of settling observed north of the catch basin should be monitored for continued settlement and if this settlement appears to affect the OU-I remedy, additional corrective actions should be considered.

Surficial cracking observed throughout asphalt cover.

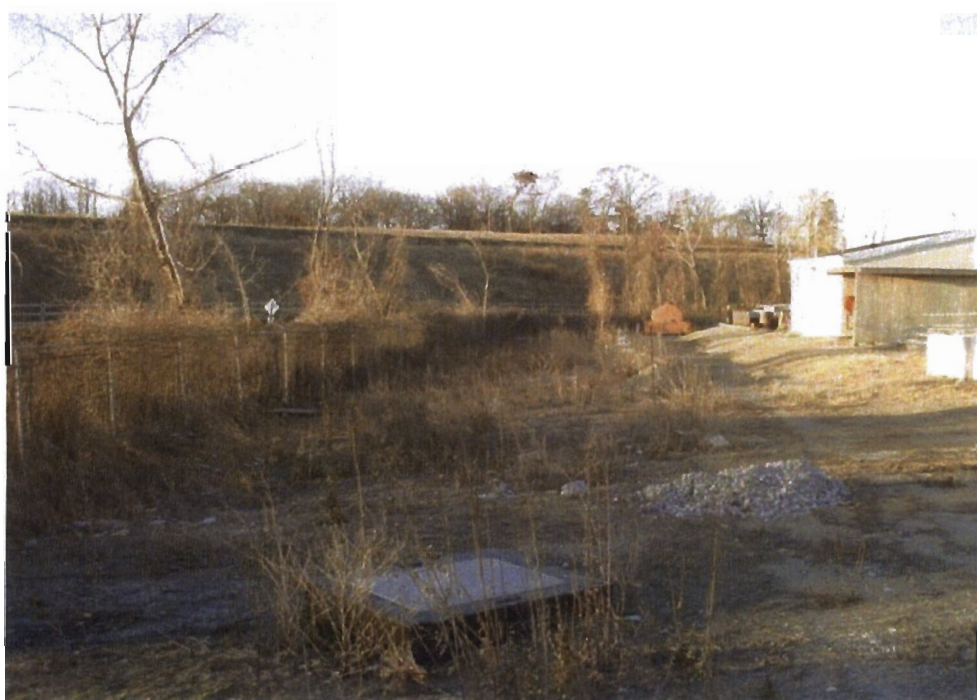
- During the June 26, 2008 inspection, there was no damage to the fence noted and the gate locks were present and in good condition. Scrub trees were observed along various portions of the fence; however, since the scrub trees have not caused a breach in the perimeter fencing a corrective action (i.e., trimming of scrub trees or removal) does not appear needed at this time.

Scrub trees observed along various portions of perimeter fencing.
