**Subject: Metro-North Railroad, Harmon Yard,  
Operable Unit I – Operations & Maintenance Status Report,  
Report Period August 1, 2008 through January 1, 2009.**

**OPERATIONS & MAINTENANCE STATUS REPORT  
PERIOD: AUGUST 1, 2008 THROUGH JANUARY 1, 2009**

**OPERABLE UNIT I  
FORMER WASTEWATER TREATMENT AREA  
METRO NORTH RAILROAD HARMON YARD  
CROTON-ON-HUDSON, NEW YORK**

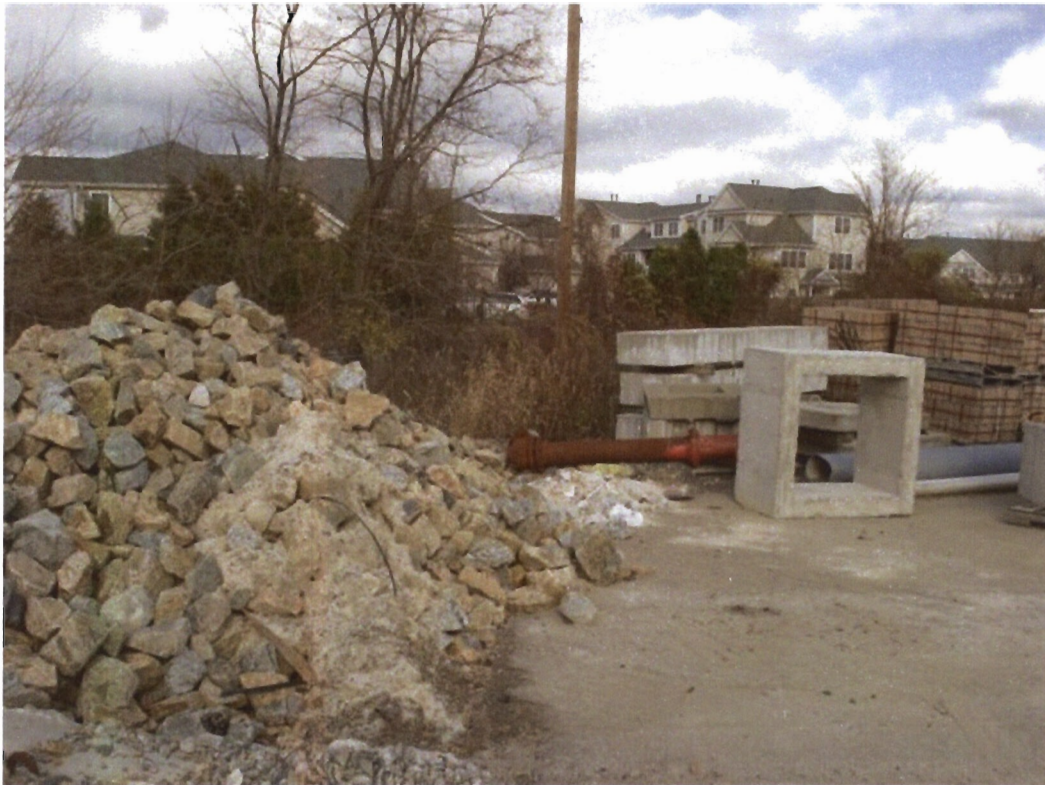
Picture #1 (11/20/08)

removed as part of preventive maintenance. In addition, the storage of rock and brick was observed on the north slope during the November 20, 2008 inspection; however, the materials were no longer being stored on the north slope during the December 17, 2008 inspection.

Rock & brick stored on north slope  
 windblown debris along fence.

Rock and brick storage on north slope around asphalt cover.

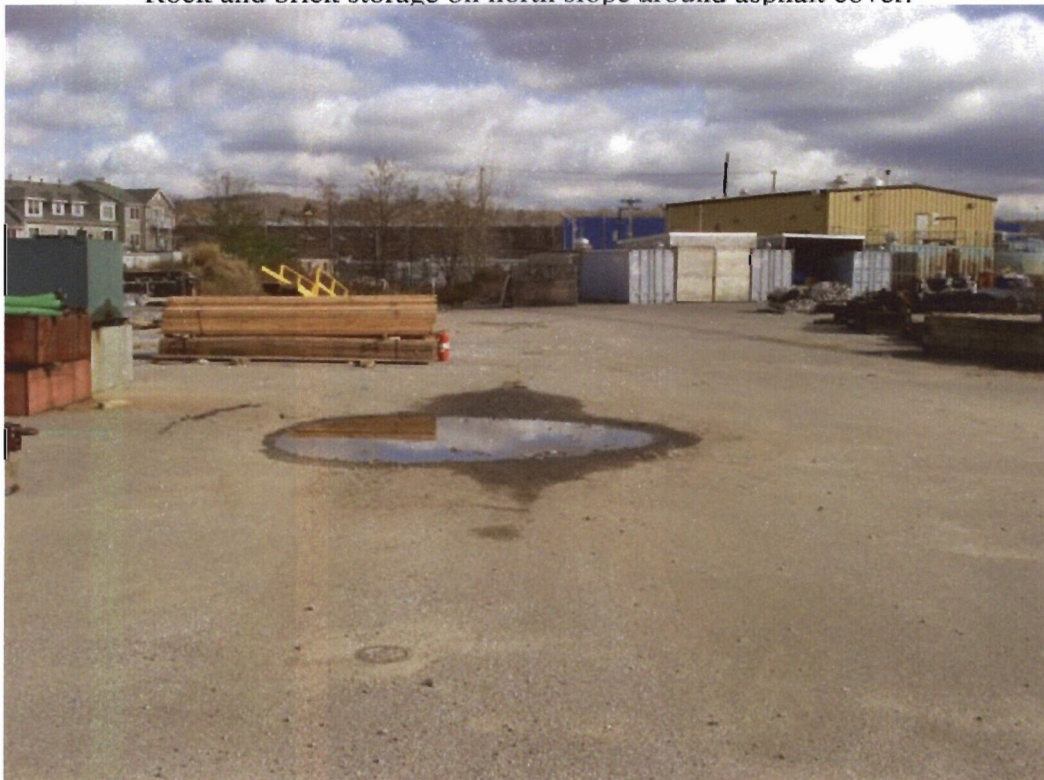
Picture #2 (11/20/08)

Minor low spot north of drainage manhole  
 Minor cracks throughout.

Surface water ponding on asphalt cover.

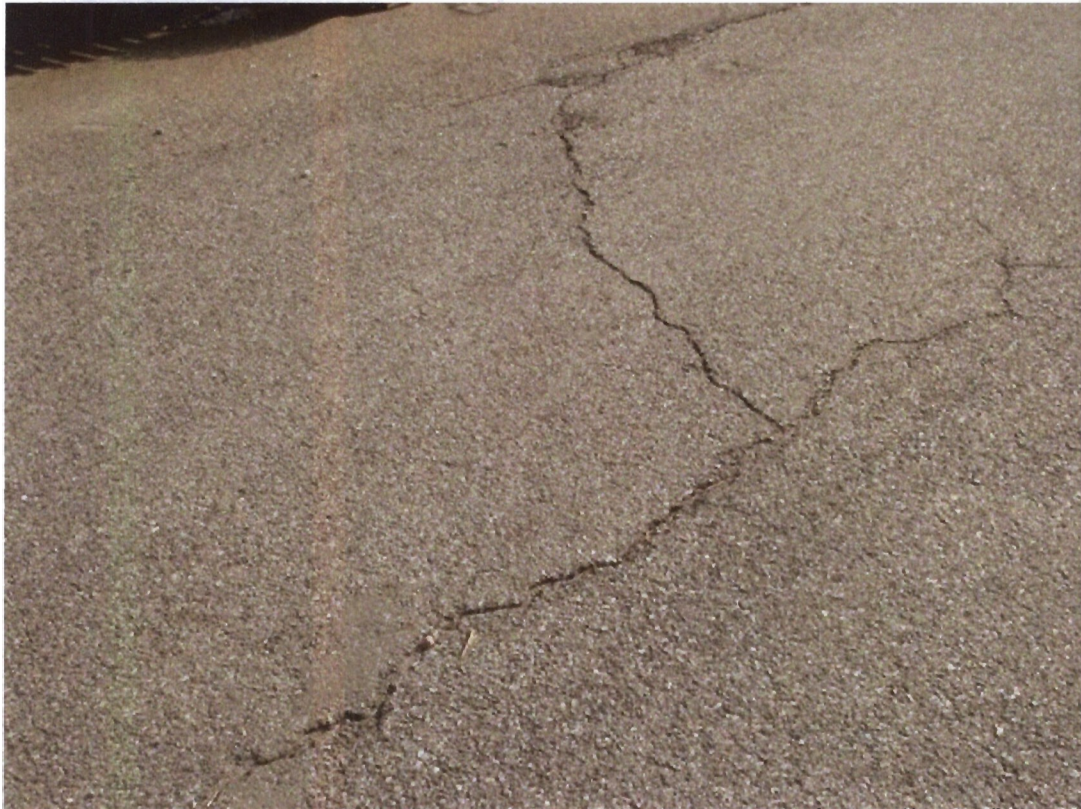
Based upon observations made on November 20, 2008 and December 17, 2008, there is minor cracking in the asphalt cover that appears to be stabilized. Although the cracking appears stabilized, a corrective action (i.e., future filling and asphalt sealing of the cracks) should be considered when weather permits. The area of settling observed during these inspections appeared similar to that observed during previous inspections. Surface water ponding was observed on the asphalt cover during the November 20, 2008 inspection but this surface water ponding was apparently drained by the December 17, 2008 inspection (i.e. the drainage modification system was functioning as designed). There were no differences in elevation observed around the grouted manhole covers within the asphalt cover during this time period.

Picture #3 (12/17/08)  
Minor cracks that appear stabilized on asphalt cover.

- Based upon observations made through December 31, 2008, there is evident cracking in the asphalt cover and visual monitoring of these cracks should continue throughout the next monitoring period. As weather permits, the cracks should be filled with joint sealer and spot sealing should be conducted along the cracks with an asphalt sealant.
- The area of settling observed north of the catch basin (i.e., the location where a drainage modification was installed in November-December 2005) should be monitored for continued settlement and if this settlement appears to affect the OU-I remedy, additional corrective actions should be considered.
