SITE MANAGEMENT PLAN STATUS REPORT
REPORT PERIOD: JUNE 1, 2016 THROUGH AUGUST 31, 2016

HARMON RAILROAD YARD
OU-I AND OU-II
WESTCHESTER COUNTY, NEW YORK
SITE NO. 3-60-010

Project Title
**METRO-NORTH RAIL ROAD
 HARMON YARD OPERABLE UNITS OU-I AND OU-II
 CROTON-ON-HUDSON, NEW YORK**

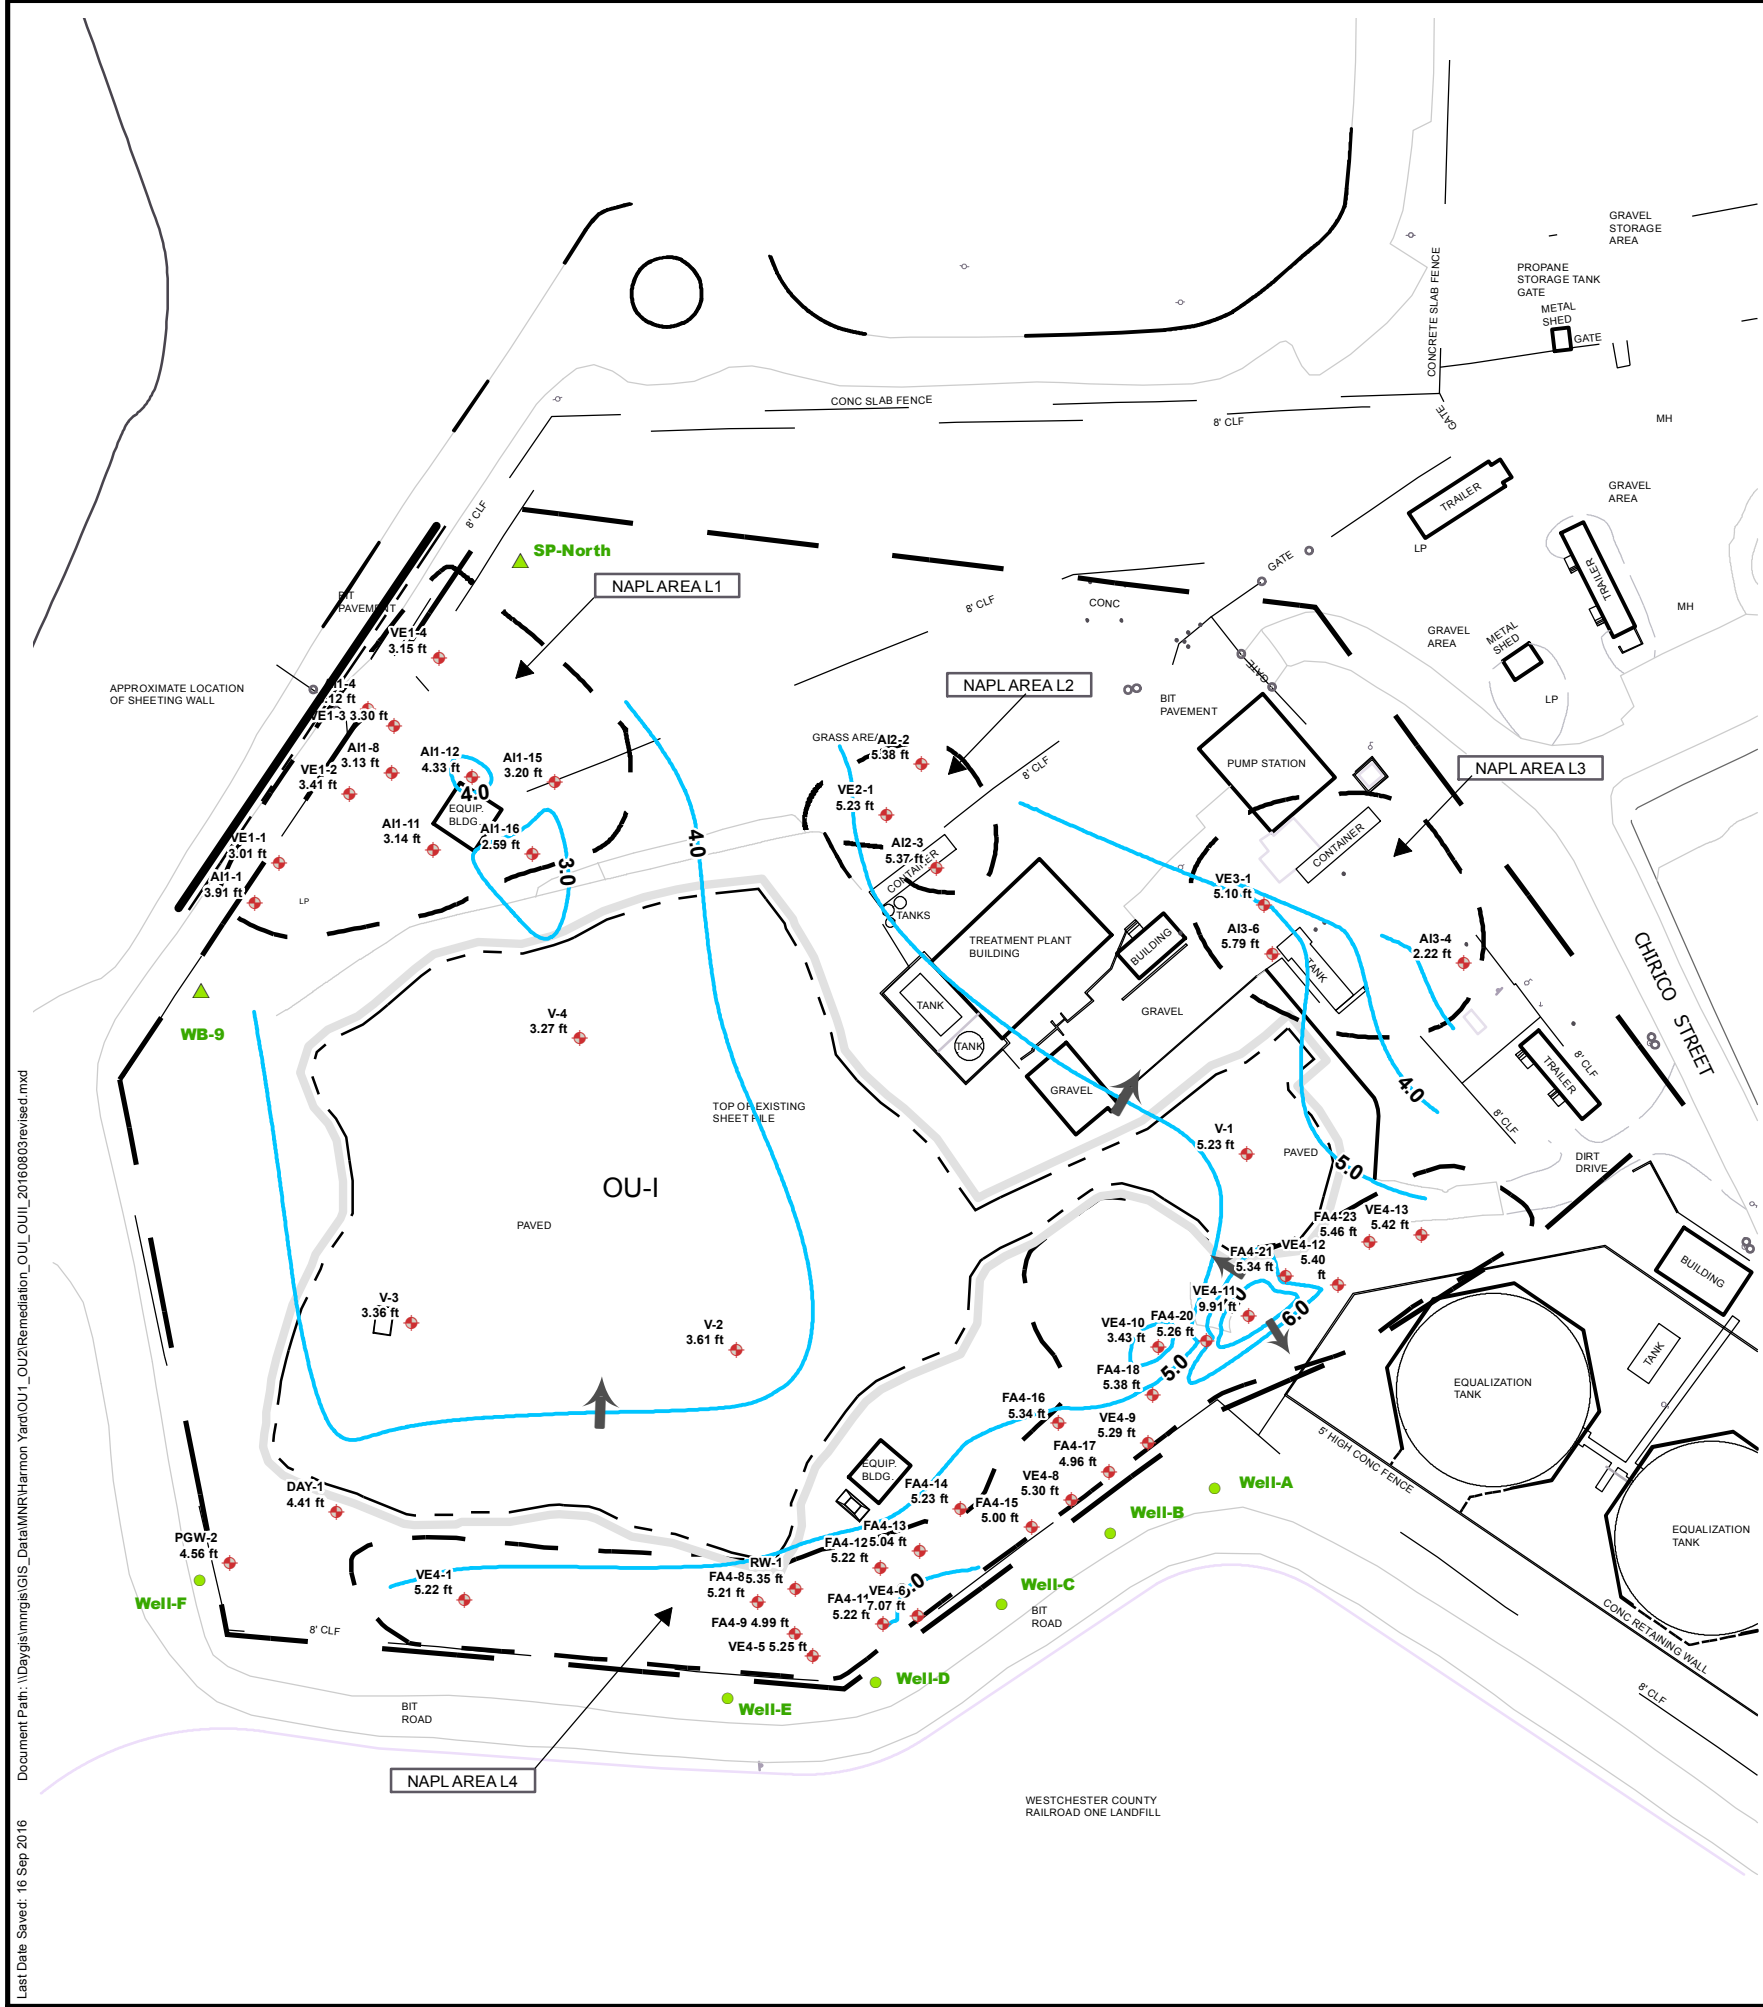
FIGURE 1

DEPTH TO GROUNDWATER AND NAPL MEASUREMENTS: During this report period, a quarterly monitoring event was conducted on August 3, 2016. This monitoring included the measurement of static water levels and NAPL thicknesses (if present) in functioning wells. The monitoring results are presented on the logs included in Attachment A. A groundwater contour map developed using static water levels measured on August 3, 2016 is included as Figure 1.

Groundwater Contour Map: August 3, 2016

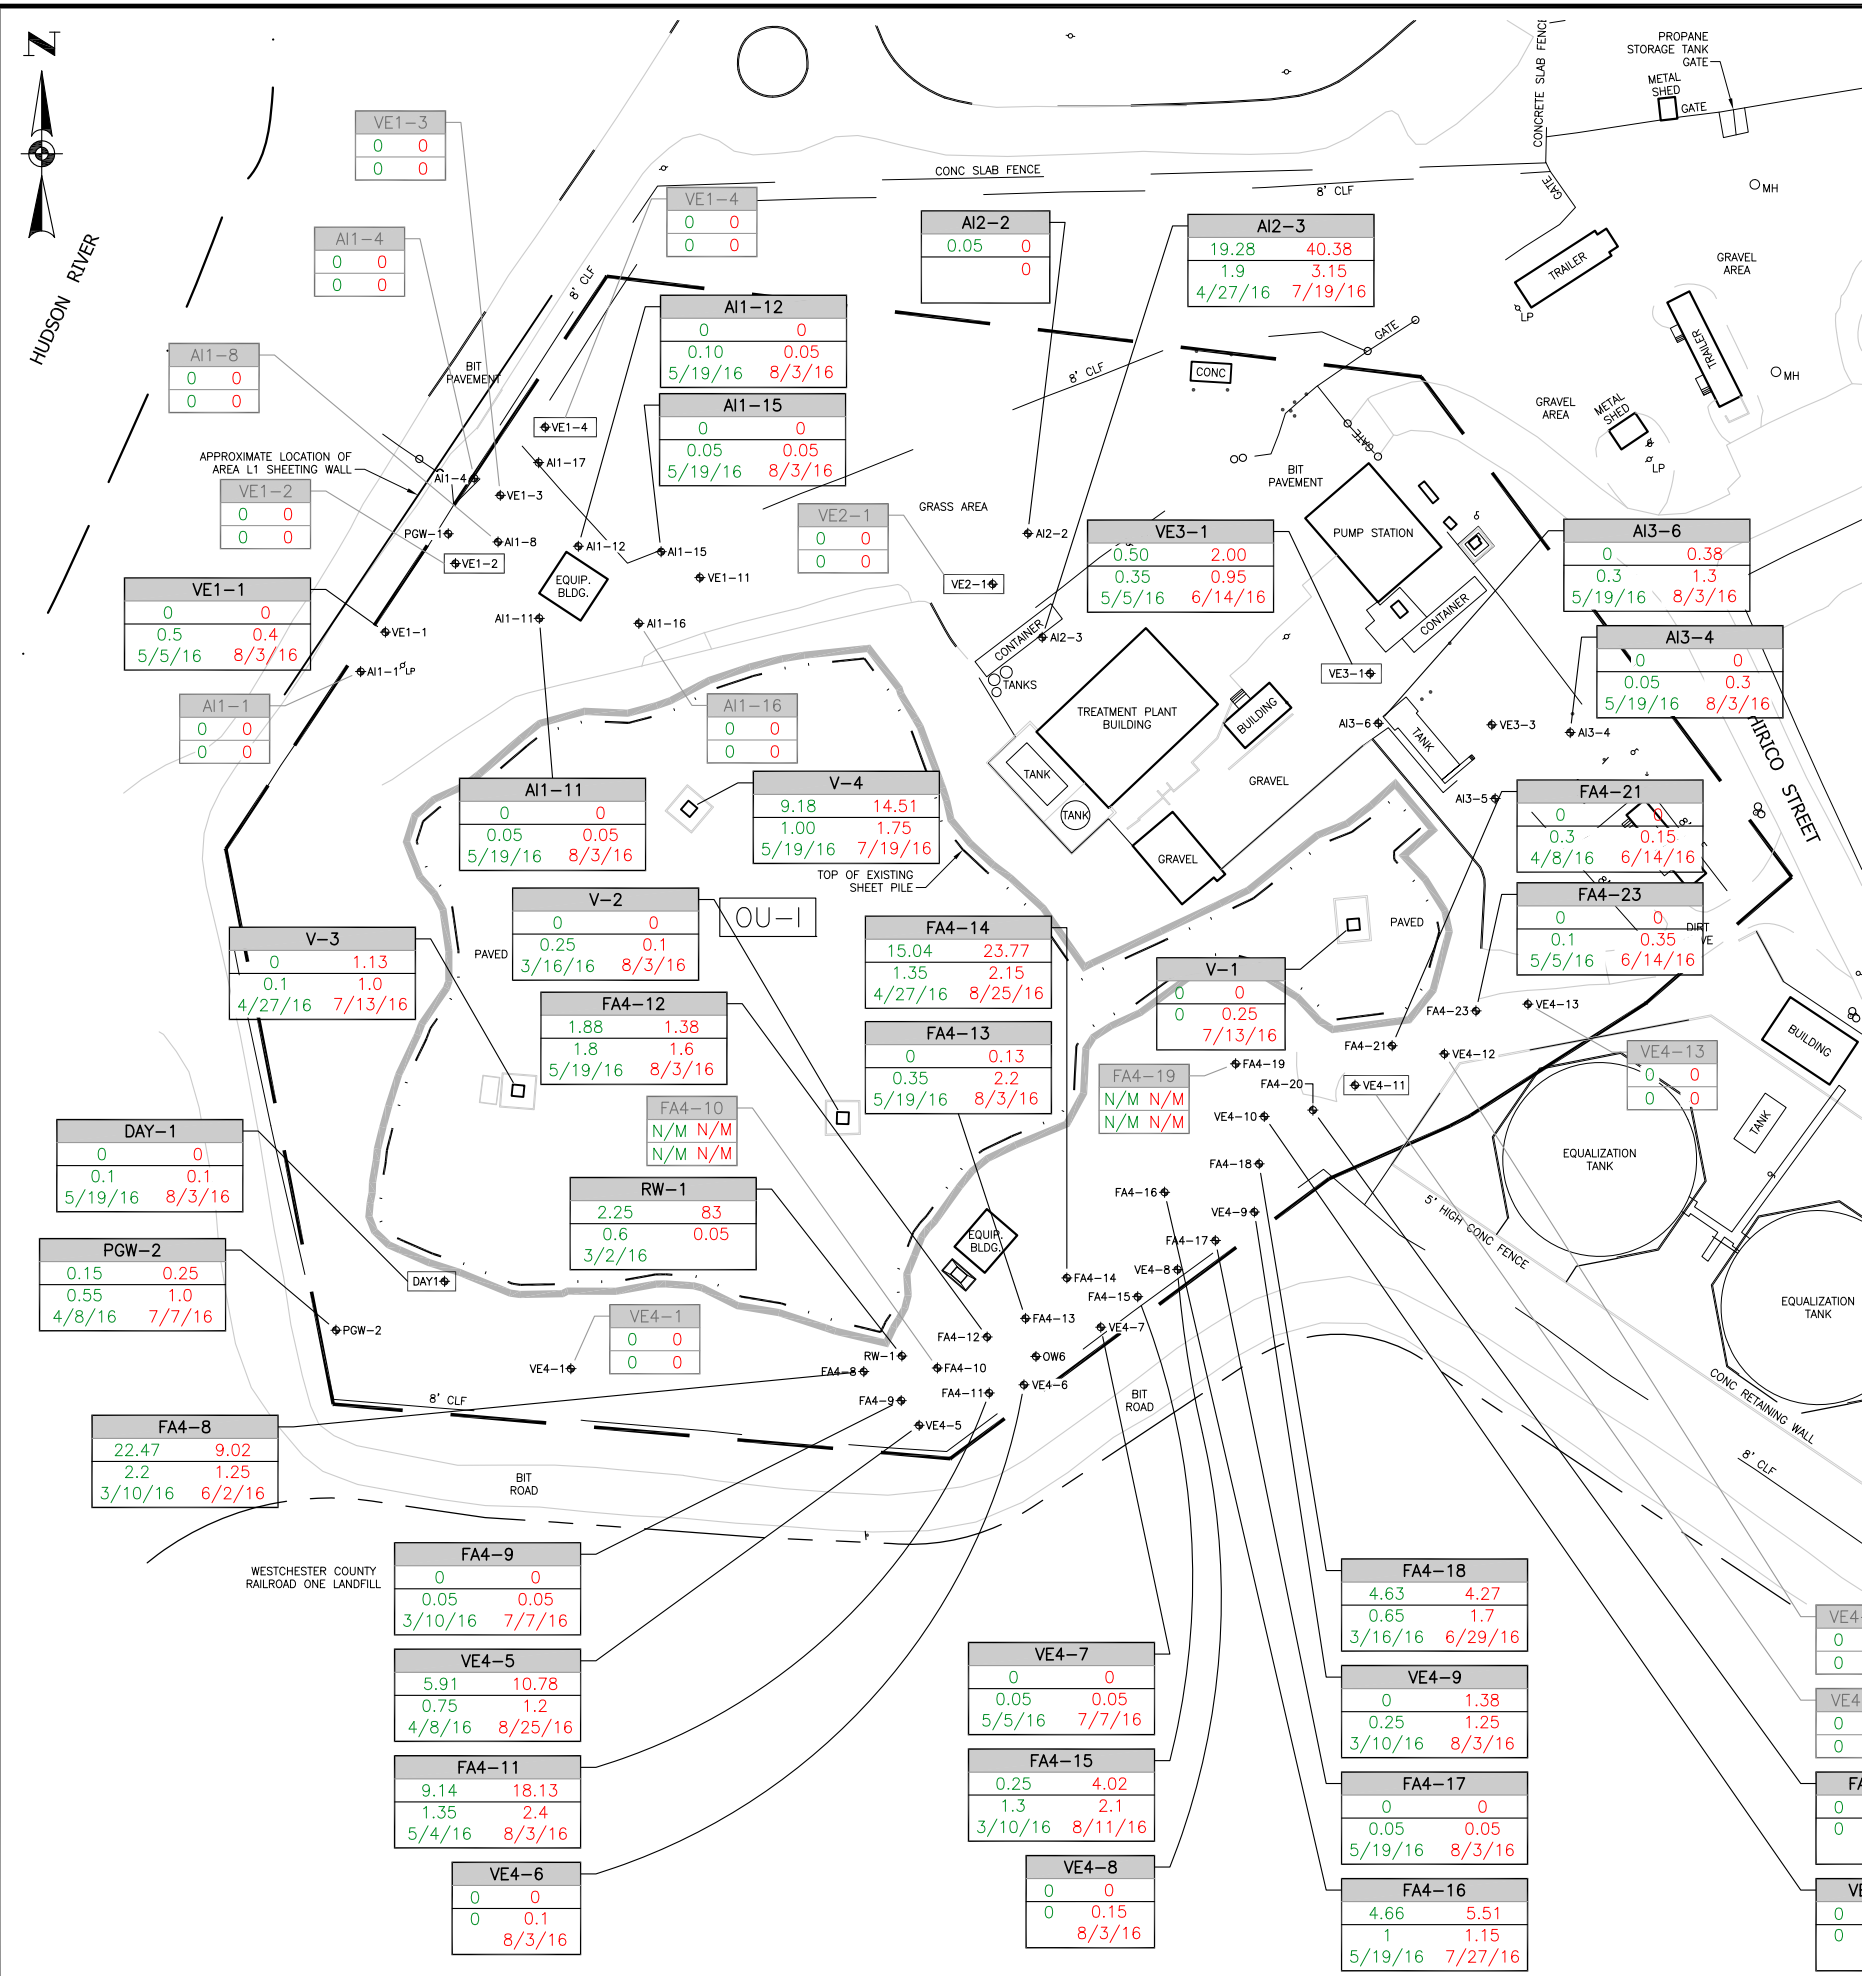
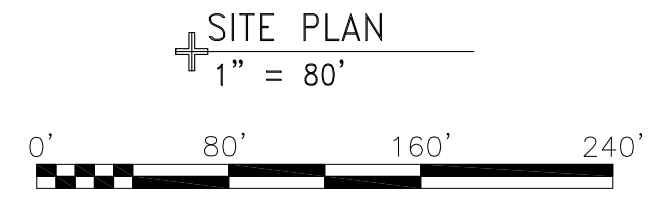
FIGURE 2

NAPL REMOVAL RECORDS: The NAPL removal records for each well evaluated during this report period are included on the logs in Attachment A. A summary of the total amount of NAPL removed from each well during the current report period is presented on Table 1, and a summary of the total amount of NAPL historically removed from each well between December 1, 2012 and August 31, 2016 is presented on Table 2. The NAPL removed was placed in 55-gallon drums. Testing and off-site disposal of the drums was not completed during this report period. A spider diagram presenting the maximum NAPL thicknesses, and the amount of NAPL removed from the wells at the Site during the current and preceding report period is included as Figure 2.

DRAWING TITLE
**Summary Of NAPL Removal For The Quarters
 March 2016 - May 2016 & June 2016 - August 2016**
