**RE: Vatrano Road Site Annual Monitoring Report (NYSDEC Site No. 401036)  
CHA Project No. 7899.1001.1102**

**GROUNDWATER MONITORING REPORT**  
**For**  
**The Vatrano Road Site**  
**Albany, New York**  
**(New York State Department of Environmental Conservation**  
**Inactive Hazardous Waste Site Number – 401036)**

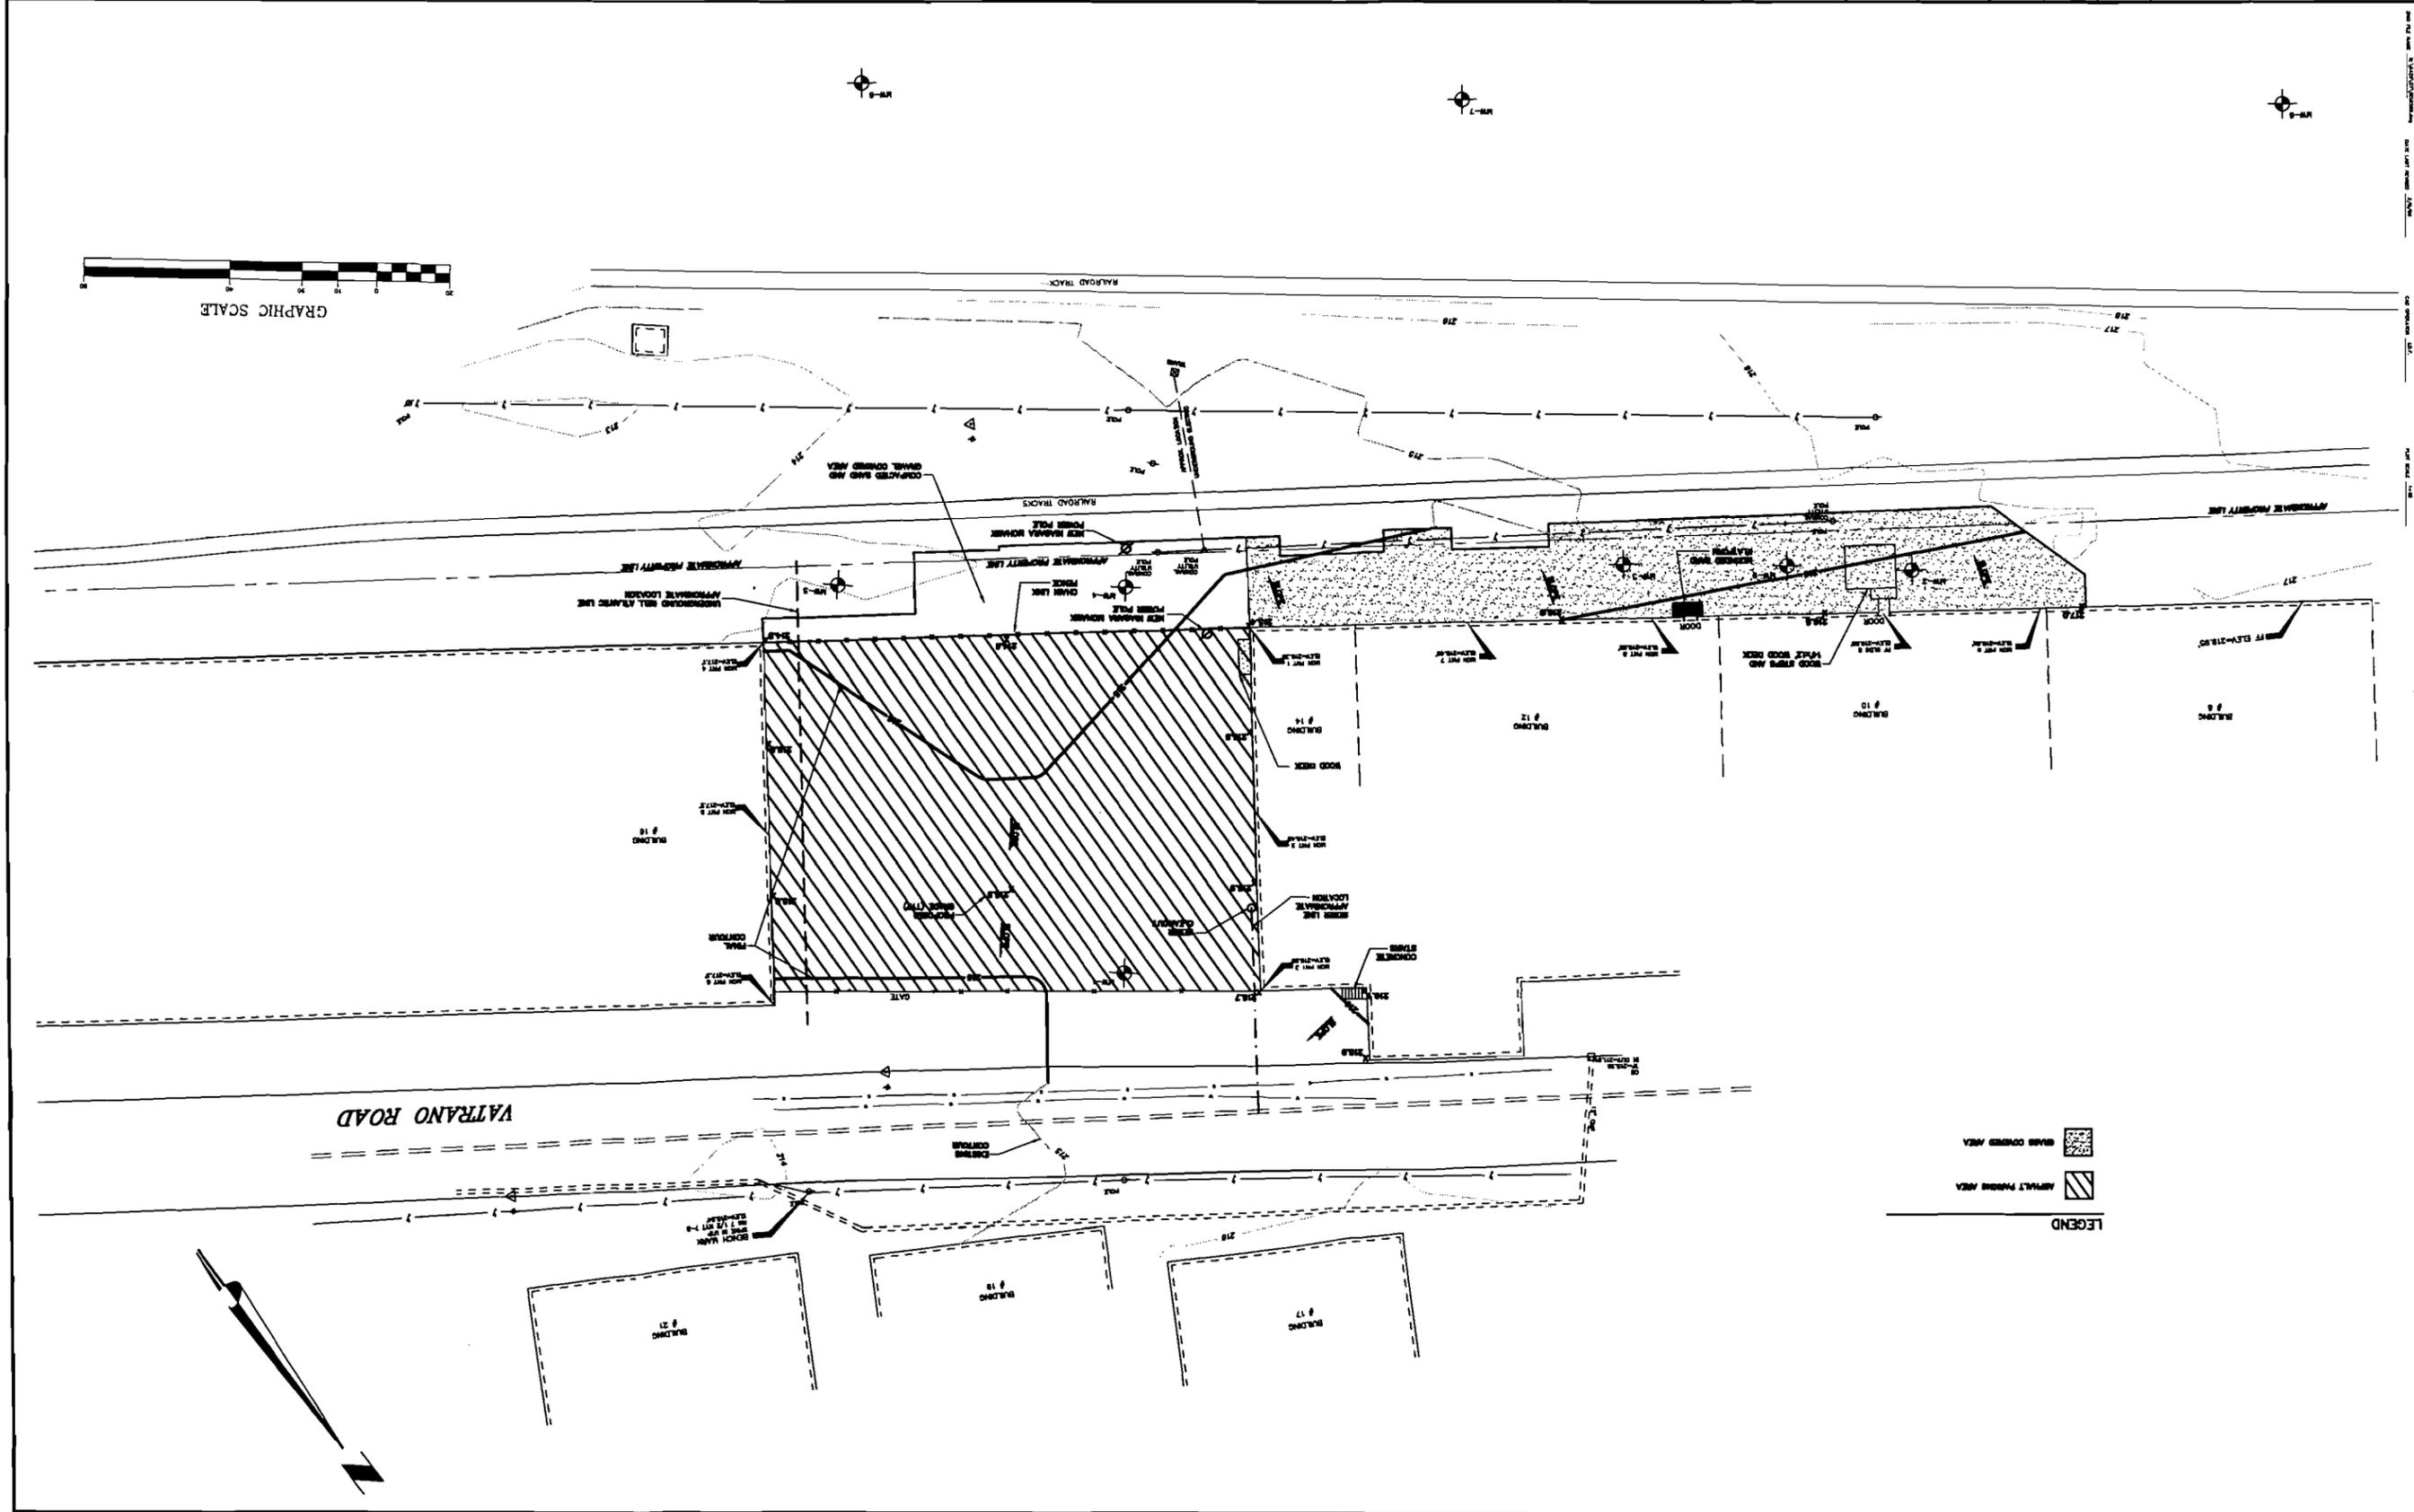
FIGURE  
 2  
 SHEET 1 OF 1  
 Drawing No.

The location of the subject site is illustrated by Figure 1. A site plan, which illustrates the portion of the property that was remediated in the fall of 1997, and the extent of the groundwater monitoring network, is provided as Figure 2.

wells (MW- 1,2,3,4,5 & 9) are located on the site. During the remediation of the site conducted in October, November, and December of 1997, the six on site groundwater monitoring wells (MW-1 through MW-5 and MW-9) were removed and replaced with six new wells. The current location of the wells are illustrated by Figure 2. The new wells were installed in similar locations and to similar depths as the original wells, however, some changes were made based on contamination discovered during the remediation. Well data and groundwater elevations from the last seven monitoring events (April 1998, October 1998, April 1999, October 1999, April 2000, March 2001 and March 2002) are presented in Table 1.

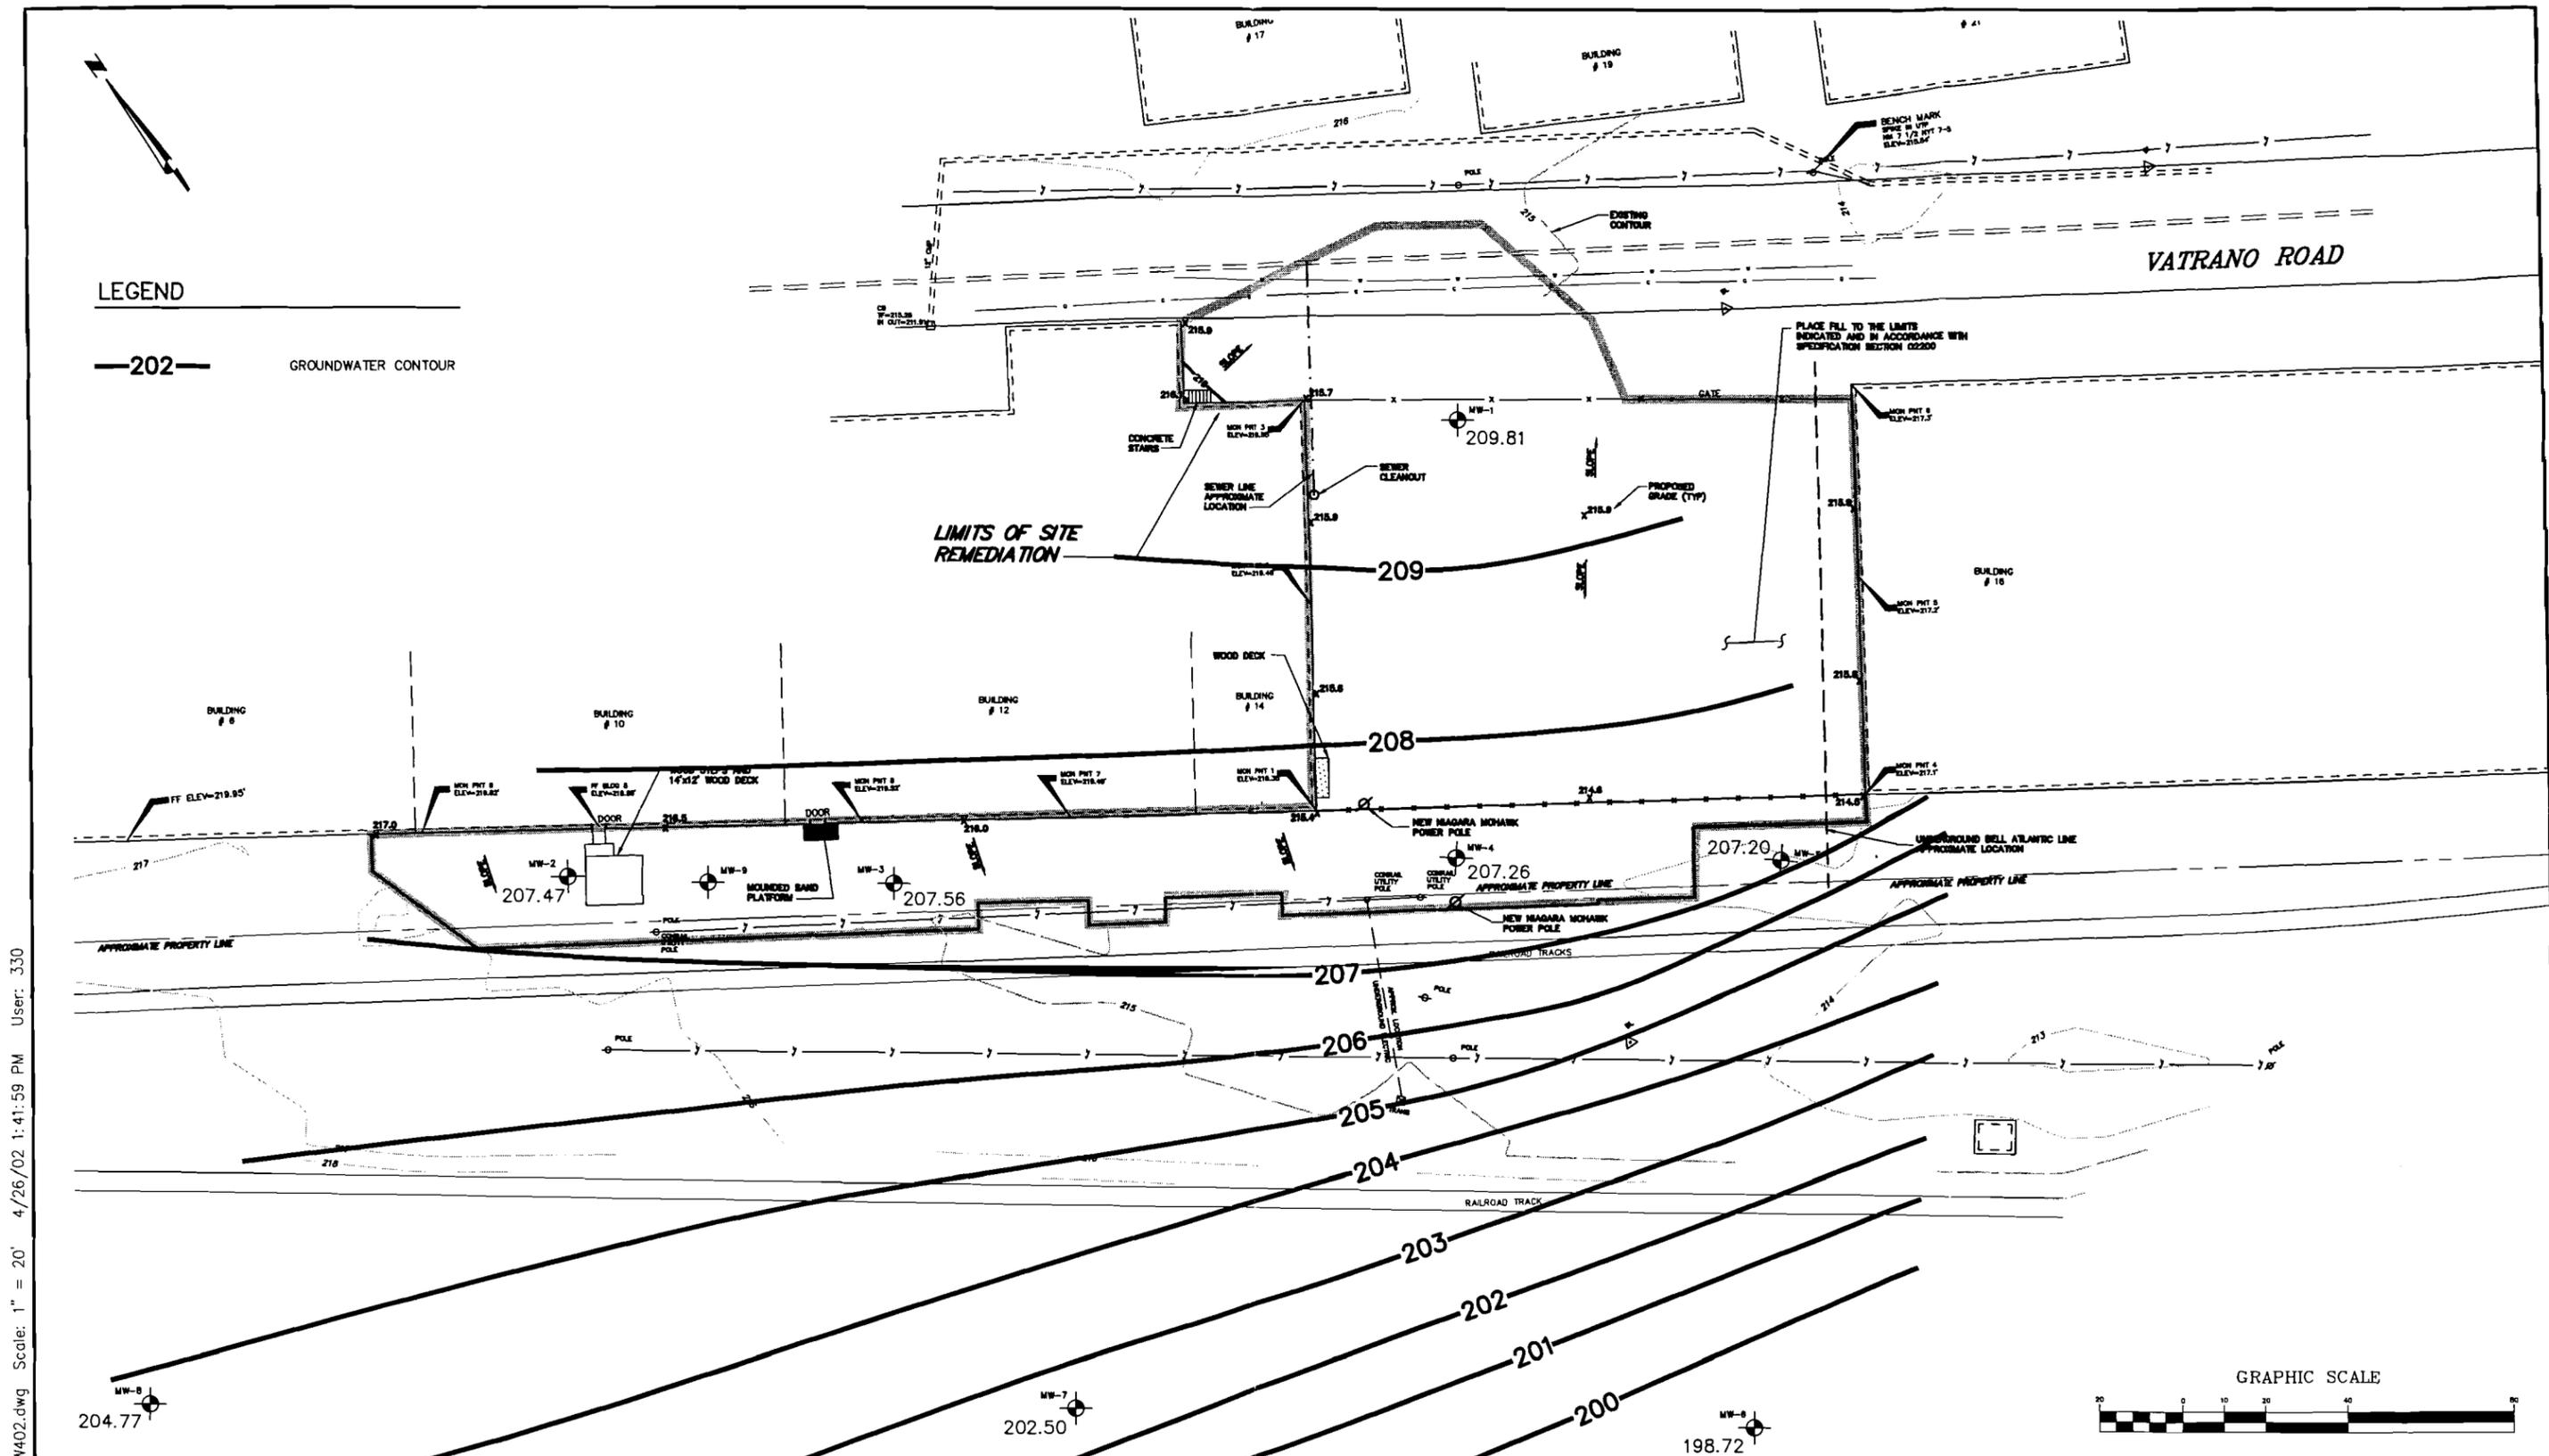
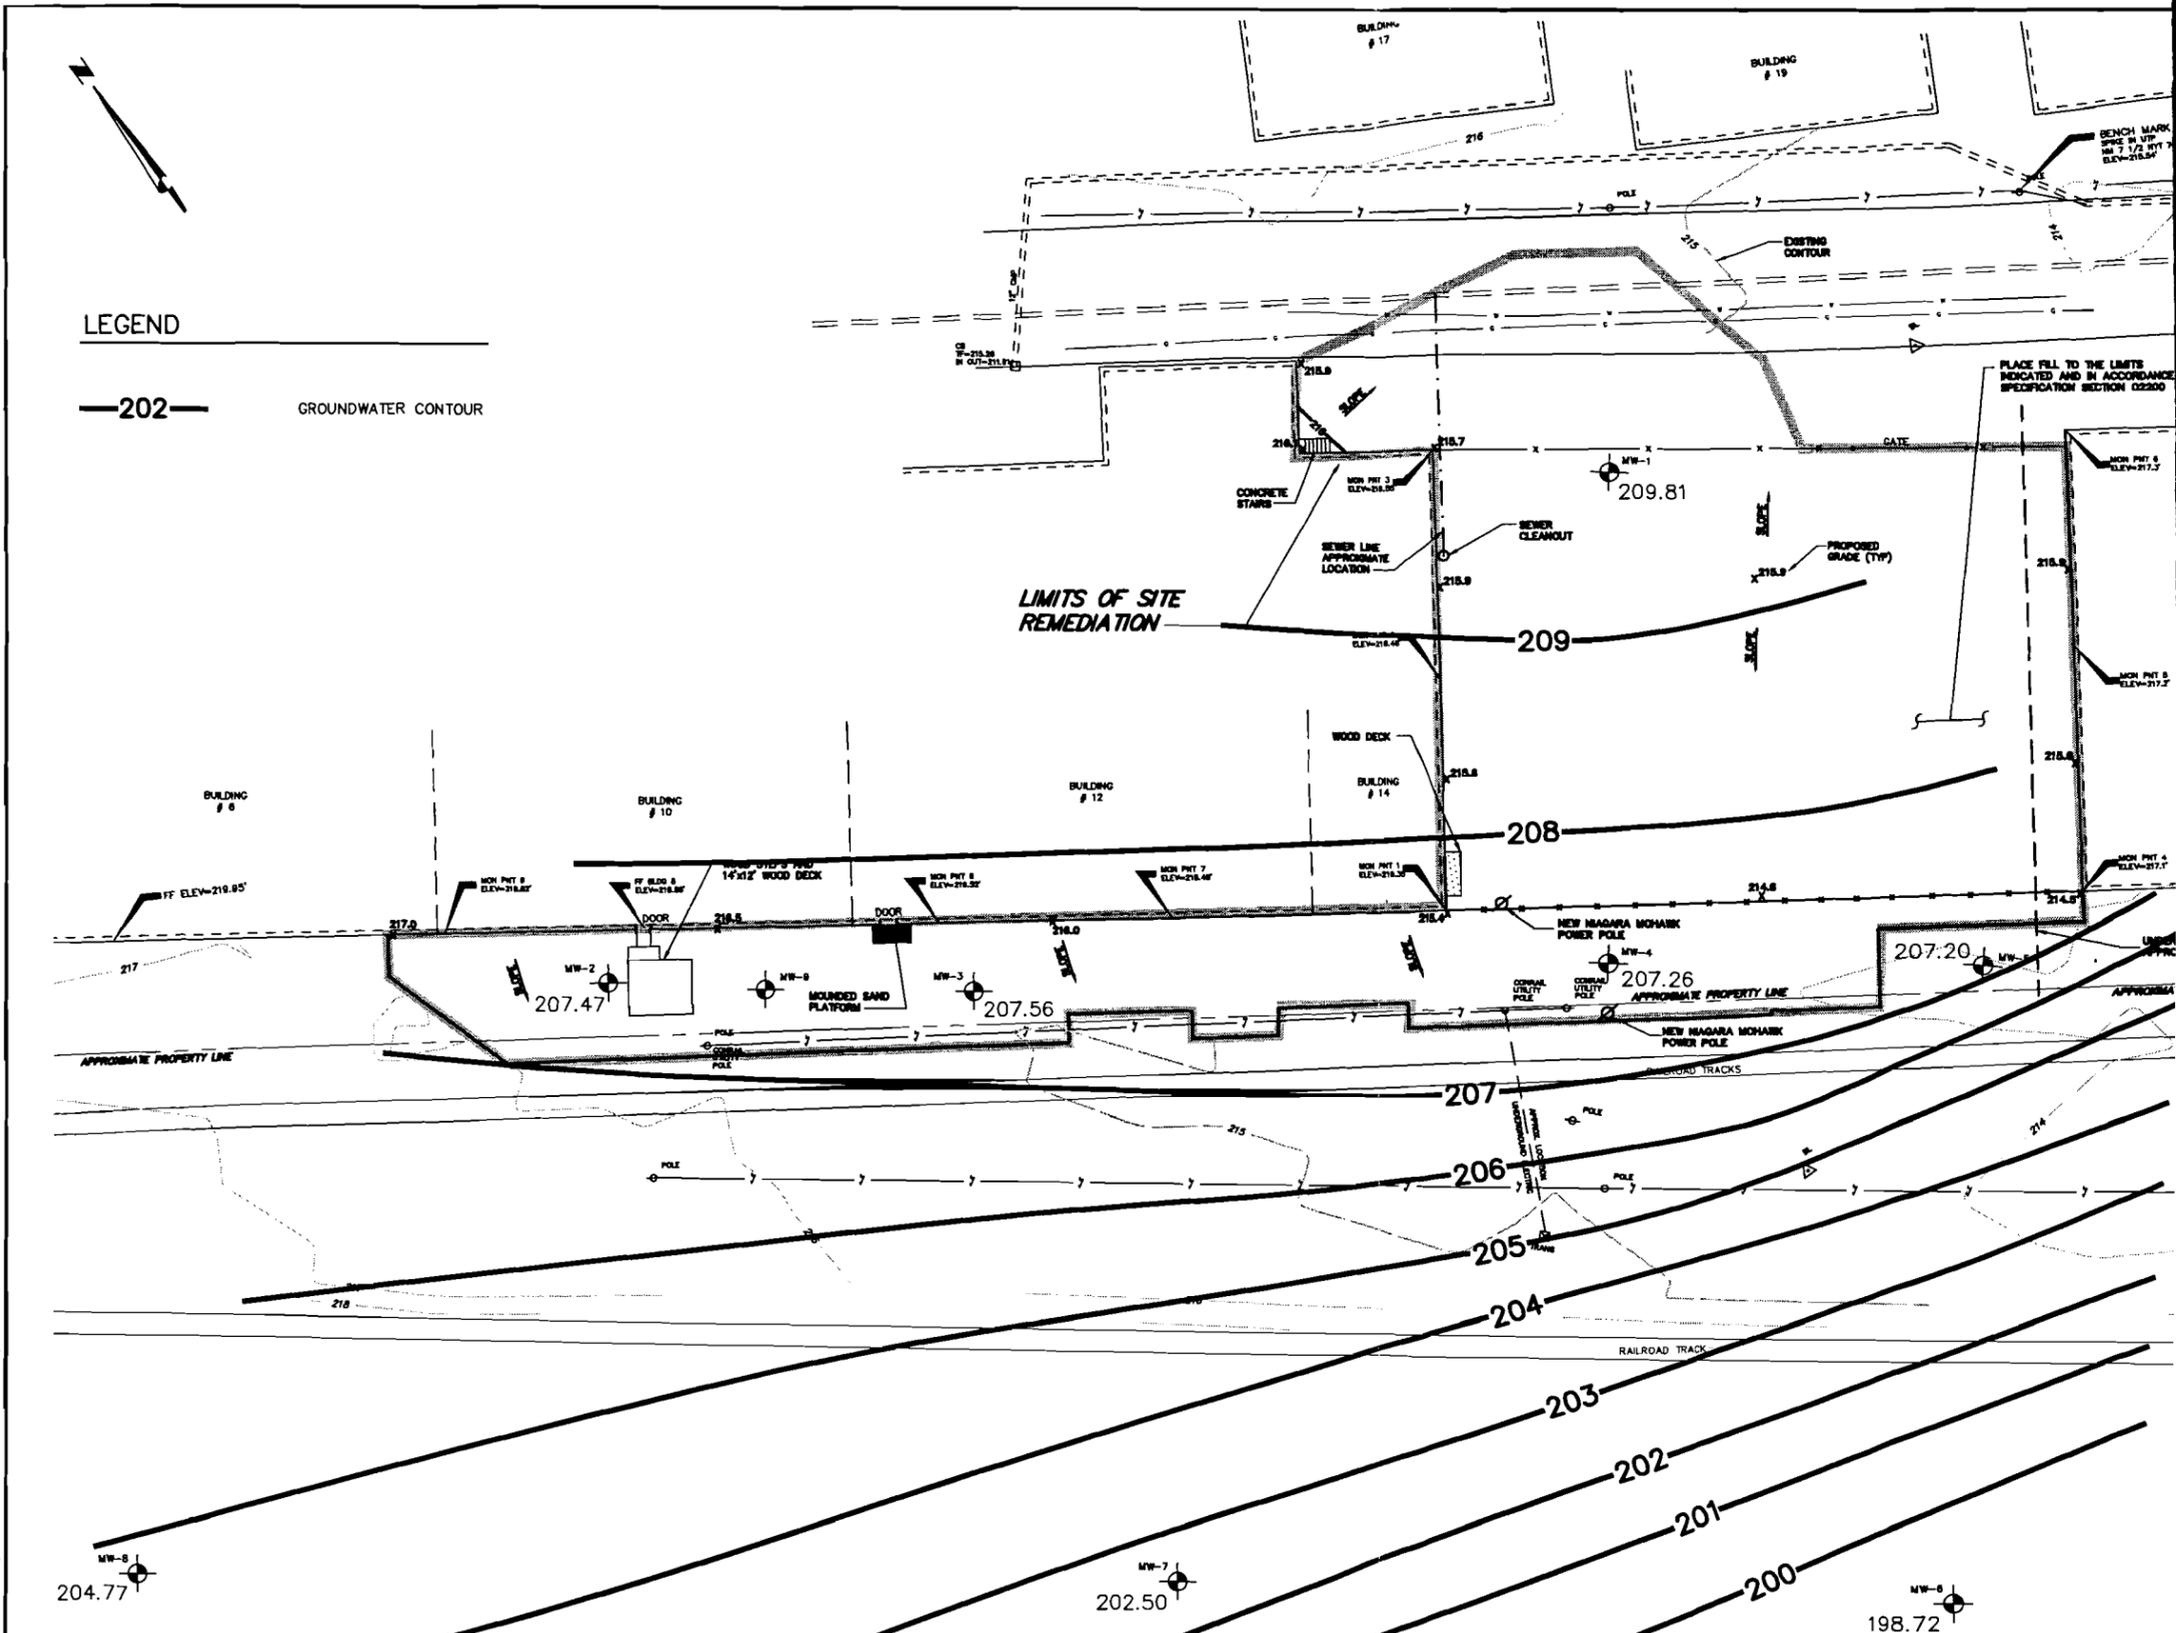
FIGURE 3  
**MONITORING REPORT**  
 MARCH, 2002 WATER TABLE GROUNDWATER CONTOUR MAP  
 REMEDIATION OF THE VATRANO ROAD SITE  
 NYSDEC ID #401036, ALBANY, NEW YORK

Based on the latest water level measurements, groundwater flow is determined to be to the south towards Patroon Creek. The hydraulic gradient across the site for the March 2002 event is calculated at approximately 0.02 feet per foot. The gradient steepens to 0.06 feet per foot at the southern end of the site reflecting the influence of Patroon Creek and the local topography. This data indicates that the shallow overburden aquifer likely discharges to Patroon Creek. Figure 3 shows the groundwater contours based on the water levels measured on March 21, 2002 in the wells installed within the shallow aquifer. MW-9 is installed deeper in the aquifer; therefore, the water levels from monitoring well MW-9 were not used in estimating the groundwater contour lines. When compared to adjacent monitoring wells that are installed in the shallow aquifer, historic water level data from MW-9 has indicated a vertically downward component of flow. Although soil boring data at the time monitoring well MW-9 was installed did not necessarily indicate the presence of a confining layer, the difference in water level could be evidence that the water bearing zone or aquifer monitored by MW-9, is confined.

Prior to sampling, the water level in each well was measured to the nearest one hundredth of a foot using an electronic water level meter. The water level meter was thoroughly decontaminated between monitoring wells using accepted protocols. This data was used to develop the groundwater piezometric map presented as Figure 3.
