# **Record of Decision (ROD) Implementation Report of Findings**

## **Former C&F Plating Facility**

406 North Pear Street  
Albany  
Albany County, New York  
**NYSDEC Site No.: 401057**

Report Completed:  
October 4, 2016

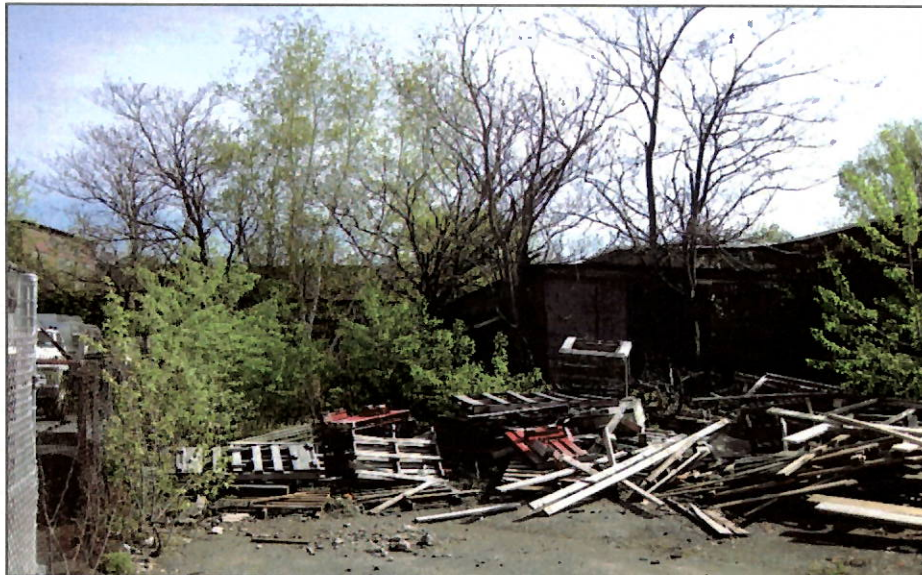
The existing buildings at the site were dilapidated and deemed structurally unsafe for entry and/or interior work. Upon PES's initial mobilization to the site, it was documented that much of ground surface within and outside of the building was covered with solid waste, trash and debris that appeared to have been dumped at the site or left by previous owners.

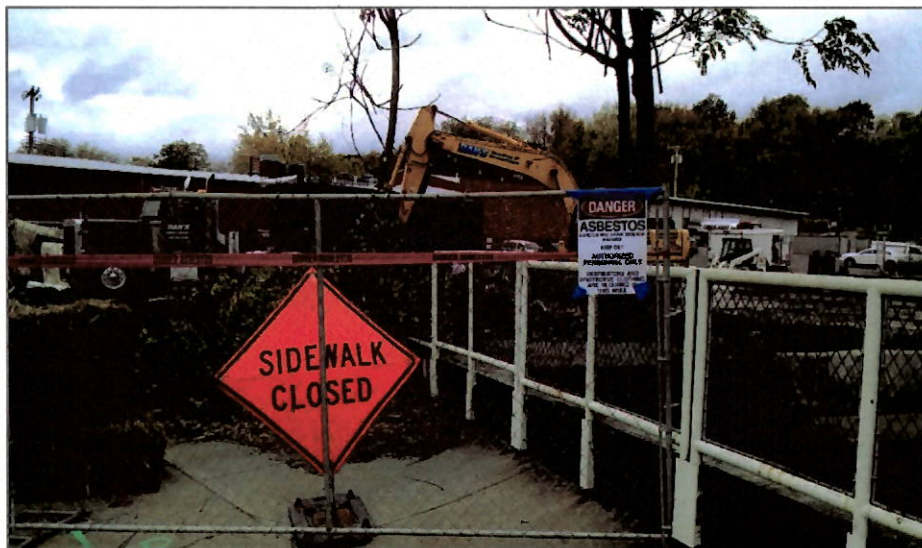
Dan's Demolition and Hauling Inc., of Troy, NY (Dan's) performed the subsequent ACM abatement and demolition work from 10/6/2014 to 10/17/2014. Dan's utilized wet methods to control dust and prevent air borne release of ACM. The building was systematically razed and all debris and building materials were either disposed of as ACM or were cleaned and recycled (non-porous steel). A total of 448.88 tons of ACM was disposed at City of Albany landfill (AL).

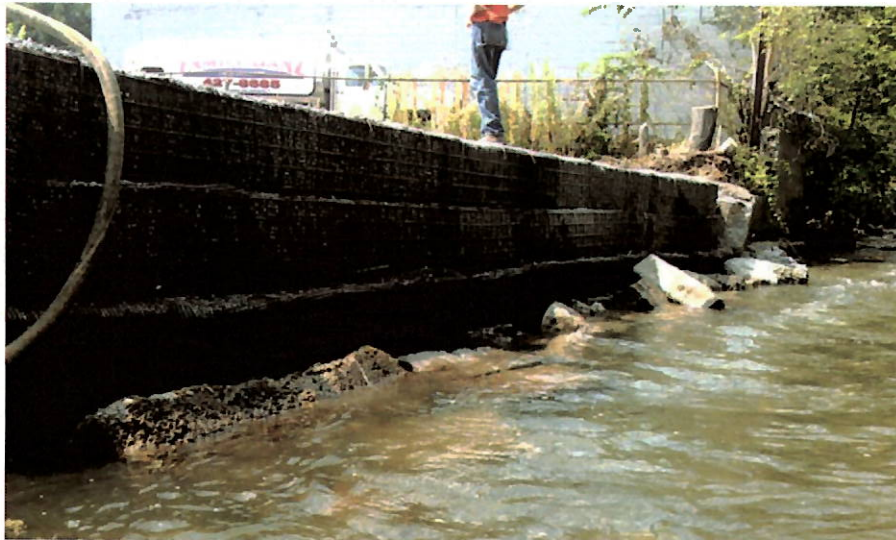
During the installation phase, large capacity sand bags were strategically placed in Patroon Creek to prevent sediment erosion and loading within the stream. The hydro barriers were left in place until a construction elevation was reached that exceeded the surface elevation of the stream.

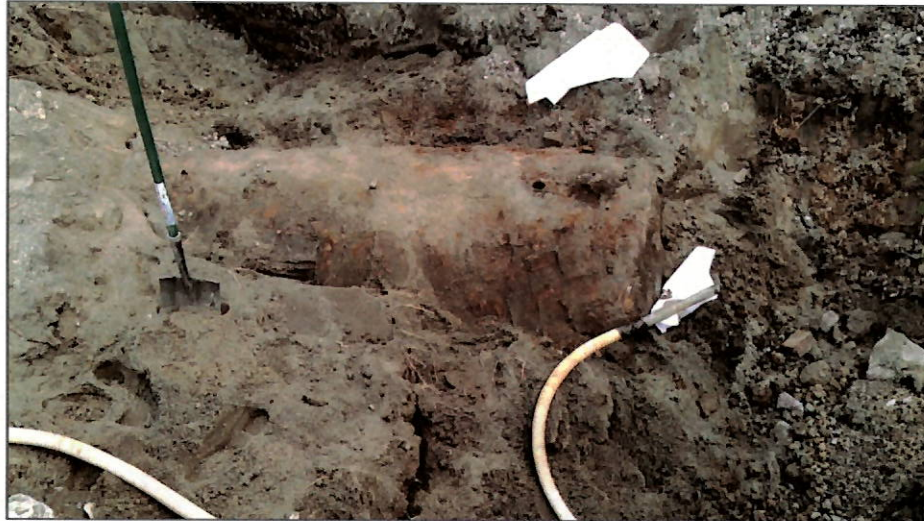
During installation of the retaining wall a 1,000-gallon underground storage tank (UST) was encountered. The UST was located within the footprint of Zone 2. Upon discovery of the vessel, the cover material was removed to expose piping access points for the purpose of assessing the volume and type of fluid content.

The assessment revealed a mixture of water and No. 2 fuel oil. A total of 850 gallons of mixed groundwater/fuel were removed (see Attachment I). The contents of the UST were removed by MacSon of Selkirk, NY under manifest. MacSon performed proper disposal of the processed fluids at Industrial Tank Services, Inc. in Oriskany, NY.

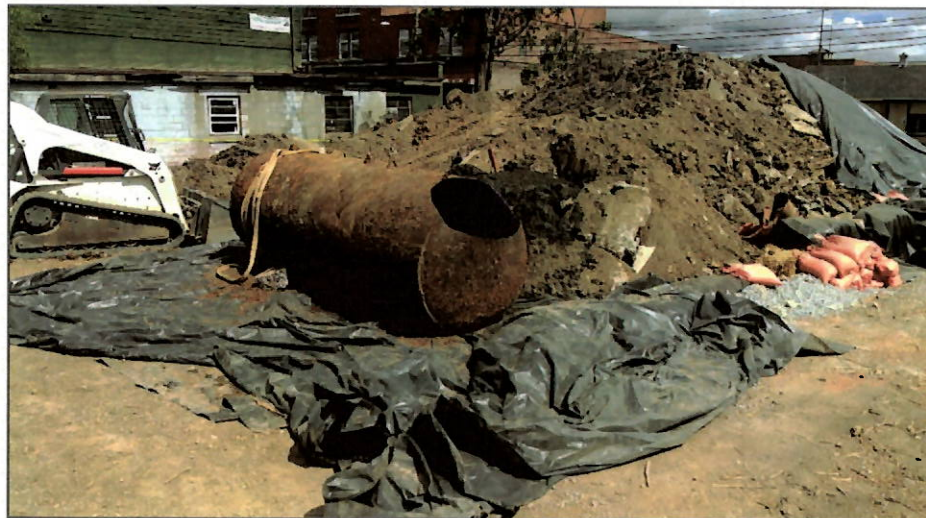
PES construction crew extracted the UST from its grave and placed it above grade on poly sheeting for cleaning.
