**Final Engineering Report  
and O&M Plan -  
Indoor Air and Soil Vapor  
Mitigation IRM**

**Ward Products Site  
Amsterdam, New York  
Site Code 4-29-004**

**RETEC Project Number: NWR01-15852-700**

**March 1, 2006**

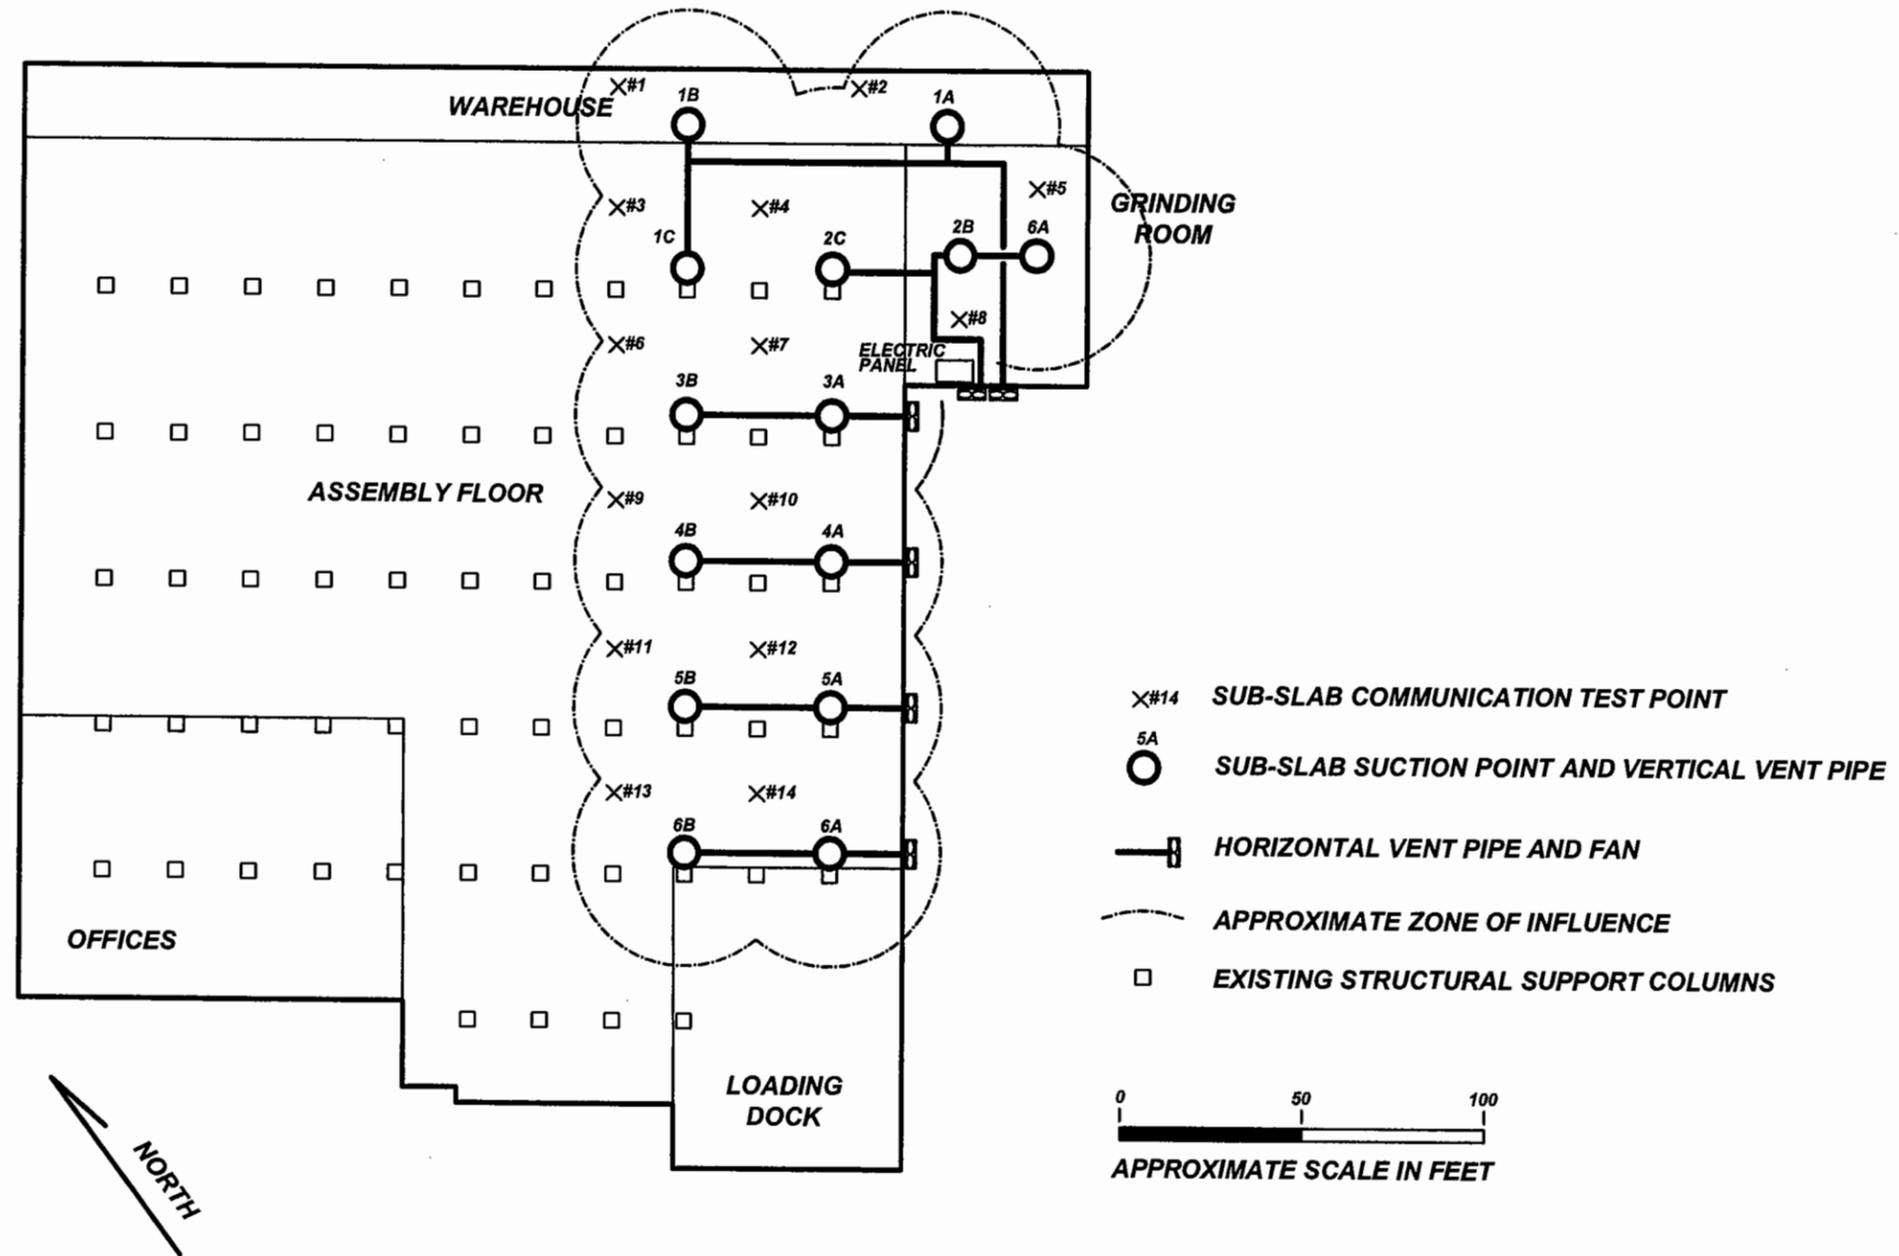
Ward Products Site Amsterdam, NY NWR0-15852-700			AS-BUILT INDOOR AIR AND SOIL VAPOR MITIGATION SYSTEM	
DATE: 02/28/06	DRWN: MRH	FILE:	LAYOUT:	FIGURE 3

The soil vapor system, as-built, consists of fourteen slab penetrations with riser pipes manifolded to six soil vapor vent fans (see Figure 3, and the photos in Appendix E).

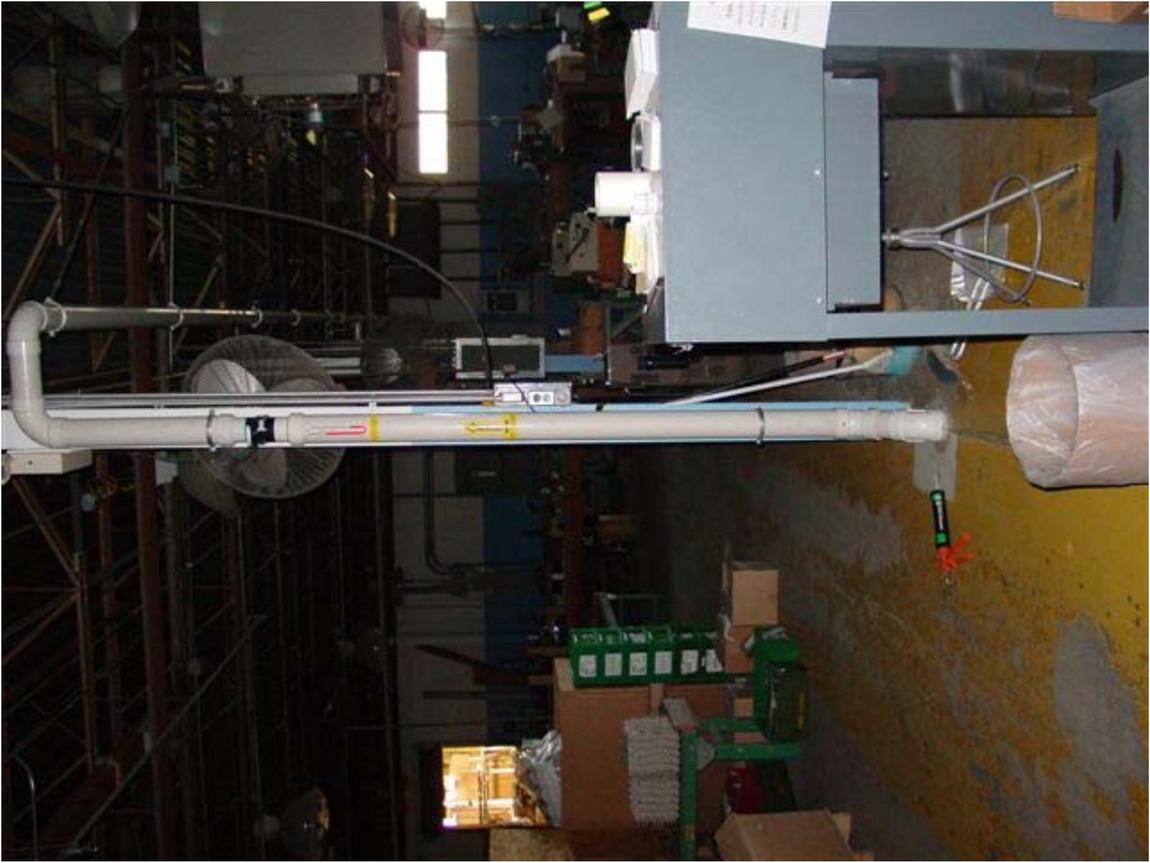
Photo 1: Typical Vent Riser with Labels, Flow Valve, Manometer

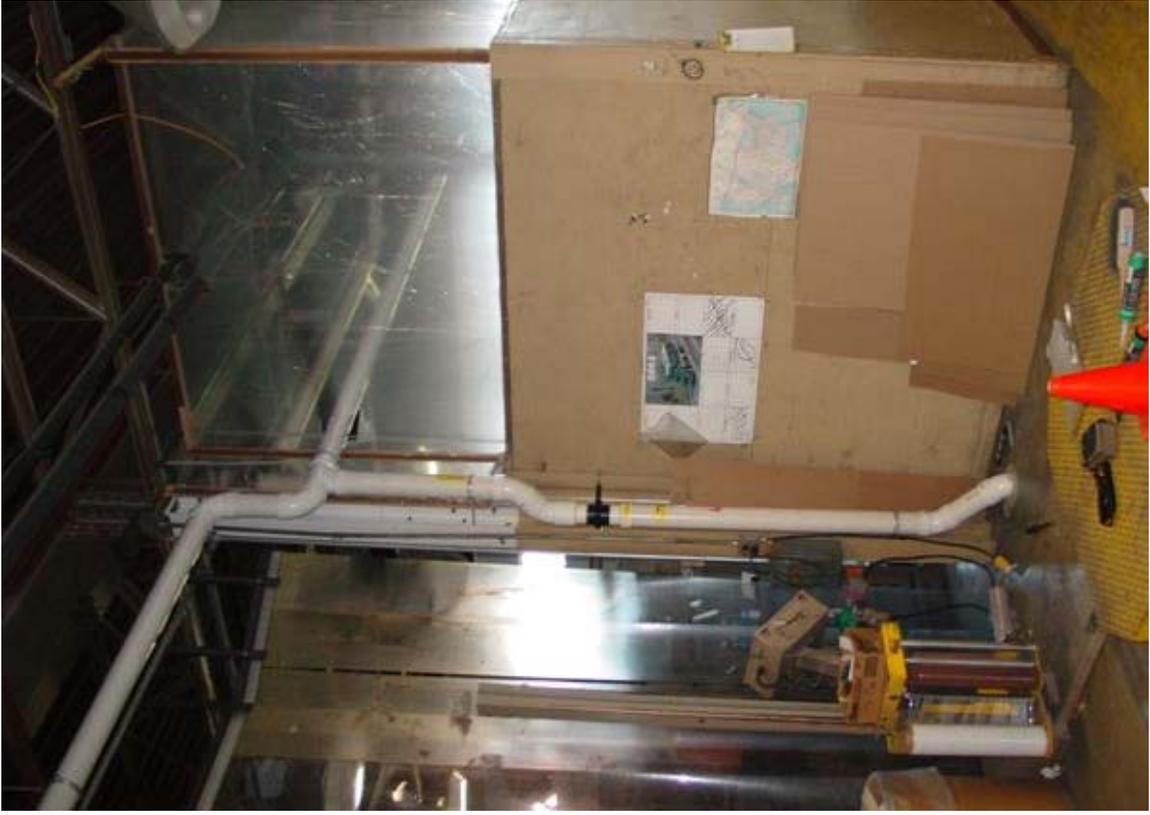
Photo 2: Another Typical Vent Riser

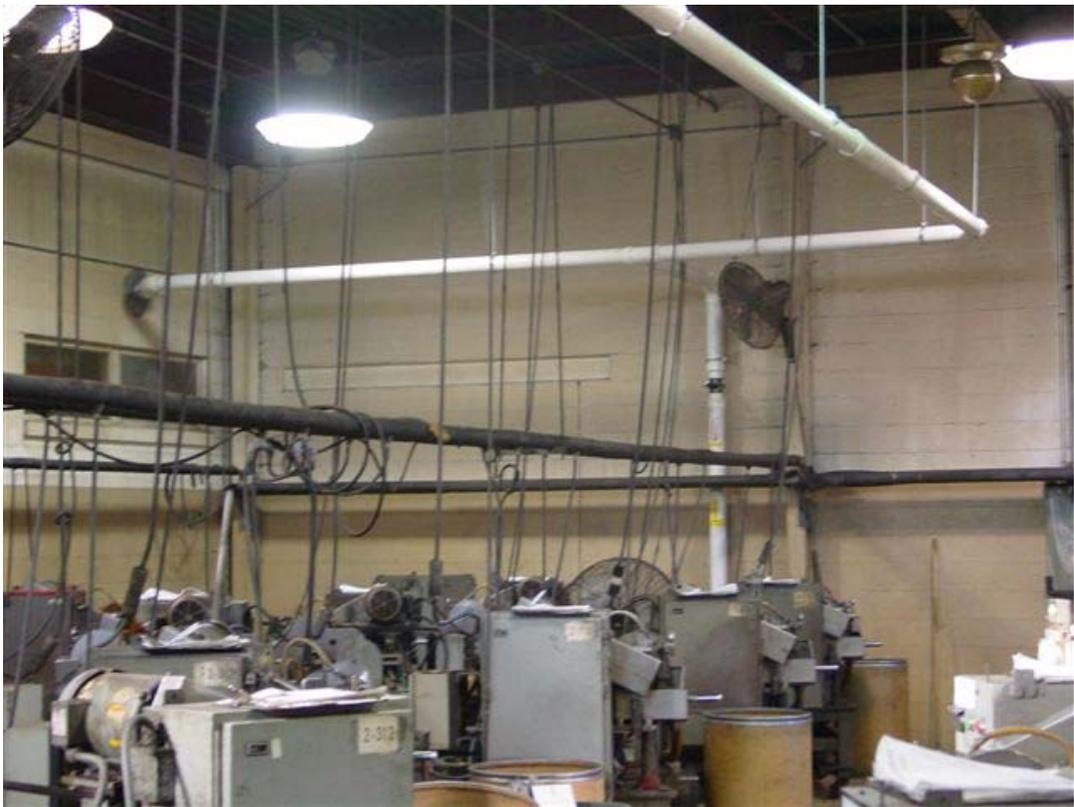
Photo 3: Overhead Piping in Grinding Room (from warehouse)

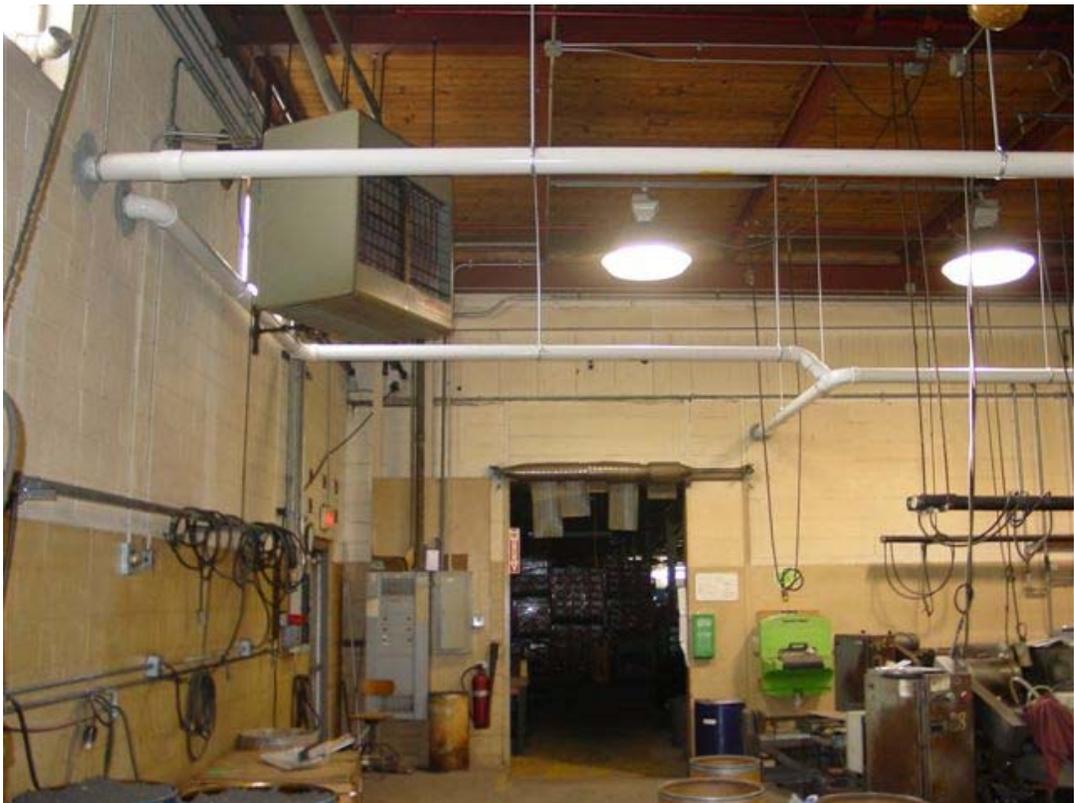
Photo 4: Overhead Piping in Grinding Room (to exterior wall and fans)

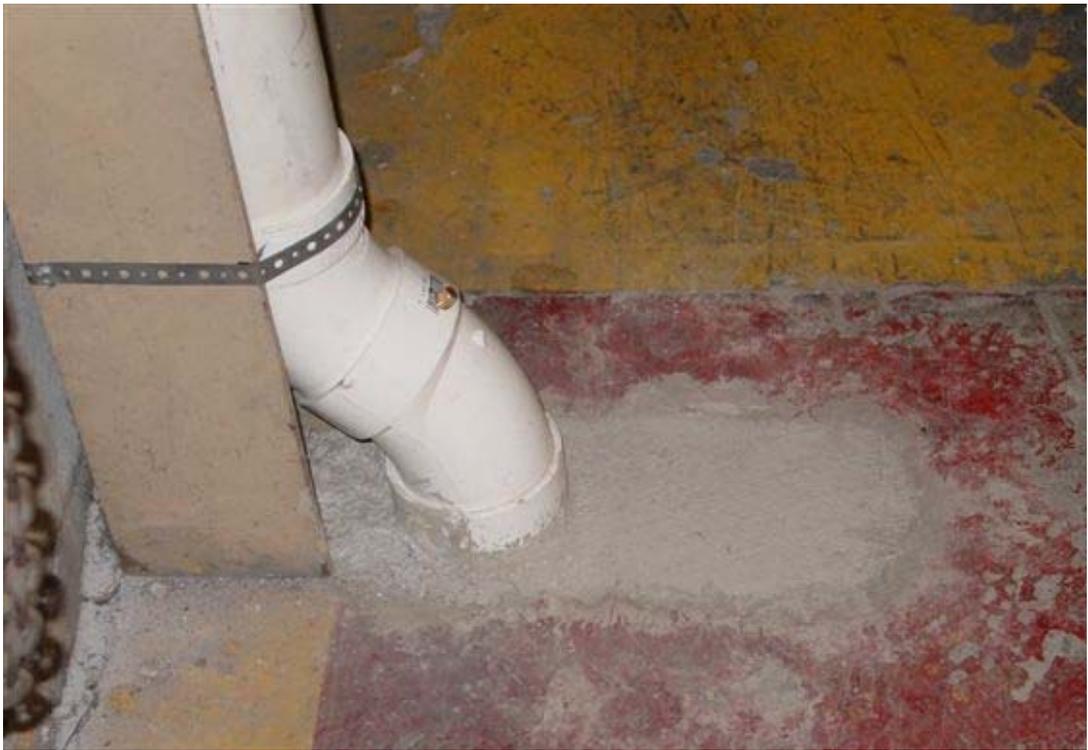
Photo 5: Typical Floor Penetration (note brass sample port plug)

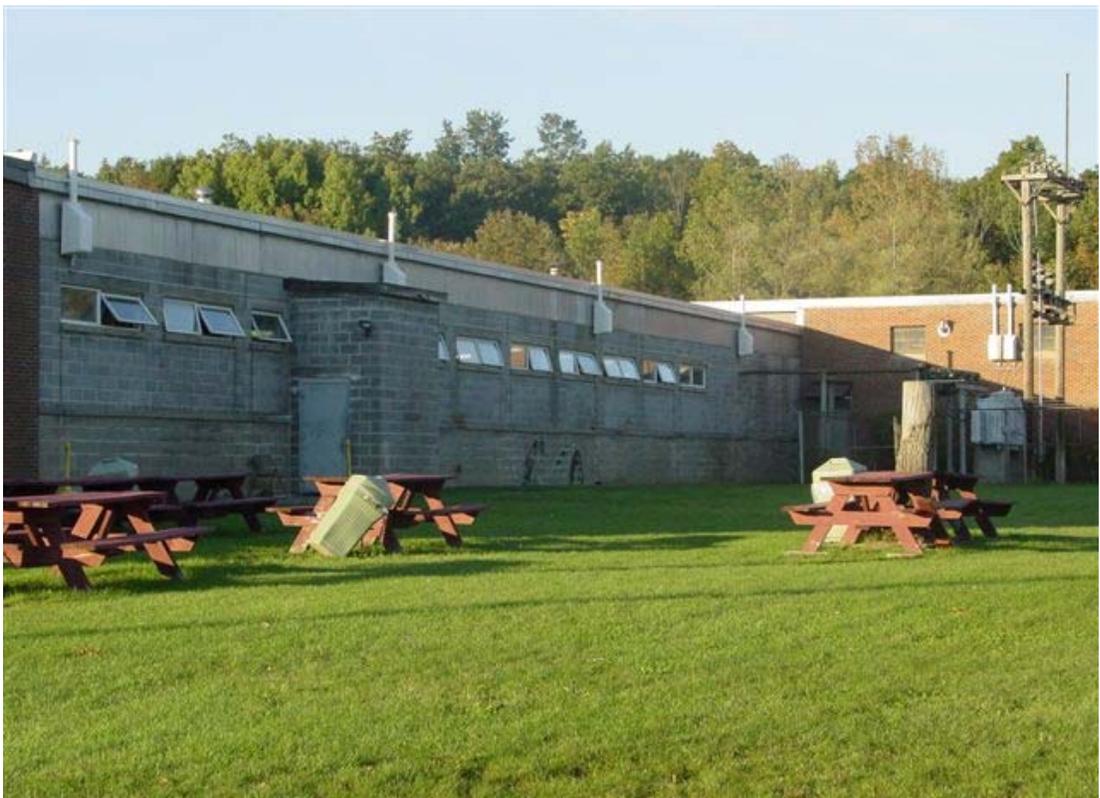
A total of six soil vapor vent fans were installed (see Figure 3 and the photos in Appendix E). The vent fans were RadonAway model GP501 and were sized to provide the pressure difference and airflow characteristics necessary to achieve sub-slab depressurization.

The vent fans were mounted on the exterior of the building in a watertight protective housing and were secured to the vent pipes with flexible couplings.

Photo 6: Vent Fans and Exhaust Stacks (total of six units)
