RYAN-BIGGS

December 17, 2010

Re: BASF Rensselaer  
Masonry Smokestack Evaluation  
Ryan-Biggs Project 9960

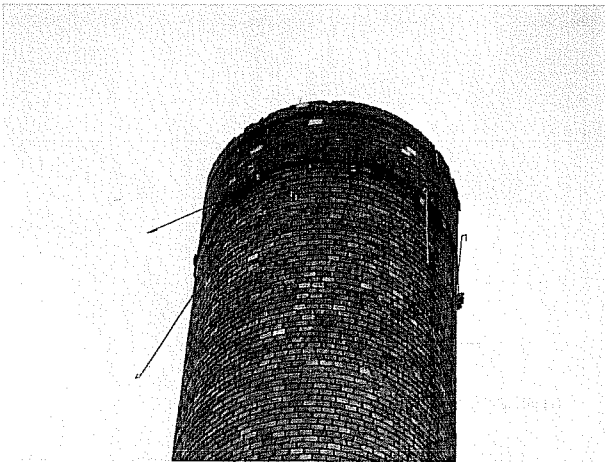
Photograph 1

At the upper portions of the chimney, there were areas of loose brick and mortar visible; however, the condition of these areas was not as bad as the top of the smokestack that has already been removed. The base and upper portions of the smokestack can be seen in Photographs 1, 2, and 3.

I believe the chimney can remain in its current condition without concern of collapse until next summer when the demolition operations resume. However, since there is the possibility of falling debris locally around the smokestack, an area extending about 20 feet around the base of the smokestack should be barricaded to keep people out of this area.
