NYS DEC Region 4
Inactive Landfill Post-Closure Inspection Report

Facility Name & Location:	Berlin/Petersburgh Landfill County Route 37 (Jones Hollow Road, Petersburgh/Cold Spring Road, Berlin), Rensselaer County
Date of Site Visit:	April 15, 2016
DEC Staff Present:	Brian Maglienti – R4 DMM, John Weidman – R4 DMM
Others Present:	None
Background Information:	<p>The Berlin/Petersburgh Landfill is located in the Town of Petersburgh just north of the town line between the Towns of Berlin and Petersburgh. After maintaining adjacent disposal facilities for many years, the Towns began joint operation of the site in early 1982. In the early 90s, DEC notified the Towns that the landfill had been operated without a valid Part 360 permit since October 31, 1984 and required that Towns to stop accepting waste at the landfill by July 1, 1991. In 1990, Energy Answers Corporation (EAC) assumed operational responsibilities for the site and agreed to close the landfill in accordance with Part 360. EAC disposed of municipal solid waste in the landfill for approximately two years to establish proper closure grades and to generate revenue to pay for the closure. According to site documents, the landfi

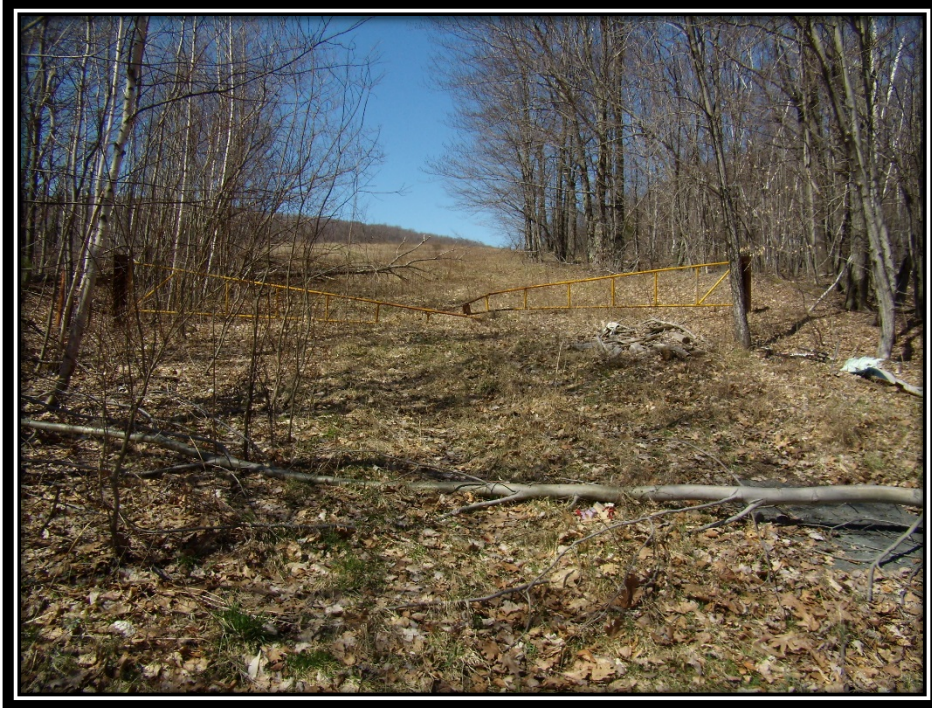
Photo 1: Entrance gate to the landfill. The gate is in poor condition but still effective in preventing vehicular access, however, the site is also accessible from at least one other location.

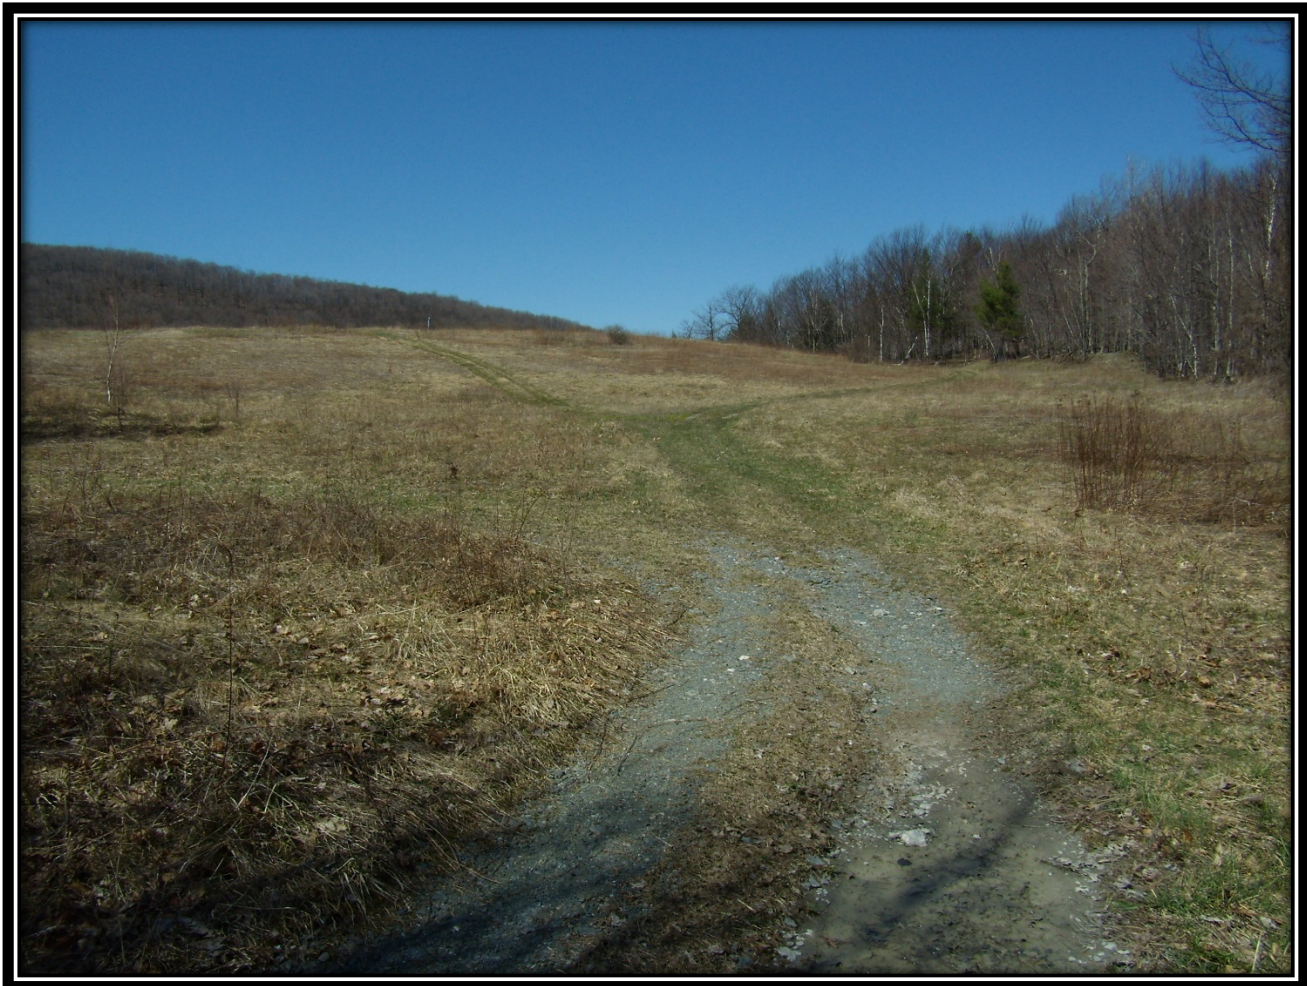
Photo 2: View of the site facing west, just past the gate. The grade of the site is shallow but then drops off toward the ravine at the western side of the landfill.

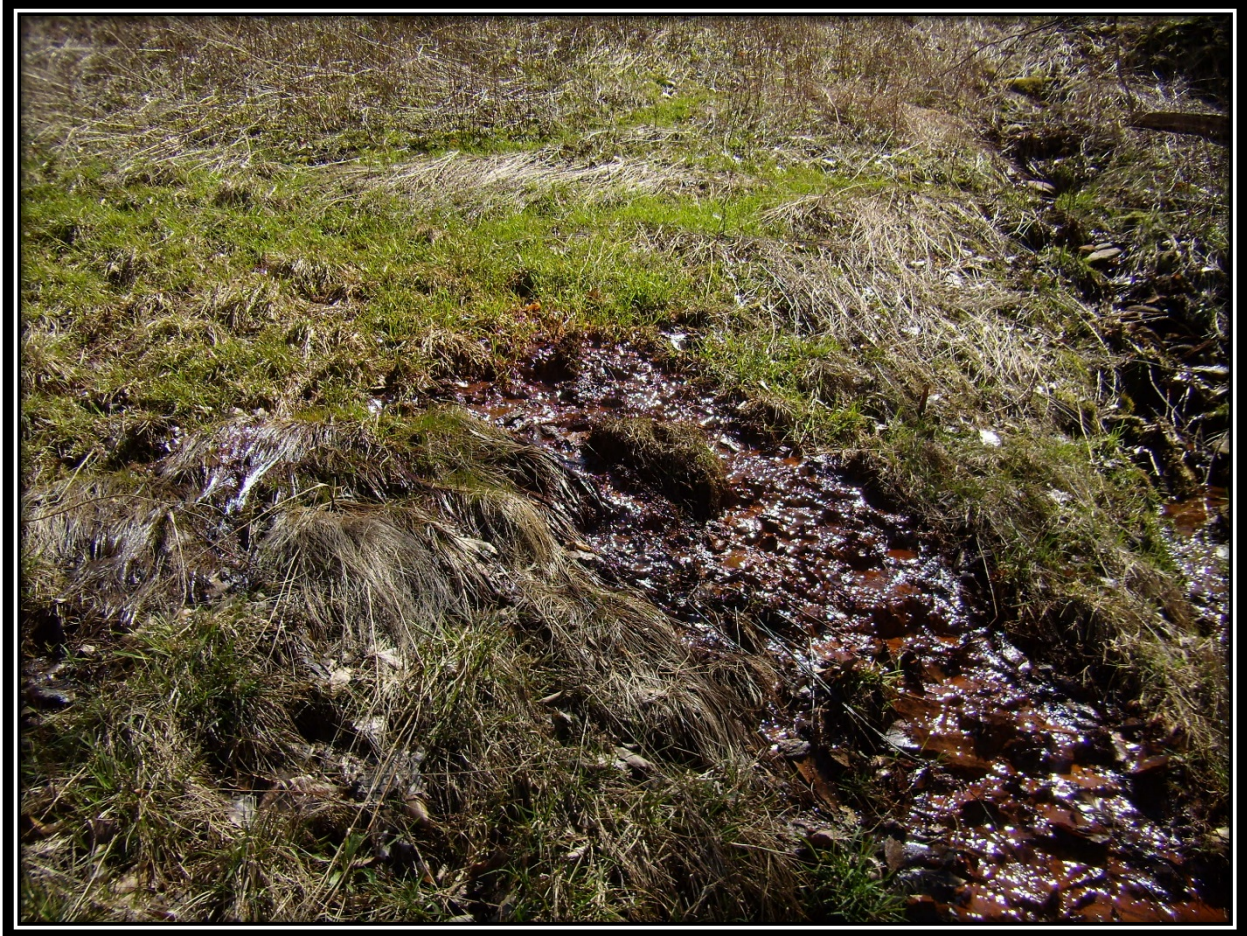
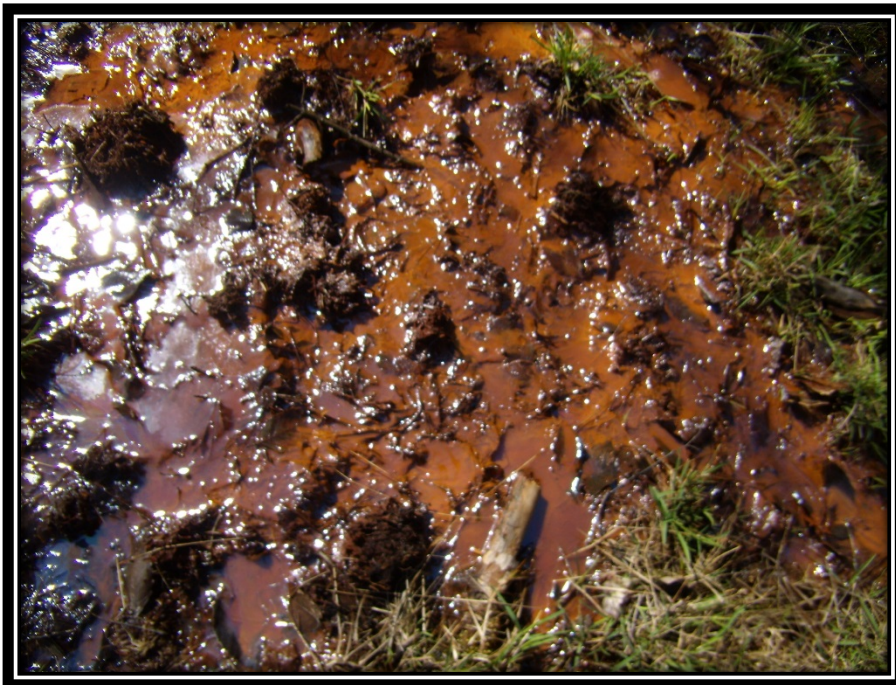
Photos 4 and 5:
Leachate impacted surface water area (LISWA) #1 located on the western toe of the landfill indicative of landfill impacted groundwater in the form of orange iron floc deposits and iron bacteria film.

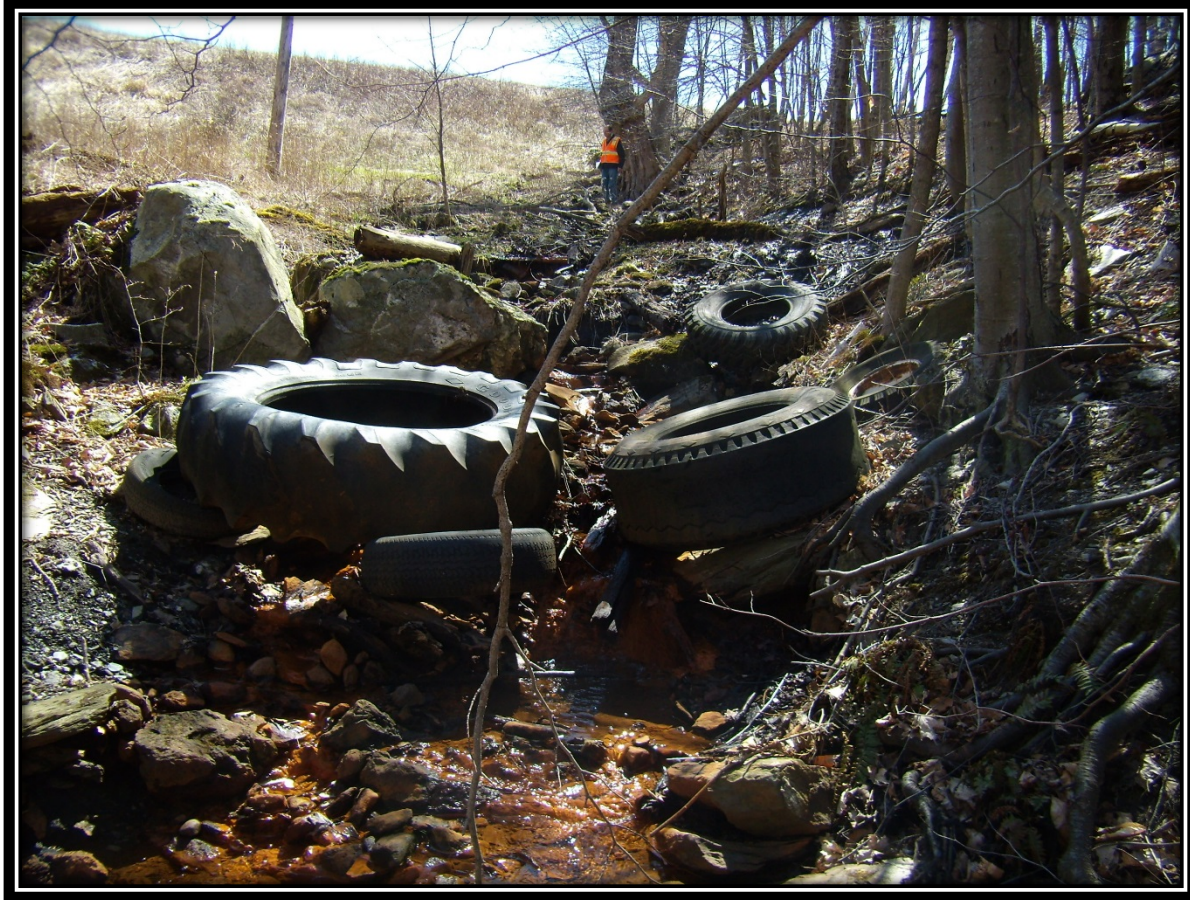
Photo 6: View looking east toward the western slope of the landfill where the LISWA #1 flows into a tributary to Jones Hollow Brook.

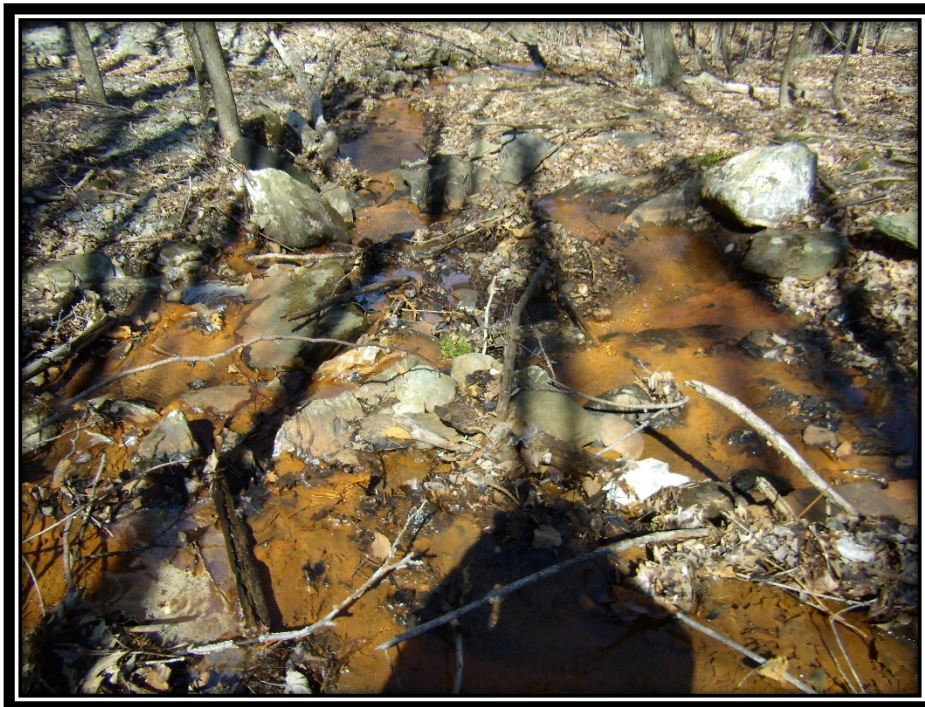
Photo 7: 180 degree view of the above location. The tributary flows toward Jones Hollow Brook.

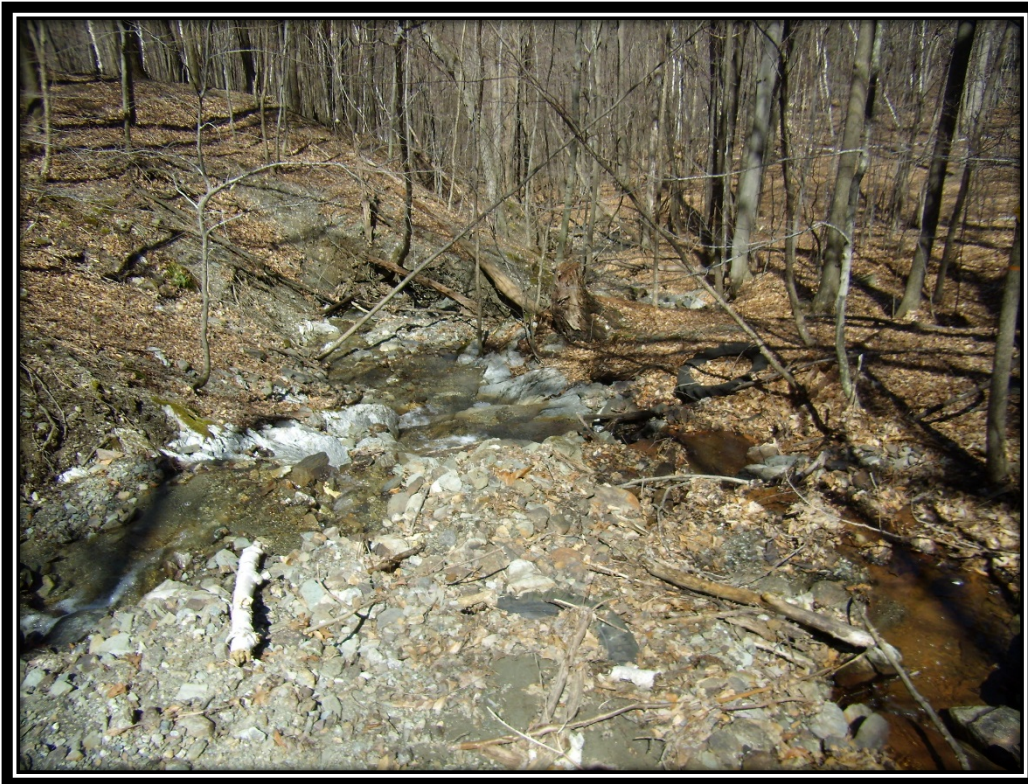
Photo 8: Convergence of the above contaminated tributary (right side of photo) and the Jones Hollow Brook. (left side of photo).

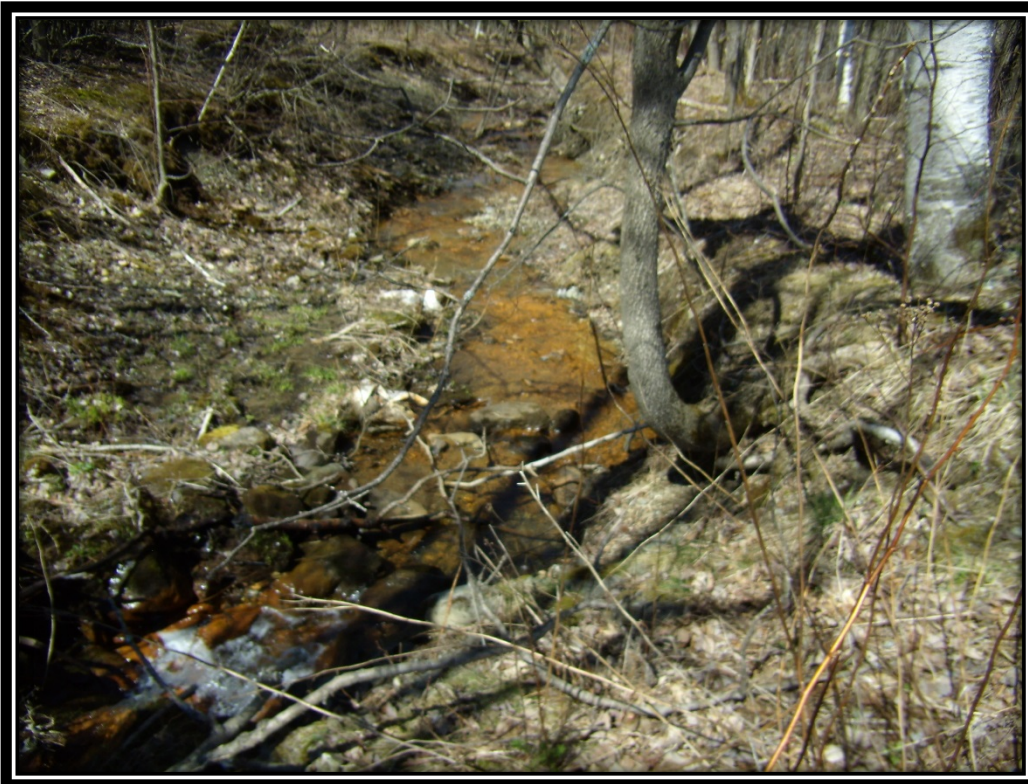
Photo 9: This is a separate leachate impacted tributary flowing along the southwestern side of the landfill, labeled as LISWA #2 on the site map. Signs of iron staining are present, although floc deposition was minimal. This is likely due to the higher velocity of this tributary.

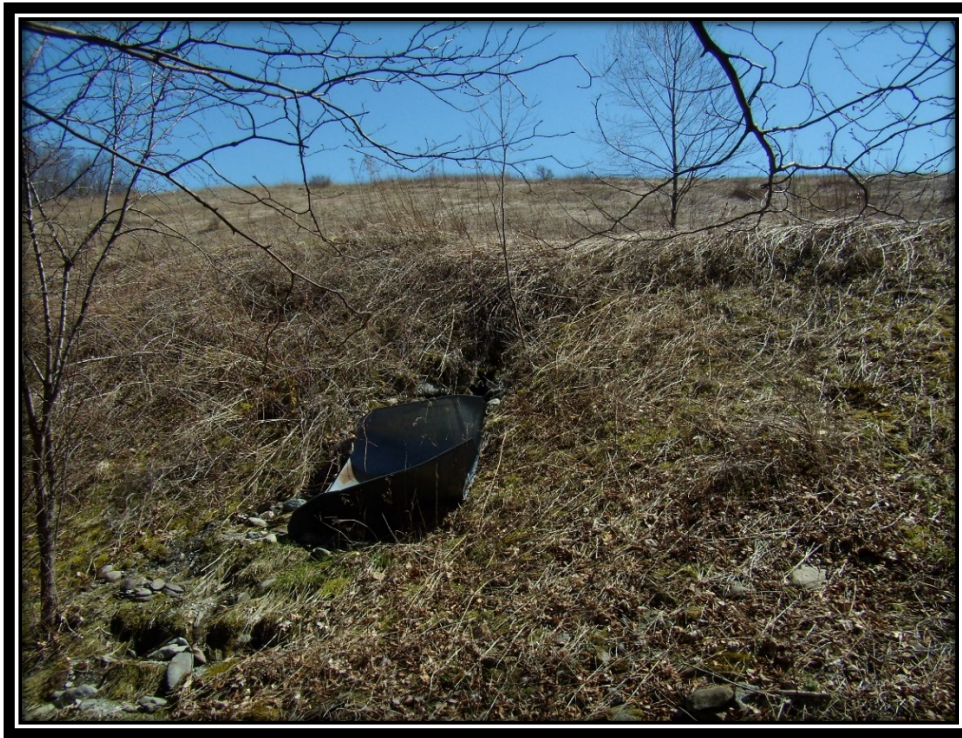
Photo 10: Several maintenance issues were identified at the site such as this culvert exit point that had a dislodged diffuser. Another culvert approximately 100 feet north of this location had the same condition.

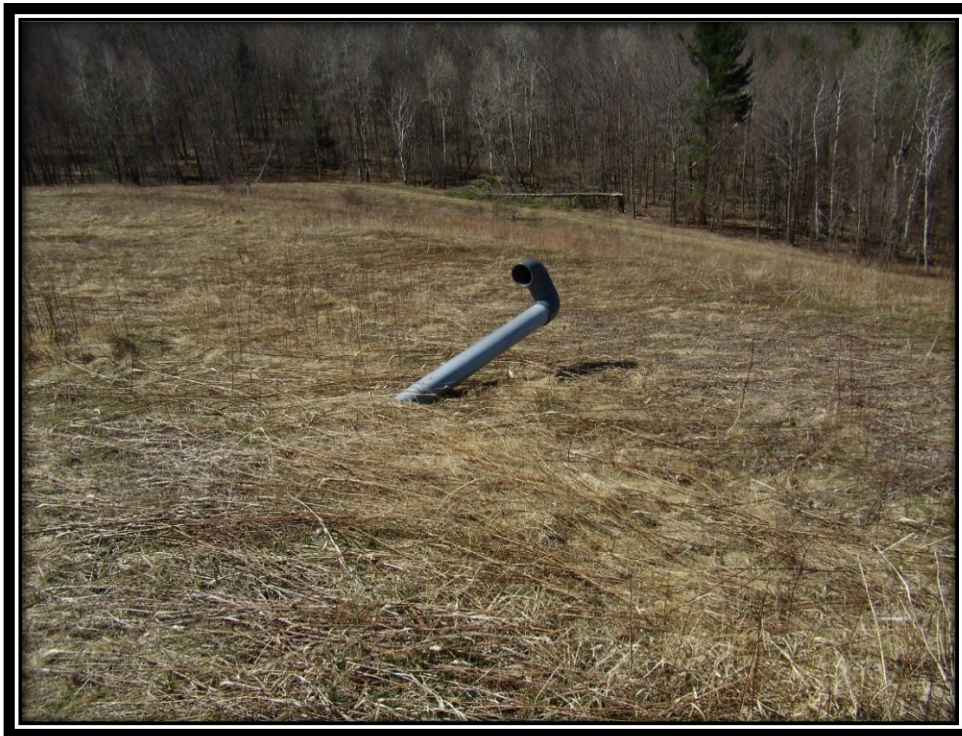
Photo 11: Broken gas well requiring repair. This is the only well, of approximately eight passive gas wells, that appeared to have any damage.

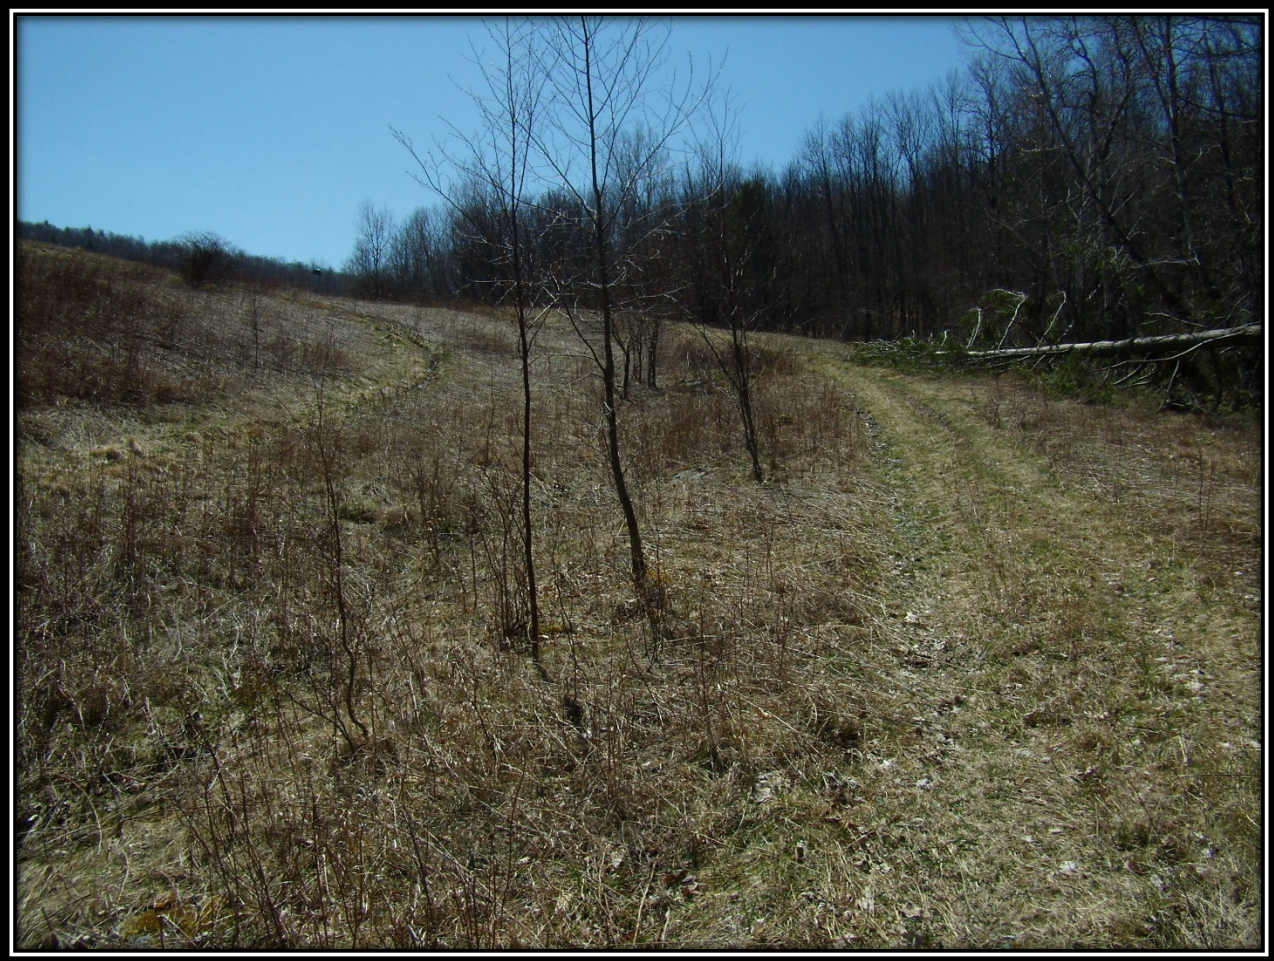
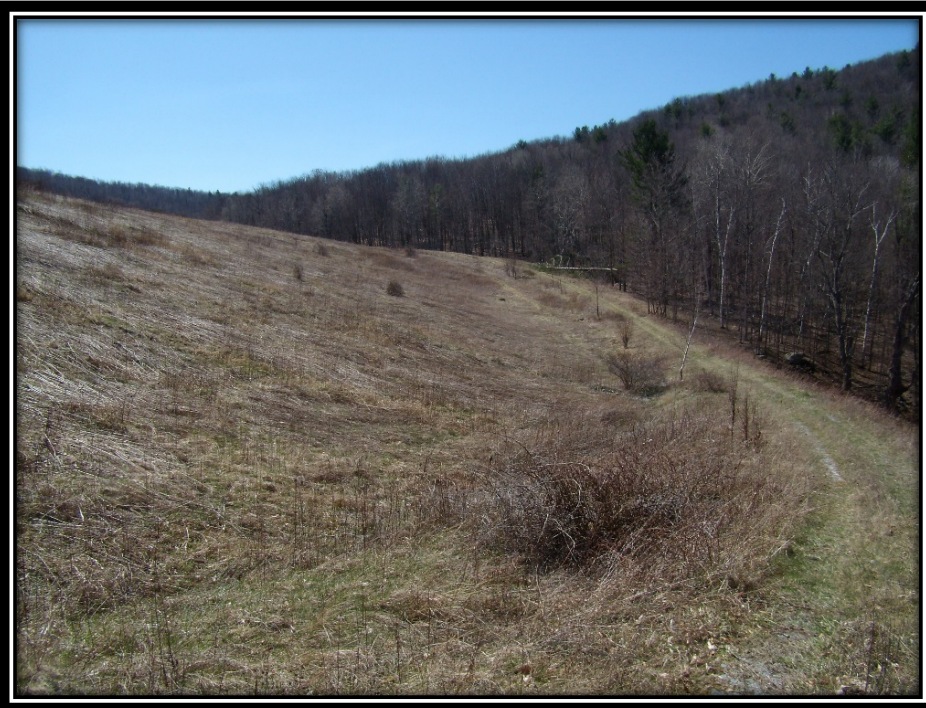
Photos 12 and 13:
Vegetation is growing within all of the stormwater features. This could eventually lead to erosion and slope stability issues if not addressed.

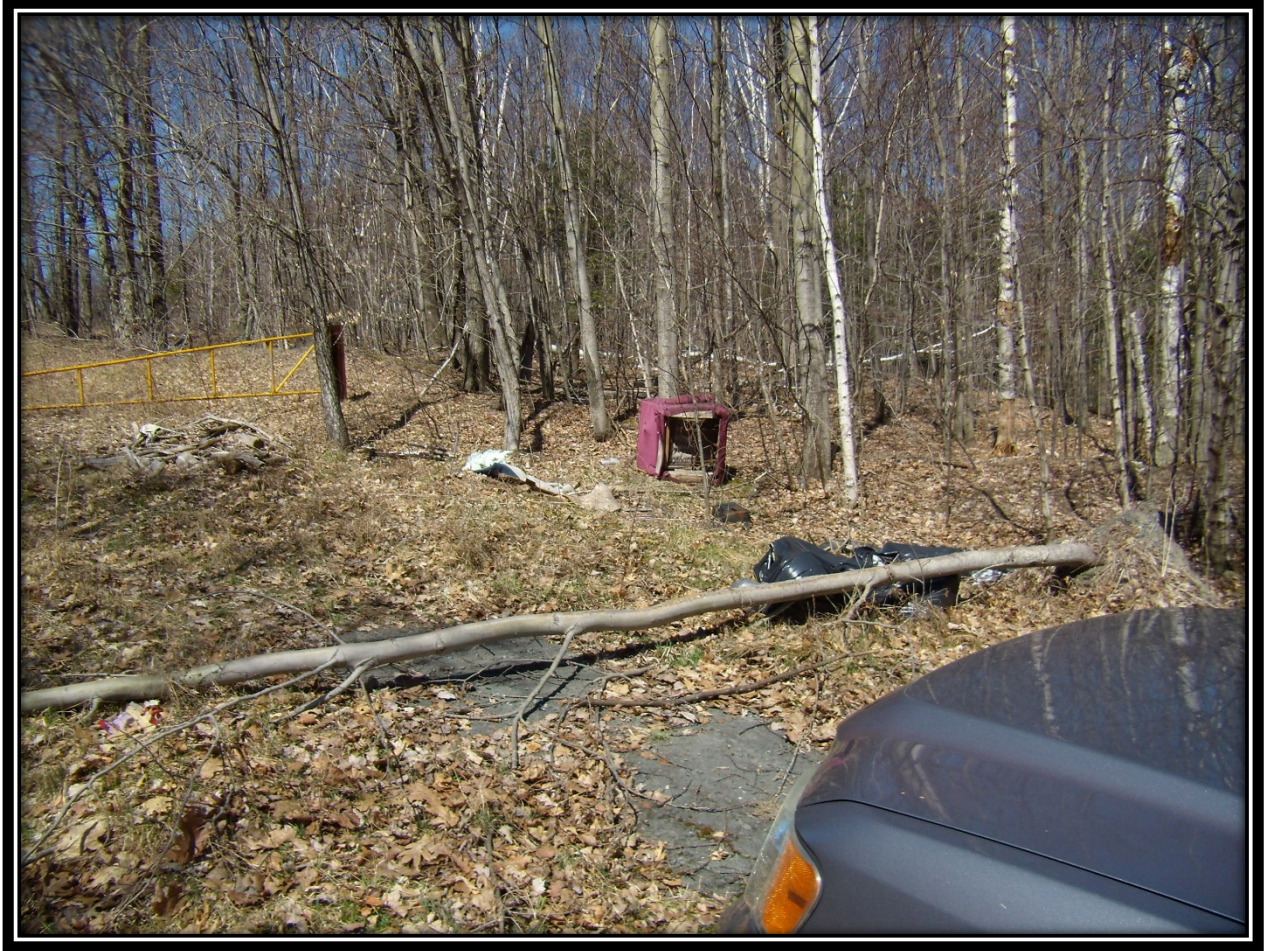
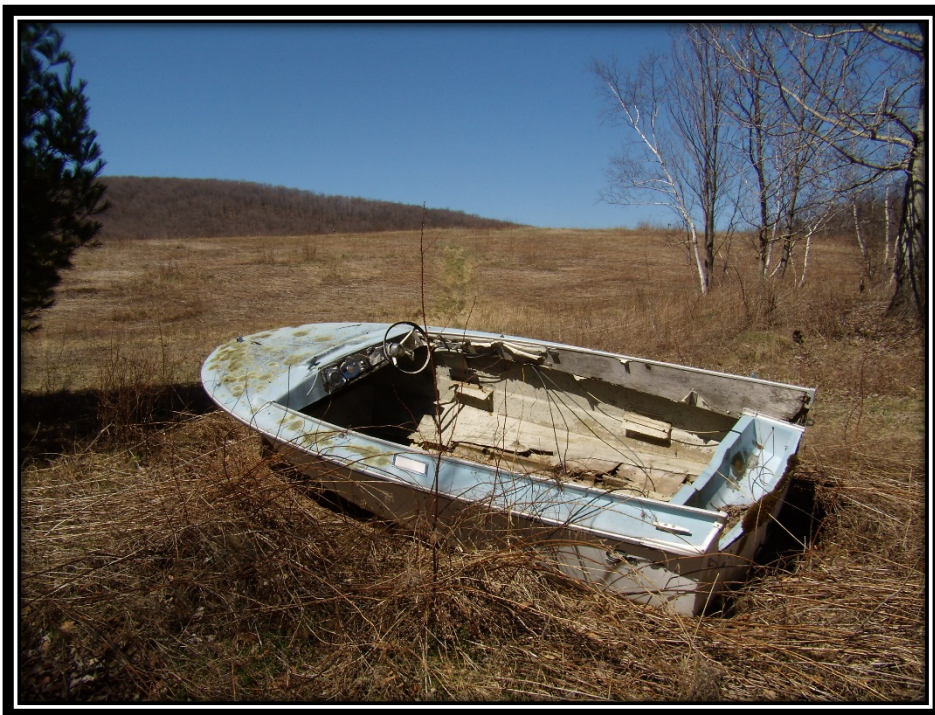
Photos 14 and 15:
Some illegal dumping has occurred near the entrances to the site indicating that the site could be better secured and/or patrolled by the Towns. However, impact from illegal dumping appears to be minor.
