SCE No. 09357.13

**Re: Review of Landfill Operations – Calendar Year 2021
Town of Conklin Landfill
Conklin, New York**

Project Name & Job Number: 2021 Conklin Landfill Annual Inspection 09357.13

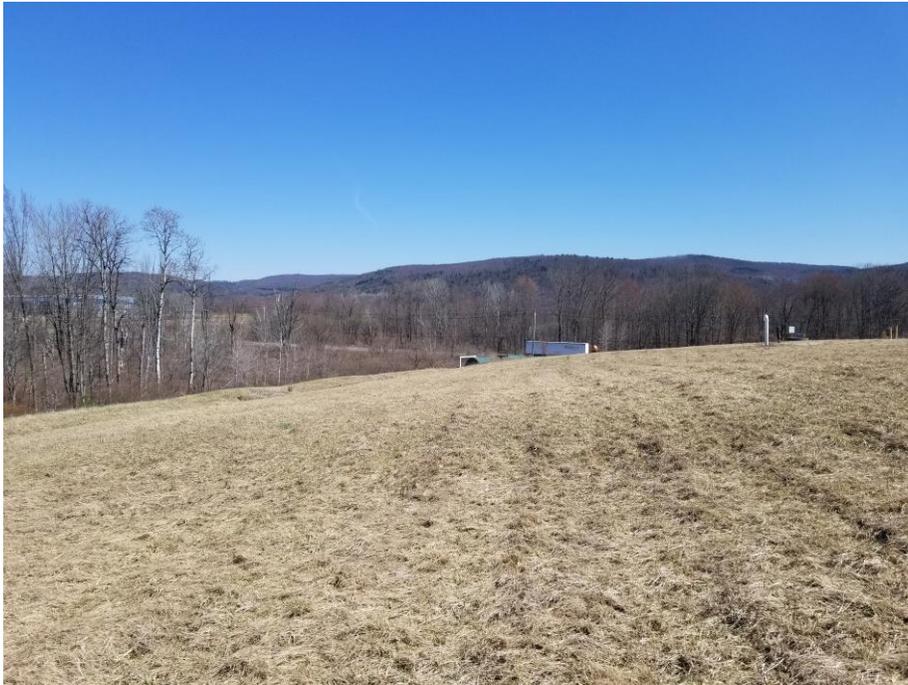
Photo Number: 1

Overall, the site appears to be in good condition. Mr. Delamarter reports that Town staff visually inspects the landfill monthly and makes repairs as needed. However, the Town does not retain a formal record of inspections and repair work performed. Town staff mows the landfill area approximately twice a year; this mowing schedule is adequate for maintaining a short shallow-rooted vegetative cover. Nonetheless, small shrubs and trees are taking root in the surface drainage swale where mowing is difficult; these trees and shrubs should be removed. Access roads have been maintained and they are traversable. The site entrance is maintained and accessible. The security fence is in generally good condition, though trees and shrubs should be cleared from the southwest perimeter to avoid compromising the integrity of the fence. Surface drainage features appeared to be stable and in good condition. The landfill cover appeared to be in good condition.

Photo Description: Cap Condition

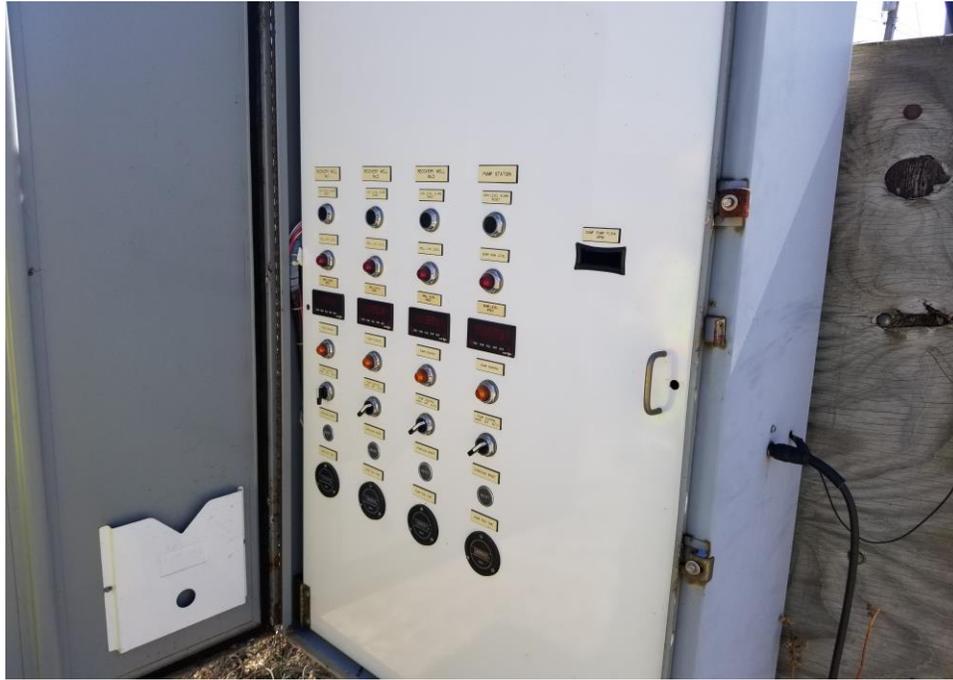
The operation of the leachate collection system was observed and tested during this field visit. All recovery wells appeared to be in working order, with the exception of Recovery Well No. 2. When checking the leachate collection pumps, Recovery Well No. 2 did not change from the initial reading. Recovery Well No. 2 should be inspected and repaired to make sure it is properly functioning.

Photo Number: 2
Photo Date: 03/30/2021
Photo Location: Control Panel
Direction Facing: NW
Photo Description: Control Panel Condition

- a. The level sensor in Recovery Well No. 2 should undergo a maintenance check to confirm proper operation.
- b. Monitoring well No. 4 is missing a cap. The cap should be replaced.
- c. Monitoring well 37 is now accessible and upright, but casing and riser are corroded and should be replaced.
- d. The leachate building flowmeter sensor was reading 'Error' when inspected. This flowmeter sensor should be repaired.
- e. As an ongoing recommendation, the Town should perform a limited amount of tree and brush removal outside of the perimeter fence, in order to ensure the long-term performance of the security fence.
- f. The rain skirt around the leachate collection tank should be re-installed to minimize rainwater accumulation within the secondary containment dike.
- g. Woody vegetation should be removed from the surface drainage swale to maintain the integrity of the landfill cap.

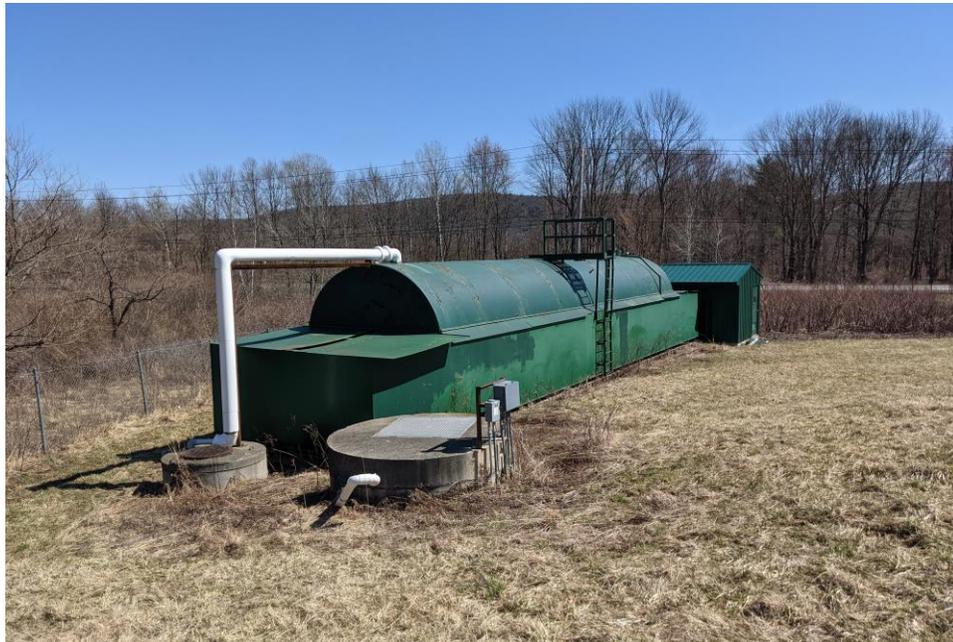
The leachate handling system was also inspected as part of this assessment. The exterior of the building that houses the leachate handling system was in good condition. No major structural or plumbing deficiencies were noted on the interior components. The secondary containment for the leachate tank has accumulated some stormwater from to the northern side of the rain skirt missing. This section of the rain skirt should be replaced and the secondary containment fully drained.

Photo Number: 3
Photo Date: 03/30/2021
Photo Location: NW Corner
Direction Facing: NW
Photo Description: Leachate Tank Condition

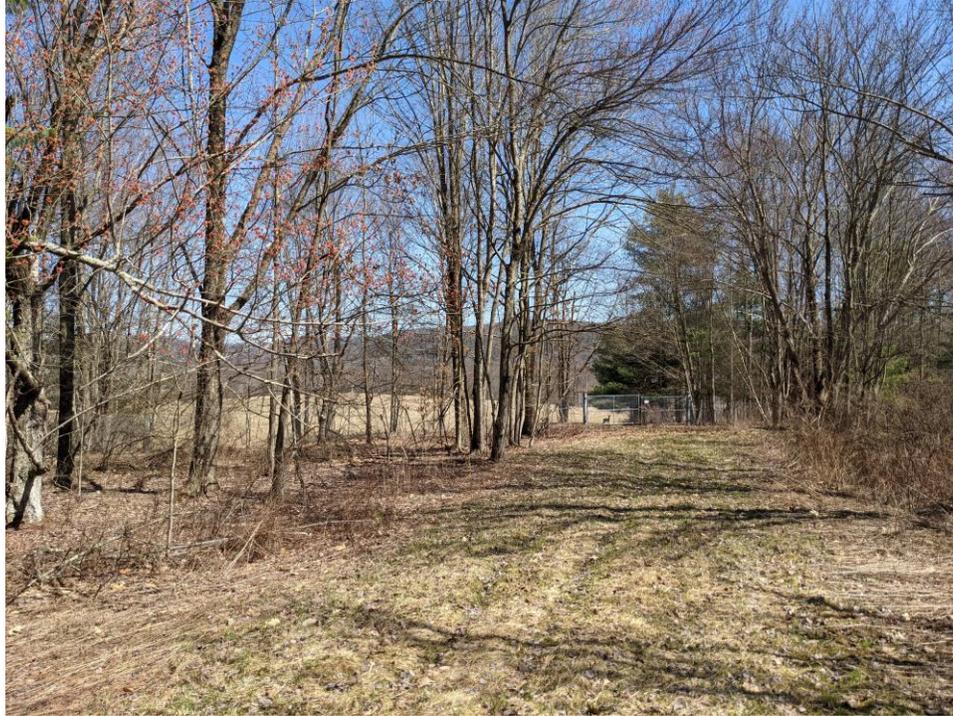
Photo Number: 4

Photo Description: Access Road and Gate Condition
