REPORT OF SOIL
EXCAVATION AND
REMEDIATION SYSTEM
INSTALLATION AT
2 BADGER AVENUE,
ENDICOTT, NEW YORK

AUGUST 1993

BUCK ENGINEERING
PO BOX 5150
3845 ROUTE 11 SOUTH
CORTLAND, NEW YORK 13045
607-753-3403

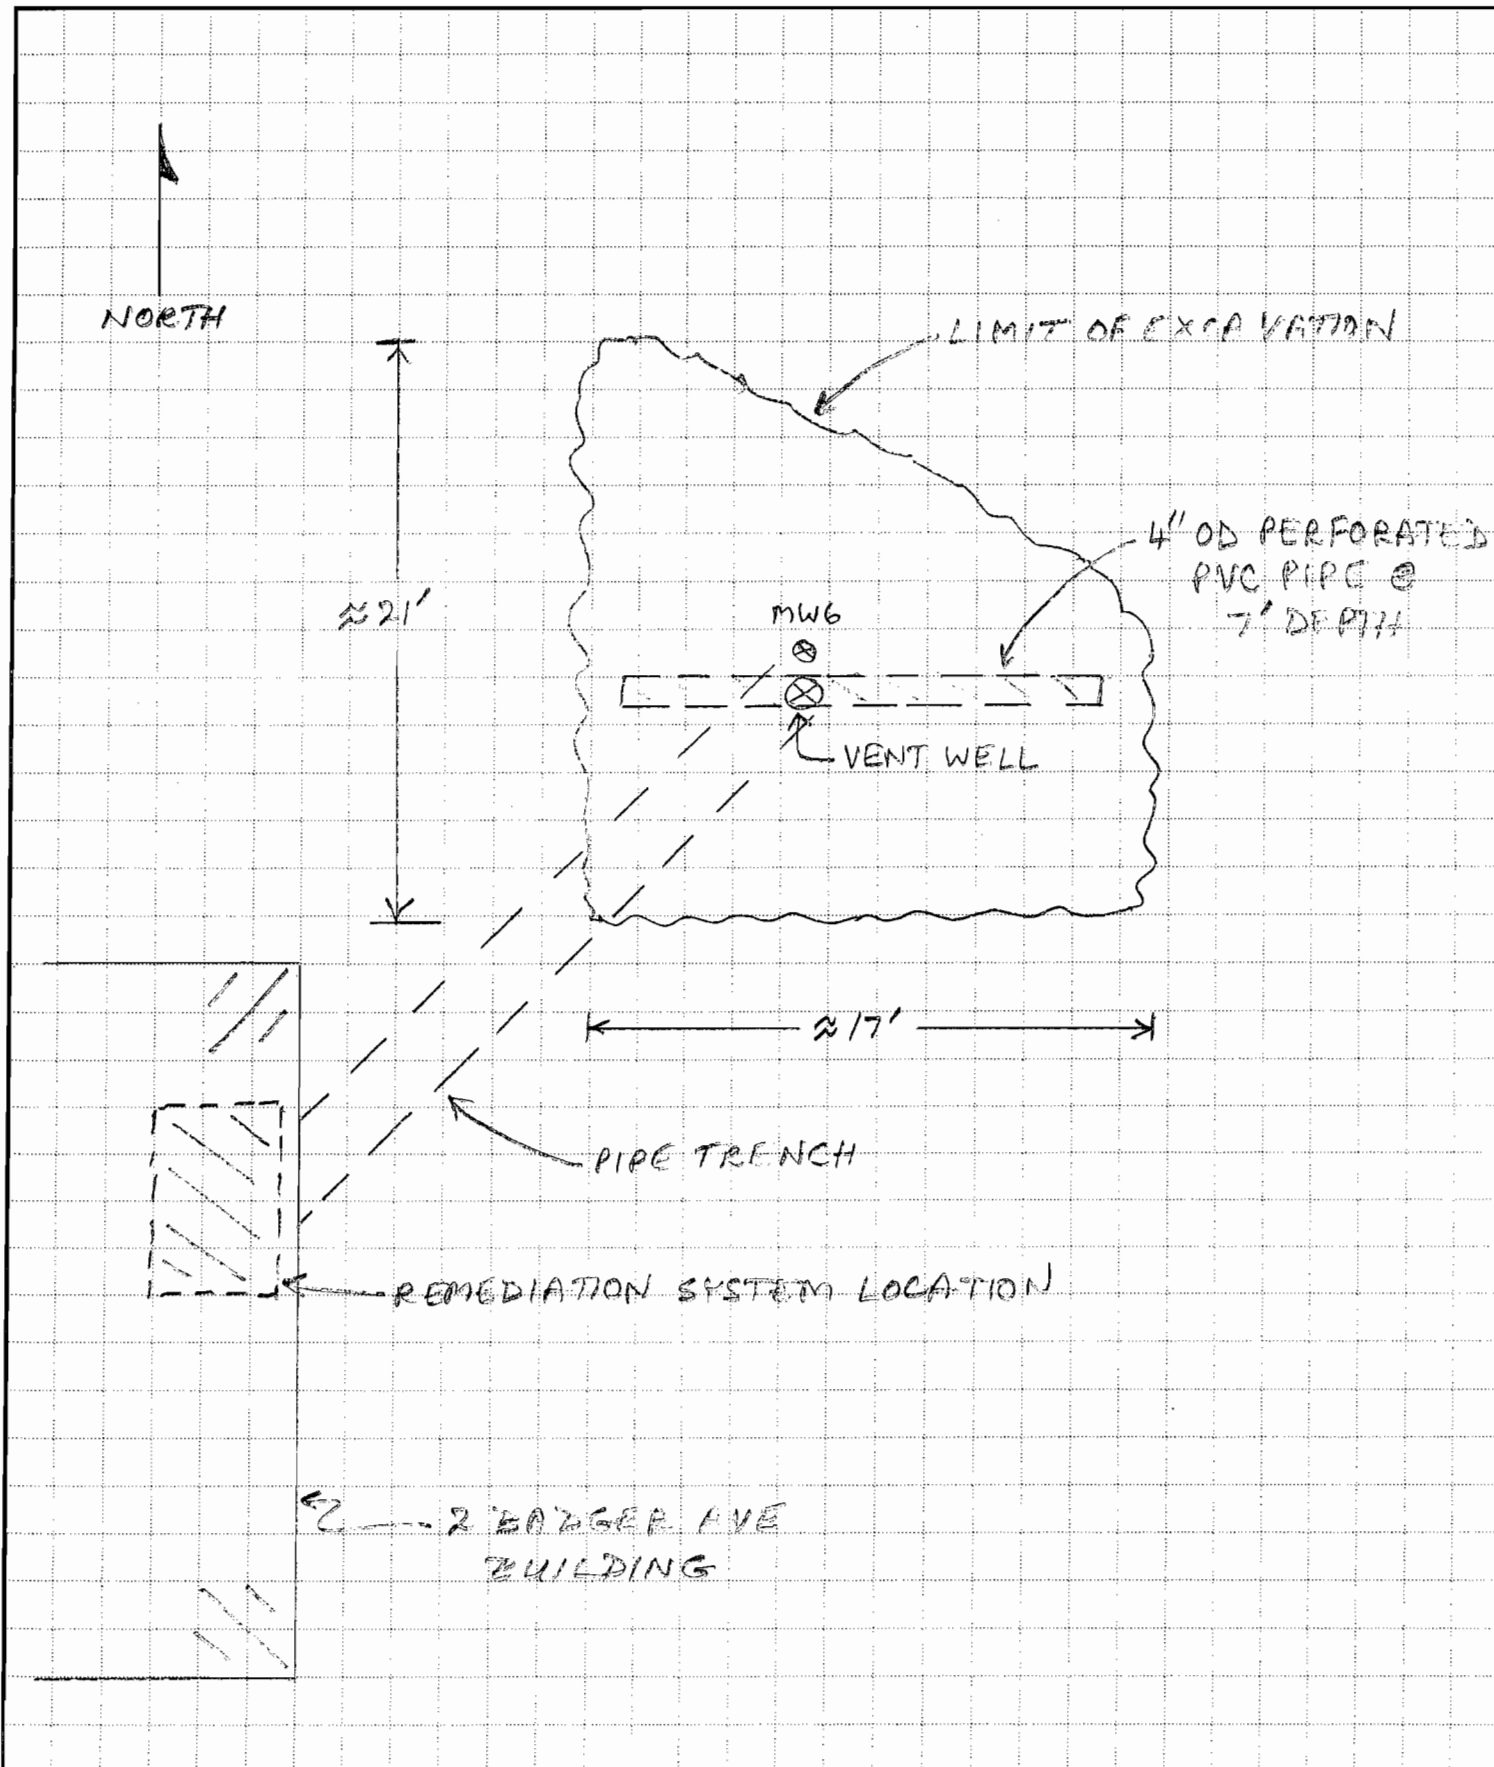
SHEET NO. SOIL EXCAVATION AREA

Additional excavation was performed in the area south of monitoring well 6. This excavation revealed a limited area (200 to 300 sq. ft.) in size that had apparently been used in the past as a dump or refuse pile. The soil in the area was black and contained wire fencing, bits of cloth, broken glass, pieces of metal and other miscellaneous objects. The subject materials were located at a depth of 1 to 2.5 ft. beneath the surface. There was a noticeable odor from the excavation. The highest HNu meter readings from this material were in excess of 20 ppm (parts per million).

The suspect material was removed from the excavation and staged on plastic sheeting for later off-site disposal. An estimated 30 cu. yd. of soil and refuse was excavated. The total depth of the excavation was approximately 6 ft. After the contaminated material was removed from the excavation, the soil in the bottom of the pit was checked with the HNu meter and no readings were obtained. A soil sample from the bottom of the excavation was obtained for laboratory analysis.

An east/west trench was excavated in the bottom of the pit to a depth of approximately 7 ft. beneath the surface. Approximately 13 ft. of perforated 4 in. diameter PVC pipe

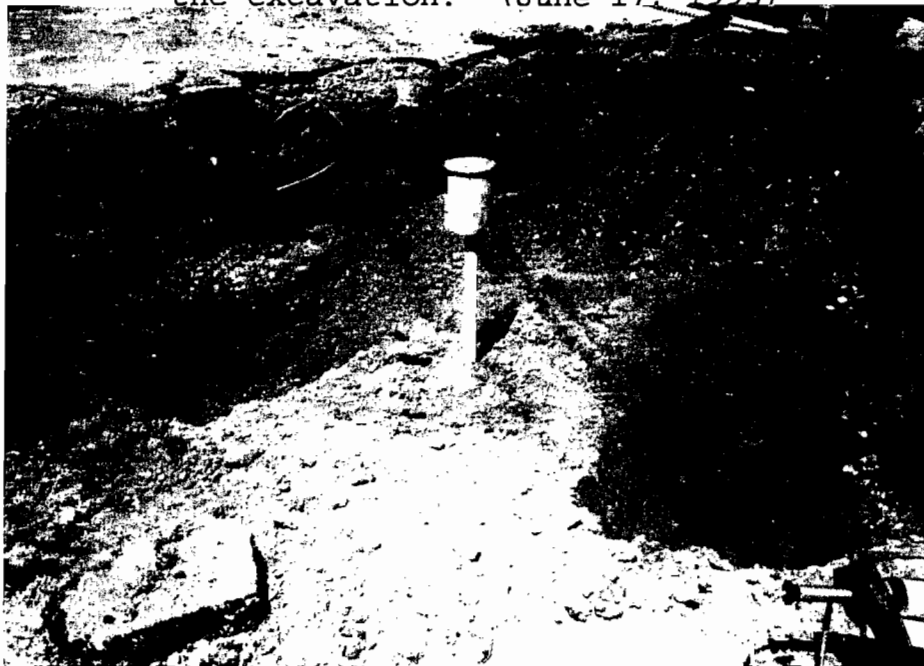
Photograph of the soil excavation taken from the southeast corner of the excavation, looking northwest. Monitoring well 6 is visible in the center of the excavation. (June 17, 1993)

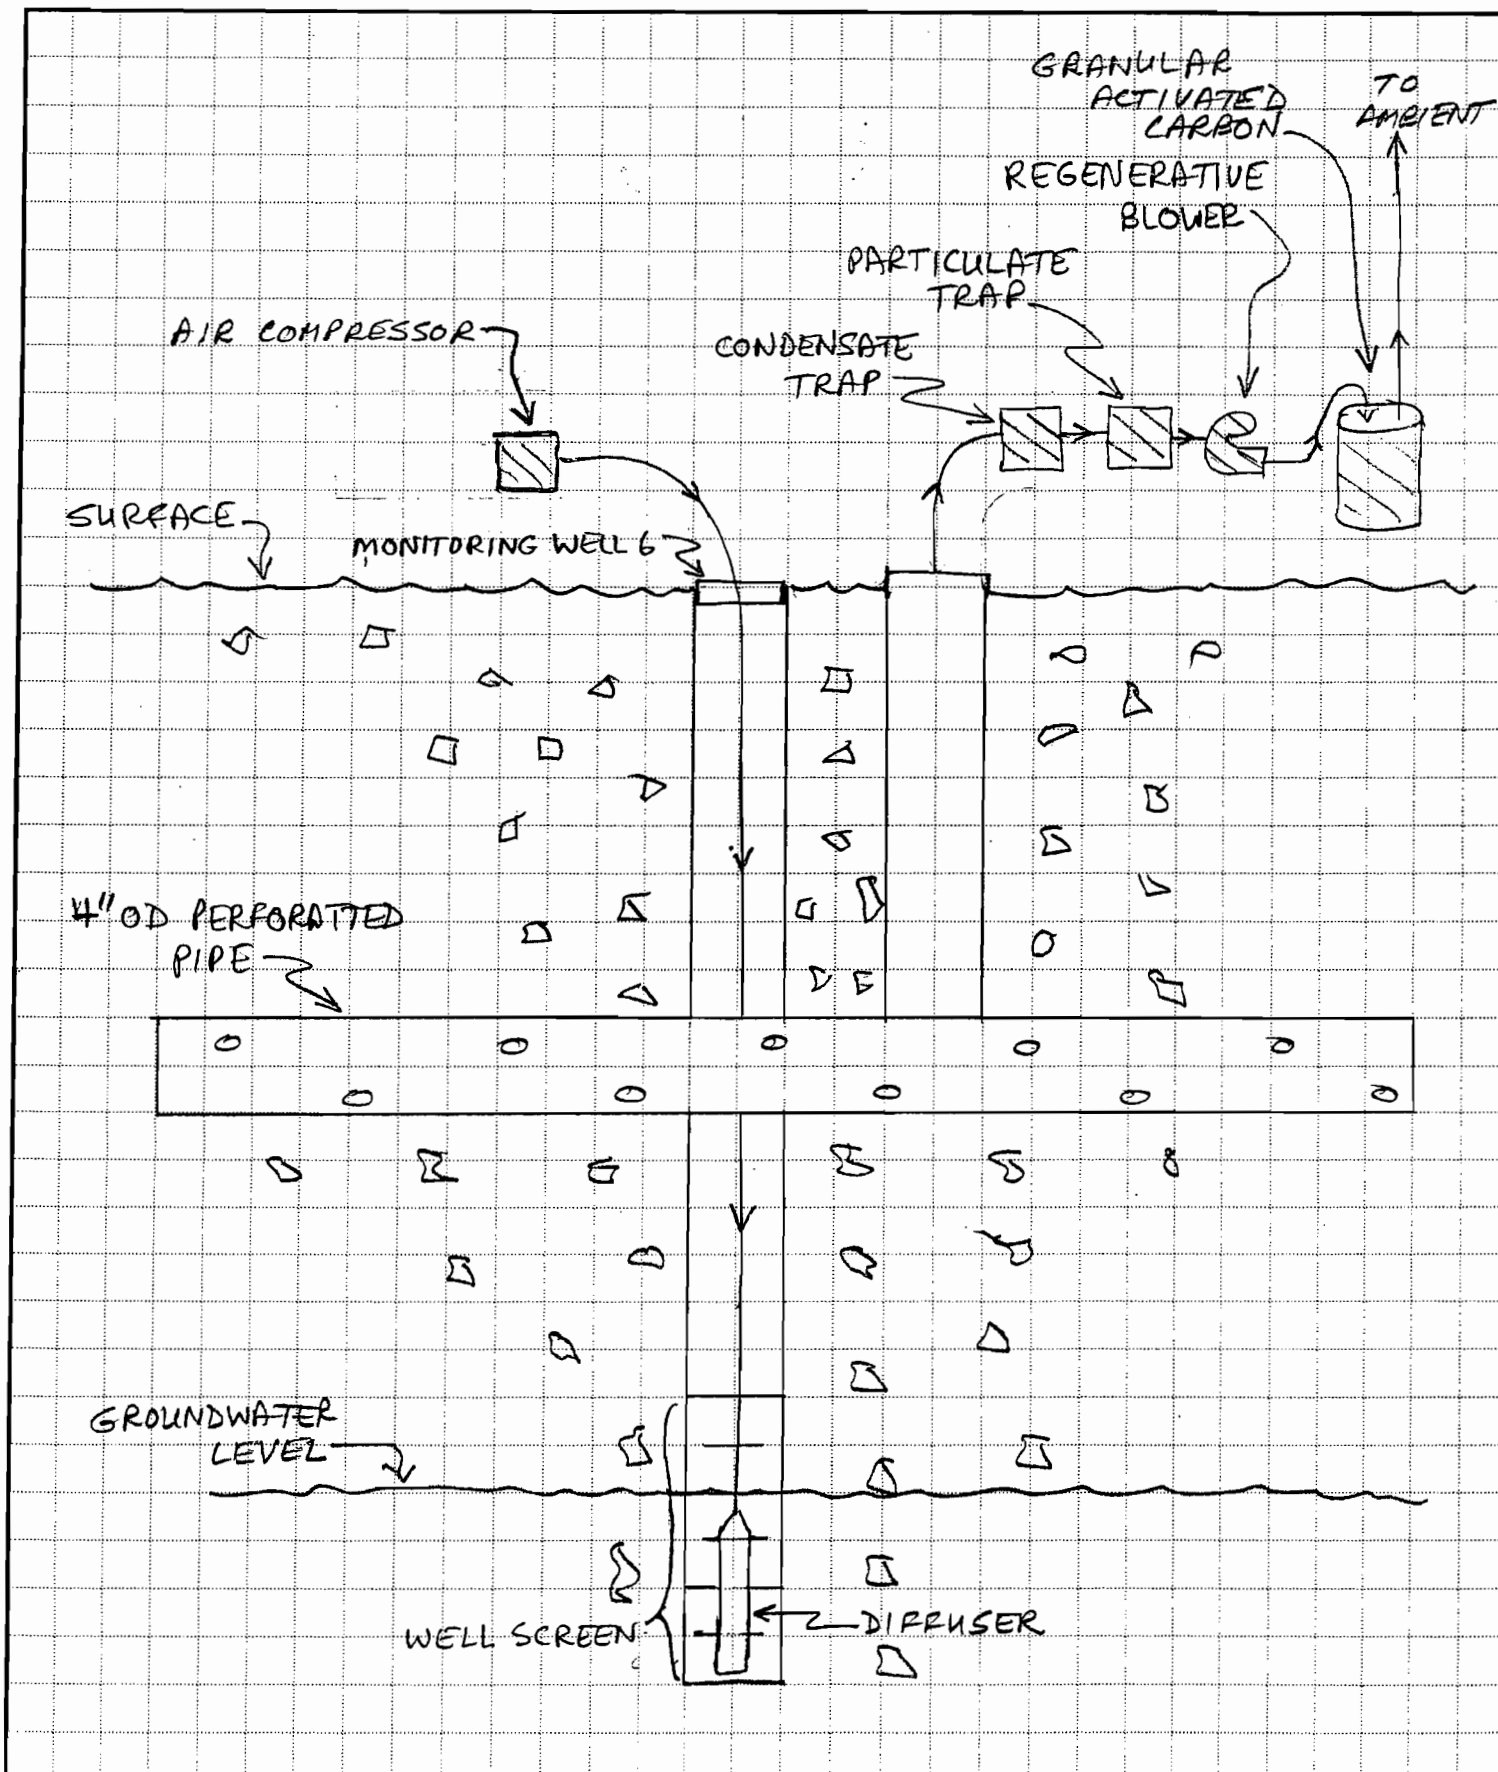
SHEET NO. SCHEMATIC DIAGRAM

The second pipe is connected to the 4 in. vent well and through the trench into the interior of the building where it is connected to a regenerative blower. The blower, specifically designed for use in soil vapor extraction systems, will create a negative pressure in the vent well, causing soil vapor to be withdrawn from the surrounding soil and groundwater. A particulate trap and a condensate trap are in series between the vent well and the blower to remove condensate or particulate that may be drawn from the vent well.

The blower exhaust is connected to a 55 gal. drum of granulated activated carbon. Soil vapor drawn from the vent well, after passing through the filters and blower, is passed through the activated carbon to remove volatile organic compounds before the vapor is released to the outside ambient air. The exhaust from the carbon barrel leads to an exhaust line that is routed out through the front wall of the building and up to roof level.

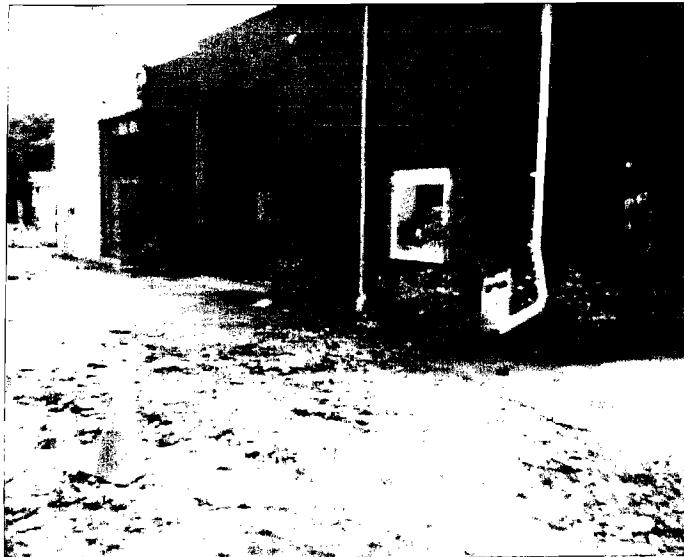
Photograph of the front of the 2 Badger Avenue building. The orange cone marks the site of the vent well. The white pipe on the front of the building to the left of the window is the system exhaust line. (August 20, 1993)

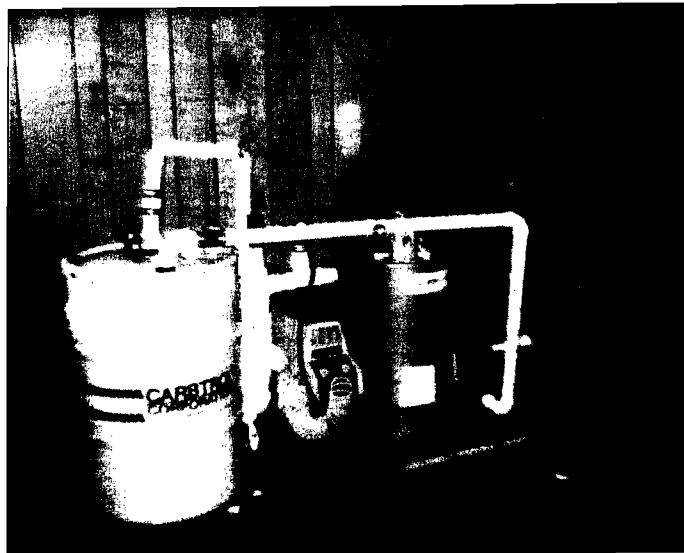
Photograph of the remediation system components inside the 2 Badger Avenue building. The components, from left to right are: carbon drum, air compressor, condensate trap, particulate trap, regenerative blower. (August 20, 1993)
