**MAESTRI SITE
904 State Fair Boulevard
Geddes, NY
NYSDEC Site: 7-34-025**

PERIODIC REVIEW REPORT

January 2016

Envirospec Engineering Project E12-621

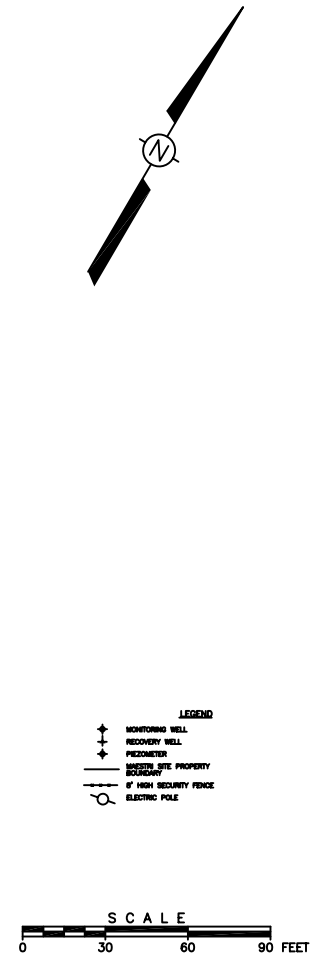
FIGURE 1
SITE PLAN
2008
MAESTRI SITE
904 STATE FAIR BLVD.
GEDDES, NEW YORK

The Site is located at 904 State Fair Boulevard, Geddes, NY, approximately three (3) miles west of Syracuse. The portion of the Site that is still actively monitored is approximately 2.5 acres. The Site is bordered by State Fair Boulevard to the southwest and residences along Alhan Parkway to the northeast. Vacant, wooded lots border the Site to the northwest and the southeast. This area is fenced as shown in Figure 1.
